# **An Evaluation of HTV-SR Insulators with Different Creepage Lengths under AC and Bipolar DC in Marine Polluted Service Conditions**

*Thesis presented in partial fulfilment of the requirements for the degree Master of Science in Engineering at the University of Stellenbosch*

This study was conducted at the Koeberg Insulator Pollution Test Station (KIPTS) on the west coast of Cape Town in the Western Cape province of South Africa. KIPTS is an internationally recognized insulator pollution test facility, which is widely used by both insulator manufacturers and academic researchers from many parts of the world. STRI and ABB, both Swedish-based companies, are good examples of international subscribers to the KIPTS research facility. The first objective of this research was to design a suitable DC excitation voltage system for both DC+ and DC- to be used at KIPTS. This apparatus was designed and built at the University of Stellenbosch. The second objective was to conduct a comparative evaluation of the performance of high temperature vulcanized silicone rubber (HTV-SR) power line insulators under AC, DC+

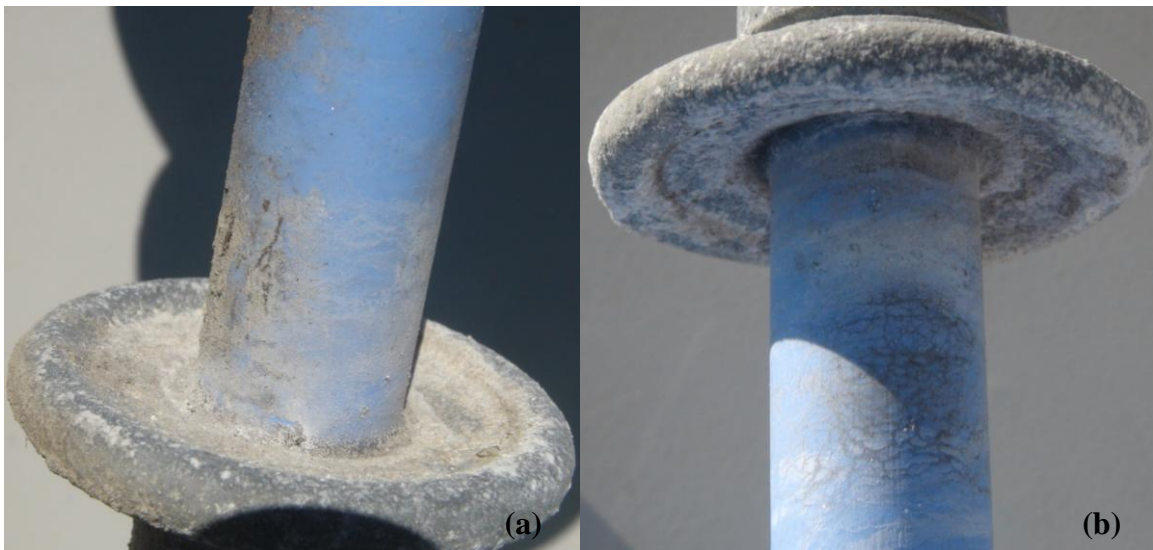
**Figure E-30: Material erosion on the sheath interfacing with the live end-fitting and (b) light crazing on the sheath interfacing with the ground end-fitting (Week 9)**

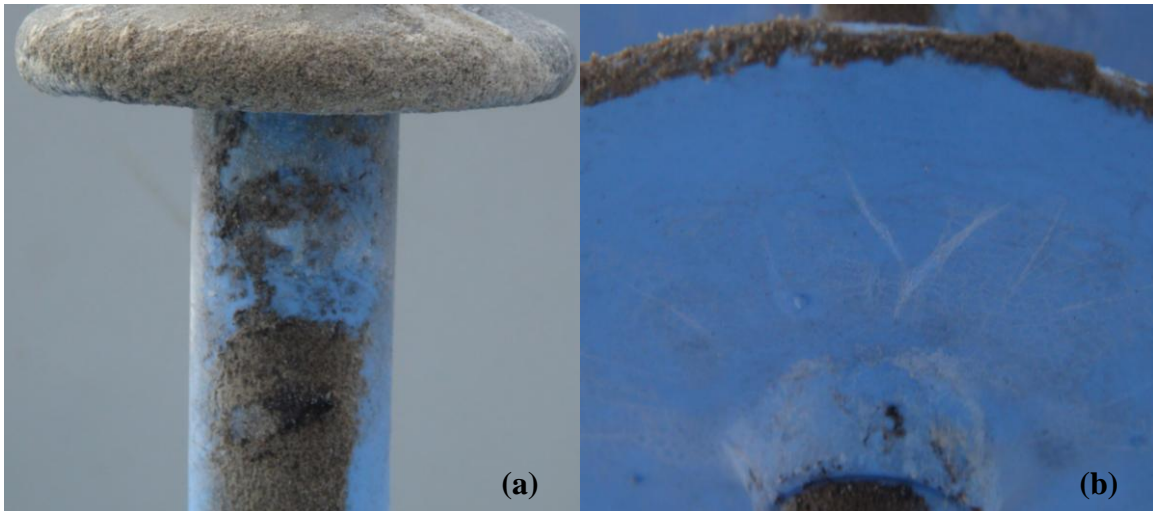
**Figure E-31: (a) Dark burns on pollution layer on the sheath interfacing with the ground end-fitting and (b) drybands on the shed bottom of HTV-SR 84 DC+ (Week 8)**

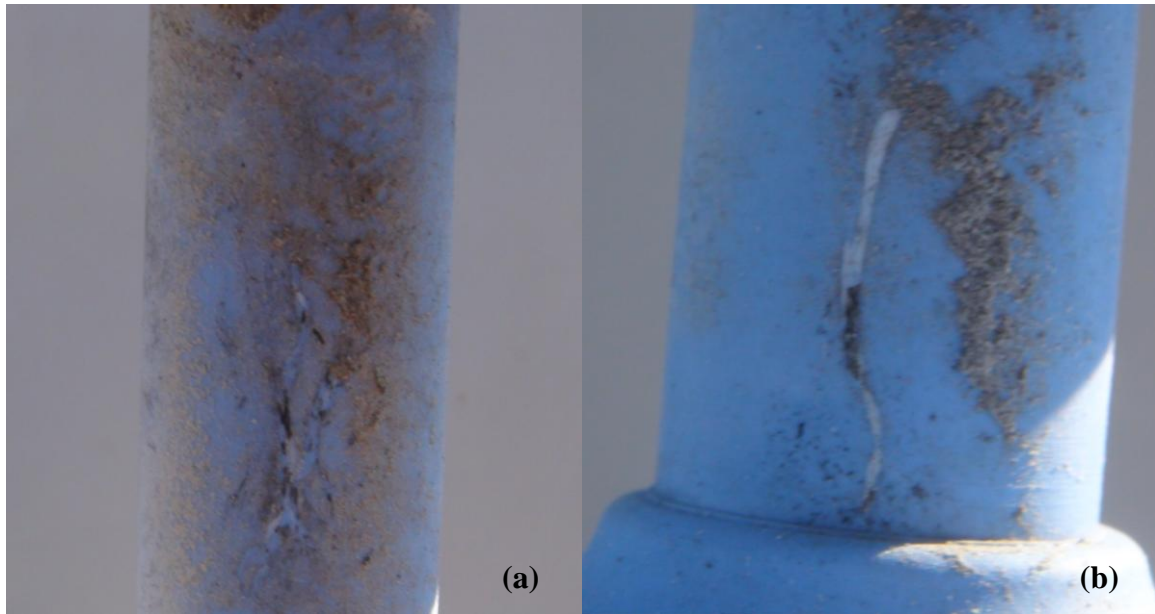
**Figure E-50: Material erosion on (a) sheath 3 and (b) sheath 5 in the southward direction (Week 13)**

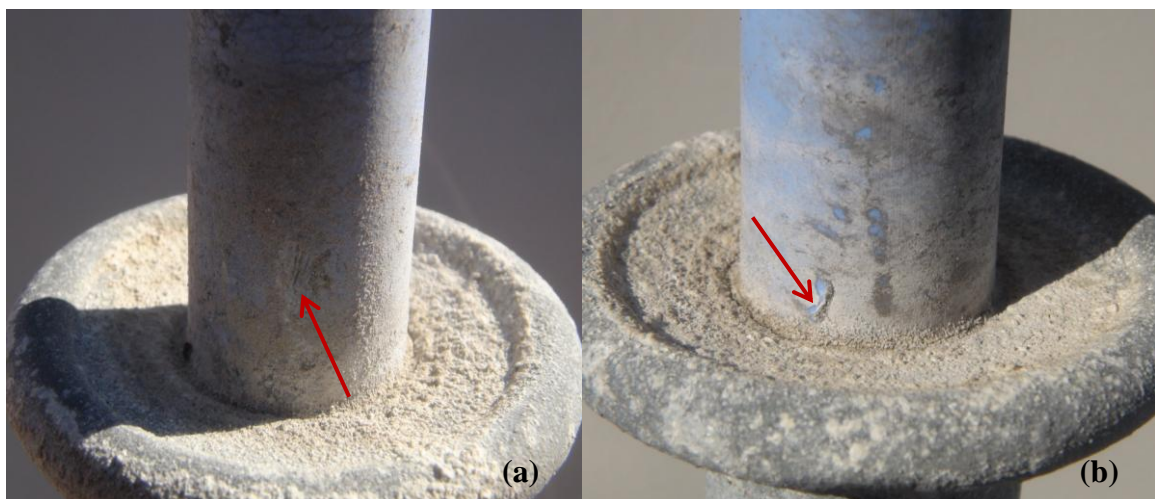
**Figure E-51: Material erosion on the sheath interfacing with the live end-fitting in the (a) southward and (b) northward directions (Week 13)**

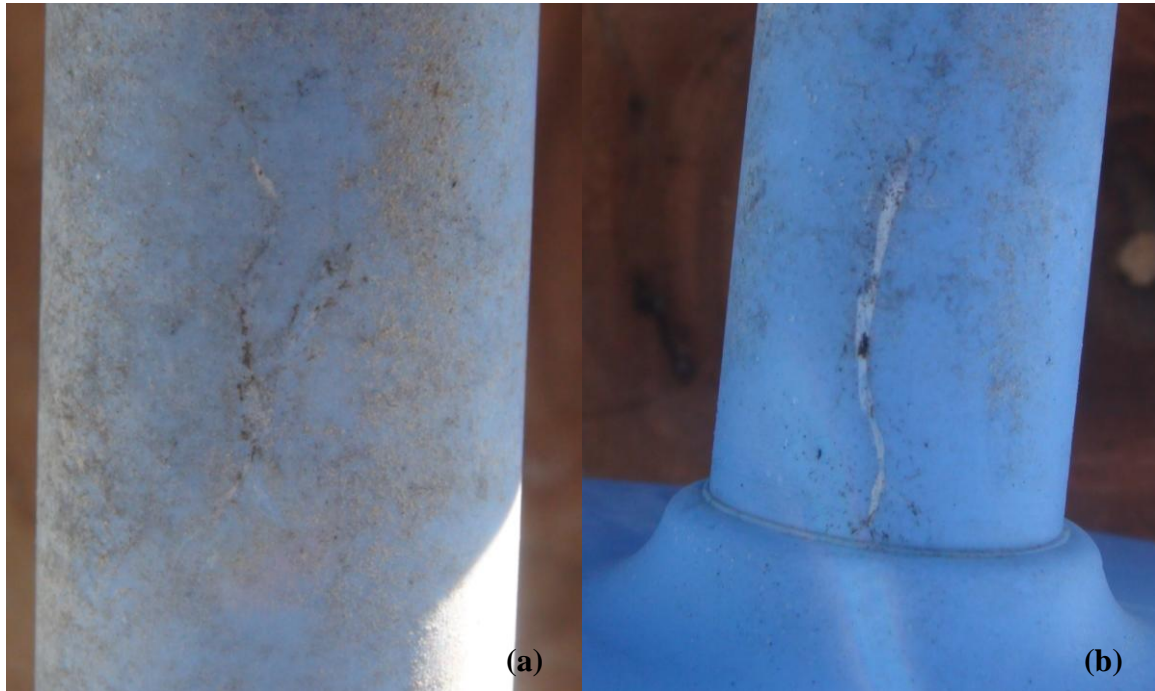
**Figure E-55: Material erosion on (a) sheath 3 and (b) sheath 5 in the southward direction (Week 22)**

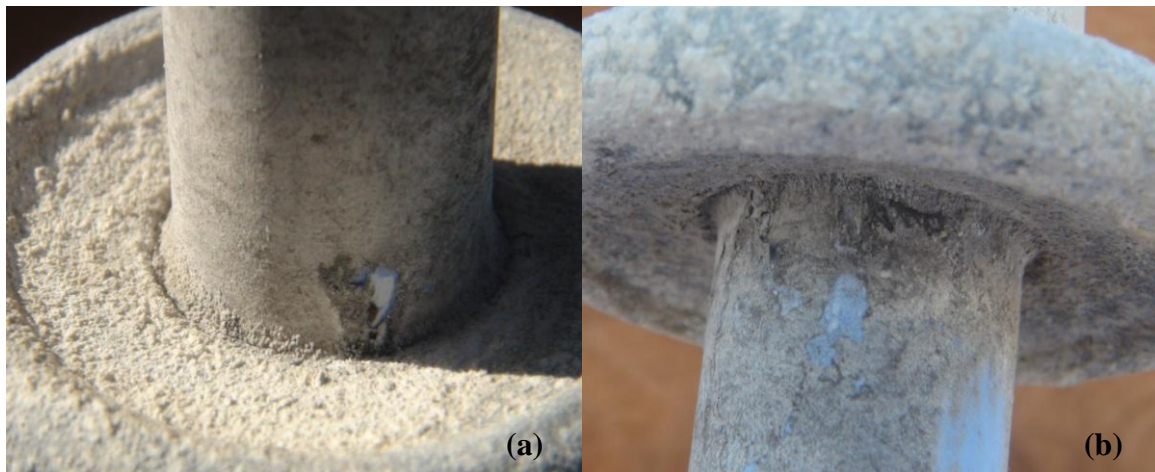
**Figure E-56: Material erosion on the sheaths interfacing with the (a) live end-fitting and (b) ground end-fitting (Week 22)**

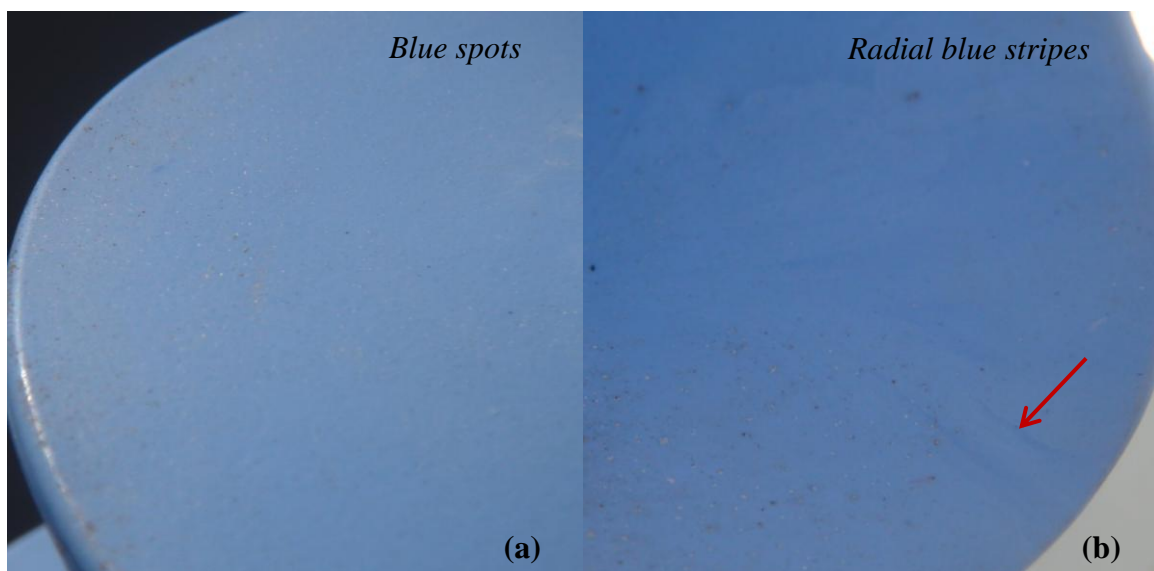
**Figure E-59: Some form of discoloration on the shed top in patterns of darker blue (a) spot and (b) radial patches (Week 16) (please zoom in)**

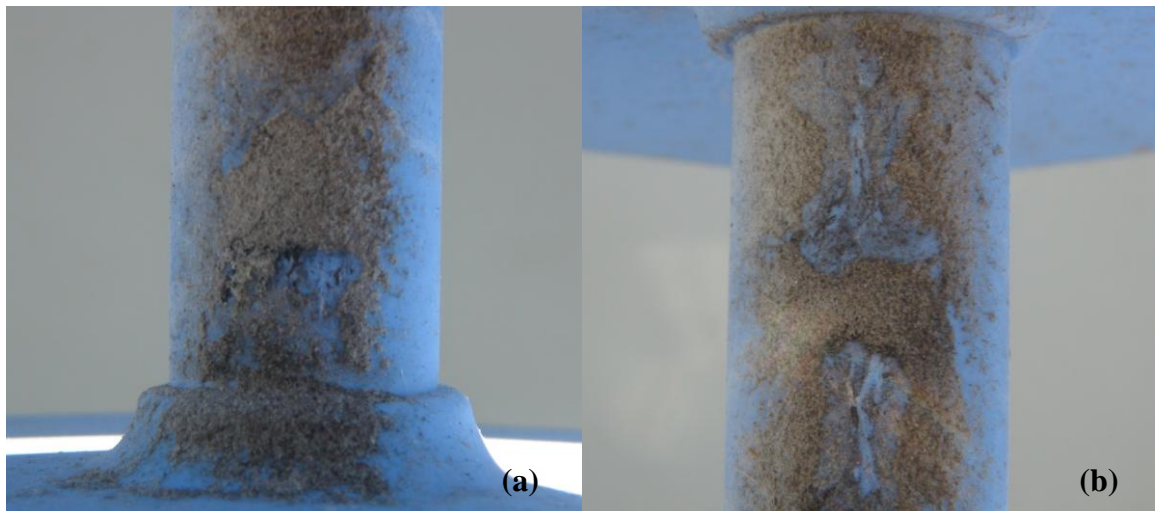
**Figure E-63: Material erosion on (a) sheath 3 and (b) sheath 4 in the southward direction (Week 9)**

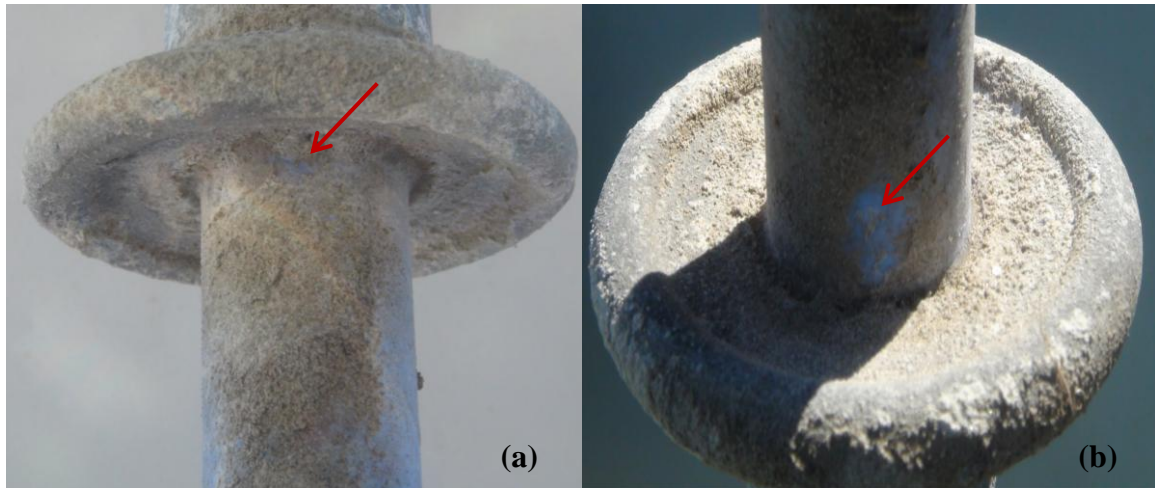
**Figure E-66: Instances of material erosion observed on the sheaths interfacing with both the (a) ground and (b) live end-fittings (Week 11)**

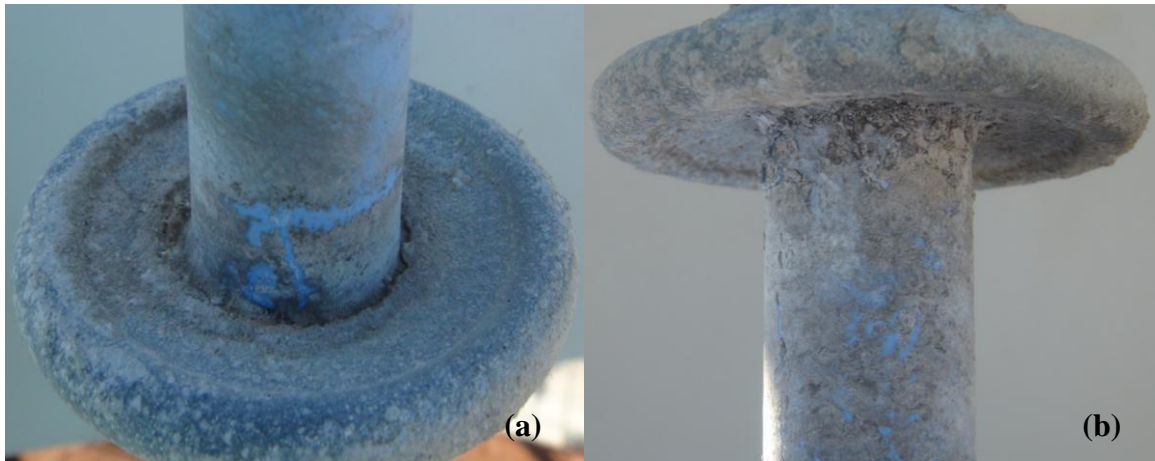
**Figure E-70: Material erosion observed on the sheaths interfacing with both the (a) live and (b) ground end-fittings (Week 18)**

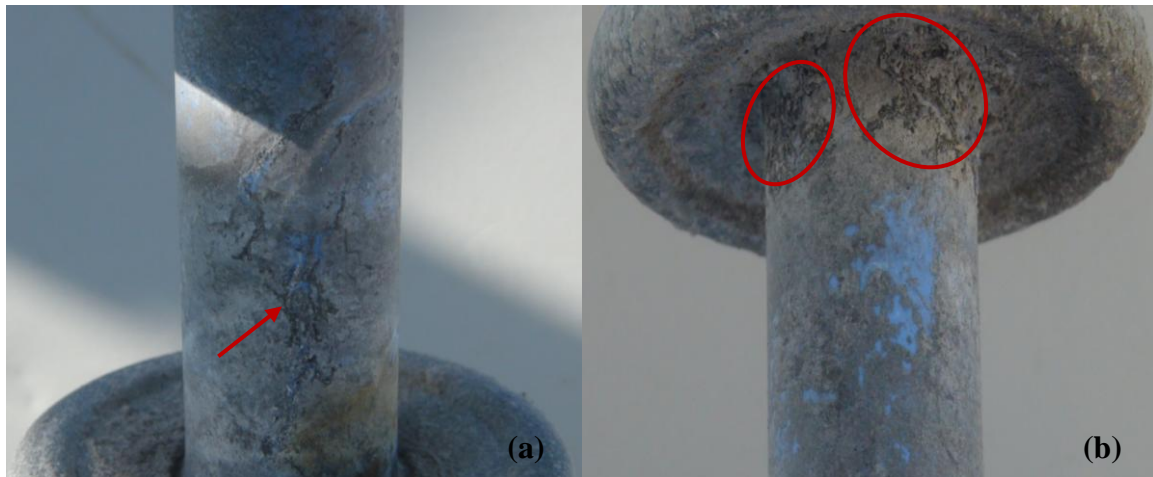
**Figure E-81: Material erosion on the sheaths interfacing with both the (a) live and (b) ground end-fitting (Week 18)**

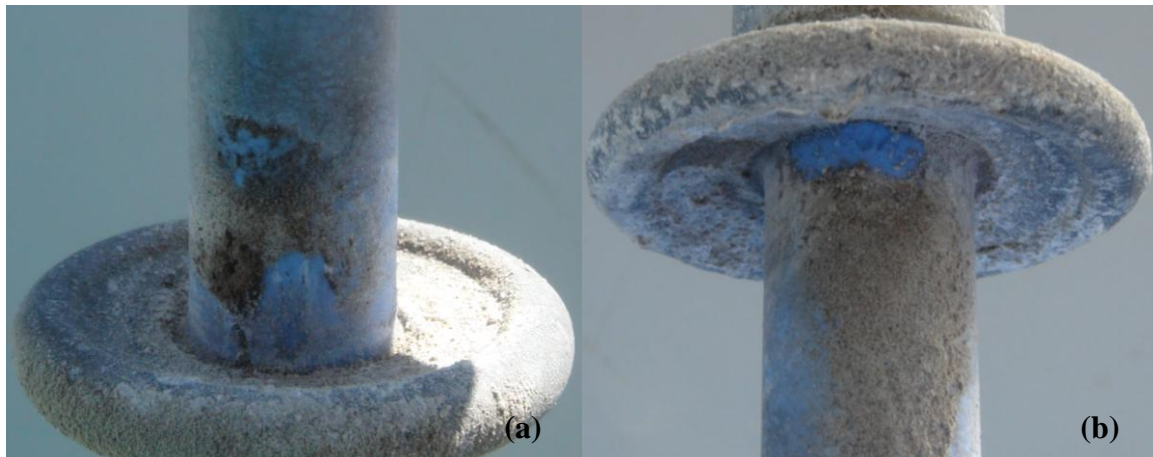
**Figure E-85: The first signs of erosion on the sheaths interfacing with both the (a) live and (b) ground end-fittings in the southward direction (week 8)**

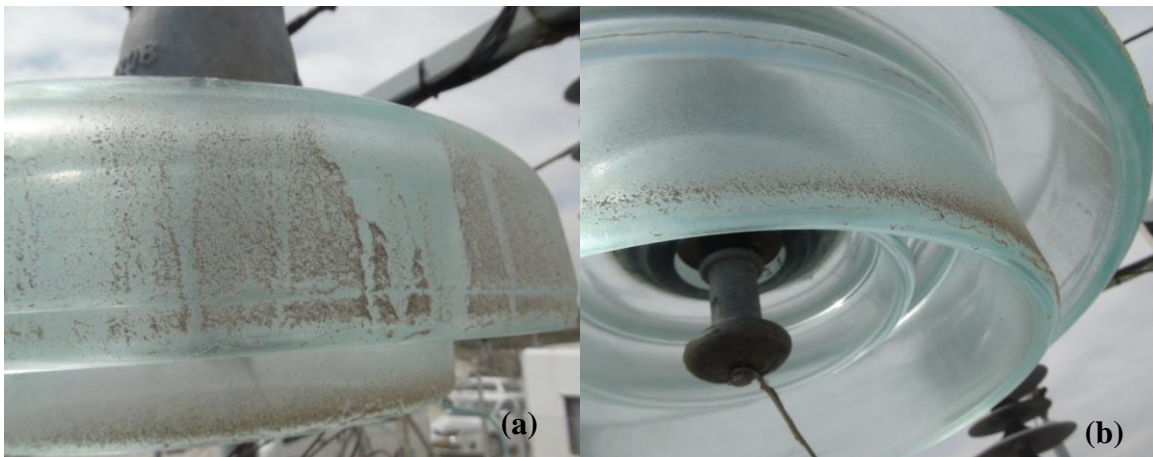
**Figure E-91: Pollution conditions on the (a) top and (b) bottom of glass disc (Week 5)**

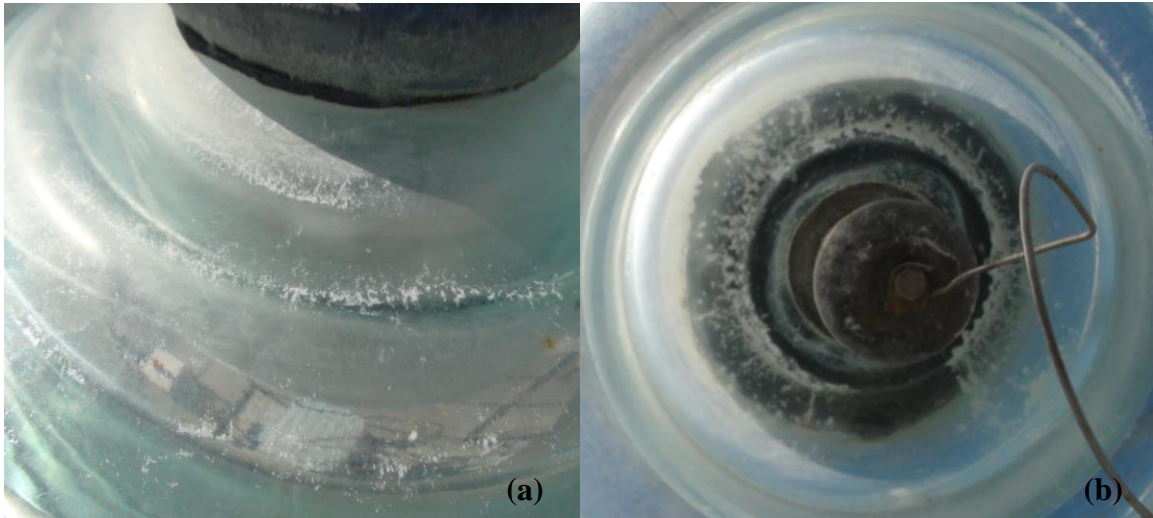
**Figure E-101: (a) Traces of dryband activity on the top of glass disc around the cap and (b) the signs of dryband activity and material erosion on the bottom side around the pin (Week 18)**
