**An Independent Review and Summary of Geotechnical
Information Pertaining to the Sidewall Stability of the
Kimberley “Big Hole” Mine, with Specific Focus on the
Weathering and Deterioration of the Kimberley shales.**

*Thesis presented in fulfilment of the requirements for the degree of Master of Engineering
in the Faculty of Civil Engineering at Stellenbosch University*

December 2017

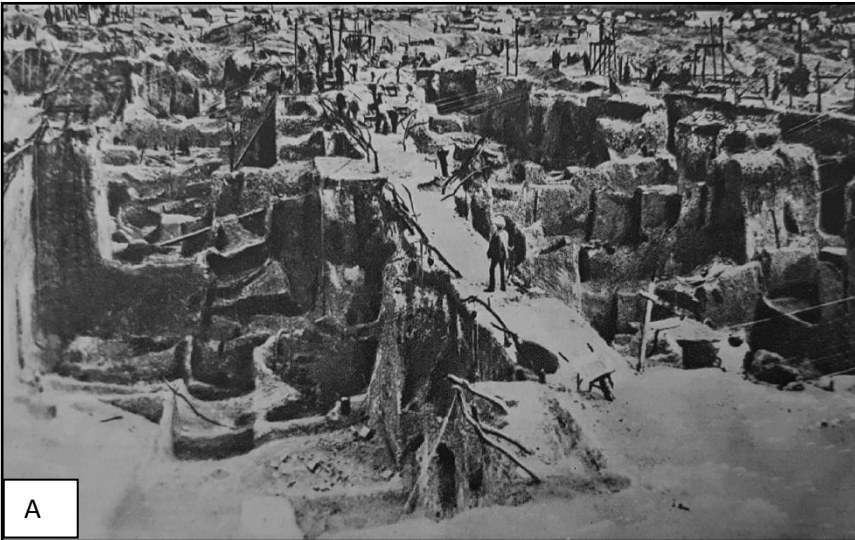
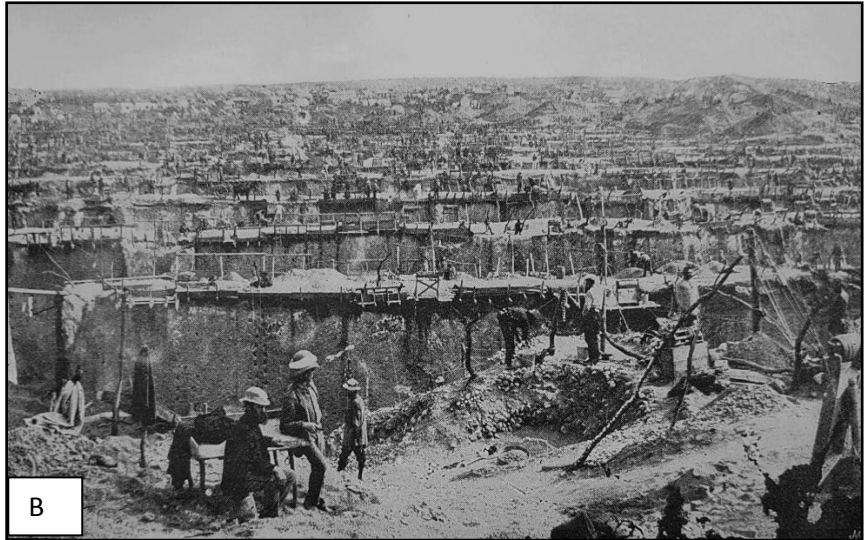
Figures 1 A & B - An illustration of the 5 meter roadways that was used to increase safety and effectiveness of individual mining operations at the Kimberley "Big Hole" Mine back in 1871 (Chilvers, 1938).

At first, individual claims at the Kimberley “Big Hole” Mine were limited to squares of approximately 10 meters, which tightly crisscrossed the “pipe” in all directions. As dozens of individual pits fell deeper and deeper into the center of the mine problems started to arise due to the fast developing honeycomb structure and overcrowding of the ever-growing “Big Hole” (Herbert, 1972). In order to reduce the number of mining fatalities and improve on the productiveness of the early mining operations at the Kimberley Mine, a newly found Digger’s Committee decided that 5-meter roadways had to be left right across the area every 15 meters as illustrated below in Figures 1 A and B.

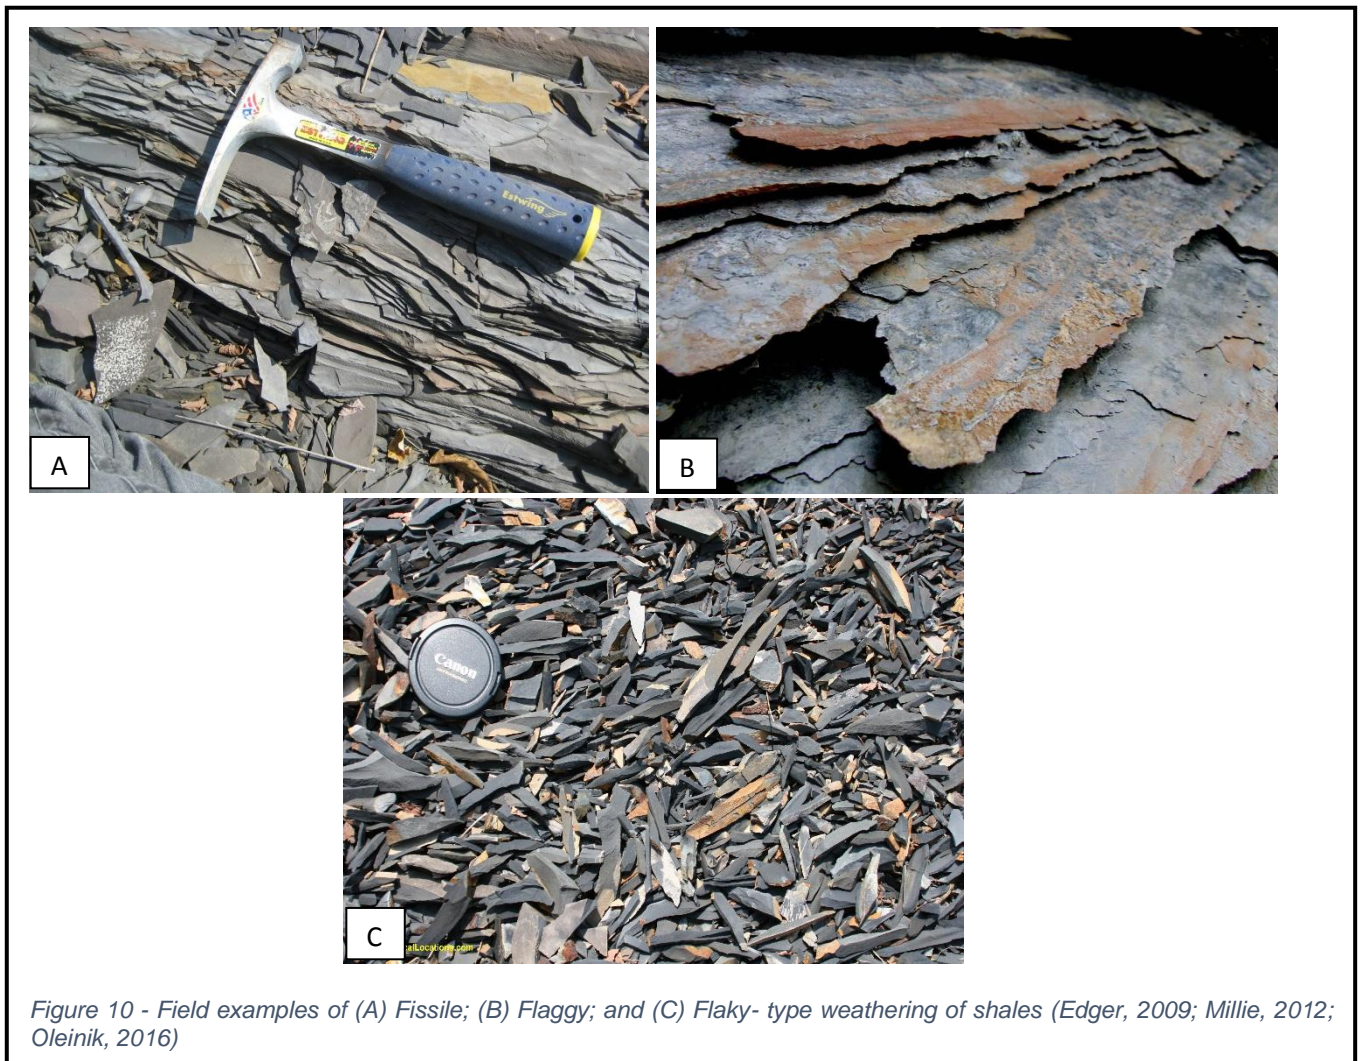
- **Fissile:** Denotes the ability of shales to split approximately parrallel to their bedding planes (see Figure 10 A).
- **Flaggy:** Denotes the ability of shales to split in such a fashion that the length and the width of the slabs are much greater than their actual thickness (see Figure 10 B).
- **Flaky:** Denotes the tendency of shales to break into smaller chips, flakes, wedges or fragments (see Figure 10 C).

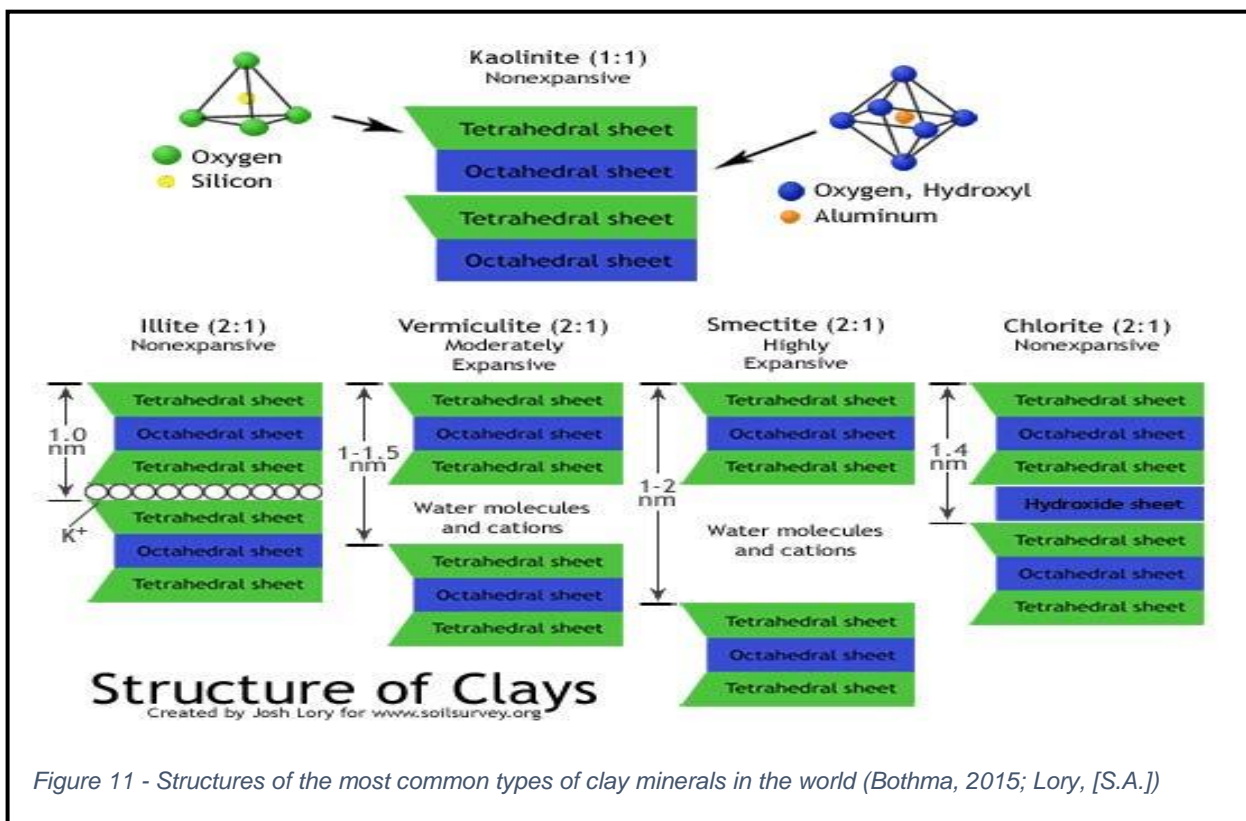
Figure 11 - Structures of the most common types of clay minerals in the world (Bothma, 2015; Lory, [S.A.]

According to Knappett and Craig (2012), the basic structural unit of most clay minerals are a silicon-oxygen tetrahedron and an aluminum-hydroxyl octahedron, which combine together to form different molecular sheet structures as illustrated in Figure 11. These tetrahedral units interact with the sharing of oxygen ions to form a silica sheet, whilst the octahedral units combine by sharing hydroxyl ions to form gibbsite sheets. The way in which the different layers are then formed, is by the bonding of a single silica sheet with either one or two gibbsite sheets. As a result, different types of clay mineral particles are formed by different stacks of these layered structures, which have different forms of bonding between them (Knappett & Craig, 2012; Bothma, 2015).

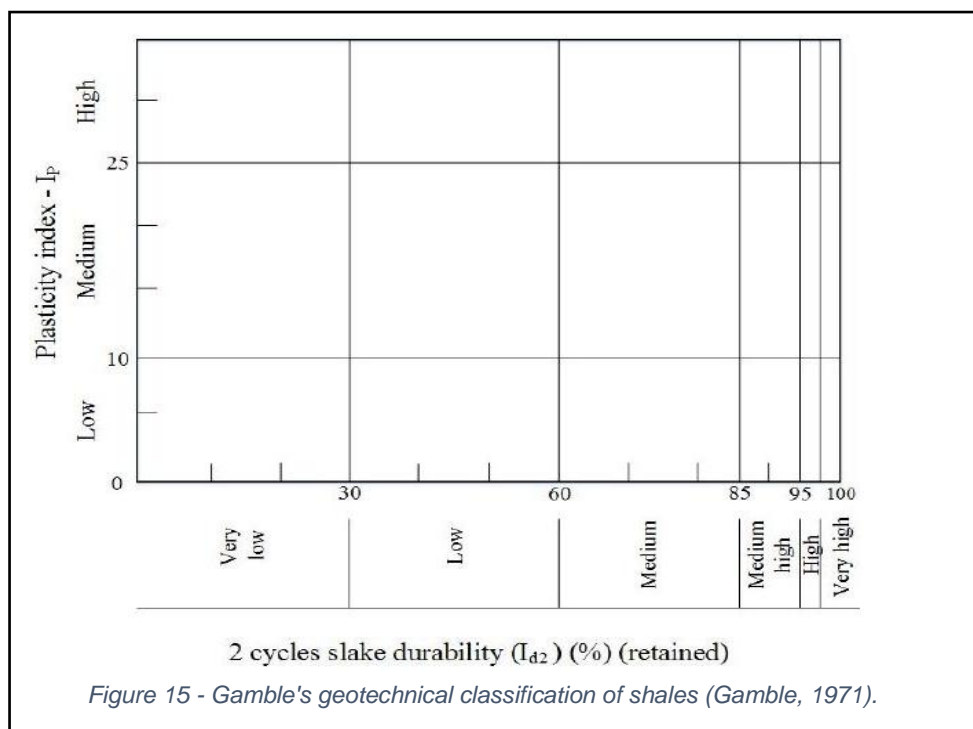
Hence a rock that is either impermeable, or non-reactive or has high intergranular strength will usually be more durable. According to Franklin and Chandra (1972), some indication of slake-durability can usually be obtained by studying the clay mineralogy and the microstructure of a rock, but it is quicker and more reliable to use a test. This must provide a means of causing slake-disruption, and a means of estimating its extent. Perhaps the most reliable means of causing disruption, if time is no object, is to leave a rock exposed to natural weathering, and much may be learned by examining naturally exposed surfaces at excavated rock slopes or quarry sites. Usually for convenience and greater control, an accelerated weathering process is employed that includes cyclic changes of environment such as drying and wetting. Franklin and Chandra (1972) states in one of their studies that there is a definite correlation between the rate of weathering of shales, the stable slope angle and the slake-durability index values obtained during testing, although such quantitative correlations have yet to be made. Gamble (1971) did however manage to produce a slake durability classification system that classifies the durability of shales according to “high”, “medium” or “low” durability as seen below in Figure 15.

With regards to Figure 15 above, the two categories of highest durability could be termed 'rock', and materials of lower durability 'soil'. A distinction between rock and soil is often required in engineering contracts, and the slake-durability index affords a possible quantitative method of discriminating between the two.

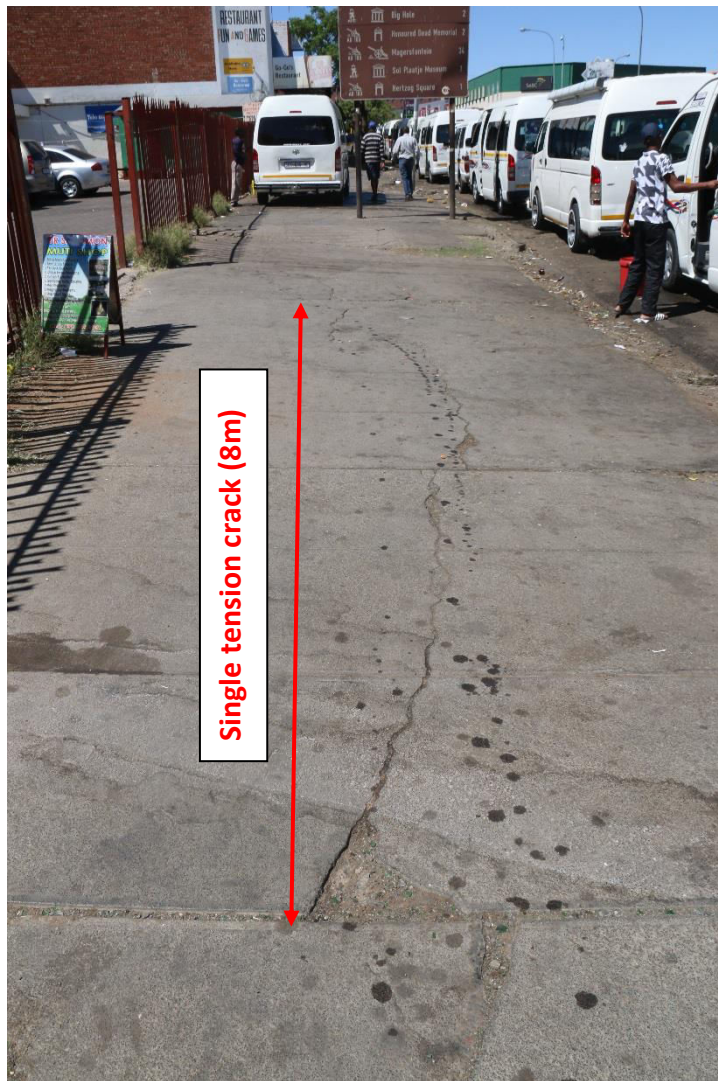
Figure 33 - A single tension crack on Bultfontein Road.

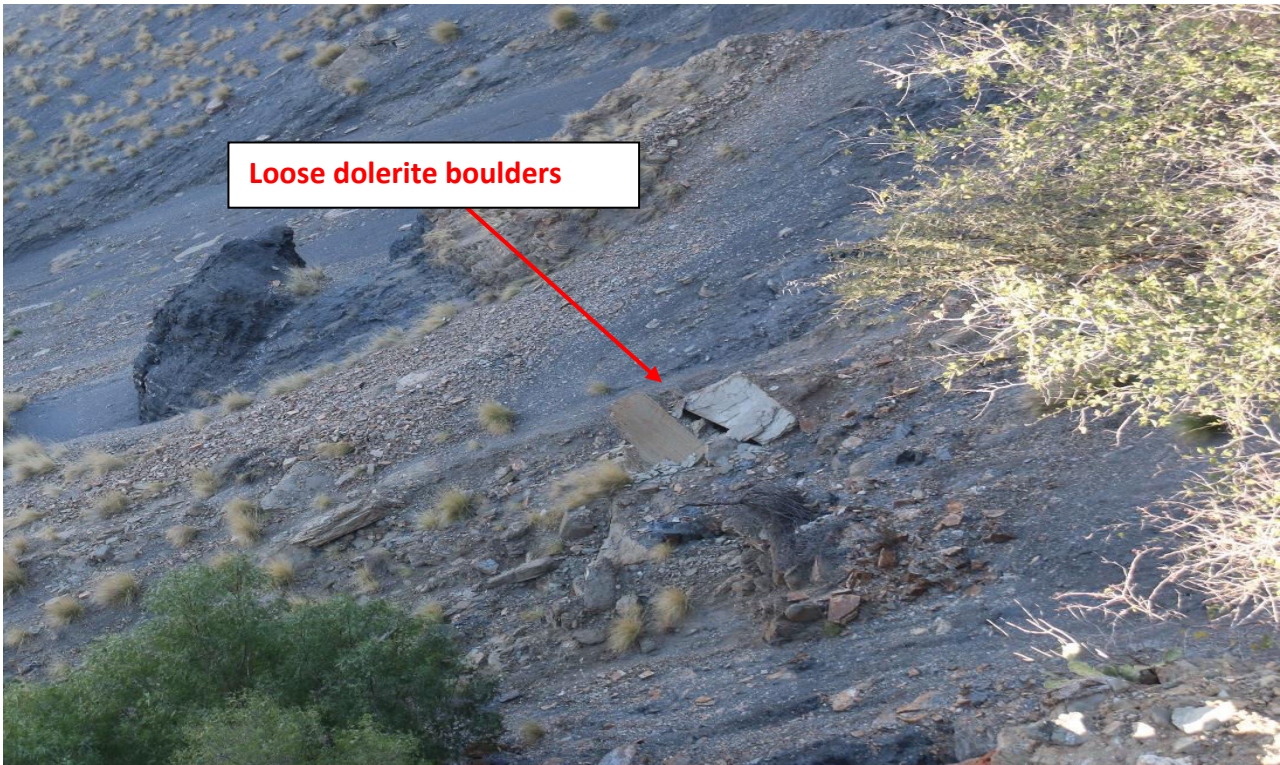
Figure 48 - Block toppling (slope) failure of the overlying dolerite caps.

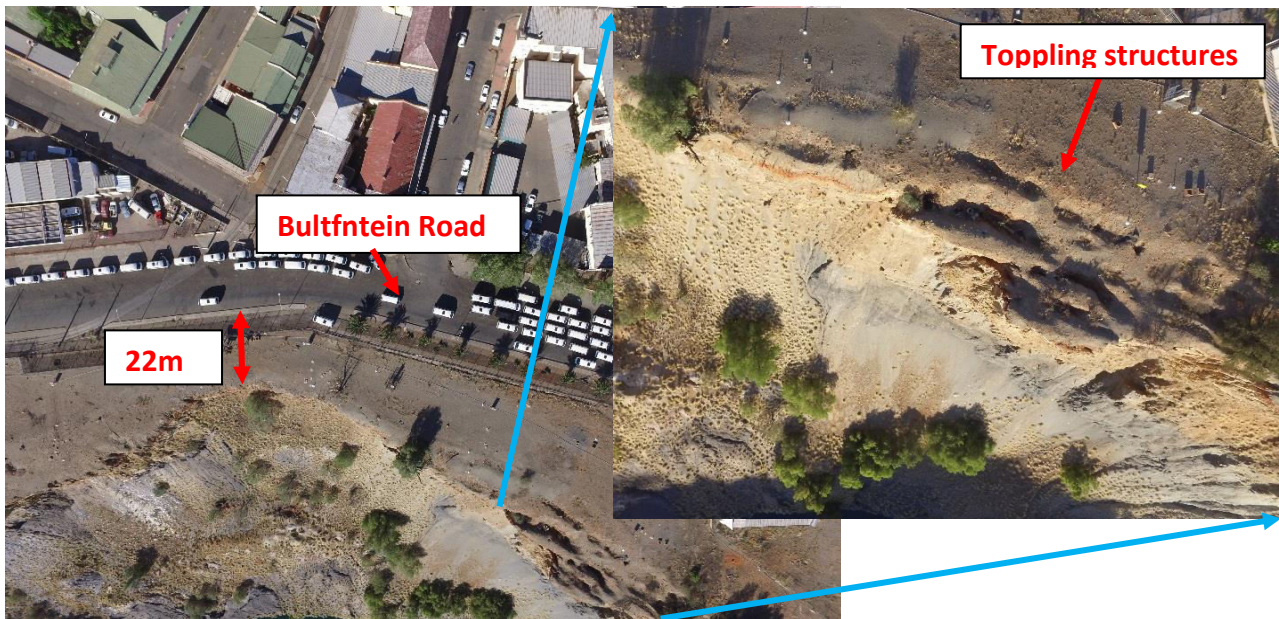
Figure 49 - Proximity of Bultfontein Road to the nearest edge of the Kimberley "Big Hole" Mine as well as large-scale toppling structures on the northeastern side of the pit.

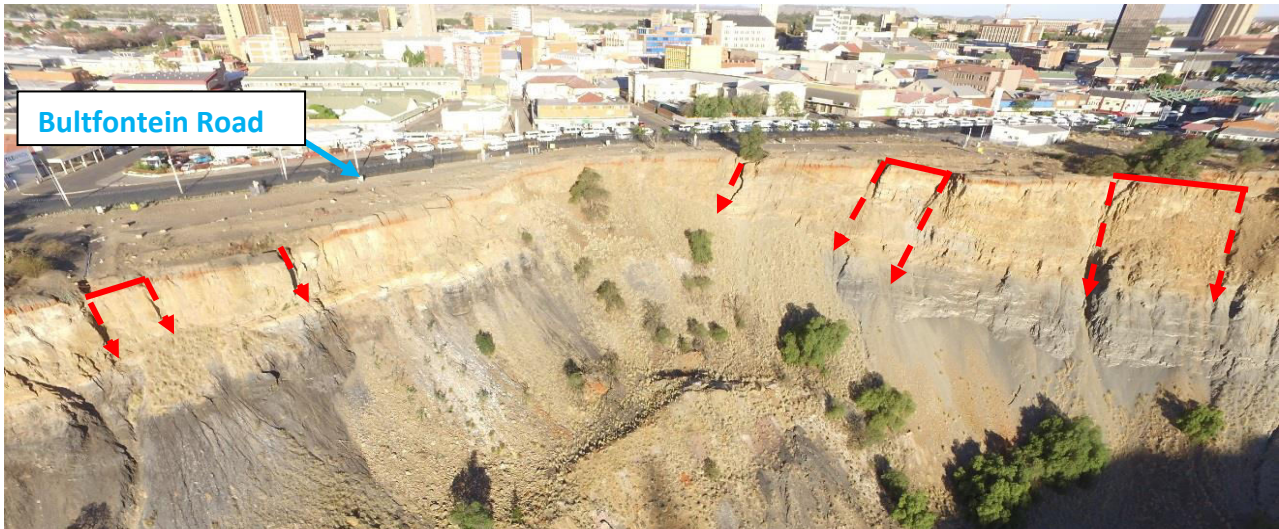
Figure 51 - Large-scale toppling blocks around the northern and northeastern side of the Kimberley Mine (closest to Bultfontein Road).

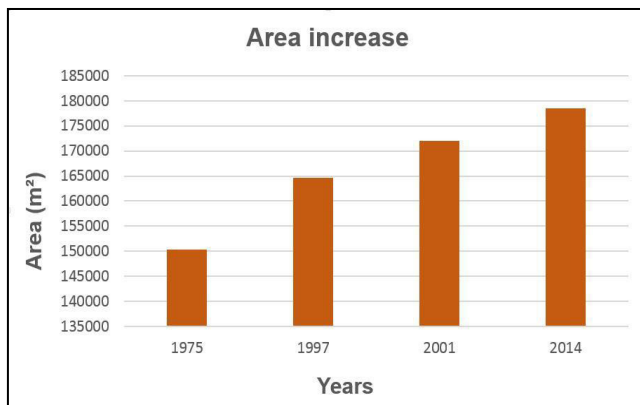
Figure 56 - Graph illustrating the total area increase of the Kimberley “Big Hole” Mine over the past few years.

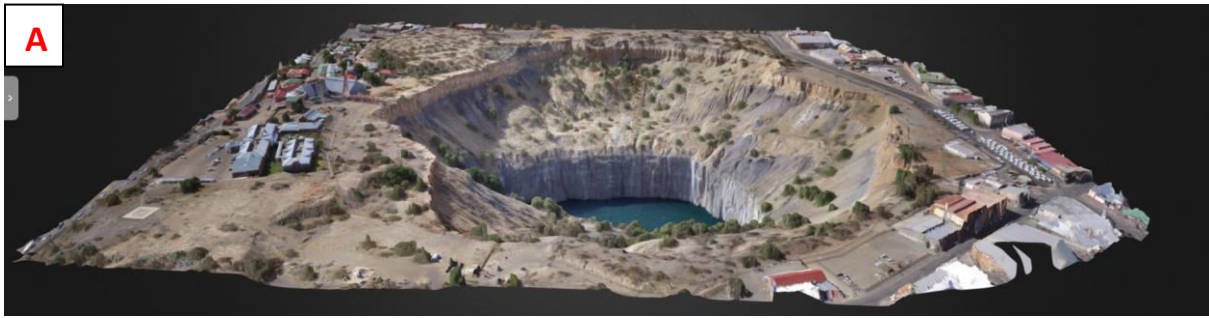
Figure 62 A - 3D model of the north facing sidewall of the Kimberley "Big Hole" Mine.

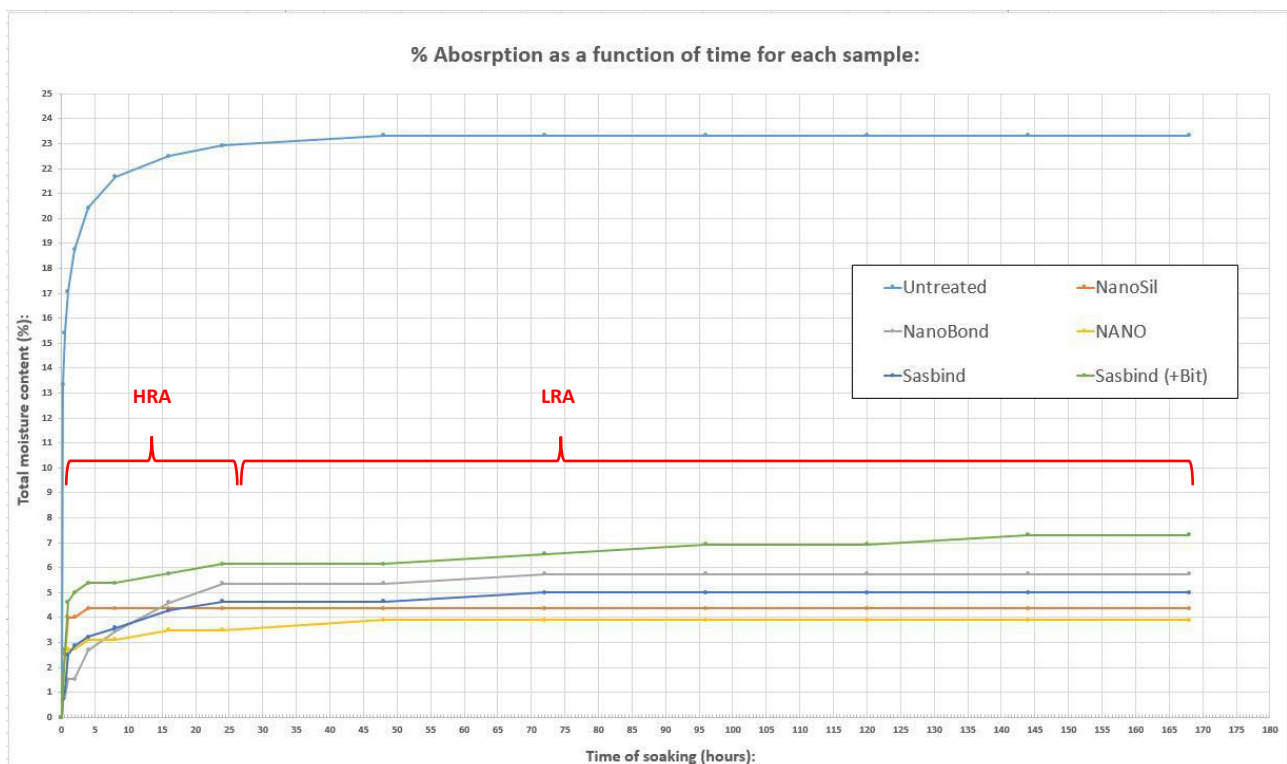
Figure 67 - Absorption rate as a percentage of the original dry mass for each DECL product and an untreated reference batch as a function of time. HRA – High Rate of Absorption; LRA – Low Rate of Absorption.

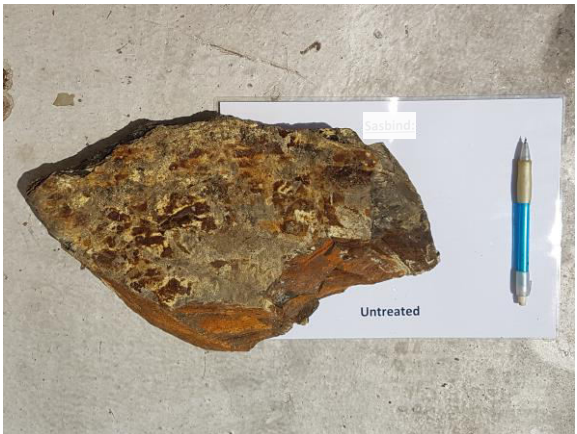
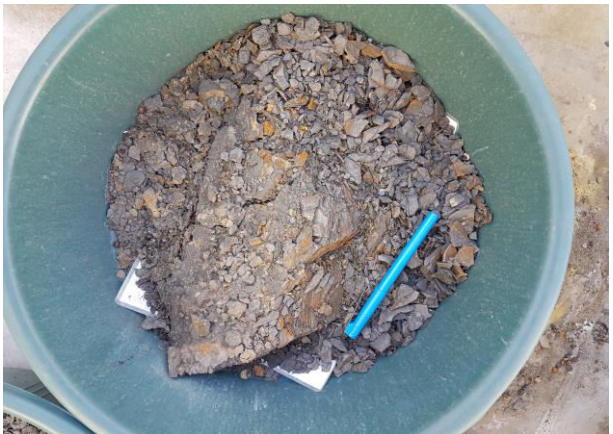
Untreated shale sample	
Original weight: 4084g	End weight: Unmeasurable
<p>First visual assessment (Week 0):</p> <p>No visual evidence of cracks or fractures on the surface of the rock (i.e. completely intact), although some evidence of flaking around the edges. Laminations run parallel to the surface of the rock and red / orange colour due to iron staining.</p>	<p>Last visual assessment (Week 4):</p> <p>Went through various stages of slaking and disintegration. First, during week 1, small cracks and fractures started to develop along the surface of the rock due to mobilization of its swelling and shrinkage potential, which initiated as a result of the wetting and drying cycle. During week 2, larger cracks and fractures started to form along the foliation planes of the rock. This initiated an even</p>

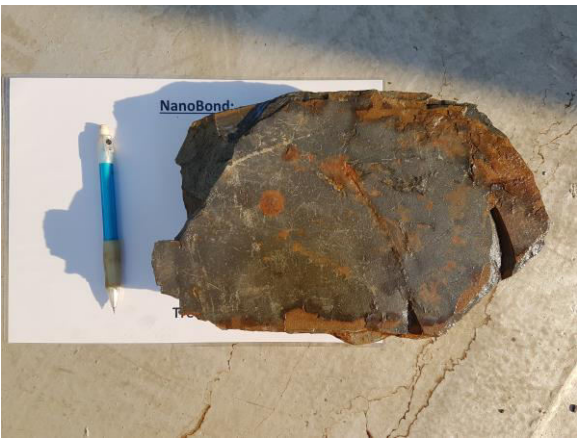
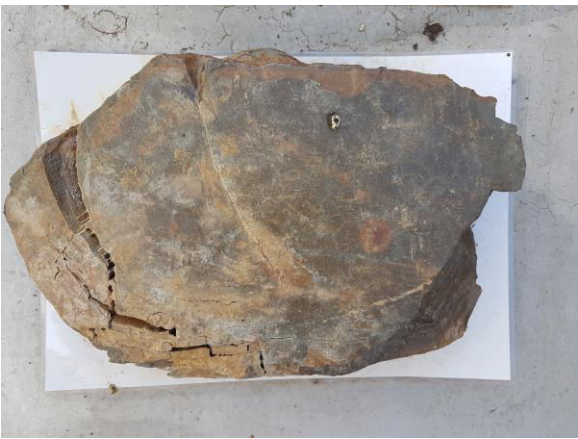
NanoBond	
Original weight: 3613g	End weight: 3501g
First visual inspection (Month 0):	Last visual inspection (Month 6):
