Insulator Aging Tests with HVAC and HVDC Excitation using the Tracking Wheel Tester

Thesis presented in partial fulfilment of the requirements for the degree

Master of Science in Engineering at the University of Stellenbosch

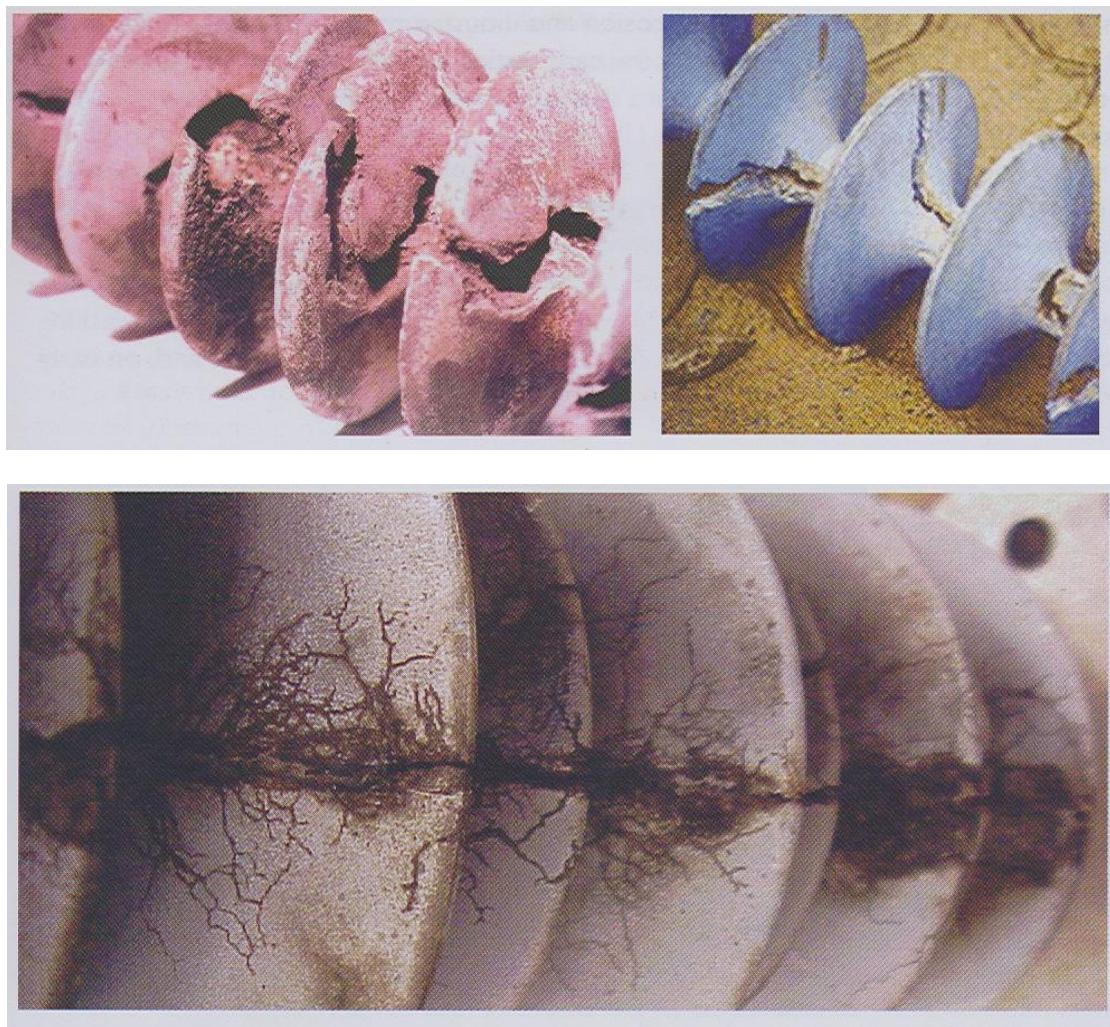
Figure 2.3: Tracking and Erosion of EPDM and SR housings

Failure of the insulator housing only affects the electrical performance of the insulators, since the housing has no mechanical function. The environmental stress, as well as the voltage being applied to the insulator may cause electrical discharges. These electrical discharges could cause erosion, and on some early housing materials, tracking. A tracked path reduces the creepage distance of the insulator, and if long enough, leads to flashover. The nature of the tracking and erosion depends on the material properties. Figure 2.3 shows examples tracking and erosion damage.

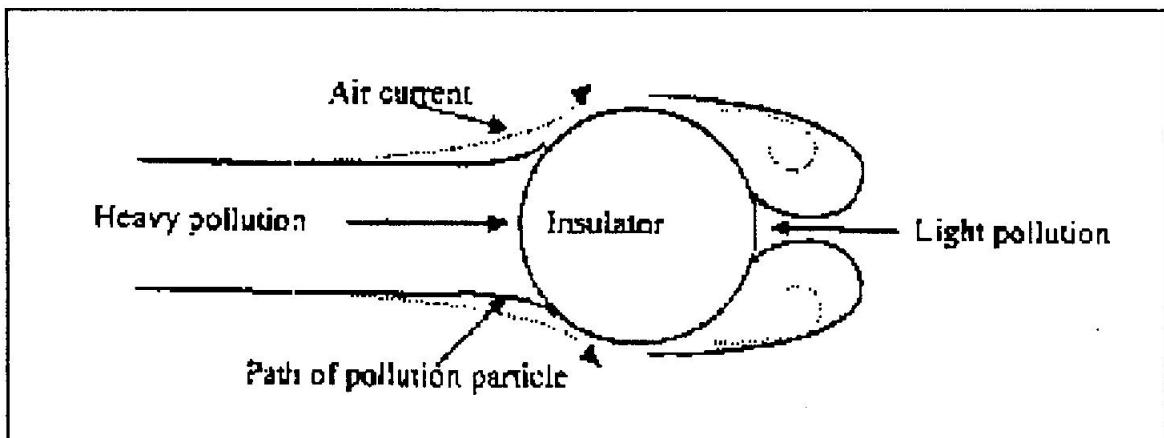
Figure 2.4: Pollution deposit by aerodynamic action [26]

The aerodynamic catch of the insulator, explained in Figure 2.4, is the most important process of pollution deposit on the insulator [26]. When air containing suspended particles flows around an insulator, the particles will be separated depending on how dense they are. The heavier particles, such as sand, will be deposited on the leading side, while the lighter particles, such as air, will follow the air current more closely. In other words, the lighter particles will be deposited on the side of the insulator where the curve of the air flow is sharp [26].

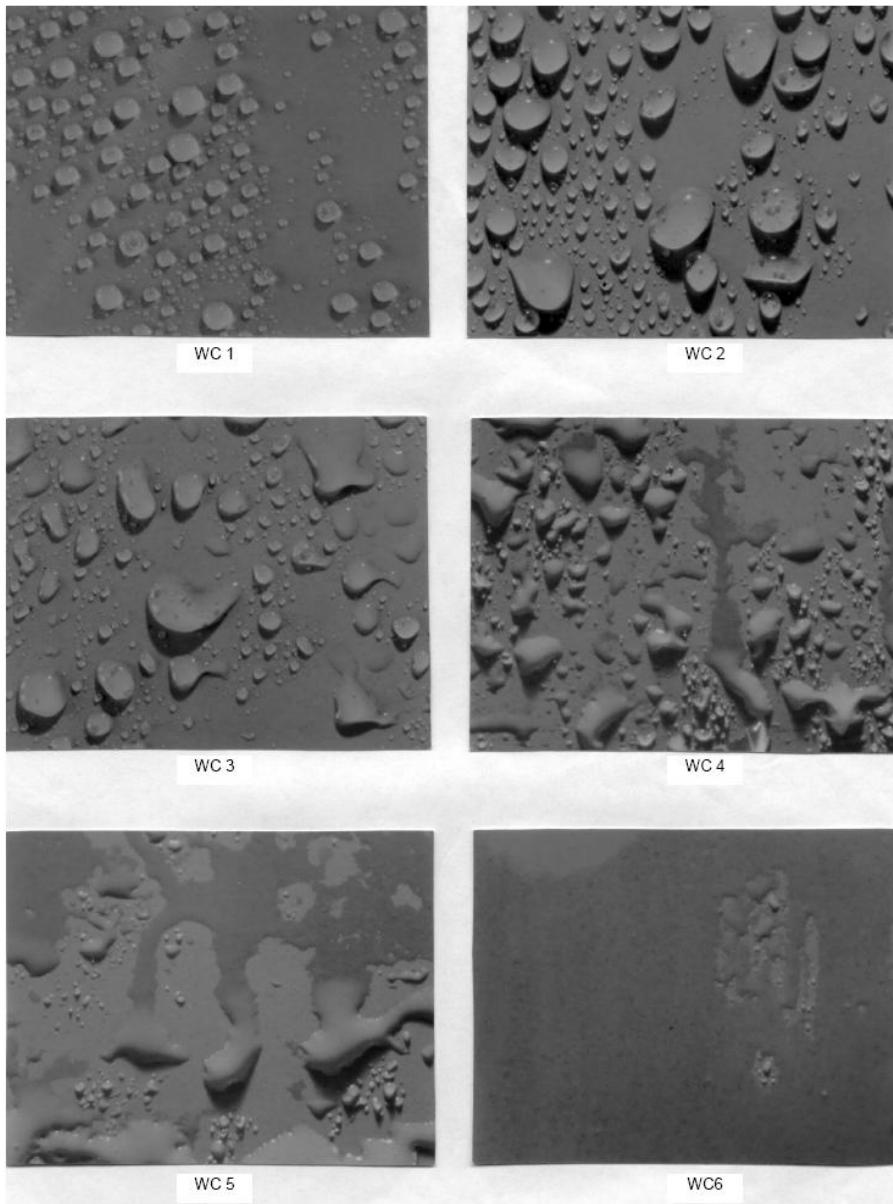
Figure 2.5: Photographs defining wettability classes WC1 to WC6 [23].

[23]. Figure 2.5 shows photos representing the different wettability classes, namely completely hydrophobic (wettability Class 1) to completely hydrophilic (wettability Class 6) [1, 23].

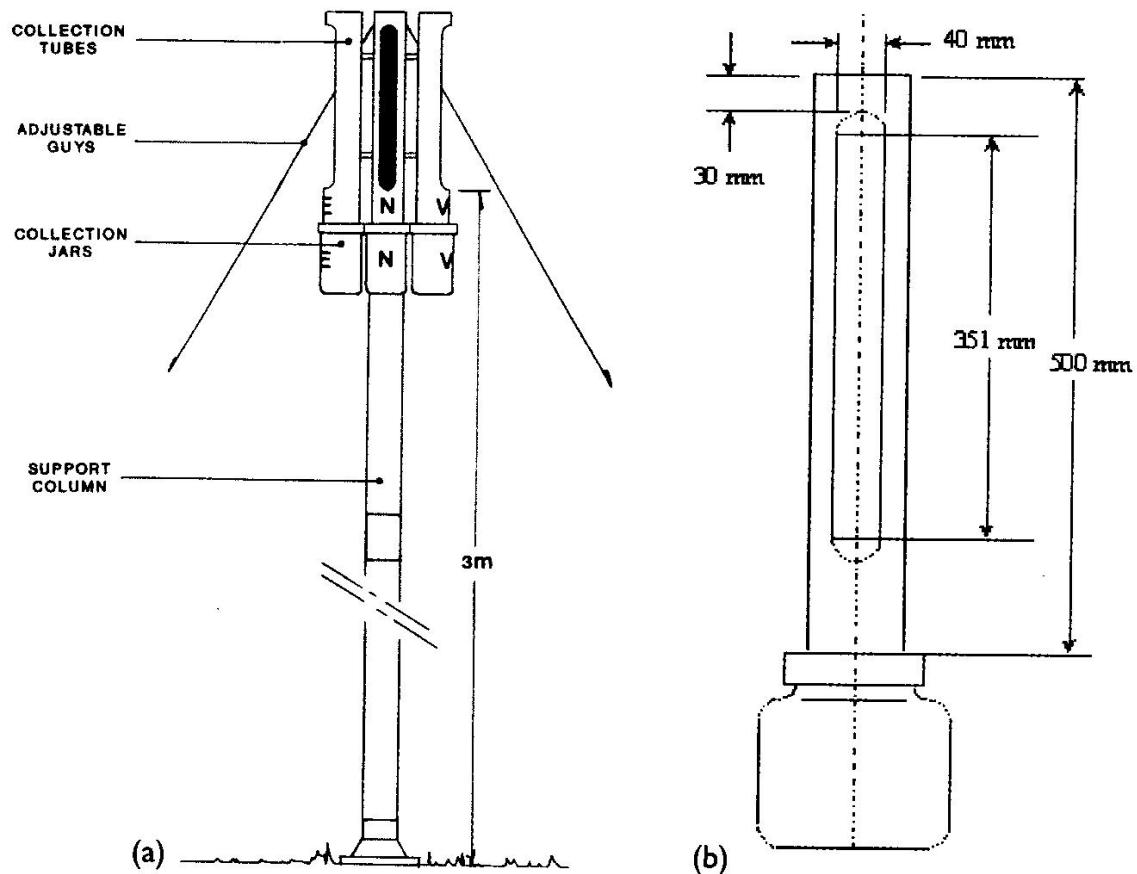
Figure 2.6: DDDG design details: (a) As installed, (b) Dimensions

The Directional Dust Deposit Gauge (DDDG) has four vertical tubes with a slot on the side. These slots are arranged such that they face north, south, east, and west. There is a removable container at the bottom of each slot which collects the deposits blown into the slots, and the containers are removed on a monthly basis for testing. The contents are mixed with 500 ml of demineralised water and the conductivities of the mixed solutions are measured. The pollution index is defined as the average of the four conductivities obtained from the four directions in [$\frac{\mu S}{cm}$] and normalised to a 30 - day interval [1]. Figure 2.6 show some design details of the DDDG.

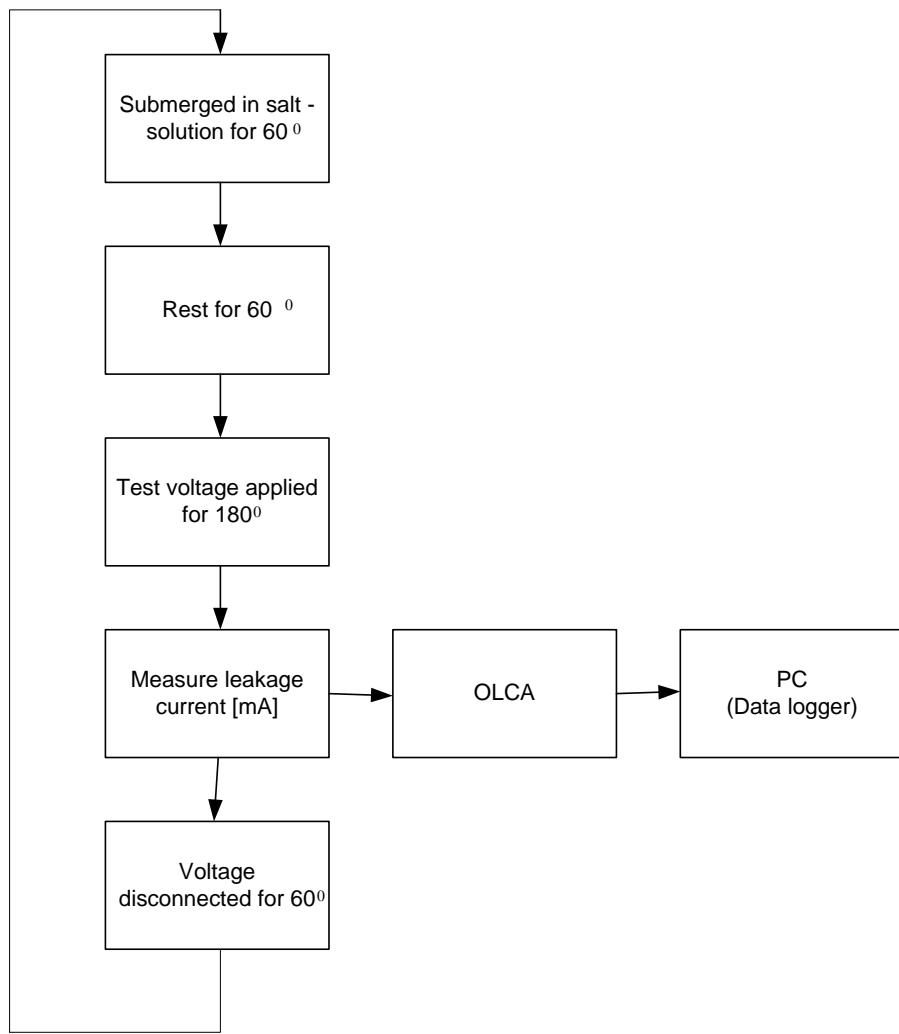
Figure 3.1: Operating sequence of the Tracking Wheel Tester

Figure 3.1 shows a flow diagram of the operation of the TWT. The rotating wheel rotates at a constant speed of three revolutions per minute. The test specimen is dipped into the salt water solution for 60° of a revolution. The test specimen is then withdrawn from the salt water solution (resting phase) and the salt water solution is allowed to drip from the surface of the test specimen. This process occupies another 60° of a revolution. The test voltage is then applied to the insulator for an interval of 180° of one revolution (excitation phase). Finally, the test specimen goes through a final resting phase for 60° of one revolution, before the cycle is repeated.

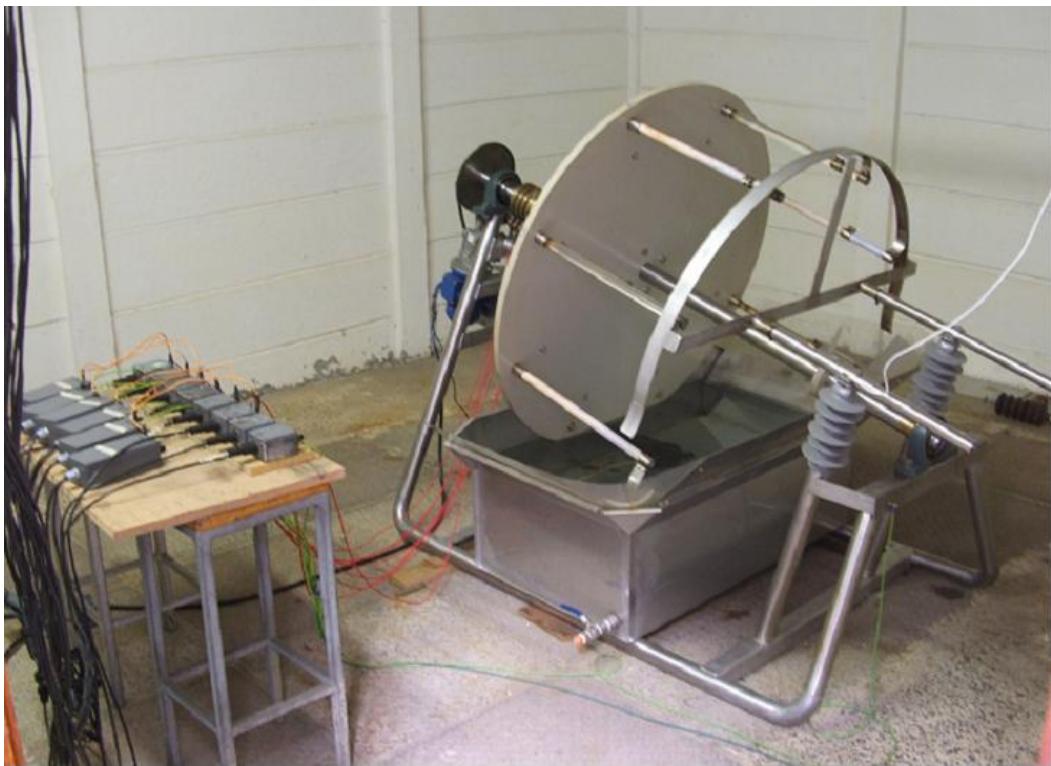
Figure 3.2: The Tracking Wheel Tester (TWT)

The mechanical structure of the TWT was designed according to the IEC 61302 specification. Figure 3.2 shows the tracking wheel tester as built for the first series of tests conducted with HVAC excitation. During this test, the performance of the TWT was evaluated for a period 1084 hours and 50 minutes.

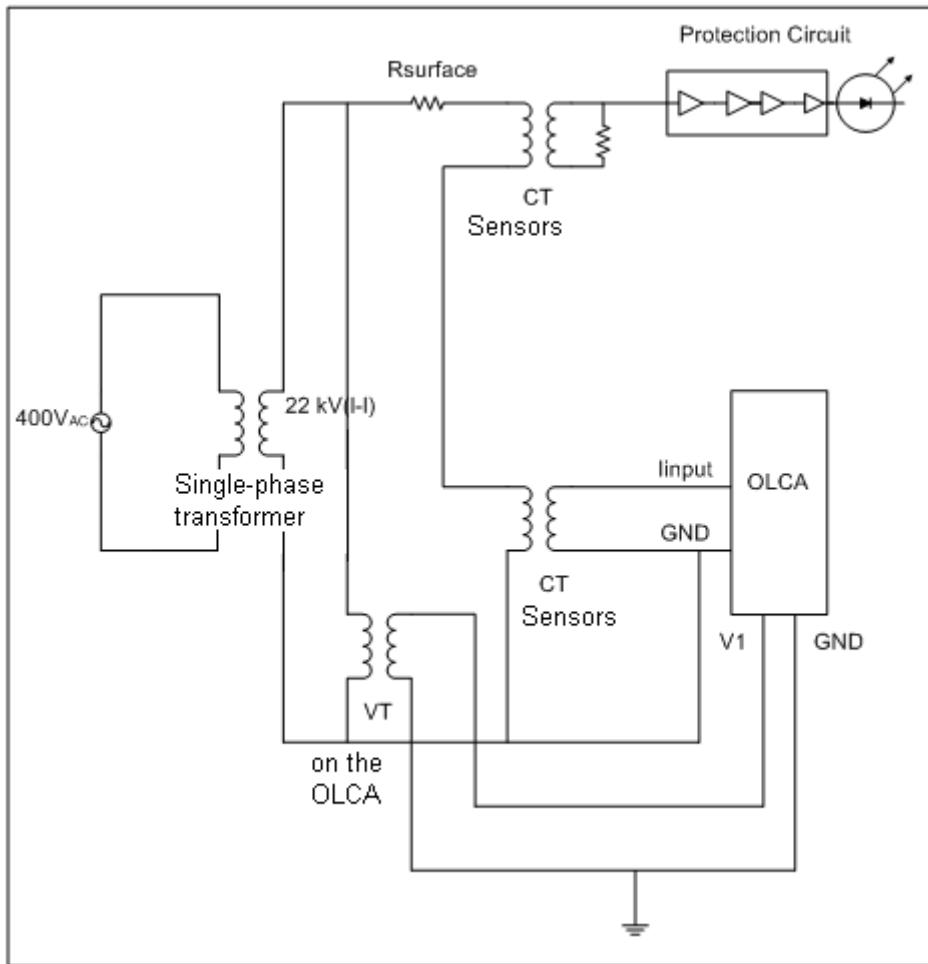
Figure 3.3: Schematic diagram of the Tracking Wheel Tester for the AC system

Figure 3.3 shows an electrical schematic of the TWT.

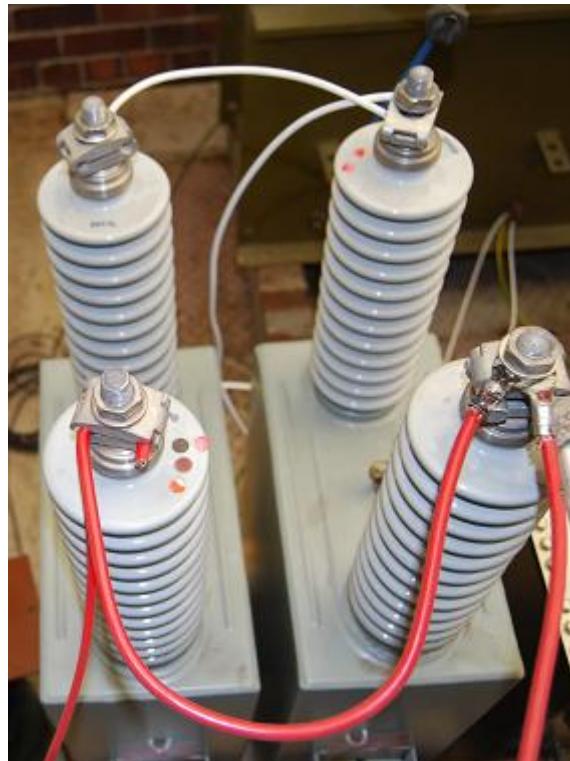
Figure 3.7: The smoothing capacitor bank

Figure 3.5 shows the HVDC source as used in the investigation, including the three-phase step-up transformer, rectifier module and capacitor bank. Figure 3.6 shows the rectifier module while Figure 3.7 shows the capacitor bank.

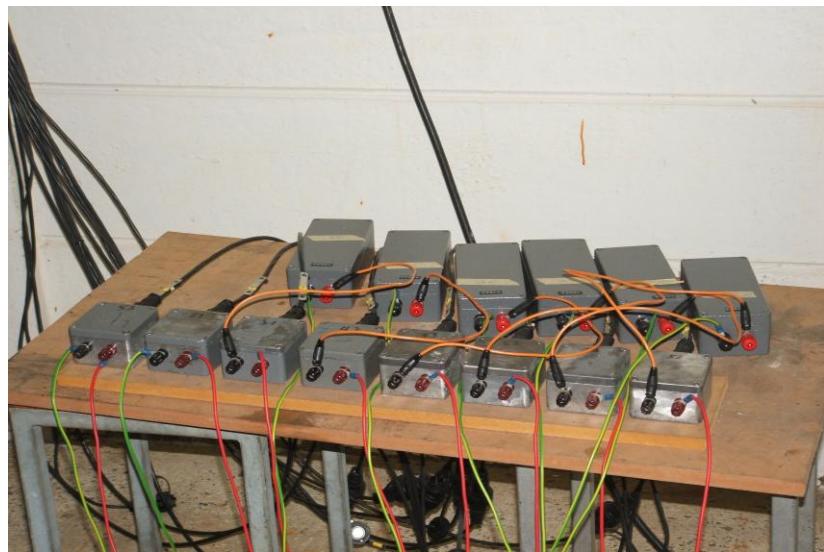
Figure 3.8: The OLCA current sensors

A commercial Online Leakage current Analyser (OLCA), using dedicated current sensors, was used to measure the peak leakage currents for the six test insulators. A separate set of current sensors were used to supply the protection circuit. Figure 3.8 and Figure 3.9 show photographs of the OLCA current sensors and OLCA measuring instrument respectively.

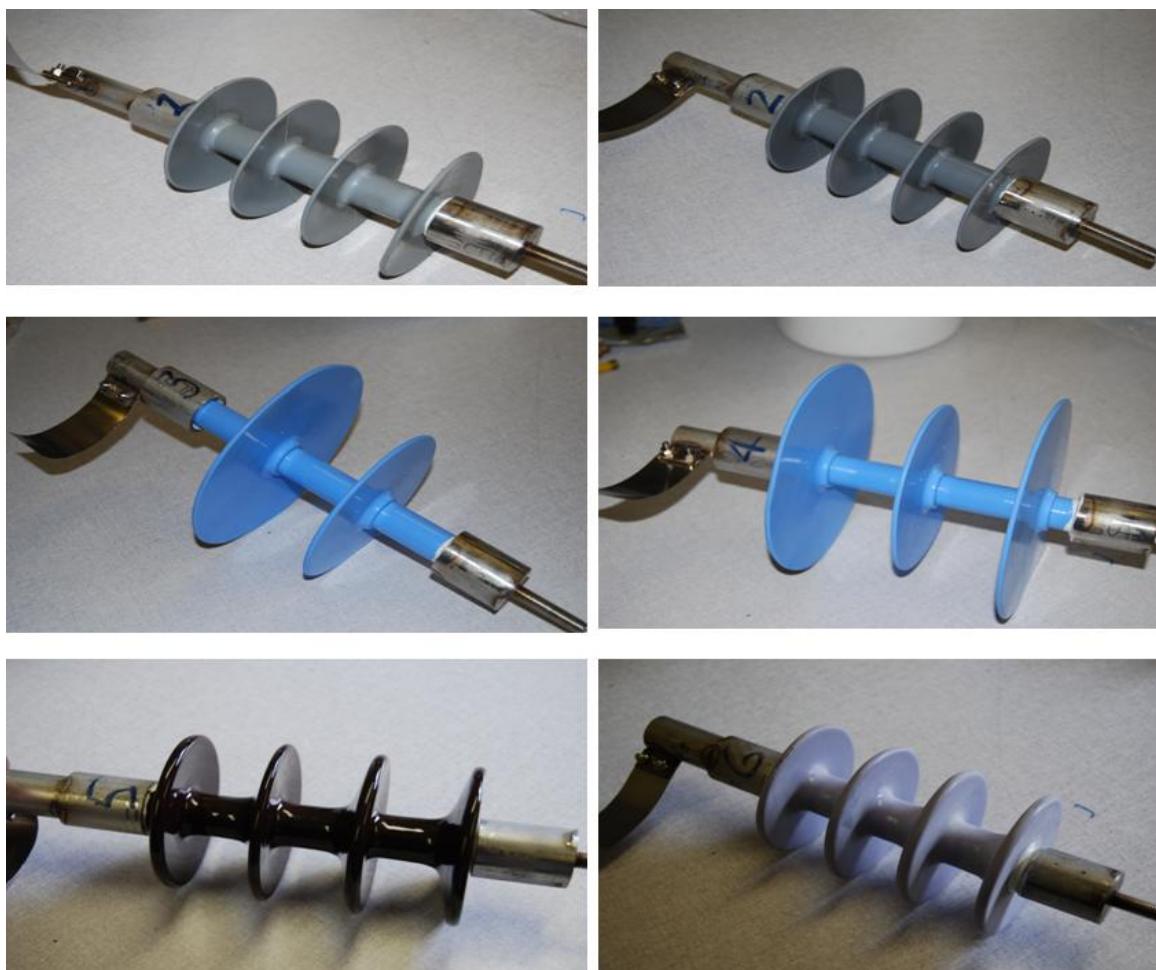
Figure 4.1: The six insulator samples tested during the second series of tests with HVAC, positive polarity HVDC and negative polarity HVDC

Channel	Material	Creepage distance [mm]	Unified specific creepage distance [mm/kV]
Channel 1	EPDM	380	28
Channel 2	HTV SR	380	28
Channel 3	HTV SR	380	28
Channel 4	HTV SR	476	35
Channel 5	Porcelain	380	28
Channel 6	RTV SR coated porcelain	380	28

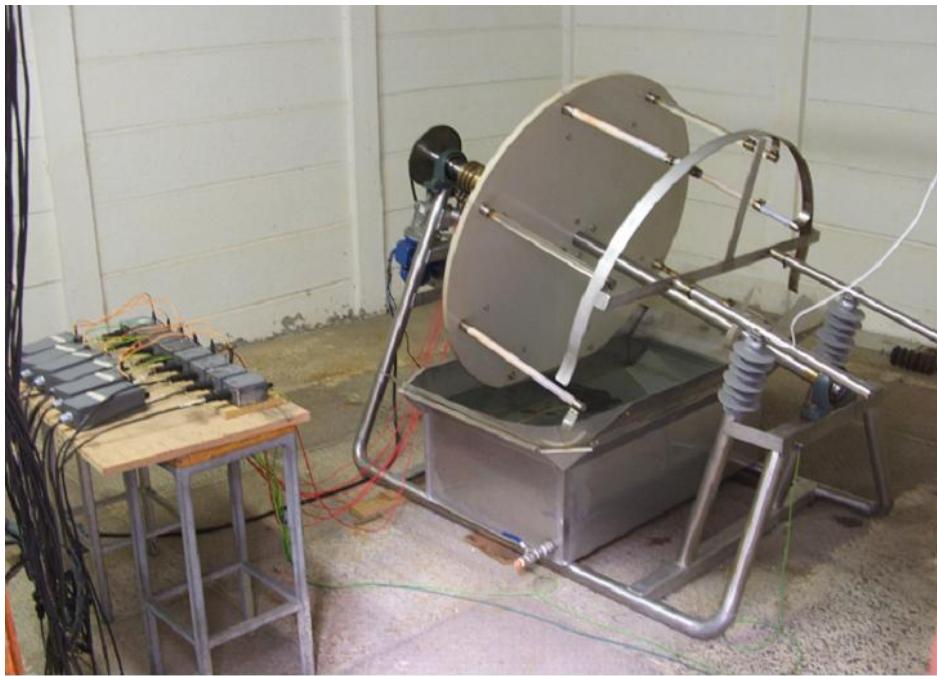
Figure 4.2: The tracking wheel tester with the test samples used in the first series of tests.

Figure 4.2 shows the TWT with the test samples as used for first series of tests. The tests were conducted according the procedures specified in the IEC 61302 standard. The main objective of the experiment is to compare the aging performance of the different test specimens with different creepage lengths when exposed to a liquid contaminant and HVAC electric stress. Furthermore, this test compares the resistance to tracking and erosion of similar materials [27].

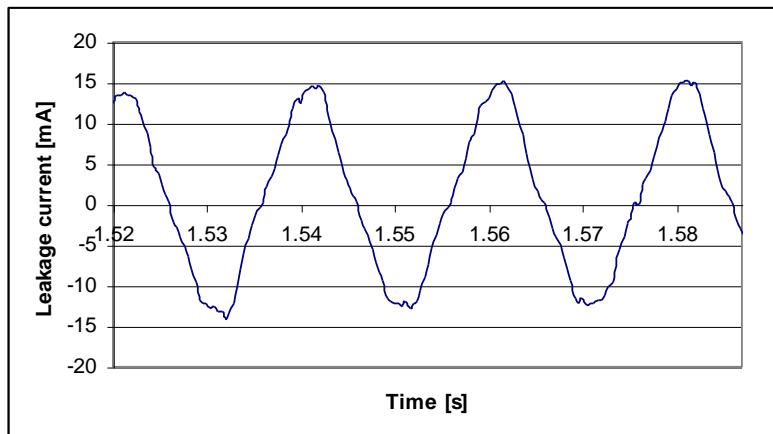
Figure 4.4: Leakage current [mA] waveform during dry band formation

Figure 4.4 illustrates the irregularities in the current waveform as a result of the dry band formation, i.e. after the voltage has been applied for some time. This distortion occurs mostly in the regions of the waveform peaks. The change in the peak current amplitudes between the results shown in Figure 4.3 and Figure 4.4 is due to the loss of the liquid contaminant on the surface of test specimen as the sample rotates with the excitation voltage applied.

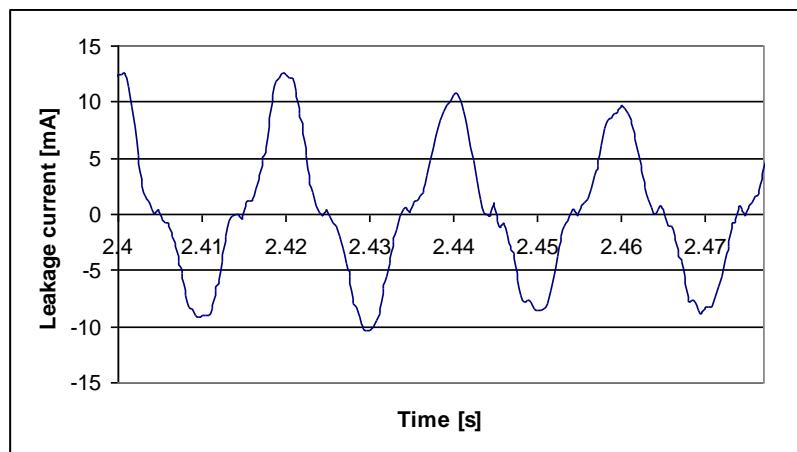
Figure 4.5: Leakage current [mA] waveform toward the end of the excitation phase

Figure 4.5 shows the current waveform recorded towards the end of the excitation phase. At this point the waveform tends to become distorted and discontinuous.

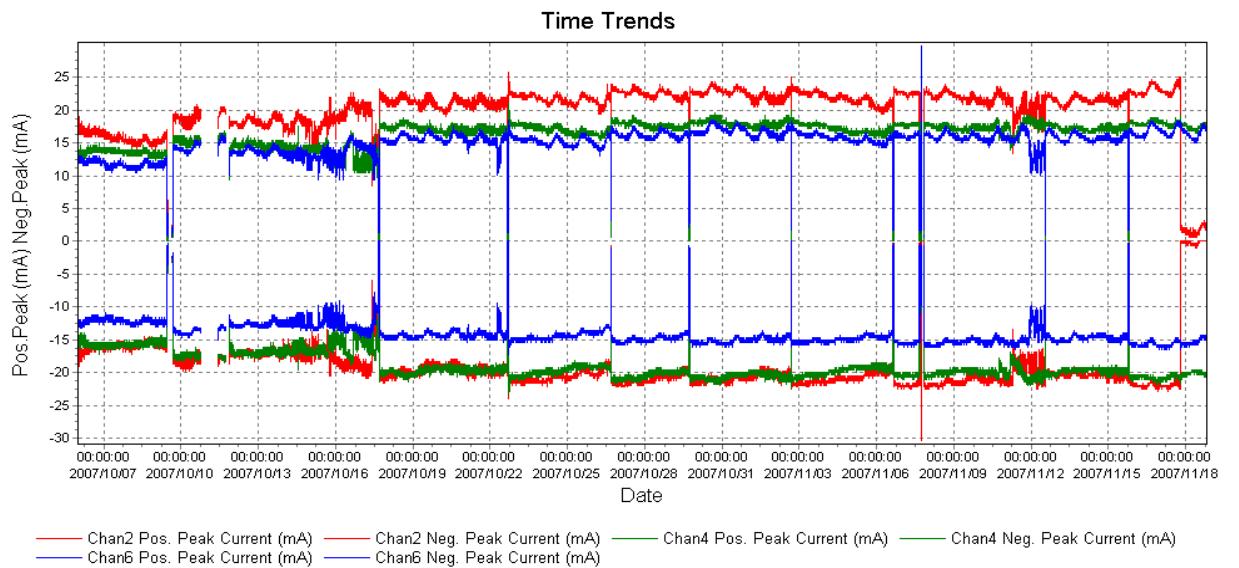
Figure 4.6: Peak leakage currents for the RTV SR coated glass samples

Figure 4.6 shows the maximum peak currents recorded for all of the RTV SR coated glass samples using the OLCA. Channel 2 with a creepage distance of 277 mm has a peak current of 26 mA while channel 4 with a creepage distance of 346 mm has a peak current of 21.6 mA. Channel 6 with a creepage distance of 433 mm has a peak current of 19.3 mA. The discontinuity in Figure 4.6 shows an electrical power failure incidence. The spikes dropping the leakage current to zero mA indicate the times when the test were stopped, which occurred regularly to adjust the water level and conductivity of the solution. The RTV SR coated glass samples shows little or no effect when the water level decreases. This shows that a shorter creepage distance causes a higher leakage current.

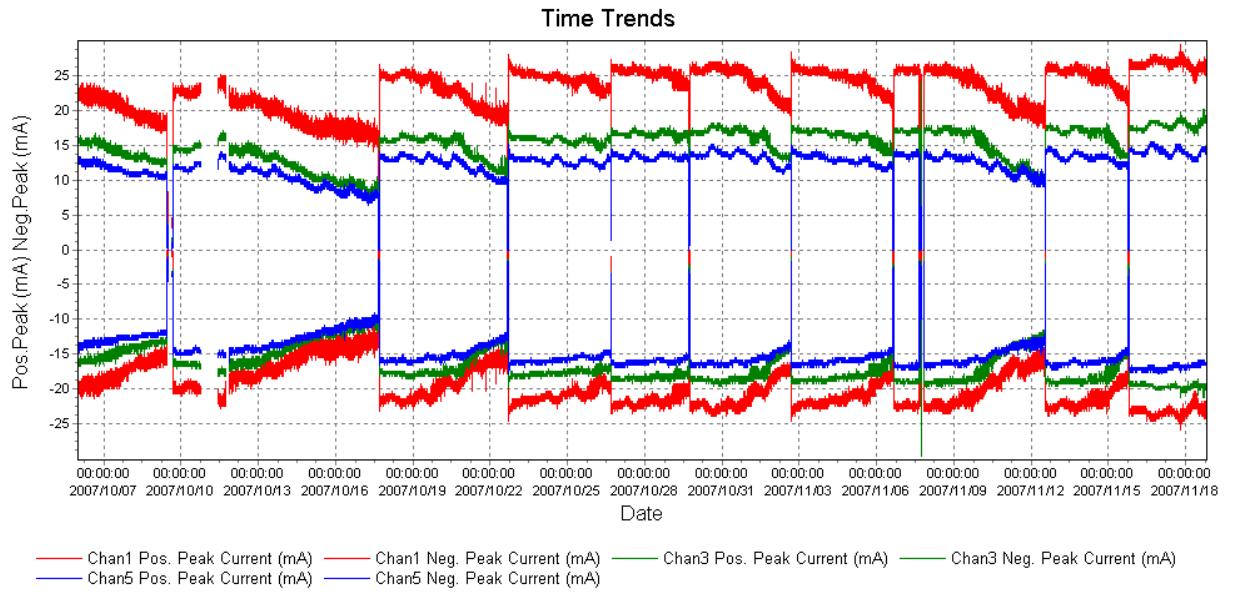
Figure 4.7: Peak leakage currents for the glass samples

Figure 4.7 shows the peak leakage currents for the glass samples. Channel 1 with a creepage distance of 277 mm has a peak current of 29 mA while channel 3 with a creepage distance of 346 mm has a peak current of 20.2 mA. Channel 5 with a creepage distance of 433 mm has a peak current of 15.2 mA. Figure 4.7 also shows that the decreasing water level due to evaporation causes the leakage currents to decrease during each test run. The discontinuity shows when the power failure was experienced and the peak currents dropping to zero indicate the times when the test was stopped. This shows that a shorter creepage distance gives rise to a larger leakage current.

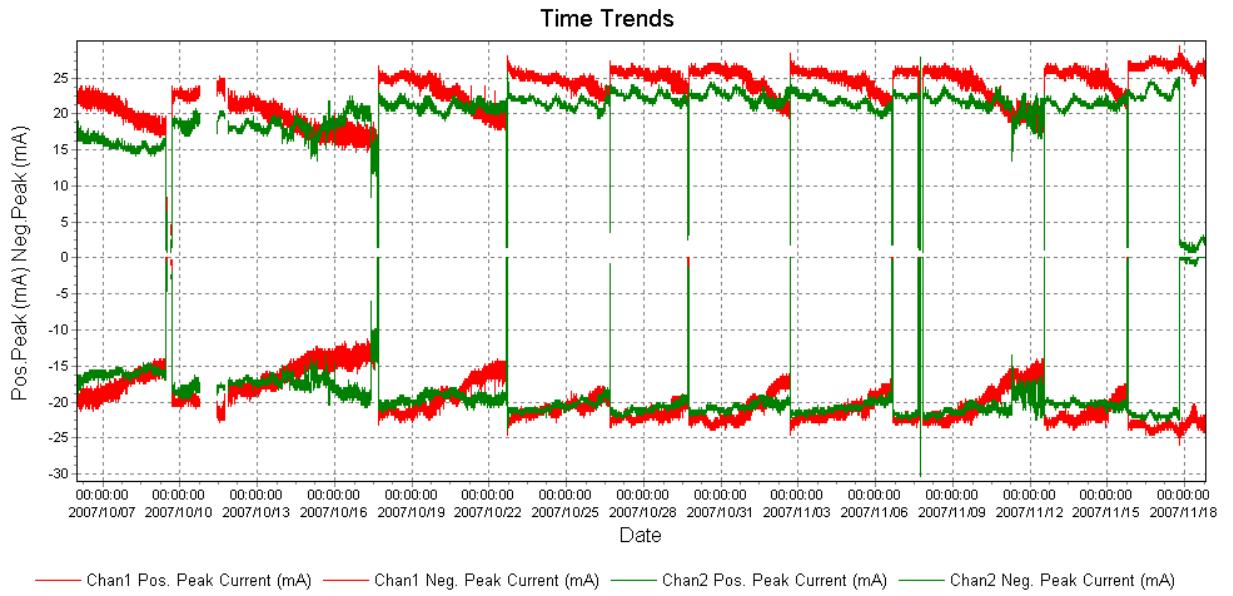
Figure 4.8: Peak leakage currents for the glass and RTV SR coated glass rods with a creepage distance of 277 mm

Figure 4.8 compares the peak leakage currents for the two insulator rods with creepage distances of 277 mm. Channel 1 represents a glass specimen while channel 2 represents RTV SR coated glass. The glass (Channel 1) has a peak current of 29 mA while the RTV SR coated class (Channel 2) has a peak current of 26 mA. Figure 4.8 shows that glass (Channel 1) is heavily affected by the drop in water level, when compared to the RTV SR coated glass (Channel 2). This is shown by the reduction in the peak currents measured for channel 1 when the water level decreases. The step response in the results for channel 2 on 17 November is due to mechanical failure of the insulator rod fastenings, causing it to drop from the wheel.

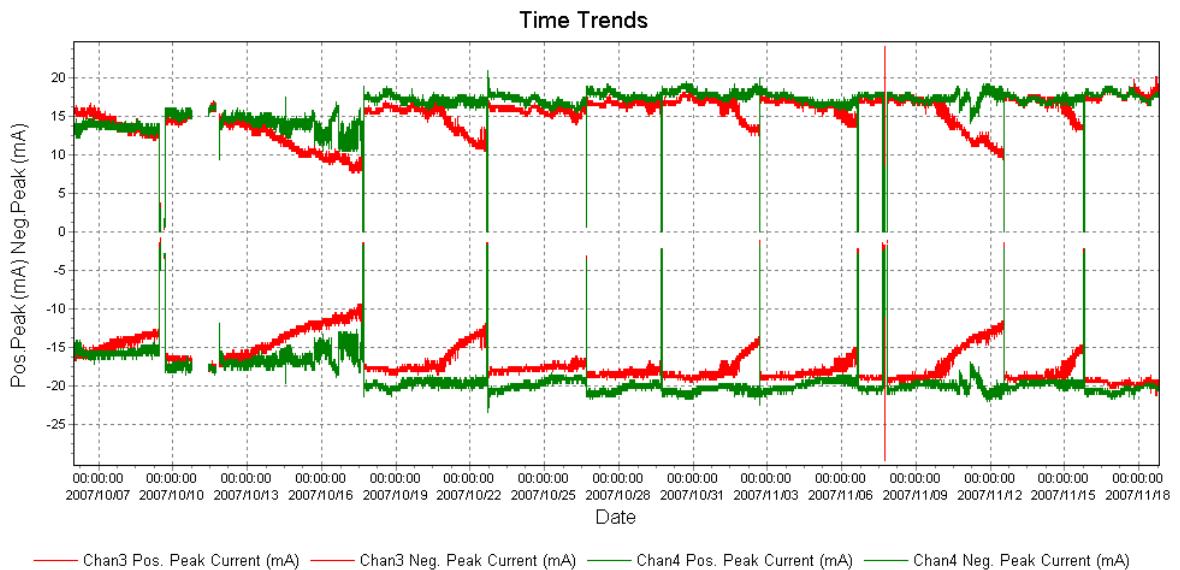
Figure 4.9: Peak leakage currents for the glass and RTV SR coated glass rods with a creepage distance of 346 mm

Figure 4.9 shows the peak leakage currents for the two insulator rods with a creepage distance of 346 mm. Channel 3 represents a glass specimen while channel 4 represents RTV SR coated glass. The glass (Channel 3) has a peak current of 20.2 mA, while the RTV SR coated glass (Channel 4) has a peak current of 21.6 mA. The leakage current for the glass decreases in peak current every time the water level decreases, while the leakage current for the RTV SR coated glass remains fairly constant.

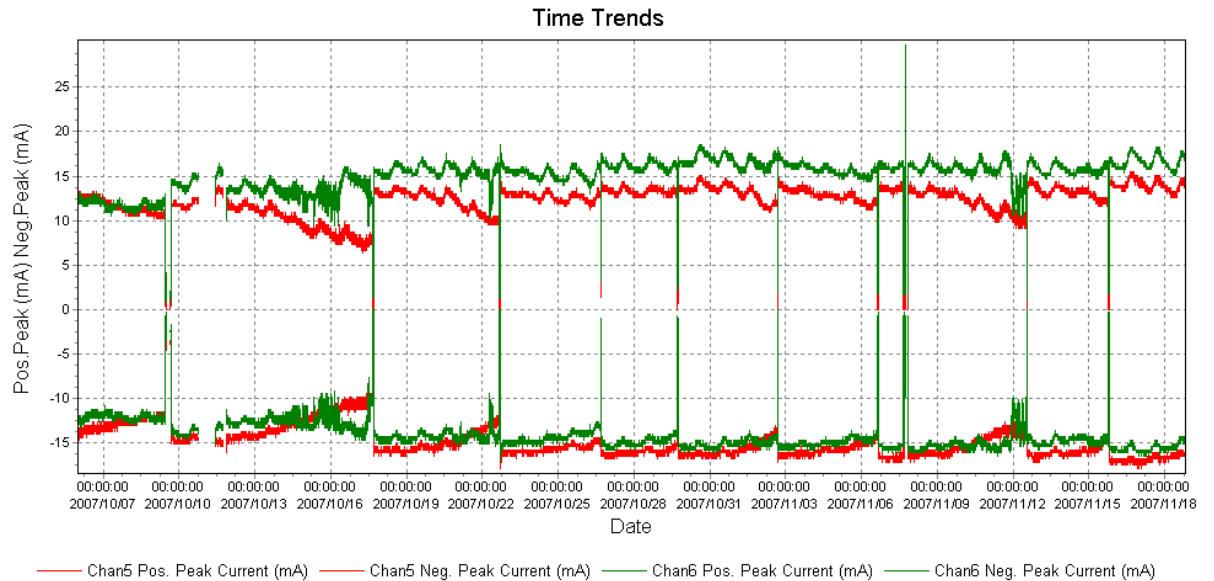
Figure 4.10: Peak leakage currents for the glass and RTV SR coated glass rods with a creepage distance of 433 mm

- An increase in conductivity value.
- A decrease in the specified salt-water level.
- A decrease in the maximum peak current.

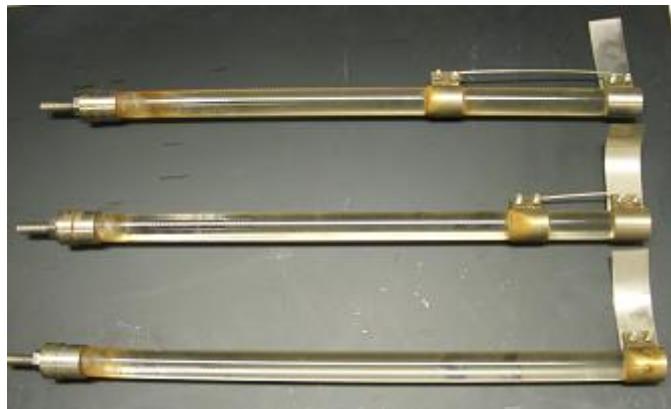
Figure 4.11: Visual aging of the glass samples

Figure 4.11 shows the glass samples that were used in the first test series, i.e. Channel 1 (Creepage distance = 277 mm), Channel 3 (Creepage distance = 346 mm), and Channel 5 (Creepage distance = 433 mm). It is clearly shown that the glass samples did not age significantly with time. There were, however, brown discolorations on all of the samples. This discoloration was brought about by the combination of the slabs touching the high voltage wheel and then dipping the insulator rod into the specified salt-water solution. As time goes by, the water starts browning and this causes the insulators to also start browning.

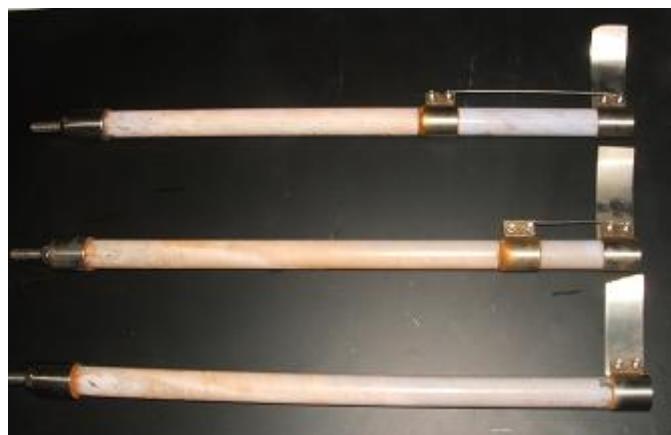
Figure 4.12: Visual aging of the RTV SR coated glass samples

Figure 4.12 shows the RTV SR coated glass samples that were used in the first test series, i.e. Channel 2 (Creepage distance = 277 mm), Channel 4 (Creepage distance = 346 mm), and Channel 6 (Creepage distance = 433 mm). These samples also showed discoloration on all of the samples as well as signs of peeling.

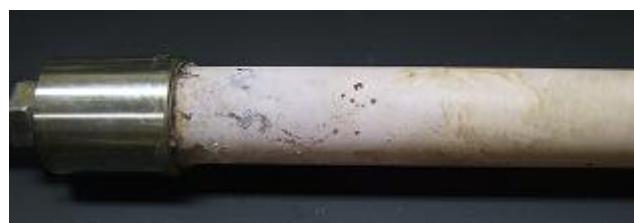
Figure 4.13: Visual aging of the RTV SR coated glass insulator with a creepage distance of 277 mm

Figure 4.13 shows the RTV SR coated glass insulator with a creepage distance of 277 mm. This insulator shows signs of erosion (loss of material), as well as peeling of the coating.

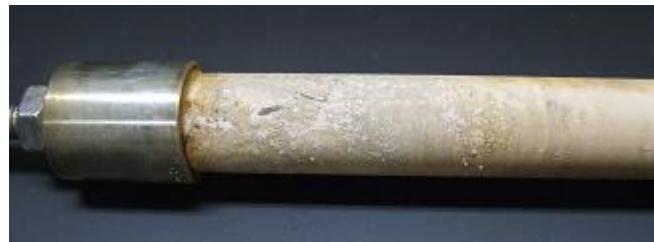
Figure 4.14: Visual aging of the RTV SR coated glass insulator with creepage distance of 346 mm

Figure 4.14 shows the RTV SR coated glass insulator with a creepage distance of 346 mm. This insulator shows very little or no signs of erosion and peeling, but there are small bubbles on the surface.

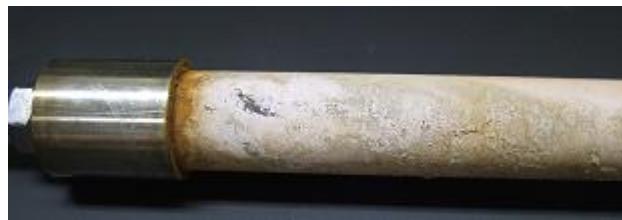
Figure 4.15: Visual aging of the RTV SR coated glass insulator with creepage distance of 433 mm

Figure 4.15 shows the RTV SR coated glass insulator with a creepage distance of 433 mm. There is less peeling and erosion when compared to the insulator with a creepage distance of 277 mm. There are also small little bubbles on the insulator coating, and it seems to be more than for the insulator with creepage distance of 346 mm.

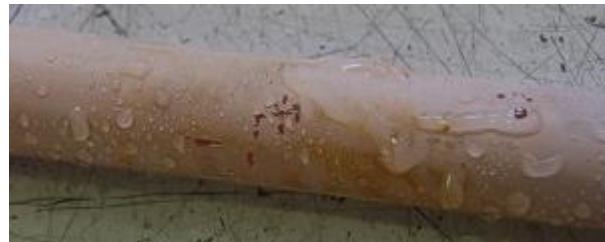
Figure 4.16: Wettability of the RTV SR coated glass sample with creepage distance of 277 mm (Channel 2)

The insulator rods were analysed to evaluate whether the insulators retained its hydrophobicity at the end of the test. Figure 4.16 show that the RTV SR coated glass sample with a creepage distance of 277 mm (Channel 2) has a wettability class of 4, thus becoming hydrophilic. The insulator surface is thus still completely hydrophobic. Therefore the RTV SR coated glass sample with creepage distance of 277mm almost became hydrophilic.

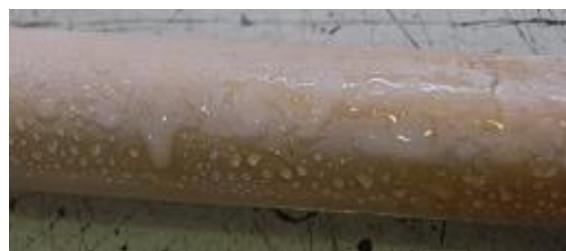
Figure 4.17: Wettability of the RTV SR coated glass sample with creepage distance of 346 mm (Channel 4)

Figure 4.17 shows that the RTV SR coated glass sample with a creepage distance of 346 mm (Channel 4) has a wettability class of 3. The insulator surface still hasn't lost its hydrophobicity and is in fact even better than the insulator with a creepage distance of 277 mm.

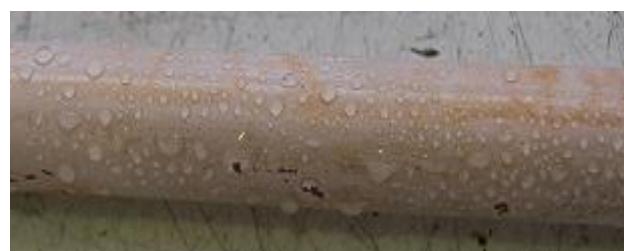
Figure 4.18: Wettability of the RTV SR coated glass sample with creepage distance of 433 mm (Channel 6)

Figure 4.18 shows that the RTV SR coated glass sample with a creepage distance of 433 mm (Channel 6) has a wettability class of 1. This insulator surface is still hydrophobic even though it has a wettability class lower than the insulator with a creepage distance of 346 mm.

Therefore, the RTV SR coated glass sample with a creepage distance of 433 mm (Channel 6) retains its hydrophobicity better, when compared to Channel 2 and Channel 4.

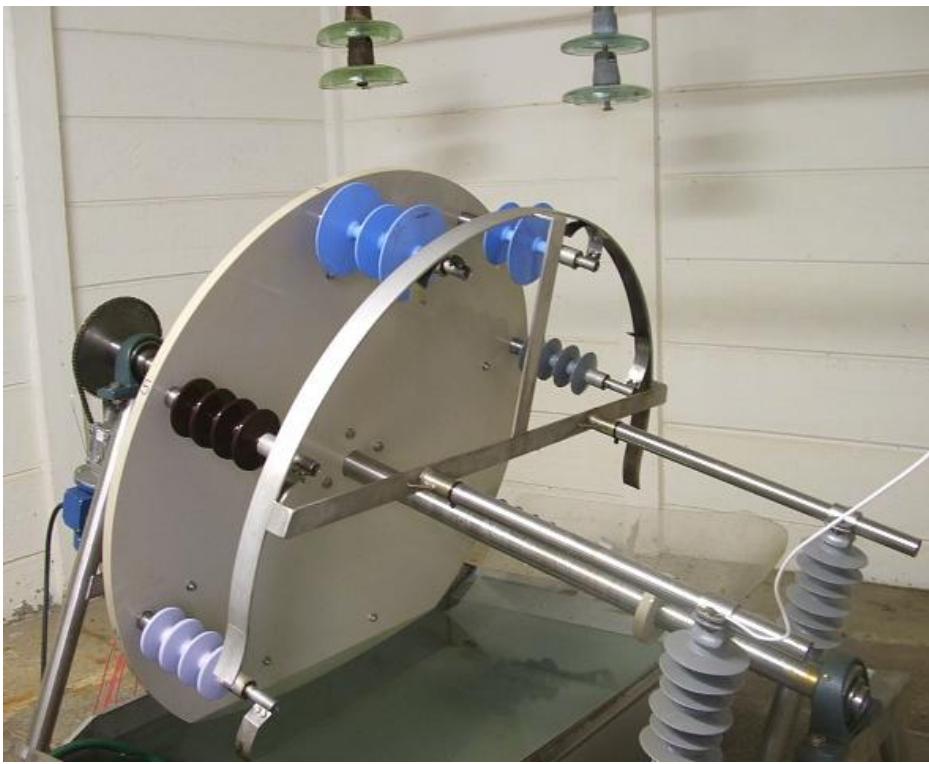
Figure 4.19: The Tracking Wheel Tester with the test samples used in the second series of tests with HVAC excitation.

Figure 4.19 shows the rotating wheel with the six insulators as installed at the beginning of the second series of tests with HVAC excitation.

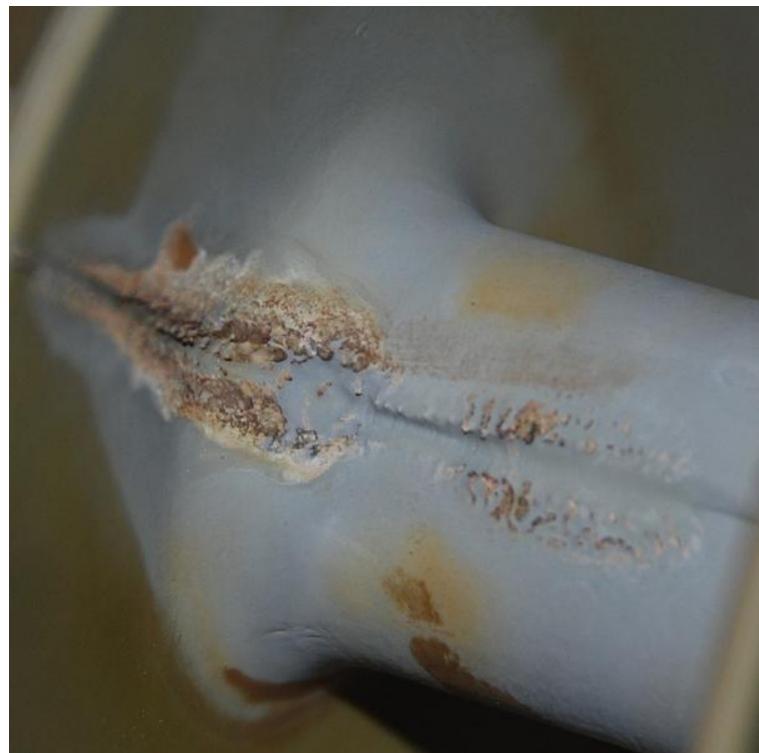
Figure 4.25: Detailed view of aging of the EPDM insulator (Channel 1) for HVAC excitation

Figure 4.24 shows the EPDM insulator with a unified Specific Creepage Distance of 28 mm/kV (Channel 1) before and after the experiment, while Figure 4.25 shows the

aging in more detail. There is a browning discolouration and loss of material or erosion on the insulator. There is also widening and small little brown bubbles across the mould lines on the insulator a clear circling between the bottom sheds and the rods as illustrated in Figure 4.25.

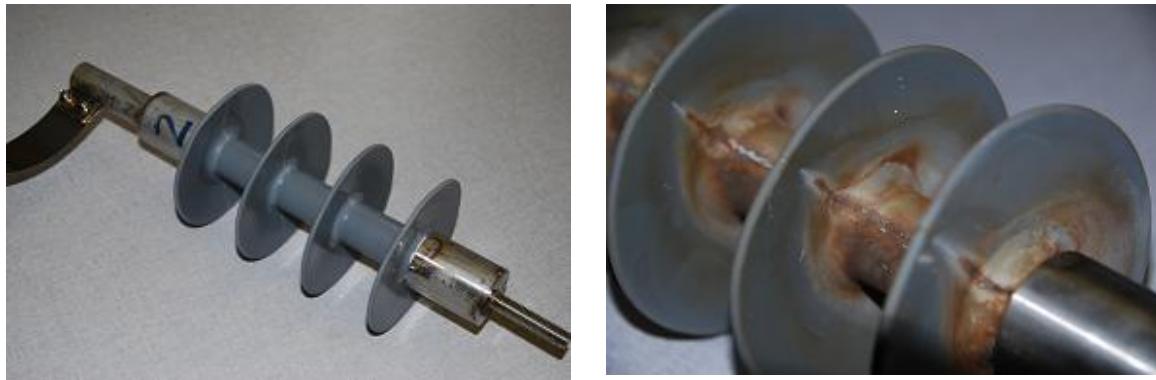
Figure 4.26: The HTV SR insulator (Channel 2) before and after the test for HVAC excitation

Figure 4.26 shows the HTV SR insulator with a unified Specific Creepage Distance of SCD_{0f} 28 mm/kV (Channel 2) before and after the experiment, while Figure 4.27 shows the aging in more detail. There are small signs of tracking on the pollution layer and darkening, as well as clearing on the mould lines. The insulator also has a

brown discoloration, which is mostly on the rods, even though there browning on the sheds as well.

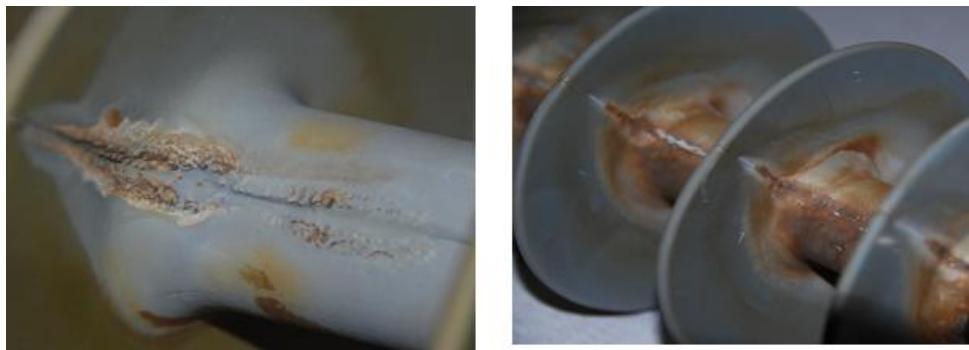
Figure 4.28 Comparison of aging of the EPDM and HTV SR insulators for HVAC excitation

Figure 4.28 shows the EPDM (Channel 1) and HTV SR (Channel 2) insulators. Both insulators had discoloration. The EPDM insulator, however, had loss of material or erosion and widening and small brown bubbles across the mould lines on the insulator. The HTV SR had small signs of tracking on the pollution layer, and darkening as well as clearing on the mould lines. Thus, it was hard to determine which material aged faster, since the aging mechanism was different.

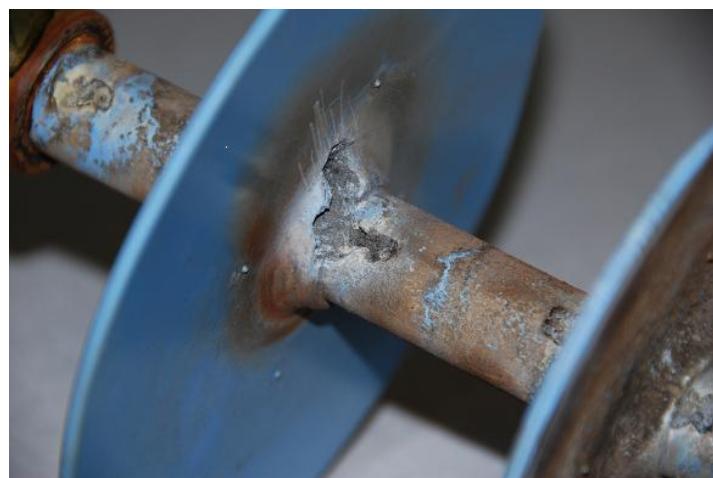
Figure 4.30: Detailed view of aging of the HTV SR insulator (Channel 3) for HVAC excitation

Figure 4.29 shows the HTV SR insulator with a unified Specific Creepage Distance of 28 mm/kV (Channel 3) before and after the experiment, while Figure 4.30 shows the aging in more detail. It developed five punctures on the sheds and rods, with white solid deposit on the punctures. There are small signs of browning or darkening at the tip of the metal end fitting and it also shows discoloration on the insulator. Furthermore, signs of tracking are evident.

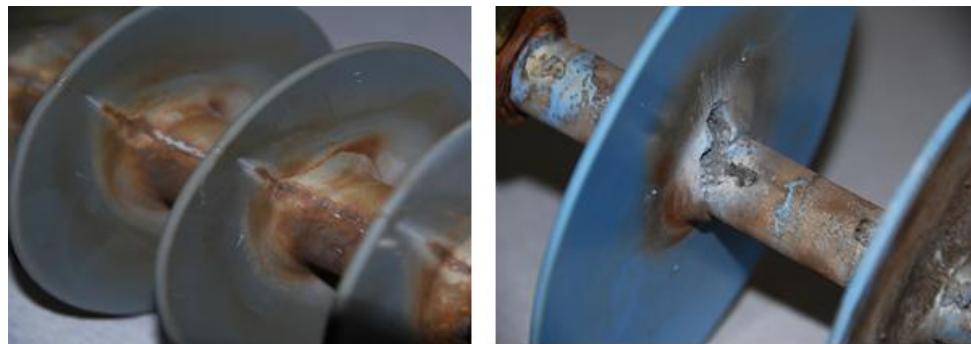
Figure 4.31: Comparison of aging of HTV SR insulators from manufacturer A and manufacturer B for HVAC excitation

Figure 4.31 show the HTV SR insulators with unified SCD of 28 mm/kV from manufacturer A (Channel 2) and manufacturer B (Channel 3) respectively. The insulator from manufacturer A had brown discoloration and small tracks on the pollution layer. The insulator from manufacturer B has five punctures and small tracks on the pollution layer, with severe erosion. In this particular case, the insulator from Manufacturer A performed better compared to the insulator from manufacturer B in terms of material aging.

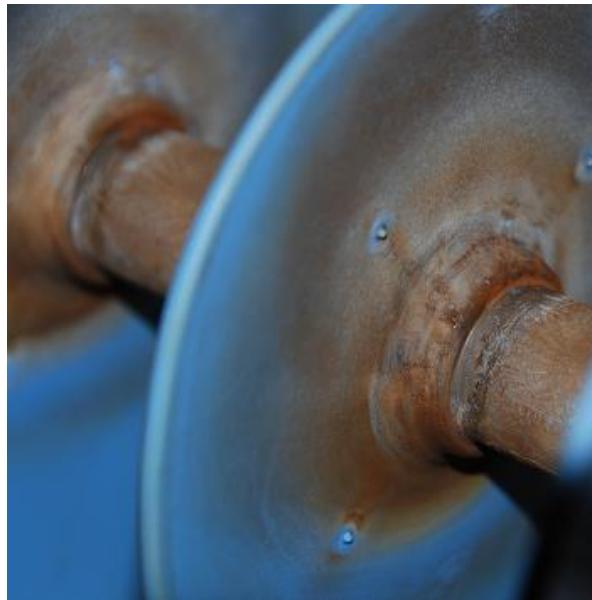
Figure 4.33: Detailed view of aging of the HTV SR insulator (Channel 4) for HVAC excitation

Figure 4.32 show the HTV SR insulator with a unified Specific Creepage Distance (USCD) of 35 mm/kV (Channel 4) before and after the test, while Figure 4.33 shows the aging in more detail. This insulator did not age much and only shows a discoloration on the rods and sheds and light tracking on the pollution layer.

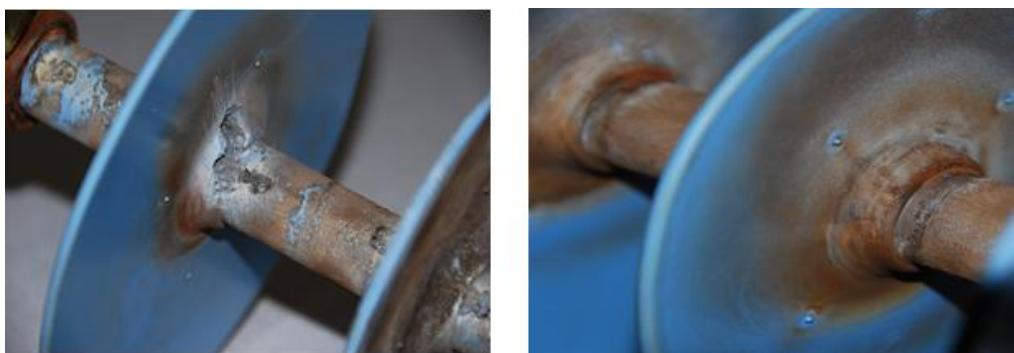
Figure 4.34: Comparison of aging of HTV SR insulators with creepage distances of 380 mm and 476 mm for HVAC excitation

Figure 4.34 shows the HTV SR insulator with unified SCD of 28 mm/kV and 35 mm/kV. The HTV SR insulator with unified SCD of 28 mm/kV (Channel 3) has eight punctures, as well as small tracking on the pollution layer. The HTV SR insulator with unified SCD of 35 mm/kV (Channel 4) only has slight tracks on the pollution layer and a brown discoloration. The insulator with unified SCD of 28 mm/kV (Channel 3) performed worse compared to the insulator with unified SCD of 35 mm/kV (Channel 4) in terms of material aging.
