Insulator Aging Tests with HVAC and HVDC Excitation using the Tracking Wheel Tester

Thesis presented in partial fulfilment of the requirements for the degree

Master of Science in Engineering at the University of Stellenbosch

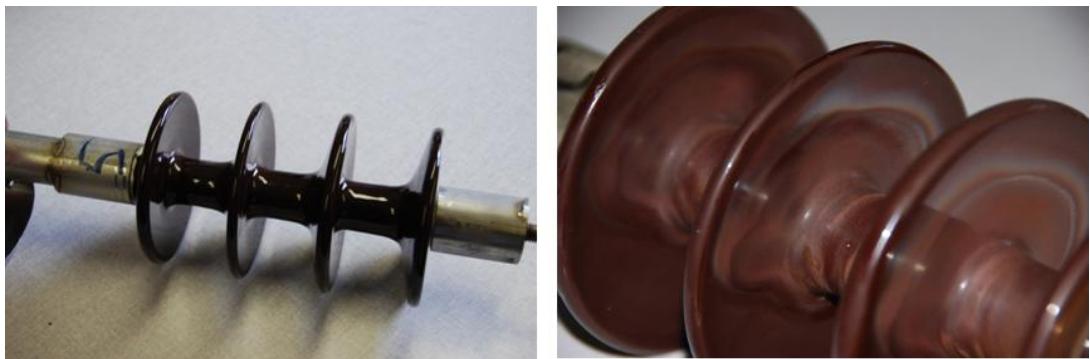
Figure 4.35: Reference porcelain insulator (Channel 5) before and after the test for HVAC excitation

Figure 4.35 show the uncoated porcelain insulator (Channel 5) before and after the test, while Figure 4.36 shows the aging in more detail. This reference porcelain insulator did not age much with time and only experienced light brown discoloration at the end of the test. The discoloration is visible when dry, though hard to see when the insulator is wet.

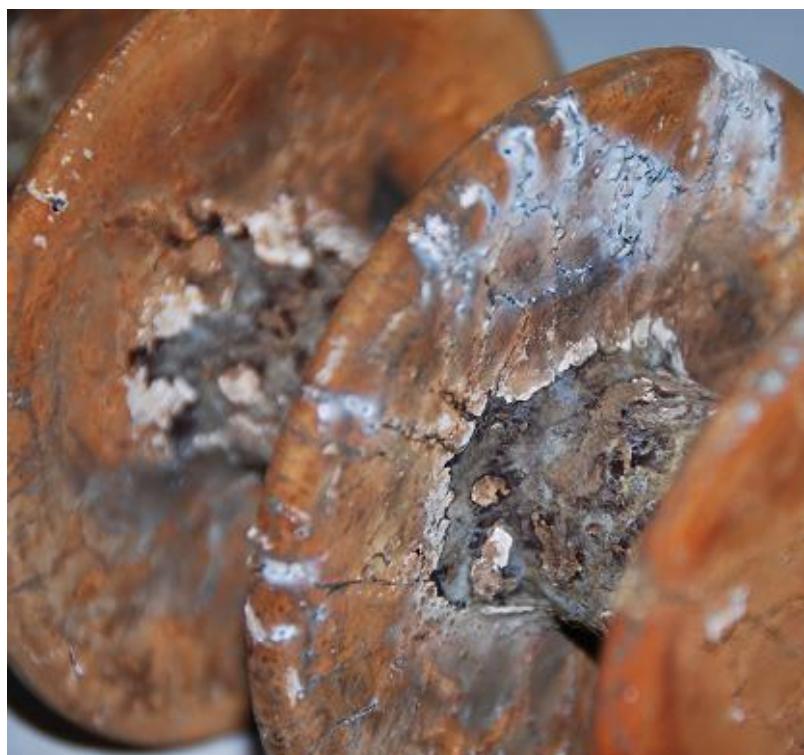
Figure 4.38: Detailed view of aging of the RTV SR coated porcelain (Channel 6) insulator for HVAC excitation

Figure 4.37 show the RTV SR coated porcelain insulator (Channel 6) before and after the test, while Figure 4.38 shows the aging in more detail. This insulator developed a brown, almost reddish discolouration and exhibits severe tracks and erosion. Some of the tracks have a whitish / pinkish colour. There is severe erosion on the sheds as well as on the rods and the insulator had lost almost the entire coating on the rods and part of the sheds. There is also severe blackening of the tip of the metal end fitting.

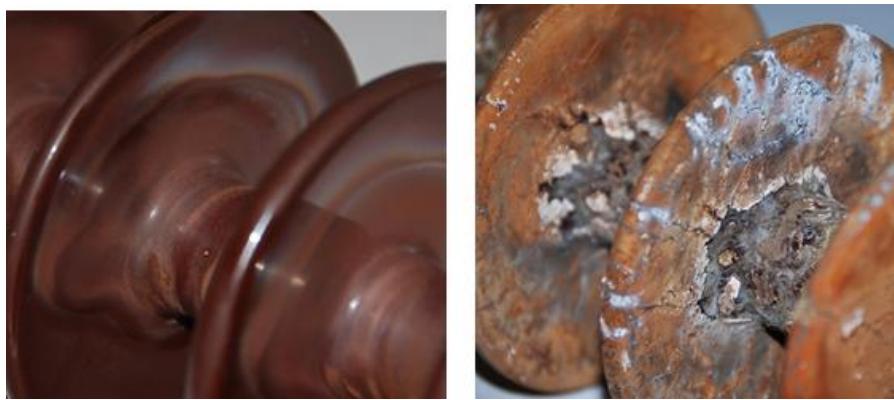
Figure 4.39: Comparison of aging of the porcelain and RTV SR coated porcelain insulators for HVAC excitation

Figure 4.39 shows the porcelain (Channel 5) and RTV SR coated porcelain (Channel 6) insulators. The porcelain insulator only had minor discoloration at the end of the test, whereas the RTV SR coated porcelain had severe tracks, erosion and discoloration. This section shows that the RTV SR coated porcelain insulator (Channel 6) aged faster than the porcelain insulator (Channel 5).

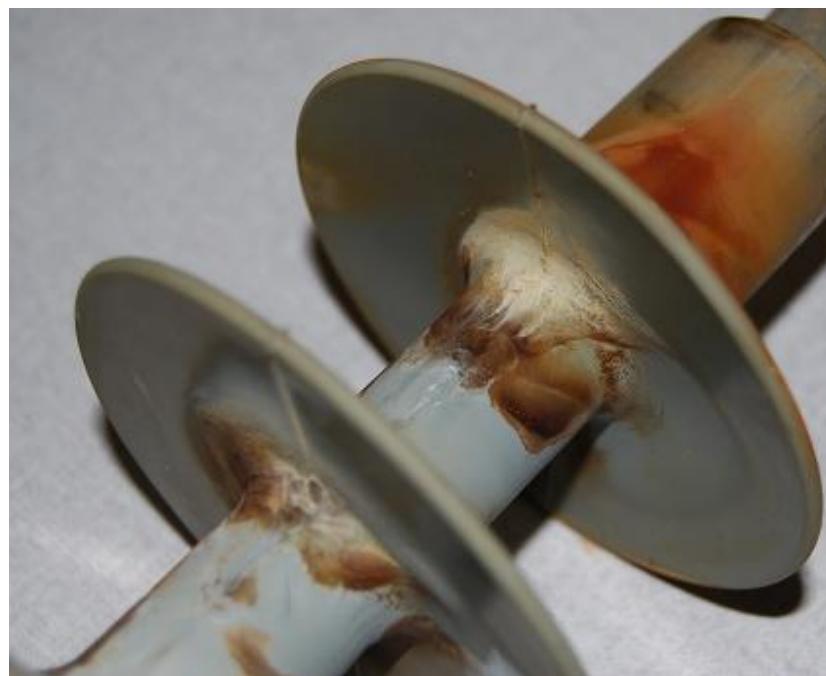
Figure 4.48: Detailed view of aging of the EPDM insulator (Channel 1) for positive polarity HVDC excitation

Figure 4.47 shows the EPDM insulator with a unified SCD of 28 mm/kV (Channel 1) before and after the test, while Figure 4.48 shows the aging in more detail. It shows discoloration on the insulator sheds and rods as well as on the metal end fittings. Furthermore, there is light tracking displayed on the pollution layer and heavy erosion. The insulator appears to be disfigured along the mould lines and there also appears to be small black burns on the 4th shed.

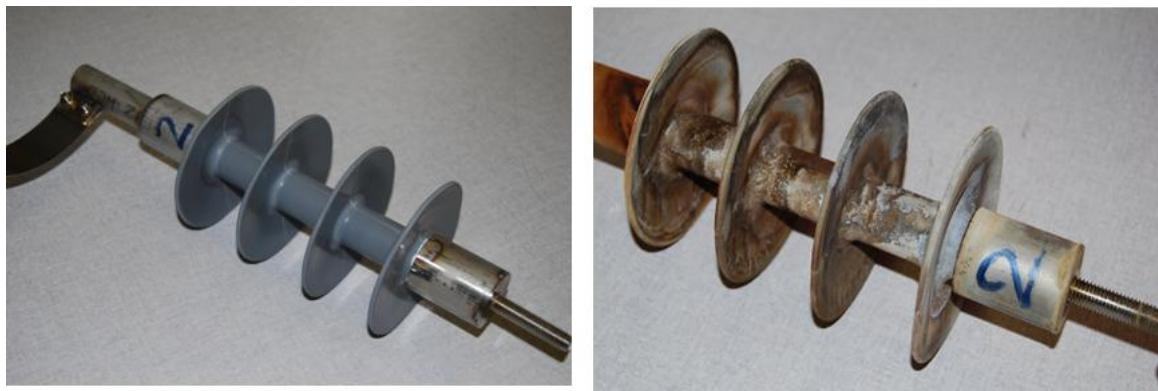
Figure 4.49: The HTV SR insulator with a unified SCD of 28 mm/kV from manufacturer A (Channel 2) before and after the test with positive polarity HVDC excitation

Figure 4.49 shows the HTV SR insulator with a unified SCD of 28 mm/kV from manufacturer A (Channel 2) before and after the test, while Figure 4.50 shows the aging in more detail. The insulator shows severe tracking and erosion. The tracking is not only on the pollution layer, but penetrates deep into the material itself. The insulator also has one small puncture and there is severe discoloration, especially on the 4th shed. A small part of the metal end fittings are burned. The mould line seems to have completely disappeared on one side, and only shows a little bit on the other side.

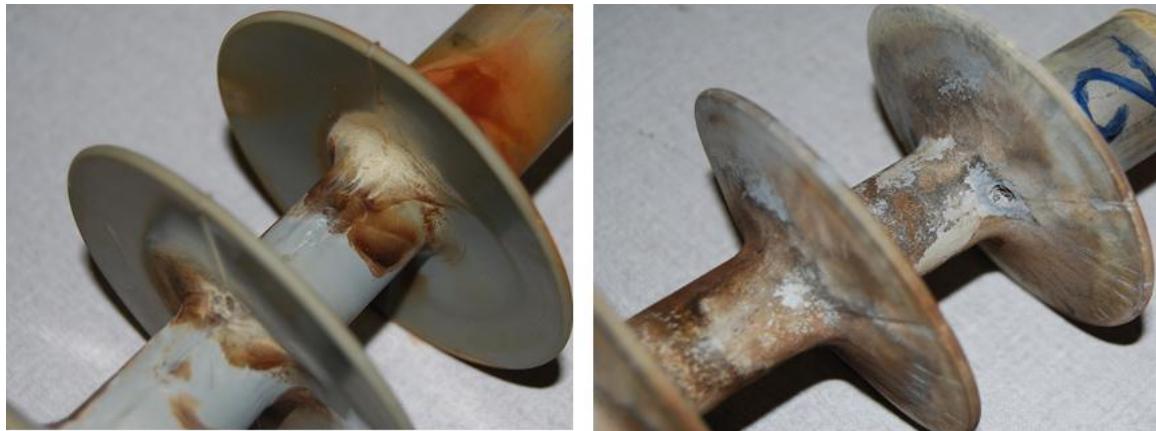
Figure 4.51: Comparison of aging of EPDM and HTV SR insulators for positive polarity HVDC excitation

The HTV SR insulator (Channel 2) seems to have aged severely compared to EPDM insulator (Channel 1).

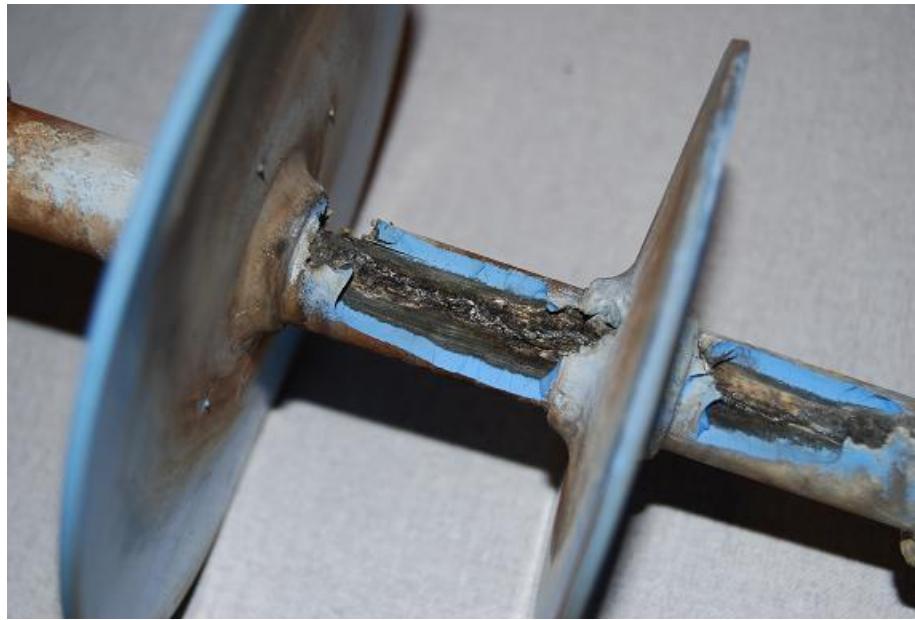
Figure 4.53: Detailed view of aging of the HTV SR insulator (Channel 3) for positive polarity HVDC excitation

Figure 4.52 shows the HTV SR insulator with a unified SCD of 28 mm/kV from manufacturer B (Channel 3) before and after the test, while Figure 4.53 shows the aging in more detail. This insulator was so severely damaged that it caused the whole system to malfunction when it tripped. The insulating material on the rod, as well as the glass-fibre rod itself, was severely burned. Tracking appeared both on the pollution layer as well as on the material itself. The insulator also had erosion and discoloration on the sheds.

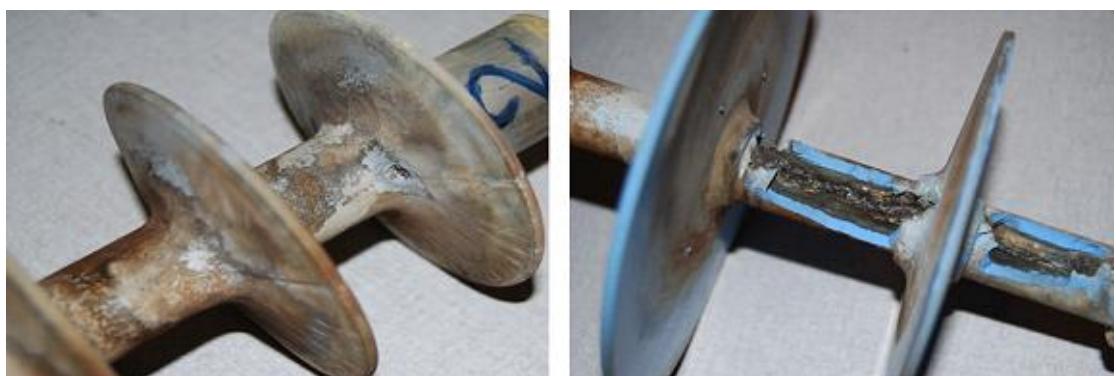
Figure 4.54: Comparison of aging of the HTV SR insulators from manufacturer A and manufacturer B for positive polarity HVDC excitation

Figure 4.54 shows HTV SR insulators from manufacturer A (Channel 2) and manufacturer B (Channel 3). The HTV SR insulator from manufacturer A (Channel 2) had punctures and severe erosion and tracking. It still performed better than HTV SR insulator from manufacturer B (Channel 3), which had lots of punctures until it failed, with erosion and tracking in a star pattern.

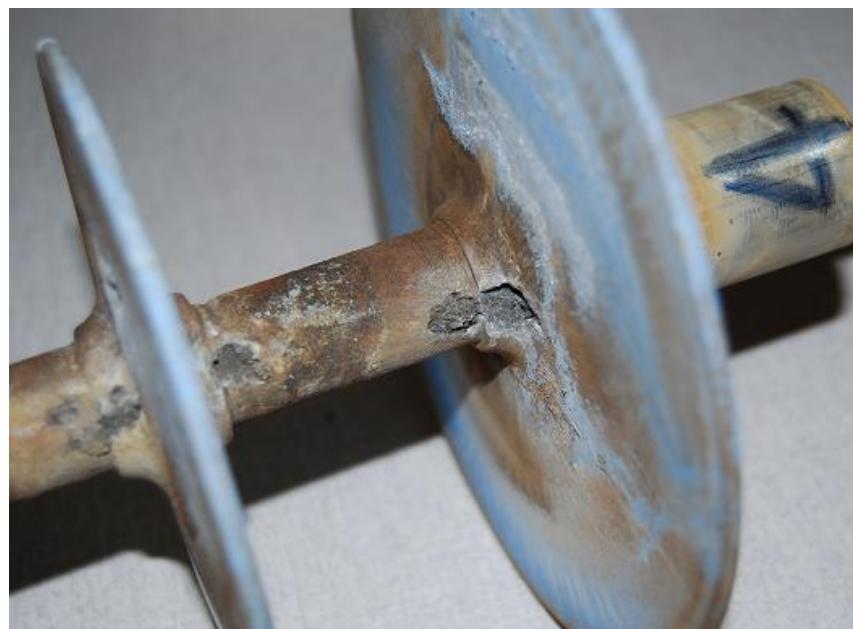
Figure 4.56: Detailed view of aging of the HTV SR insulator (Channel 4) for positive polarity HVDC excitation

Figure 4.55 shows the HTV SR insulator with a unified SCD of 35 mm/kV from manufacturer B (Channel 4) before and after the test, while Figure 4.56 shows the aging in more detail. The insulator developed eight punctures and also had severe tracking and erosion in the form of a star effect. The tracking appeared only on the

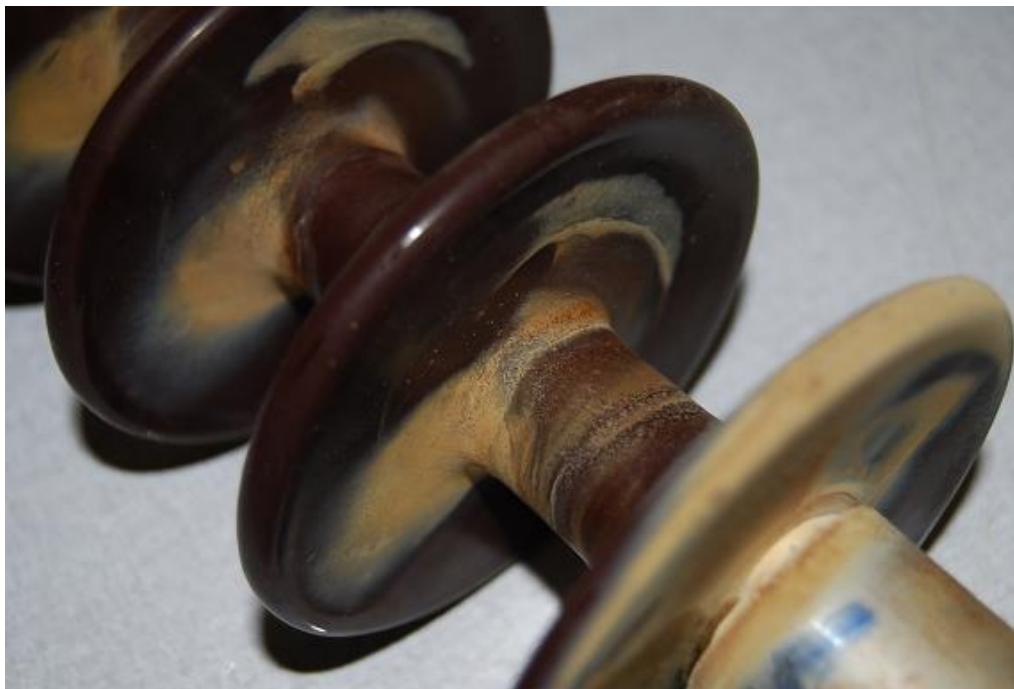
Figure 4.59: Detailed view of aging of the porcelain insulator (Channel 5) for positive polarity HVDC excitation

Figure 4.58 shows the porcelain insulator (Channel 5) before and after the test, while Figure 4.59 shows the aging in more detail. This insulator shows brown discoloration but did not age much. The insulator experienced no material degradation.

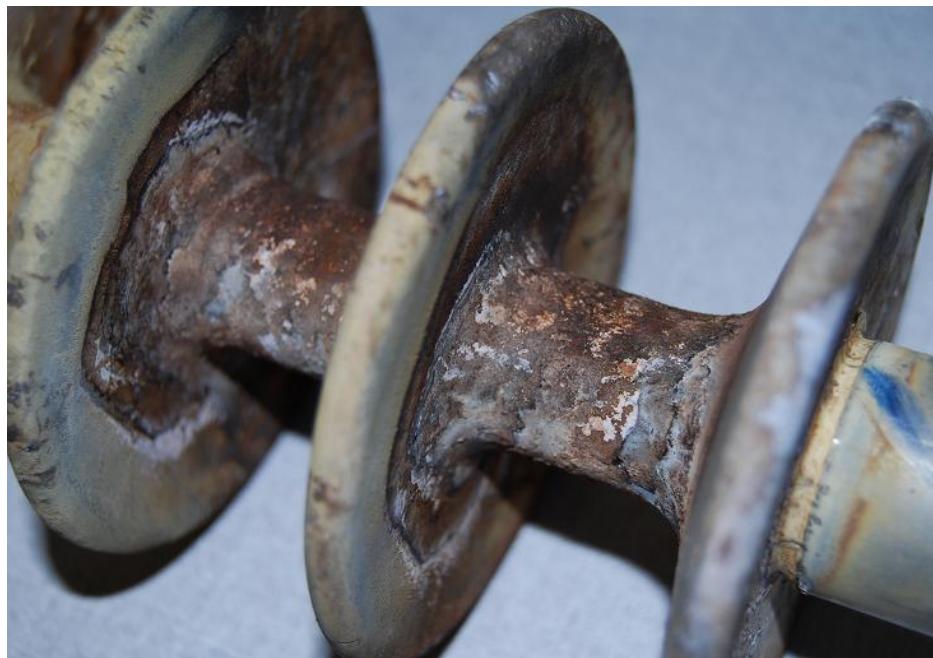
Figure 4.61: Detailed view of aging of the RTV SR coated porcelain insulator (Channel 6) for positive polarity HVDC excitation

Figure 4.60 shows the RTV SR coated porcelain insulator (Channel 6) before and after the test, while Figure 4.61 shows the aging in more detail. The aging of the insulator is clearly evident. The skin had eroded away, especially on the rods where the material was completely cleared off. There was not that much erosion on the sheds, even though there was a lot of discoloration on the insulator itself. There is evidence of a white discoloration.

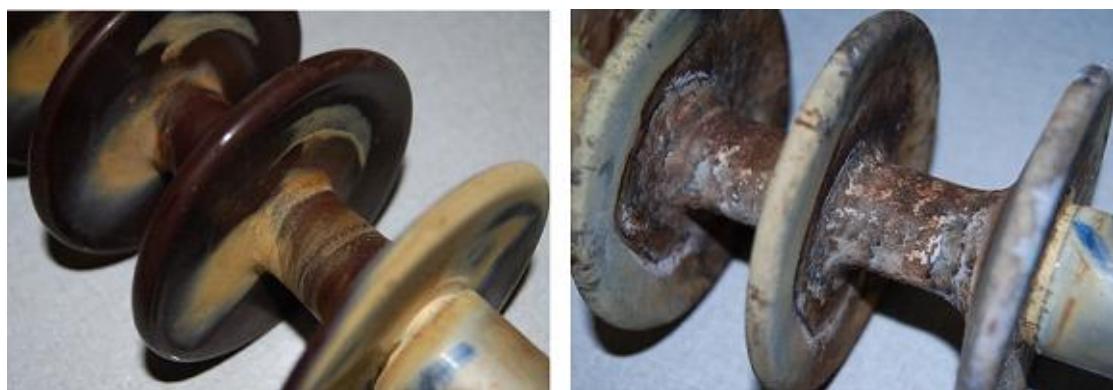
Figure 4.62: Comparison of aging of the porcelain and RTV SR coated porcelain for positive polarity HVDC excitation

Figure 4.62 shows the porcelain (Channel 5) and RTV coated porcelain (Channel 6) insulators. The porcelain insulator (Channel 5) only had a slight brown discoloration and did not age much. The RTV SR coated porcelain insulator (Channel 6) seemed to have aged faster since it had severe discoloration and erosion, as well as flaking of the coating. The RTV SR coated porcelain insulator (Channel 6) seems to have aged faster compared to the porcelain insulator (Channel 5).

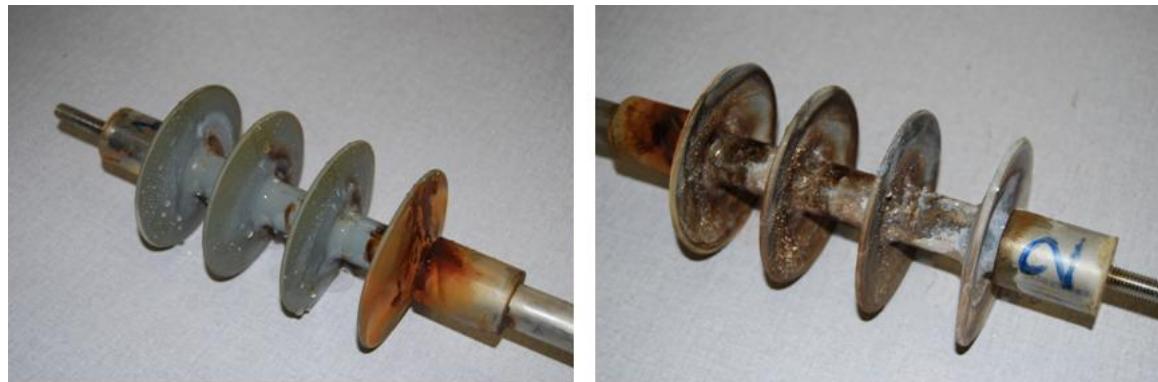
Figure 4.63: Wettability of the EPDM insulator (Channel 1) and the HTV SR insulator (Channel 2), both with a unified SCD of 28 mm/kV

Figure 4.63 compares the hydrophobicity of the EPDM insulator (Channel 1) and the HTV SR insulator (Channel 2). The EPDM insulator has a wettability class of 5,

while the HTV SR insulator has a wettability class of 3. In other words, the EPDM insulator seems to have lost hydrophobicity, while the HTV SR insulator recovered hydrophobicity.

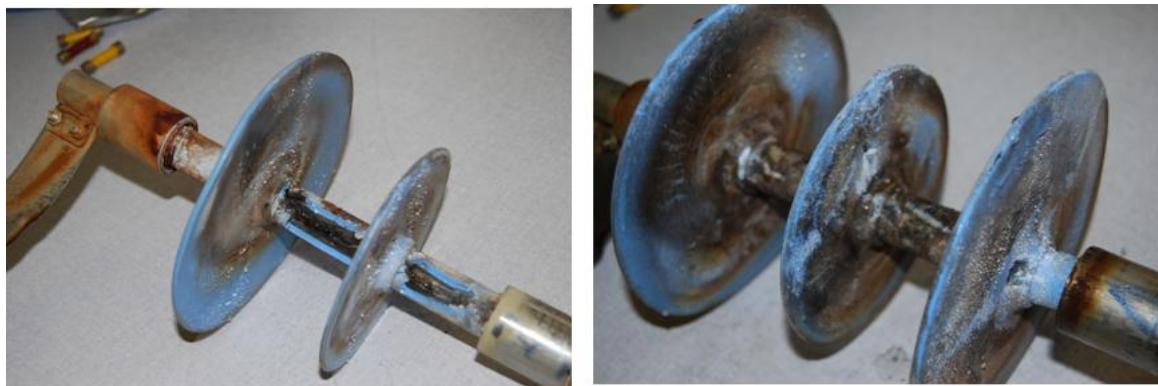
Figure 4.65: Wettability of the HTV SR insulator with a unified SCD of 28 mm/kV (Channel 3) and the HTV SR insulator with a unified SCD of 35 mm/kV (Channel 4)

Figure 4.65 compares the hydrophobicity of the HTV SR insulator with a unified SCD of 28 mm/kV (Channel 3) with the HTV SR insulator a unified SCDof 35 mm/kV (Channel 4). Channel 3 has a wettability class of 4, while Channel 4 has a wettability class of 3 to 4. Thus the HTV SR insulator (Channel 4) with a longer unified SCDretained hydrophobicity better than the HTV SR insulator with a shorter unified SCD (Channel 3).

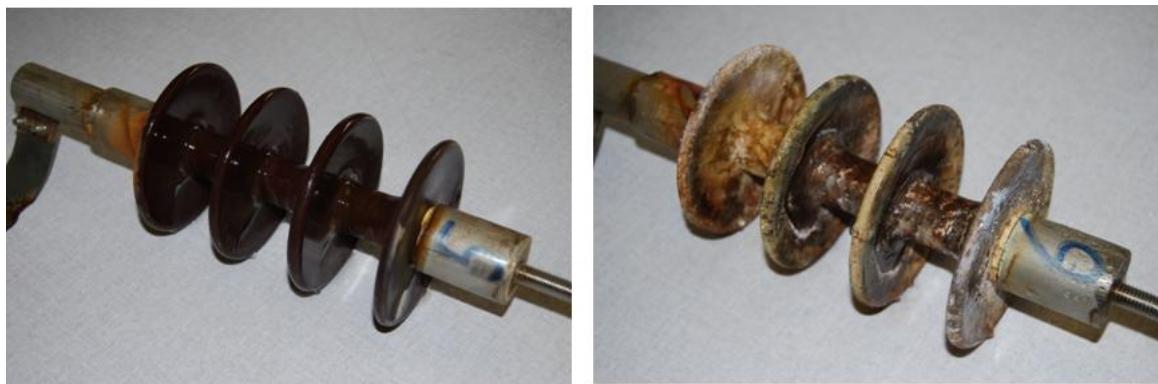
Figure 4.66: Wettability of the porcelain insulator (Channel 5) and the RTV SR coated porcelain insulator (Channel 6)

Figure 4.66 compares the hydrophobicity of the porcelain insulator (Channel 5) with the RTV SR coated porcelain insulator (Channel 6). The porcelain Channel 5 is completely hydrophilic, since it has a wettability class of 6, while Channel 6 has a wettability class of 4 to 5. Thus, the RTV SR coated insulator (Channel 6) seems to retain its hydrophobicity better than the porcelain insulator (Channel 5).

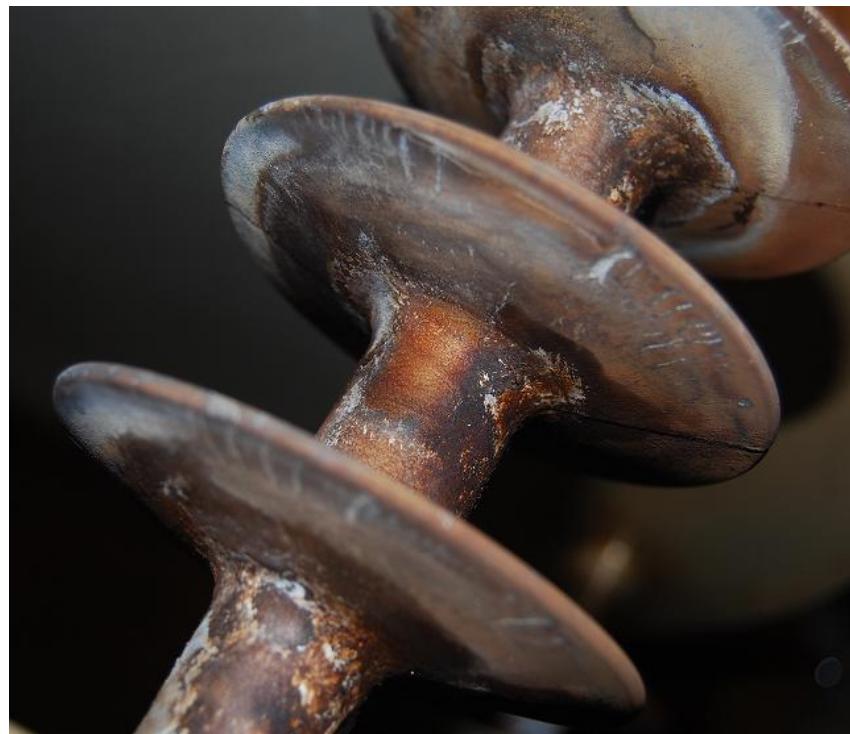
Figure 4.74: Detailed view of aging of the HTV SR insulator (Channel 2) for negative polarity HVDC excitation

Figure 4.73 shows the HTV SR insulator with a unified SCD of 28 mm/kV (Channel 2) before and after the test, while Figure 4.74 shows the aging in more detail. The insulator has tracks and erosion in the form of a star effect. The tracks appear on the pollution layer, with a little bit on the actual material. There is also a lot of discoloration on the sheds and rods.

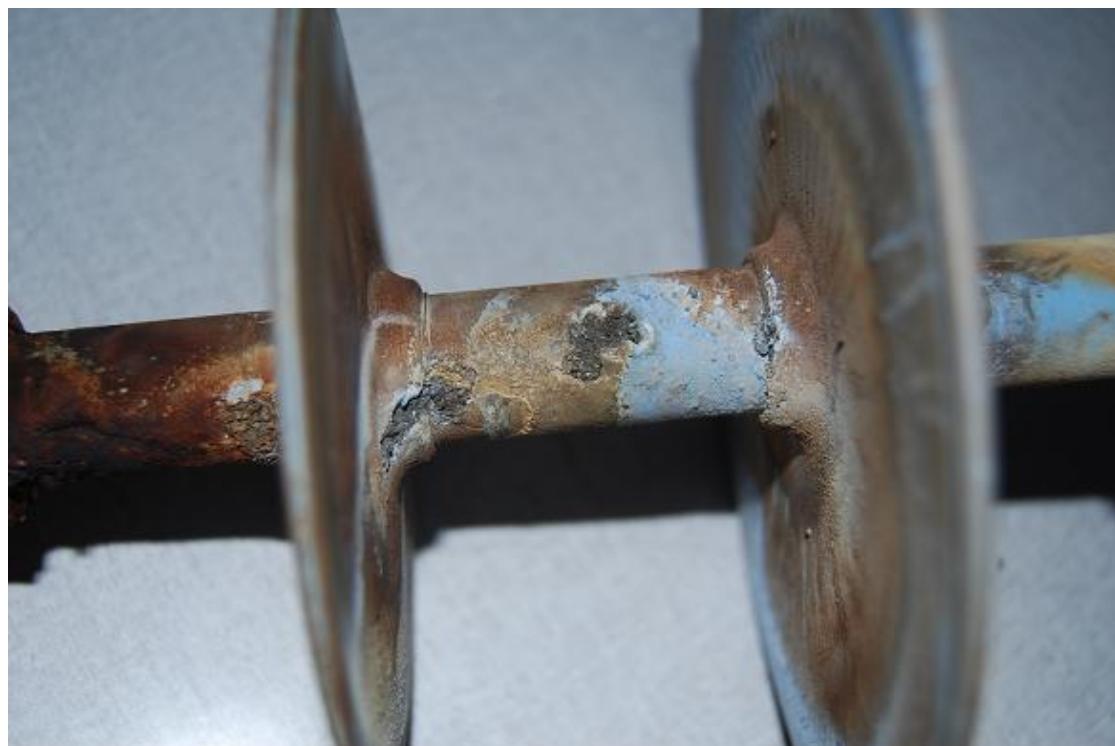
Figure 4.77: Detailed view of aging of the HTV SR insulator from manufacturer B (Channel 3) for negative polarity HVDC excitation

Figure 4.76 shows the HTV SR insulator with a unified SCD of 28 mm/kV from manufacturer B (Channel 3) before and after the test, while Figure 4.74 shows the aging in more detail. The insulator shows discoloration and erosion, as well as severe

tracks on the pollution layer in the form of a star effect. The insulator has four punctures, as well as burn marks on one side of the metal end fitting. A part of the rod is completely burned out and blackened.

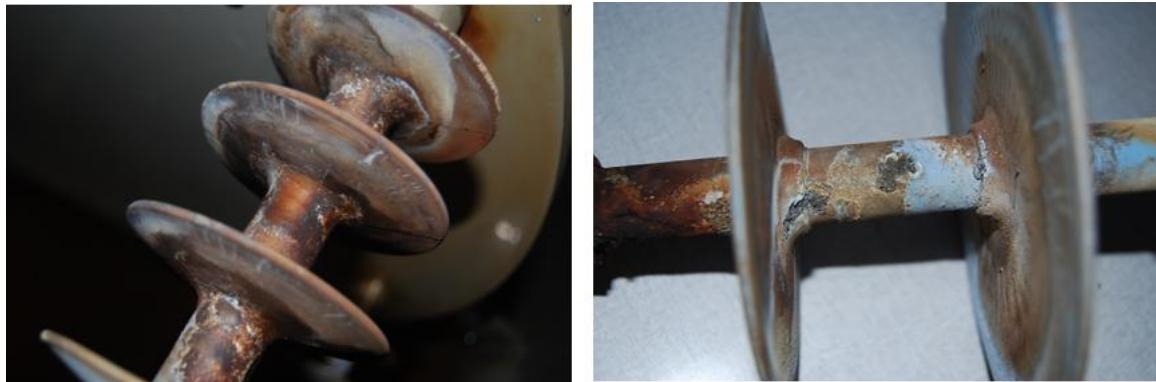
Figure 4.78: Channel 2 and Channel 3 after the test with negative polarity HVDC excitation

Figure 4.78 compares the HTV SR insulators with a unified SCDoF of 28 mm/kV from manufacturer A (Channel 2) and manufacturer B (Channel 3). Channel 2 aged a little bit slower than Channel 3 since it had only one puncture, while Channel 3 had four punctures. Furthermore, Channel 3 had one side of the rod before the first shed completely burned out, while Channel 2 only had a slight burn at the metal end fitting.

Both insulators had tracks in the form of a star effect on the pollution layer, with a little bit on the actual insulator.

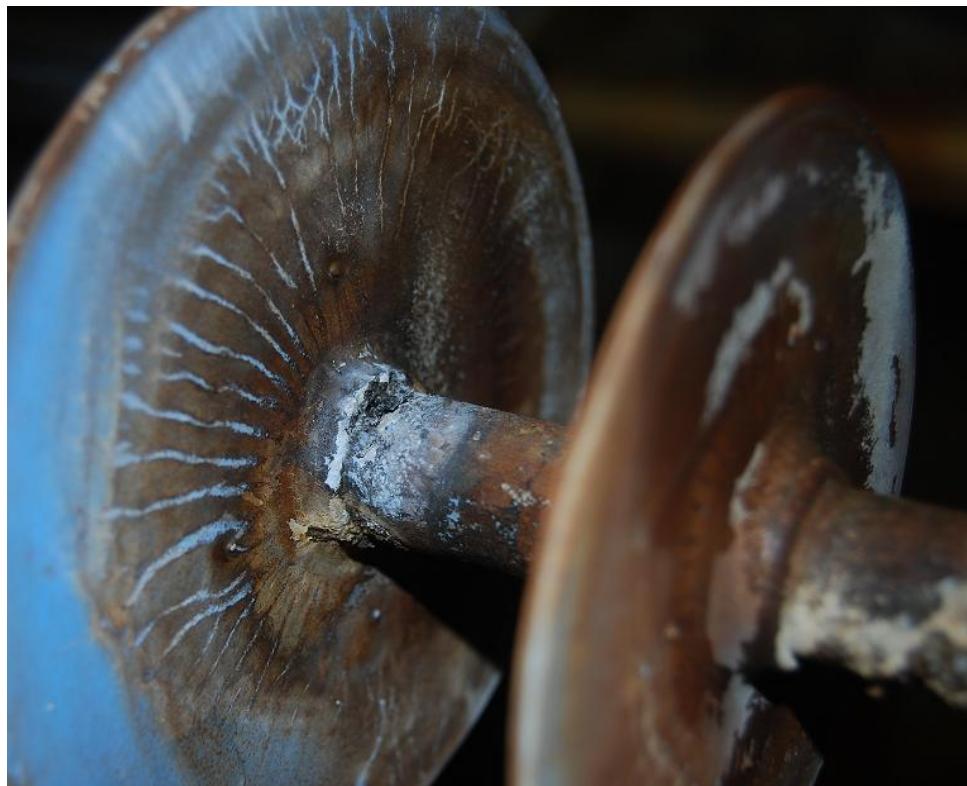
Figure 4.80: Detailed view of aging of the HTV SR insulator with a SCD of 35 mm/kV for negative polarity HVDC excitation

Figure 4.79 shows the HTV SR insulator with a unified SCD of 35 mm/kV (Channel 4) before and after the test, while Figure 4.80 shows the aging in more detail. The insulator shows erosion, as well as the tracks on the sheds of the insulator. There is discoloration on the sheds and the rods. There insulator had tracks on the pollution layer in the form of a star effect. There are two punctures on the insulator and some of the material has worn away on the sheds and rods, as well as at the tips of the sheds.

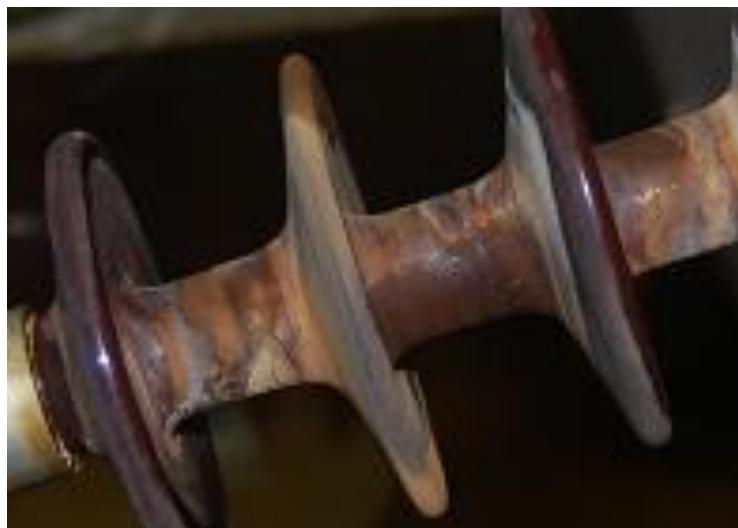
Figure 4.83: Detailed view of aging of the porcelain insulator for negative polarity HVDC excitation

Figure 4.82 shows the porcelain insulator (Channel 5) before and after the test, while Figure 4.83 shows the aging in more detail. The insulator did not age much and there is only minor brownish discoloration on the insulator.

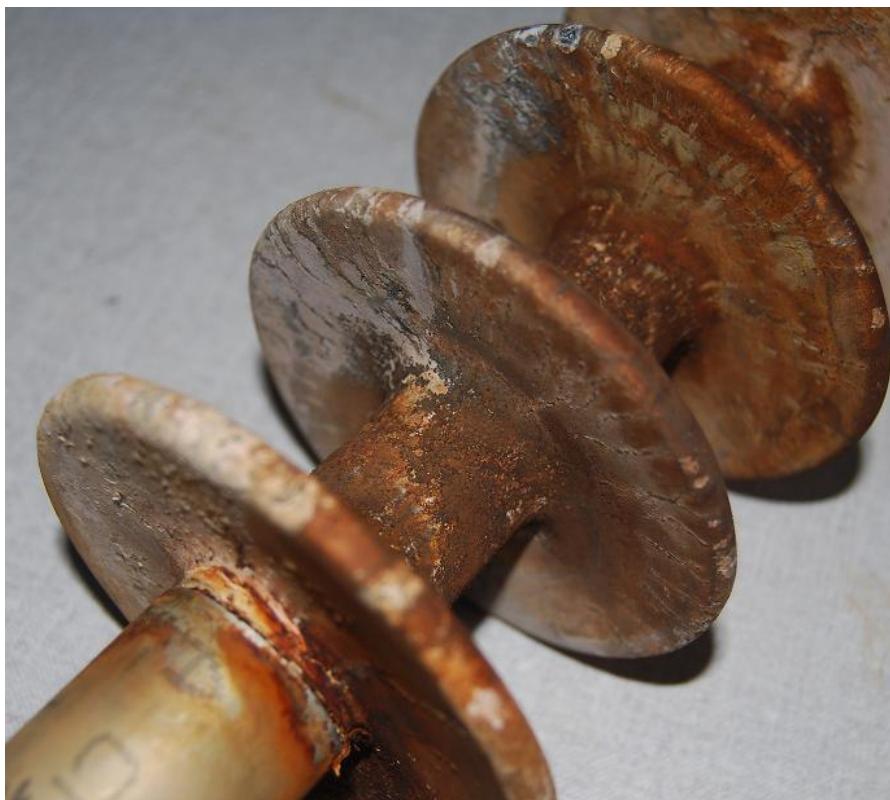
Figure 4.85: Detailed view of aging of the RTV coated porcelain insulator for negative polarity HVDC excitation

Figure 4.84 shows the RTV SR coated porcelain insulator (Channel 6) before and after the test, while Figure 4.85 shows the aging in more detail. The insulator has both severe tracking and erosion and a brownish/reddish discoloration. Some of the material has flaked off.

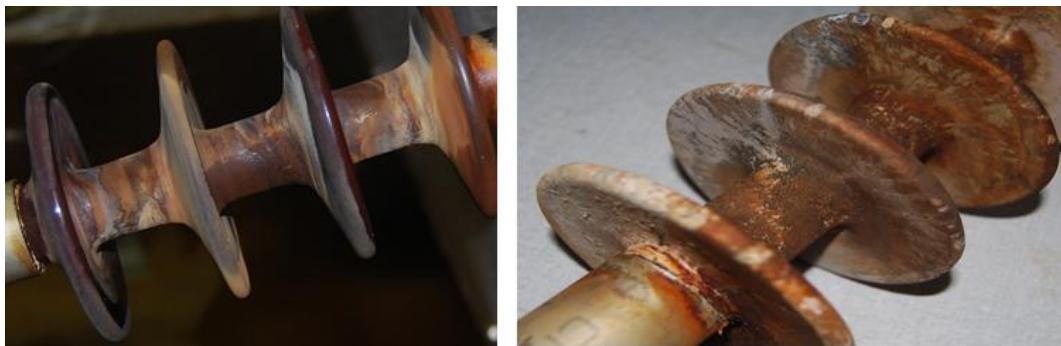
Figure 4.86: Channel 5 and Channel 6 after the test with negative polarity HVDC excitation

Figure 4.86 compares the reference porcelain insulator (Channel 5) and the RTV SR coated porcelain insulator (Channel 6). The porcelain insulator did not age much, while RTV SR coated porcelain insulator aged severely, with severe tracking and erosion. The porcelain insulator has a brown discoloration, while the RTV SR coated porcelain insulator has a brown/reddish discoloration.

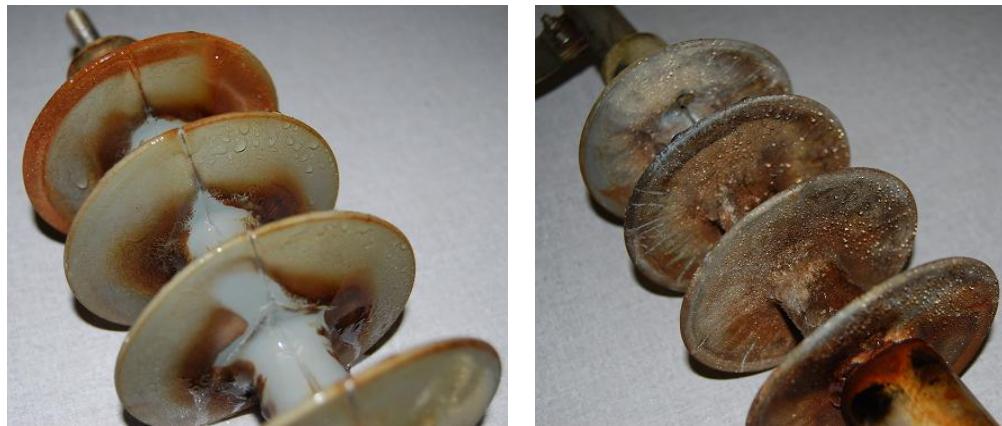
Figure 4.87: Wettability of the EPDM insulator (Channel 1) and the HTV SR insulator (Channel 2), both with a unified S_{CD} of 28 mm/kV

Figure 4.87 compares the hydrophobicity of the EPDM insulator (Channel 1) and the HTV SR insulator (Channel 2). The EPDM insulator as well as the HTV SR insulator has a wettability class of 5. Thus, both insulators were becoming almost hydrophilic.

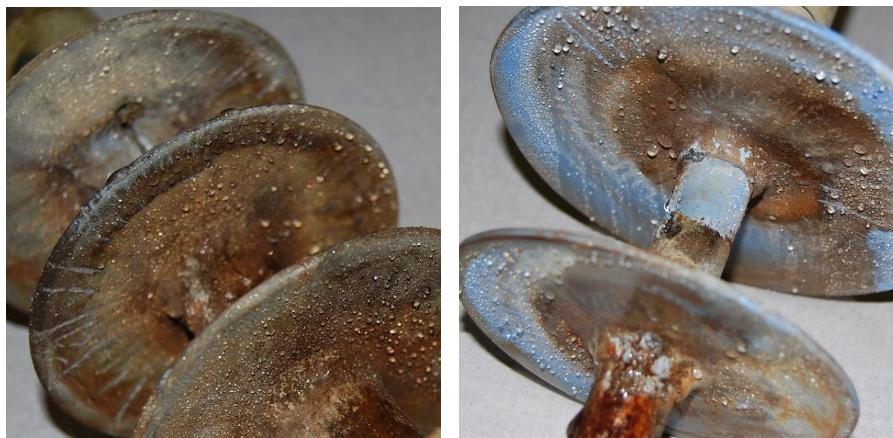
Figure 4.88: Wettability of the HTV SR insulators with a unified SCD of 28 mm/kV from manufacturer A (Channel 2) and from manufacturer B (Channel 3)

Figure 4.88 compares the hydrophobicity of the HTV SR insulators with a unified SCDof 28 mm/kV from manufacturer A (Channel 2) and from manufacturer B (Channel 3). Channel 2 has a wettability class of 5, while Channel 3 had a wettability class of 4.

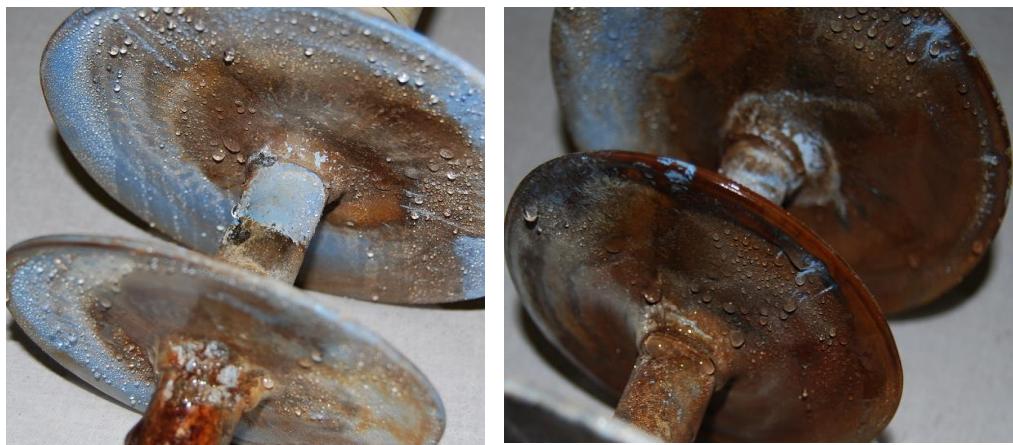
Figure 4.89: Wettability of the HTV SR insulators with a unified SCD of 28 mm/kV (Channel 3) and a unified SCD of 35 mm/kV (Channel 4)

Figure 4.89 compares the hydrophobicity of the HTV SR insulator with a unified SCD of 28 mm/kV (Channel 3) and the HTV SR insulator with a unified SCD of 35 mm/kV (Channel 4). Channel 3 has a wettability class of 4 and Channel 4 has a wettability class of 5. Thus, Channel 3 seems to retain hydrophobicity better compared to Channel 4.

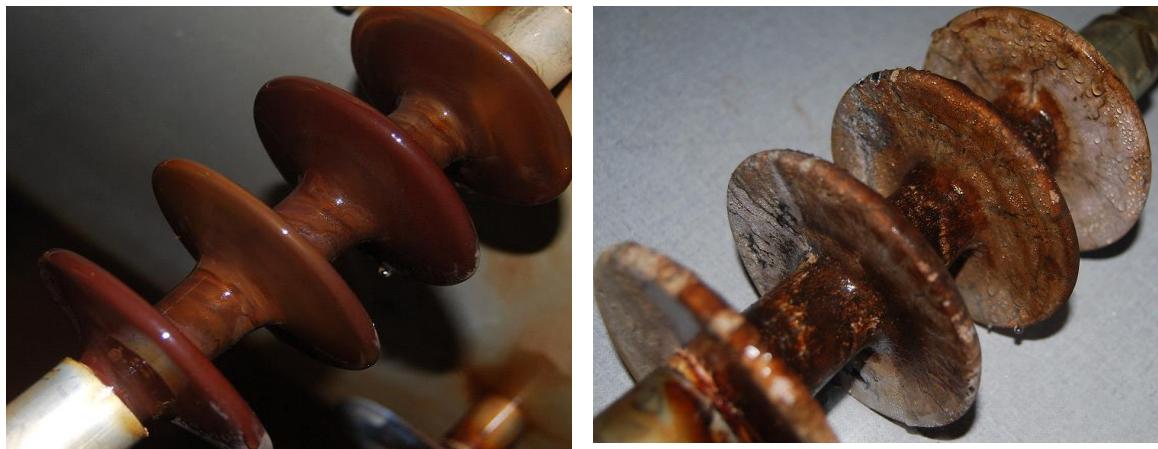
Figure 4.90 compares the hydrophobicity of the porcelain insulator (Channel 5) and the RTV SR coated porcelain insulator (Channel 6). The reference porcelain insulator has a wettability class of 6 and is completely hydrophilic. The RTV SR coated porcelain insulator has a wettability class of 4 and still retains hydrophobicity. Thus, the coating does improve the hydrophobicity or wetting class of the insulators.

Figure 4.90: Wettability of porcelain insulator (Channel 5) and the RTV SR coated porcelain insulator (Channel 6)

- The RTV SR coated porcelain (channel 6) had reddish brown surface discolouration with the coating severely degraded and partly stripped from the surface of the insulator. The reference porcelain insulator (channel 5) showed only slight surface discoloration.

- The porcelain insulator remained completely hydrophilic (wettability class of 6), whereas the RTV SR coated porcelain insulator (channel 6) had recovered to a wettability class of 4. It is observed that coating improves the hydrophobicity of the insulator. This type of coating cannot endure the continued high stresses created by the tracking wheel tester.

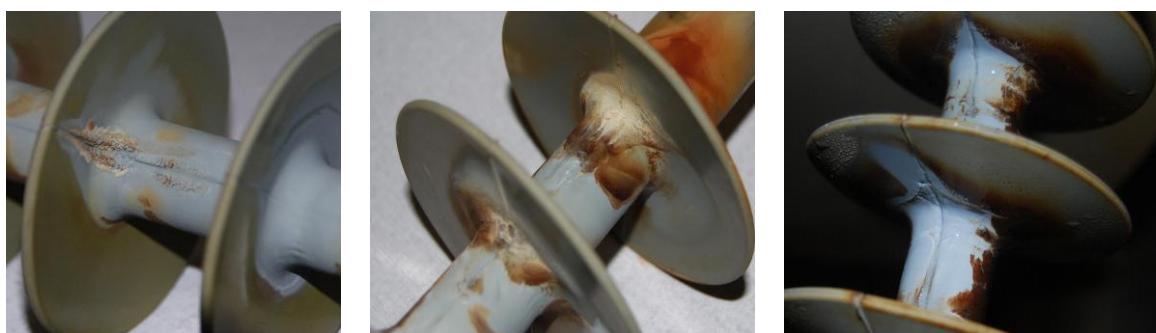
Figure 5.1 shows the material aging of the EPDM insulator (Channel 1) for HVAC and positive and negative polarity HVDC excitation. The EPDM insulator under HVAC excitation had discolouration, widening on the mould lines, and little brown bubbles on the mould lines. The EPDM insulator under positive HVDC excitation had discolouration and severe erosion localised to the mould lines. The EPDM insulator under negative HVDC excitation had less erosion along the mould lines, with sharp erosion on the sheds along the mould lines. The diagram shows that the EPDM aged the worst for the positive polarity HVDC excitation, followed by the negative HVDC excitation and finally the HVAC excitation.

Figure 5.1: Comparison of material aging of the EPDM insulator for HVAC and positive and negative polarity HVDC excitation

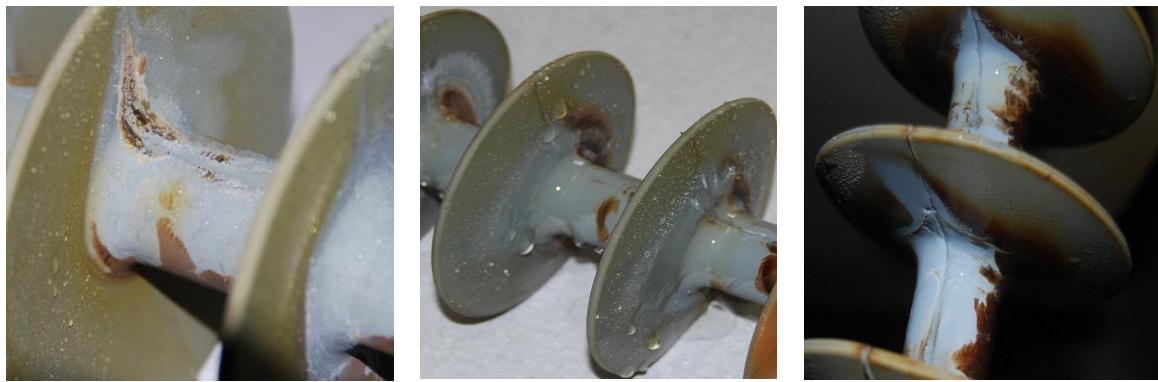
Figure 5.5 shows the hydrophobicity of the EPDM insulator (channel 1) for HVAC and positive and negative polarity HVDC excitation. The EPDM insulator fell within a wettability class of 5 with the HVAC and positive and negative polarity HVDC excitation. The EPDM insulator is almost hydrophilic and did not recover its hydrophobicity for any of the excitation types.

Figure 5.5: Comparison of hydrophobicity for the EPDM insulator (channel 1) for HVAC and positive and negative polarity HVDC excitation

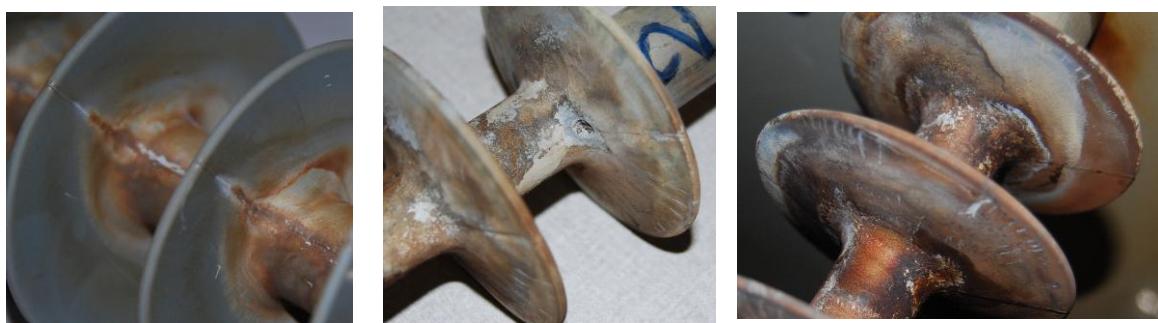
Figure 5.6 shows the HTV SR insulator (channel 2) for HVAC and positive and negative polarity HVDC excitation. The HTV SR insulator aged the slowest for HVAC excitation, as it showed only a brown discoloration as well as light tracking on the surface. The HTV SR insulator aged severely for positive polarity HVDC excitation. It had severe tracks and erosion in the form of a star shape. This insulator showed heavy discoloration, flaking of material, as well as a puncture. The HTV SR insulator had aged faster for negative polarity HVDC excitation than for HVAC excitation, but not as severely as for the positive polarity HVDC excitation. The HTV SR insulator for negative polarity HVDC excitation also showed brown discoloration, severe erosion and tracks in the form of the star. The HTV SR insulator, therefore, had aged most severely for positive polarity HVDC excitation, followed by the negative polarity excitation and had aged very slowly for HVAC excitation.

Figure 5.6: Comparison of aging for the HTV SR insulator (channel 2) for HVAC and positive and negative polarity HVDC excitation

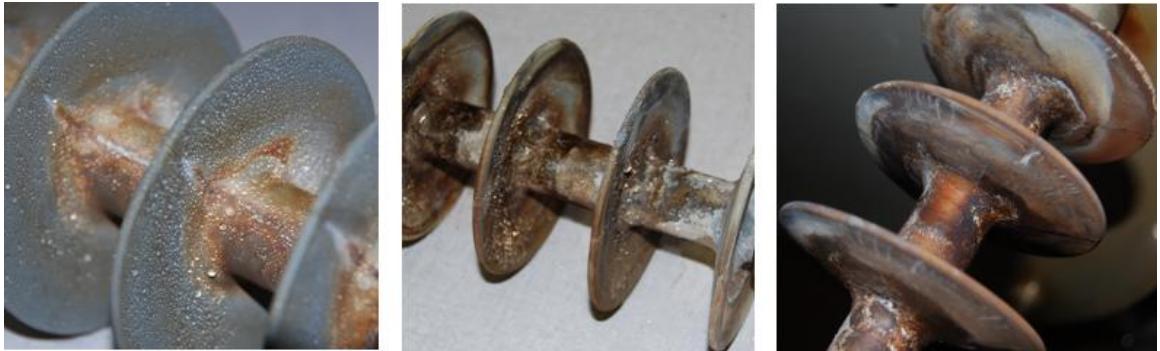
Figure 5.10 shows the hydrophobicity for the HTV SR insulator (channel 2) of manufacturer A for HVAC and positive and negative polarity HVDC excitation. The HTV SR insulator (channel 2) fell within a wettability class of 1 for HVAC excitation, thus having recovered its hydrophobicity. The HTV SR insulator (channel 2) had a wettability class of 3 for positive polarity HVDC excitation excitation, implying that the insulator was still slightly hydrophobic. The HTV SR insulator had a wettability

class of 5 for negative polarity HVDC excitation, showing that the material did not recover and became almost completely hydrophilic.

Figure 5.10: Comparison of the the hydrophobicity of the HTV SR insulator (channel 2) for HVAC and positive and negative polarity HVDC excitation

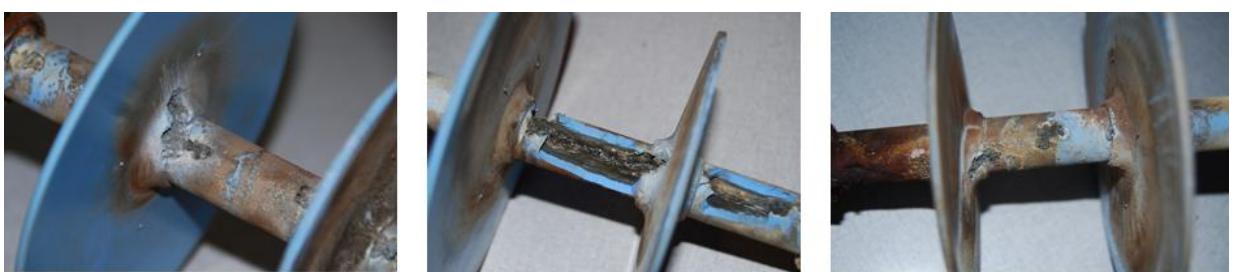
Figure 5.11 compares the material aging of the HTV SR insulator (channel 3) with unified SCD of 28 [mm/kV] from manufacturer B for HVAC excitation with that of the positive and negative polarity HVDC excitation respectively. The HTV SR insulator aged severely for HVAC excitation, but not as severe as for the other two cases. The HTV SR insulator had eight punctures, discoloration and small tracks on the surface for HVAC excitation. The HTV SR insulator showed some material and part of the shed removed from the insulator for positive polarity HVDC excitation. The HTV SR insulator had a part of the rod burned, turning it black, in colour for negative HVDC excitation. The HTV SR insulator with unified SCD of 28 [mm/kV] from manufacturer B performed the worst for positive HVDC excitation, followed by negative polarity HVDC excitation and performed the best with HVAC excitation.

Figure 5.11: Comparison of aging for the HTV SR insulator (channel 3) with a unified SCD of 28 mm/kV for HVAC and positive and negative polarity HVDC excitation

- The occurrence of each new puncture hole through the HTV SR insulator sheds (Channel 3) brought about increasingly higher peak currents, causing a fast rise in the peak current and eventual failure of the sample.

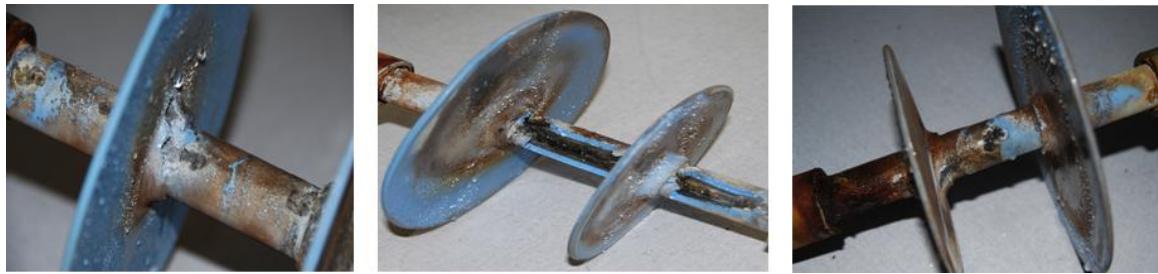
Figure 5.15 compares the hydrophobicity of the HTV SR insulator (channel 3) for HVAC and positive and negative polarity HVDC excitation. The HTV SR insulator fell within a wettability class of 2 for HVAC excitation, a wettability class of 3 for positive polarity HVDC excitation and a wettability class of 4 for negative polarity HVDC excitation. The HTV SR insulator seems to retain its hydrophobicity better for HVAC excitation, followed by positive and then negative polarity HVDC excitation.

Figure 5.15: Comparison of hydrophobicity for the HTV SR insulator (channel 3) with a unified SCD of 28 mm/kV for HVAC and positive and negative polarity HVDC excitation

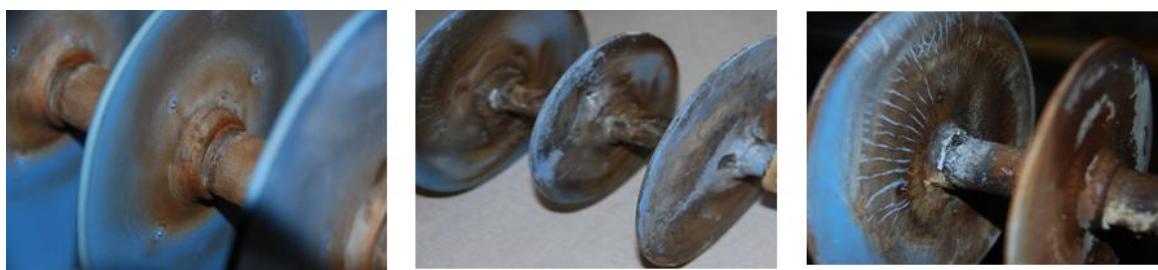
Figure 5.16 compares the material aging of the HTV SR insulator (channel 3) with a unified SCD of 35 mm/kV from manufacturer B for HVAC excitation with that for positive and negative polarity HVDC excitation respectively. The HTV SR insulator (channel 4) did not age significantly for HVAC excitation and showed only slight discoloration and light tracking on the surface. The HTV SR insulator (Channel 4) had degraded severely for positive polarity HVDC excitation. The insulator had a lot of punctures, tracks, erosion in the form of a star and was heavily discoloured. The HTV SR insulator had aged severely for negative polarity HVDC excitation. It had punctures, tracks on the surface and was heavily discoloured.

Upon comparison of the three cases, it was found that the HTV SR insulator (Channel 4) did not age significantly for HVAC excitation, but aged severely for HVDC excitation, with the positive polarity excitation showing the most severe signs of aging.

Figure 5.16: Comparison of material aging of the HTV SR insulator (channel 4) for HVAC and positive and negative polarity HVDC excitation

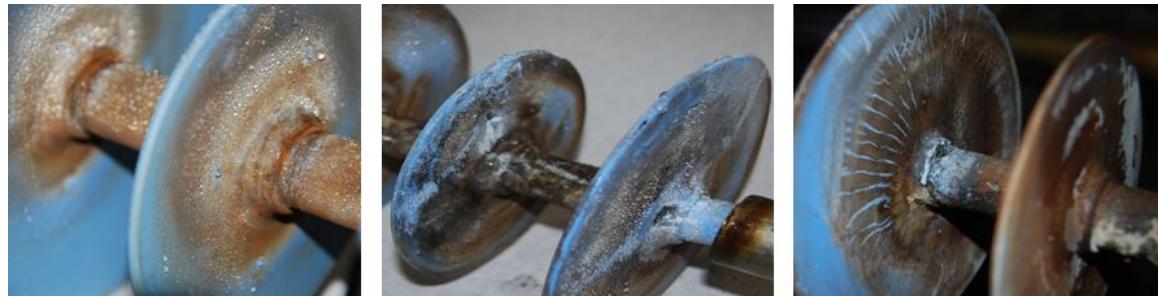
Figure 5.20 compares the hydrophobicity of the HTV SR insulator (channel 4) with a unified SCDof 35 mm/kV for HVAC and positive and negative polarity HVDC excitation. The HTV SR insulator (channel 4) fell within a wettability class of 1 for HVAC excitation, a wettability class of 3 for positive polarity HVDC excitation and fell within a wettability class of 5 for negative polarity HVDC excitation. Upon comparison it is shown that the HTV SR insulator (channel 4) retained its hydrophobicity for HVAC excitation, retained part of its hydrophobic properties for

positive polarity HVDC excitation, but had lost most of its hydrophobic properties for negative polarity HVDC excitation.

Figure 5.20: Comparison of hydrophobicity for the HTV SR insulator (channel 4) with a unified SCD of 35 mm/kV for HVAC and positive and negative polarity HVDC excitation

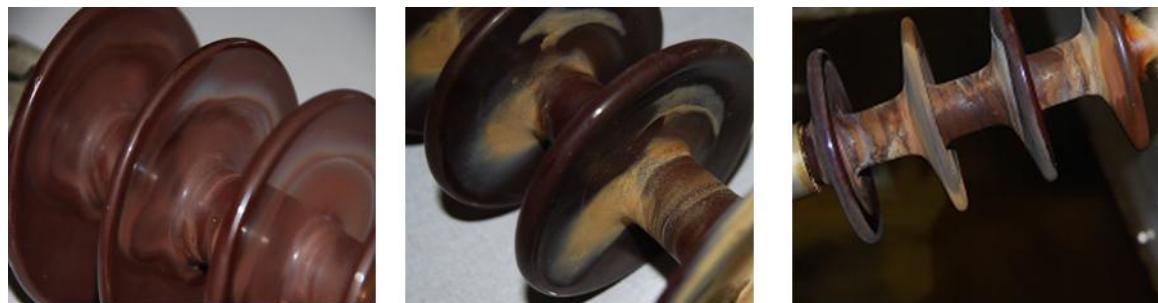
Figure 5.21 compares the material aging of the porcelain insulator (channel 5) with a unified SCD of 28 mm/kV for HVAC excitation with that of positive and negative polarity HVDC excitation respectively. The porcelain insulator did not show any significant signs of degradation for HVAC excitation, nor for positive or the negative polarity HVDC excitation. The insulator showed minor discoloration for HVAC excitation, brown discoloration for positive polarity HVDC excitation and reddish-brown discoloration for negative polarity HVDC excitation.

Figure 5.21: Comparison of material aging of the Porcelain insulator (channel 5) for HVAC and positive and negative polarity HVDC excitation
