Insulator Aging Tests with HVAC and HVDC Excitation using the Tracking Wheel Tester

Thesis presented in partial fulfilment of the requirements for the degree

Master of Science in Engineering at the University of Stellenbosch

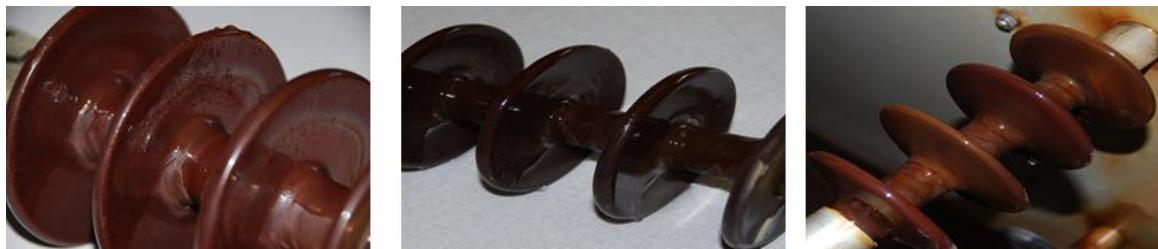
Figure 5.25 compares the hydrophobicity of the porcelain insulator (channel 5) with a unified SCDof 28 mm/kV for HVAC and positive and negative polarity HVDC excitation. The porcelain insulator (Channel 5) fell within a wettability class of 6 for the HVAC and positive and negative polarity HVDC excitation. The insulator remained completely hydrophilic, irrespective of the type of excitation.

Figure 5.25: Comparison of hydrophobicity for the porcelain insulator (channel 5) with a unified SCD of 28 mm/kV for HVAC and positive and negative polarity HVDC excitation

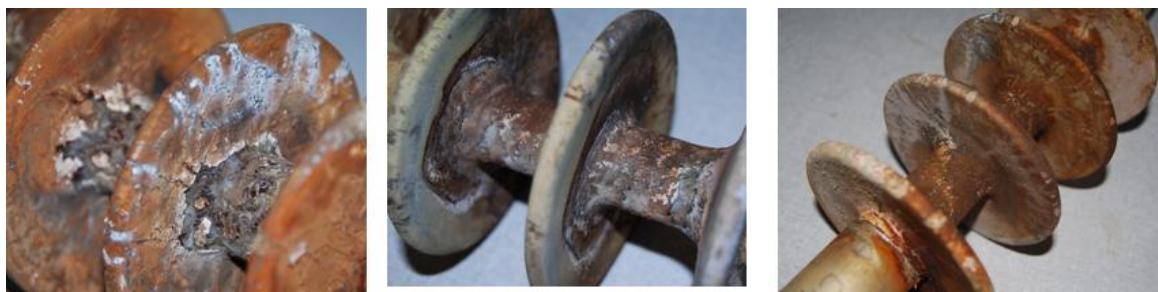
Figure 5.26 compares the material aging of the RTV SR coated porcelain insulator (channel 6) with a unified SCD of 28 mm/kV for HVAC excitation with that for positive and negative polarity HVDC excitation respectively. The RTV SR coated porcelain insulator had severe tracks, erosion and discoloration on the insulator for HVAC excitation. The coating material had been completely removed from the rods, with some parts of the coating on the sheds remaining intact. The RTV SR coated porcelain insulator (Channel 6) showed severe tracks, discoloration, as well as erosion to the coating material for positive polarity HVDC excitation. The coating had been peeled from the surface. The RTV SR coated porcelain insulator (Channel 6) had less tracks and erosion, as well as slight discoloration of the surface for negative polarity HVDC excitation. The peeling of the coating was not as severe as for positive polarity HVDC and the HVAC excitation. The RTV SR coated porcelain aged the worst for HVAC excitation, followed by positive polarity HVDC excitation and then negative polarity HVDC excitation.

Figure 5.26: Comparison of material aging of the RTV SR coated porcelain insulator (channel 6) for HVAC and positive and negative polarity HVDC excitation

- The effect of a RTV SR coating on the performance of insulators for positive polarity HVDC stress was evaluated. It was found that the RTV SR coated porcelain insulator (channel 6) seemed to age faster than the uncoated porcelain insulator (Channel 5), which did not show any signs of degradation. Both the coated and the uncoated insulators showed signs of discolouration, whereas the RTV SR coated porcelain insulator (channel 6) showed parts of the coating to have been cleared off or removed from the insulator surface.

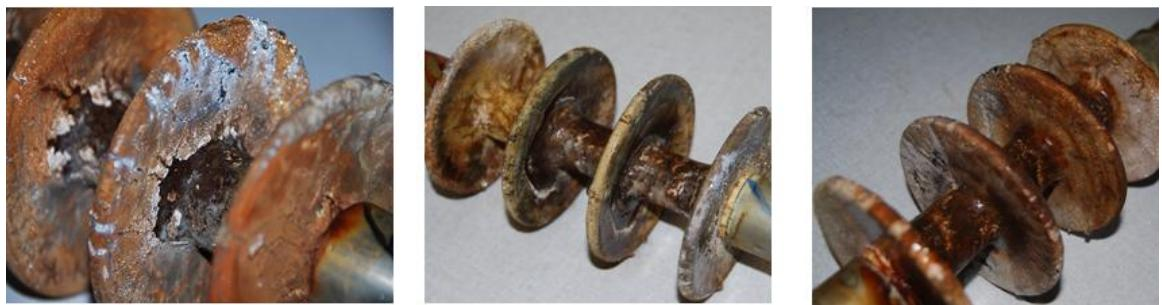
Figure 5.30 compares the hydrophobicity of the RTV SR coated porcelain insulator (channel 6) with a unified SCD of 28 mm/kV for HVAC and positive and negative polarity HVDC excitation. The RTV SR coated porcelain insulator (channel 6) fell within a wettability class of 3 for HVAC excitation, a wettability class of 4 for positive HVDC excitation and a wettability class of 4 for negative HVDC excitation.

Figure 5.30: Comparison of hydrophobicity for the RTV SR coated porcelain insulator (channel 6) with a unified SCD of 28 mm/kV for HVAC and positive and negative polarity HVDC excitation

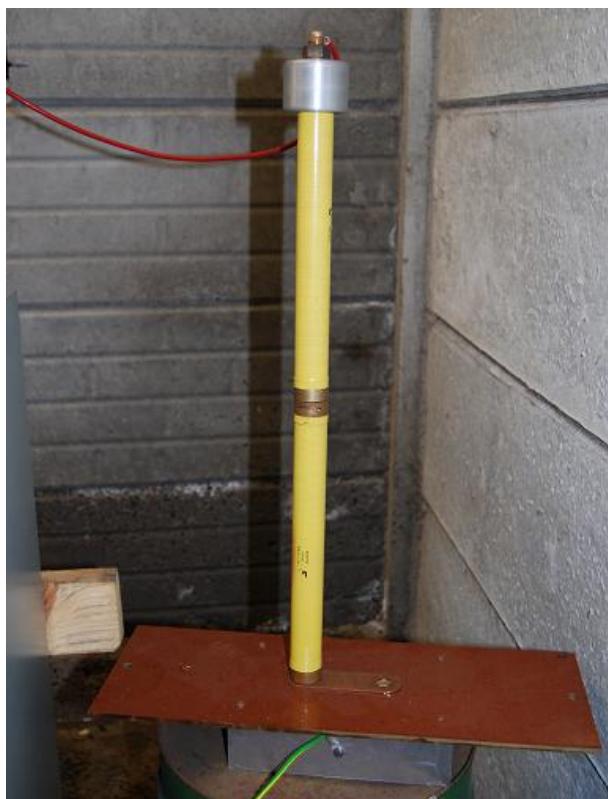
Figure D. 2: The voltage divider that was connected to the DC Source

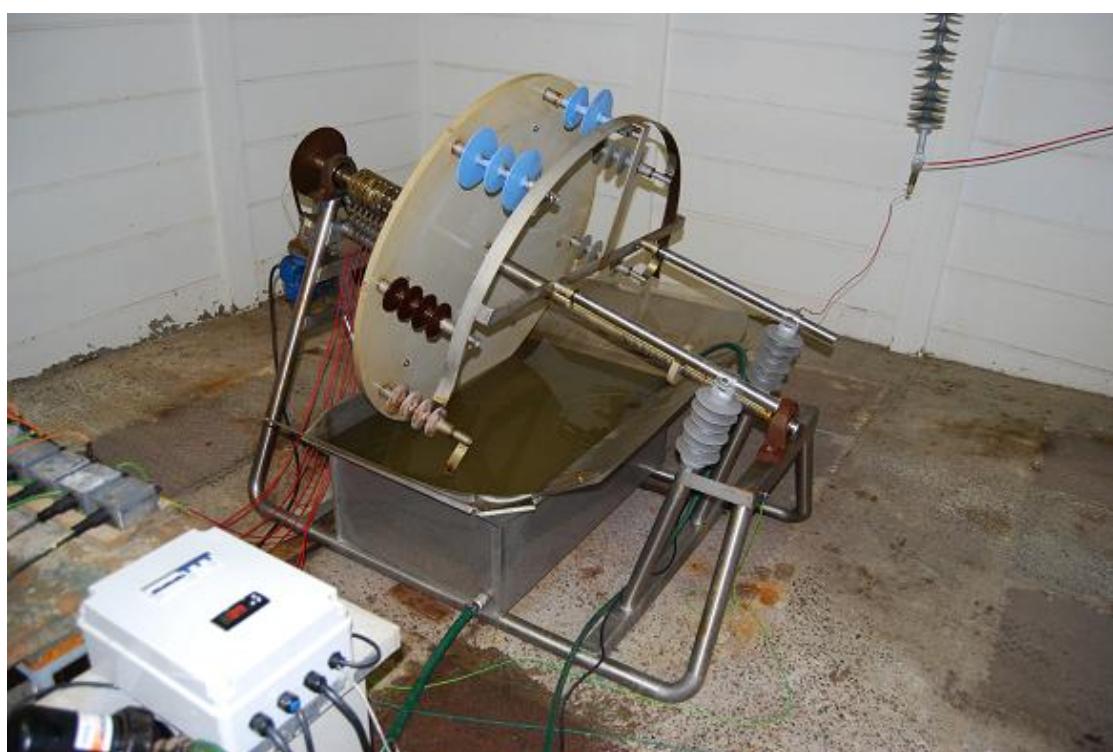
Figure D. 3: The Tracking Wheel Tester (TWT) with the fuse setup
