# **Non-Destructive Testing of Capless Porcelain Line Post Insulators to Detect Internal Defects**

Leslie Borrill

Thesis submitted for the Masters Degree in Engineering Sciences at the  
University of Stellenbosch

December 2003

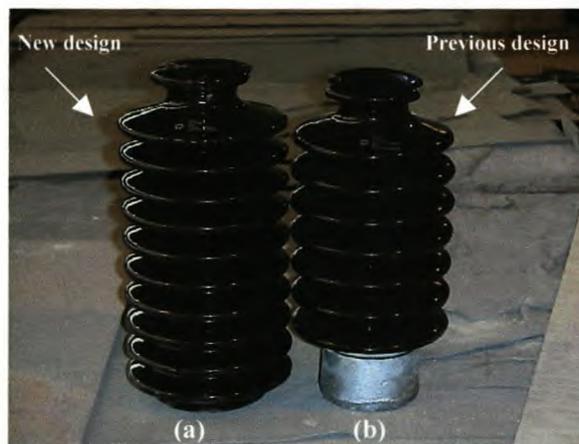
**Figure 1.1: Porcelain line post insulators, (a) a 33kV capless 4kN (900mm creepage) insulator and (b) a 33kV capped 4kN (786mm creepage) insulator.**

In 1986 a different design of porcelain line post insulator became commercially available. Previous insulators had an external metal electrode at the insulator base, but the new design uses substantially less metal, as an embedded electrode is fitted into the insulator's base. The capless (embedded electrode) and the capped (external electrode) insulators can be seen in figure 1.1.

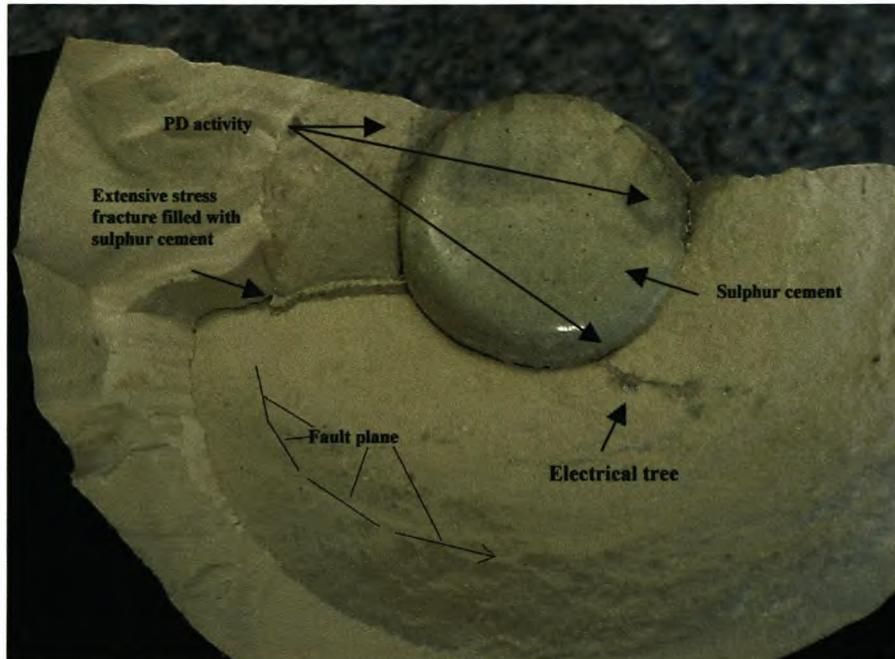
**Figure 1.2:** A fragment of a capless porcelain post insulator, which failed under windloading. The photograph shows PD activity at the sulphur cement to porcelain interface and sulphur cement that has filled an extensive stress fracture. Also visible is the fault plane of the failed insulator.

A recovered fragment of a damaged insulator is shown in figure 1.2. This insulator is suspected of breaking under mechanical stress under wind loading conditions (and not due to lightning in this case). However, inspection of the fragment showed evidence of partial discharge activity in the form of electrical treeing in the vicinity of the sulphur cement to porcelain interface. The sulphur cement has the shape of the insert hole, which has a flat top with a small radius of curvature at the edges.

Another interesting feature was an extensive stress fracture (see section 2.2) that was filled with sulphur cement. A mechanical fault plane, involving this stress crack, covers 60% of the insulator's diameter. The fault plane was present in all failed insulators.

The voids that cause PD activity are thought to be due to the geometry of the insert hole that houses the embedded electrode. The top of the hole was flat with small radius of curvature at the edges leading to stress fractures as a result of the drying out during the insulator manufacturing process. The shape of the top of insert hole was subsequently changed to a semicircular cross-section in the hope that this would reduce the stress fracturing. At this time the manufacturer provided no distinguishing features for identification of insulators with the different insert hole shapes.

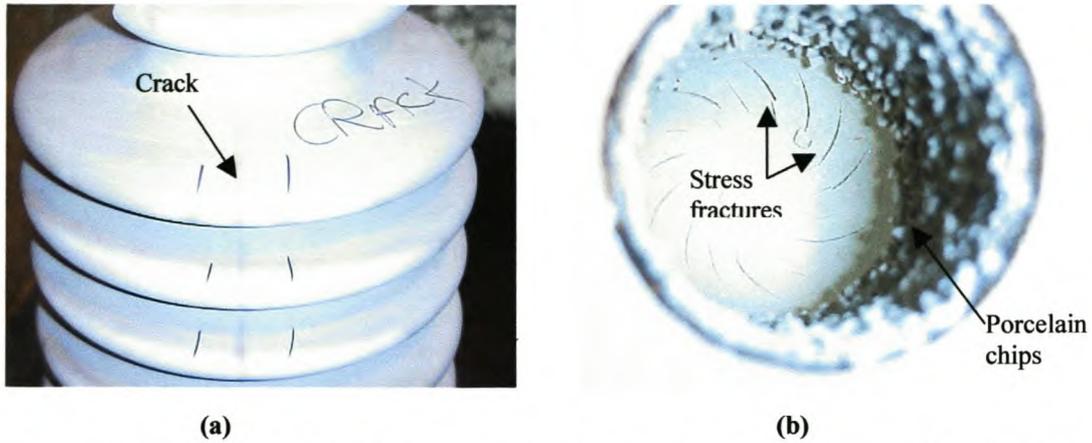
**Figure 2.2:** (a) Insulator rejected due to crack prior to glaze application, and (b) insert hole at insulator base coated with unfired porcelain chips with stress fractures visible at the top of the hole.

During a visual inspection of the insulator in figure 2.2 (a), a vertical crack the full height of the insulator as detected, resulting in the insulator being rejected.

Also shown in this figure are some stress fractures due to the drying and machining processes.

Figure 2.2 (b) reveals stress fractures at the top of the hole at the base of the insulator. When the cementing in section 2.4 takes place these fractures will either be filled with the sulphur cement or even worse air can become entrapped. Both the air and the sulphur cement have permittivities that are lower than that of porcelain and under the application of an alternating voltage electric field enhancement will occur with possible discharges inside these fractures.

The cause of the stress fractures at the top of the metal insert holes seen in figures 2.2 (b), 2.8 (a), (c) and (d) are a function of the geometry of the hole and the drying out of the porcelain.

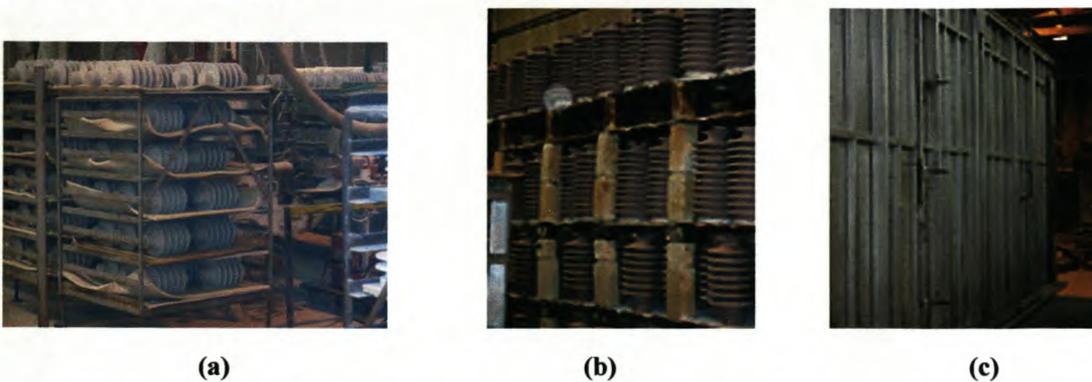
**Figure 2.3:** (a) Insulators stacked ready for glazing, (b) glazed insulators stacked and ready for firing, and (c) kiln lowered over stacked insulators.

The unfired insulators as shown in figure 2.3, are then placed in the kiln for a period of approximately seven days during which the temperature is increased from ambient temperature to 1200°C according to a firing schedule [1]. The fired insulators are then cooled down in a controlled manner with the kiln still in place. Figure 2.4 shows the extent of the shrinkage of the insulator body from just prior to glazing until after the firing process is completed.

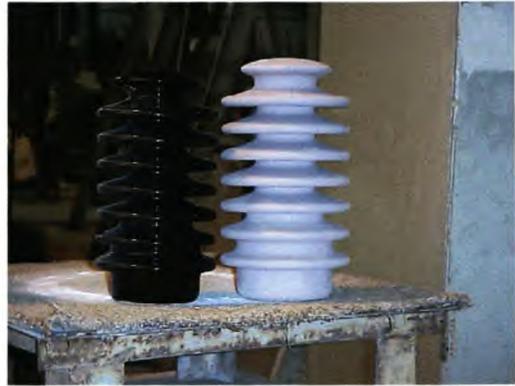
Figure 2.4: Insulator shrinkage due to drying out.

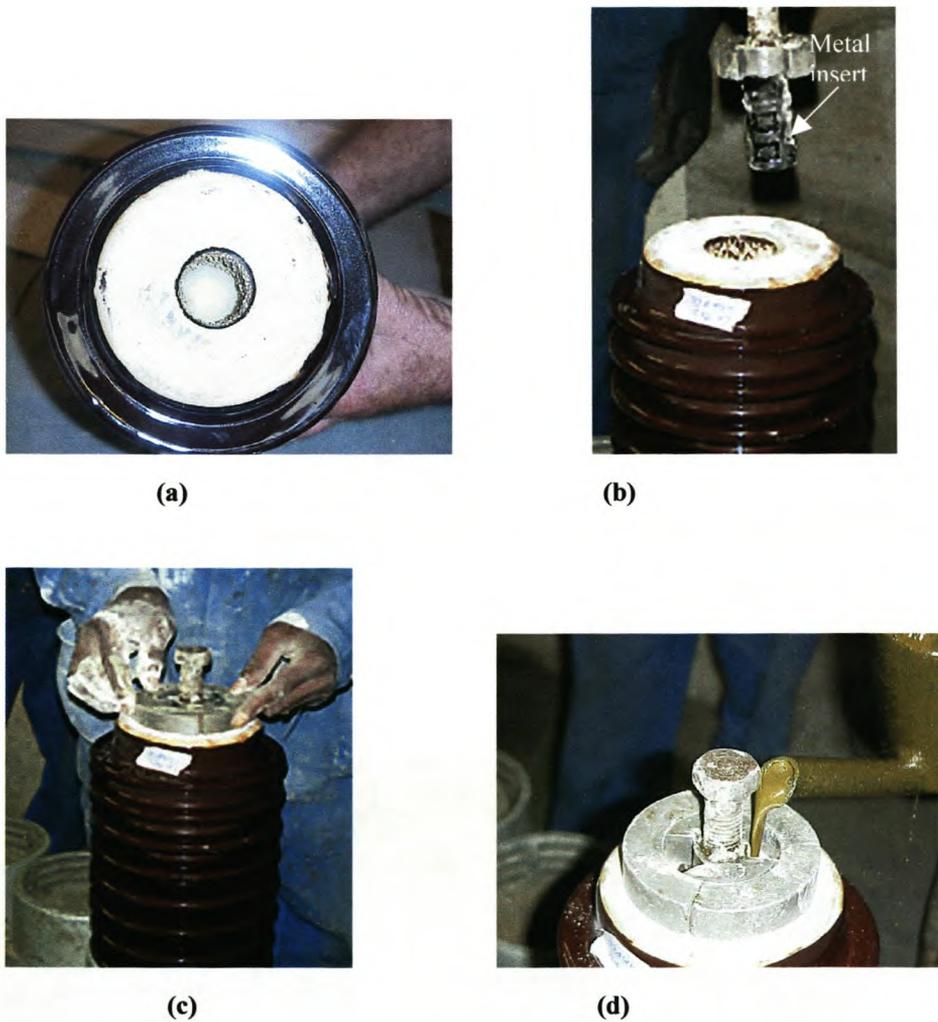
**Figure 2.6: (a) Glazed insulator revealing hole for metal insert, (b) insertion of metal insert, (c) jig is positioned over insulator base, and (d) sulphur cement is poured into the cavity.**

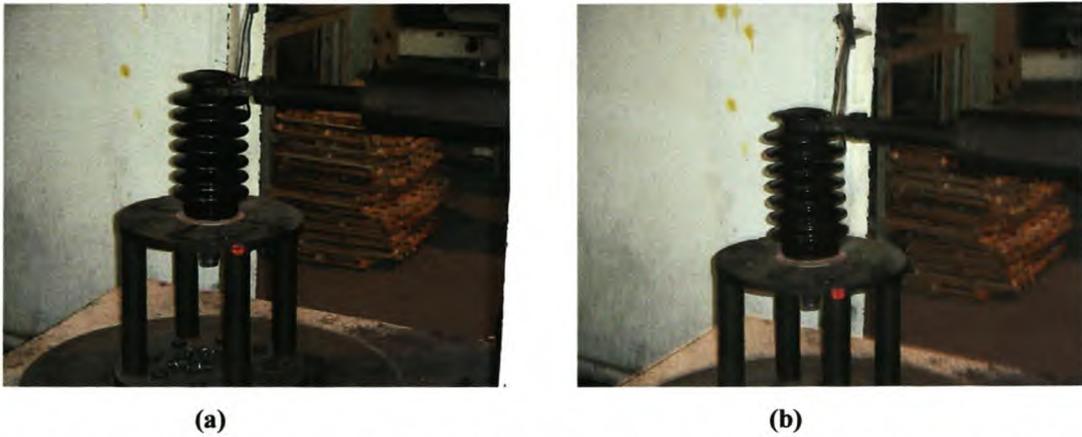
**Figure 2.7:** (a) Insulator is bolted to test table and the test arm is positioned against the free end of the insulator body, and (b) insulator deflecting under cantilever loading.

load may be applied in more than one direction, each for a time of three seconds. By agreement between the purchaser, ESKOM, and the manufacturer, a cantilever test is performed routinely on each insulator to 60% of minimum specified failing load [1]. The cantilever test is shown in figure 2.7.

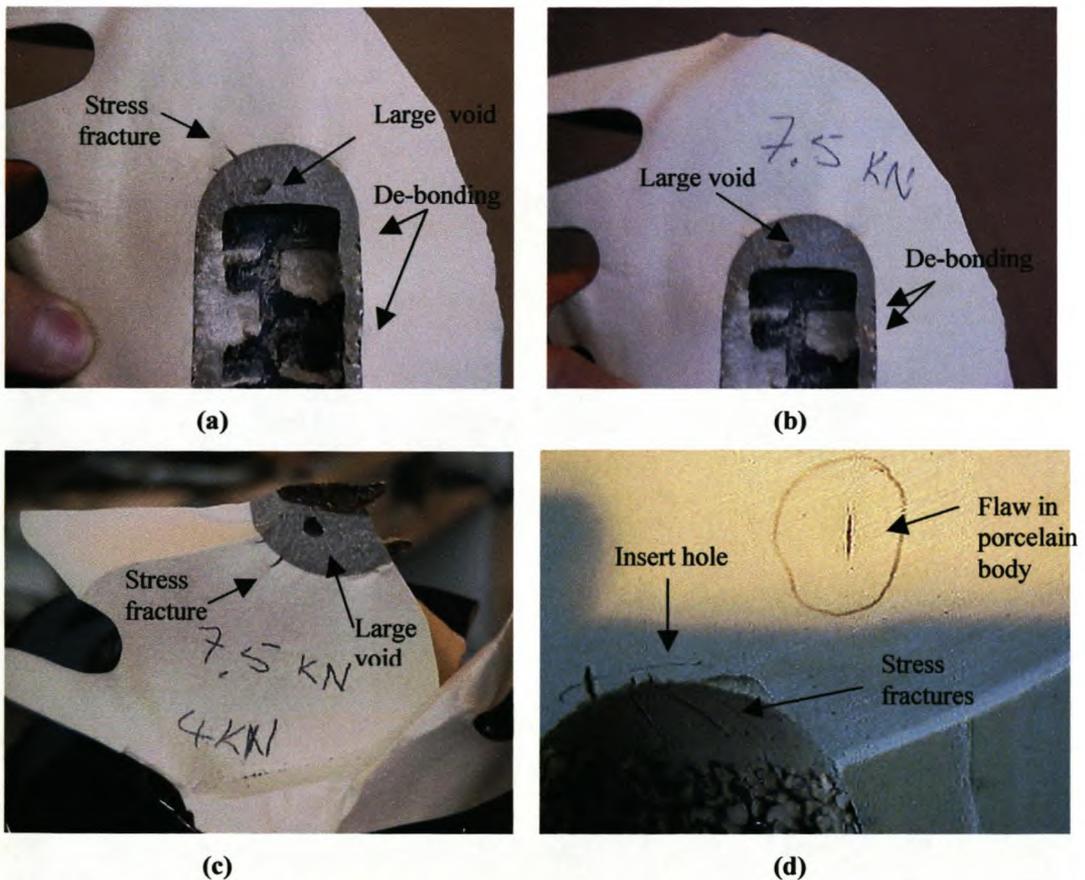
**Figure 2.8: (a), (b) and (c) are failed insulators showing clear evidence of internal flaws.**

Figures 2.8 (a), (b), (c) and (d) consist of four damaged insulators photographed during a visit to the insulator factory. They do not represent a specific batch of insulator samples, but are only presented here as evidence of the types of internal flaws that are typically found with this type of insulator. Figures 2.8 (a), (b) and (c) are large fragments of three porcelain post insulators that were loaded to failure during cantilever testing and figure 2.8 (d) is a cut through of a porcelain post insulator (the metal insert has not yet been cemented into position). The pencil markings on figures 2.8 (b) and (c) indicate that during cantilever testing, failure occurred well in excess of the specified minimum bending failure load of 4kN. This

Table 2.1 is a summary of the different types of flaws found in each of the four photographed insulators.

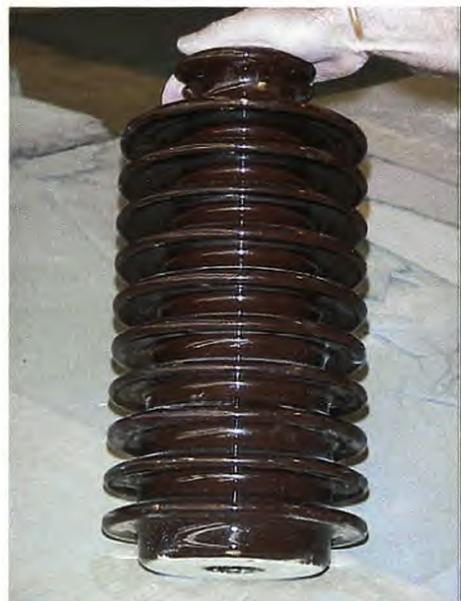
**Figure 3.1:** 33kV 4kN (900mm creepage) capless porcelain line post insulator.

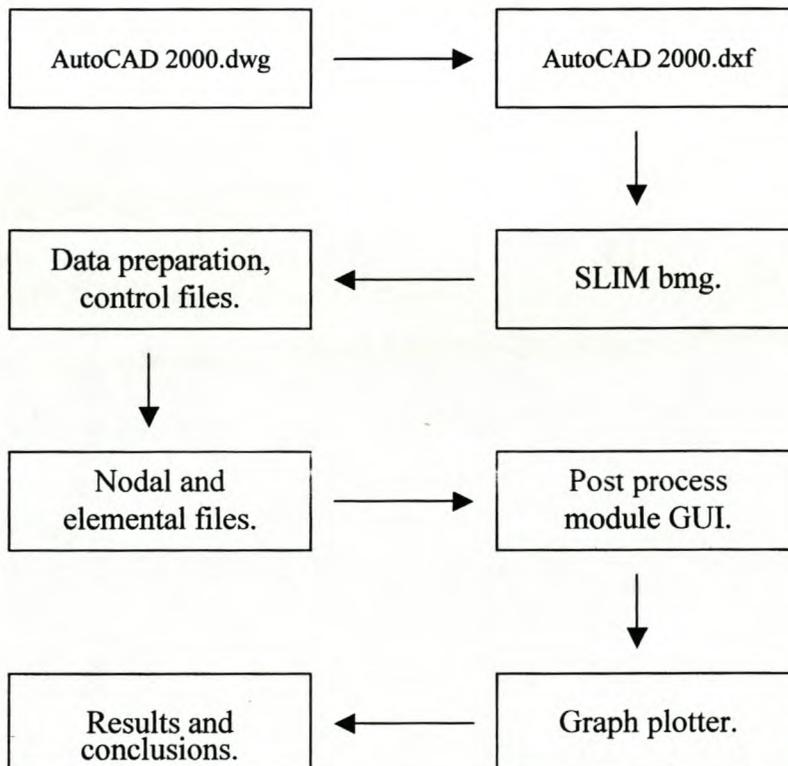
Figure 3.2: Flow diagram of simulation method followed [1].

A flow diagram outlining the simulation method followed in the electric field simulations is shown in figure 3.2.

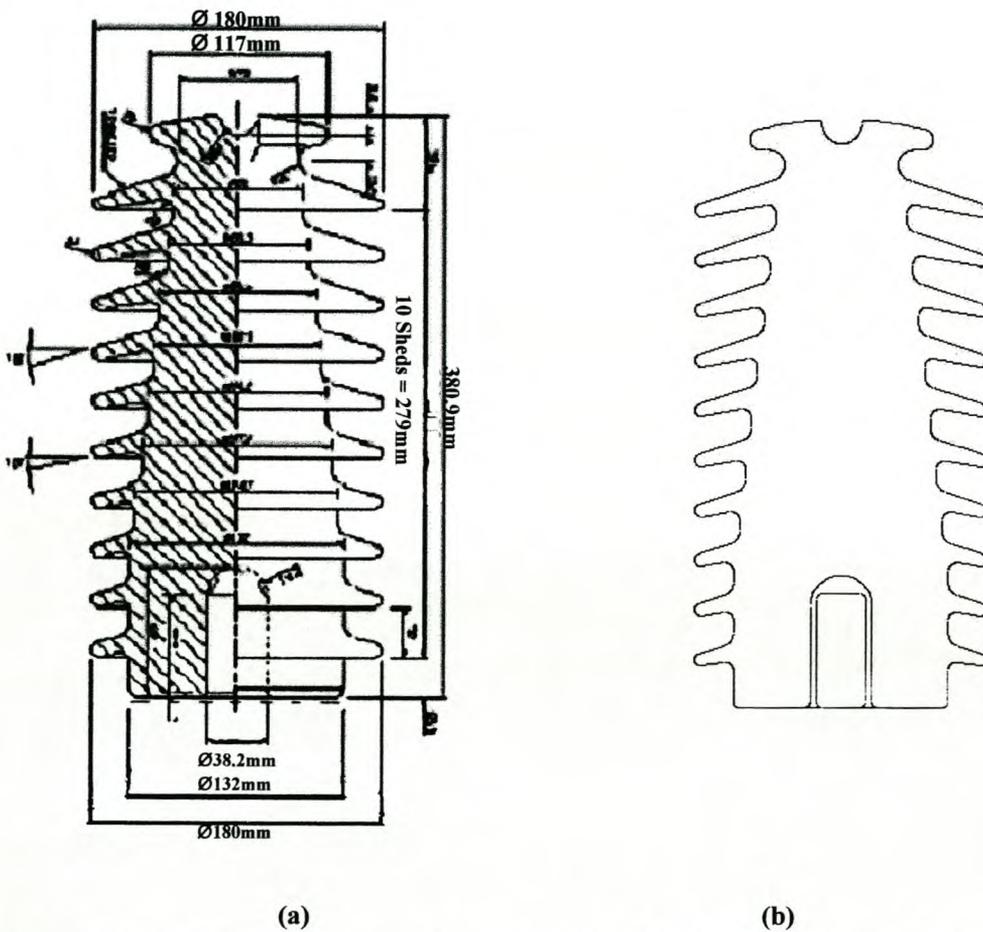
Figure 3.3: Insulator profiles, (a) manufacturer and (b) edited for importing into SLIM [1].

The 33kV insulator profile was received from the insulator manufacturer as an AutoCAD file. This file was then edited and interfaced with the SLIM electrostatic software module so that the simulations were based on actual geometric measurements [1]. The manufacturer and edited insulator profiles are shown in figure 3.3.

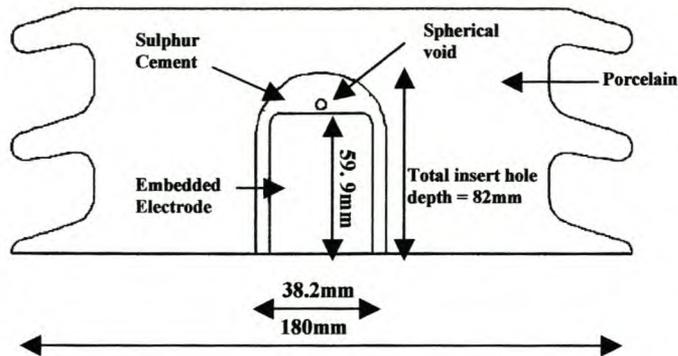
**Figure 3.4: Blown up section of base of insulator with void visible in the sulphur cement.**

of the insulator is shown in figure 3.4 where the porcelain body of the insulator, sulphur cement, embedded electrode and the void are clearly visible.

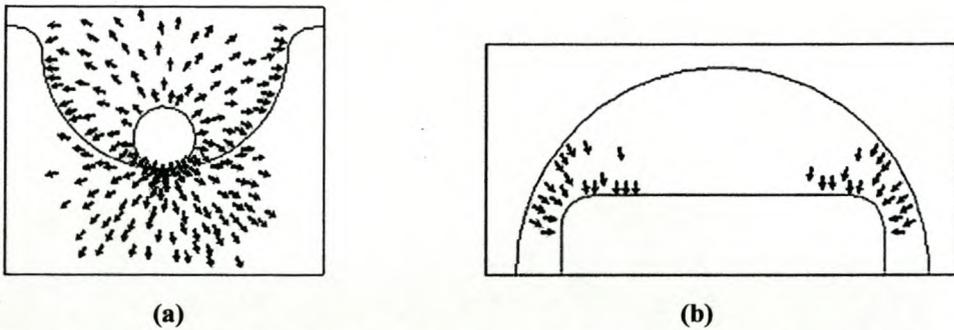
Figure 3.6: Electric field vectors (a) at conductor surface and (b) inside sulphur cement [1].

Figures 3.6 (a) and (b) show clearly that there are three points of highest stress for the insulator and these are around the conductor surface at the top of the insulator and at the curved edges of the embedded electrode inside the insulator base.

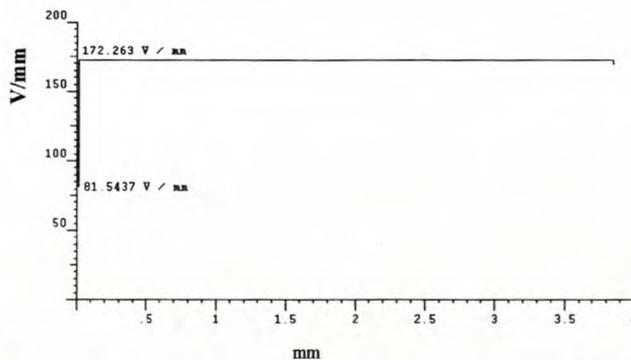
Figure 3.7: Electric field strength for path A to B at 19kv without a void [1].

The computed graphs for the electric field strength along paths AB and CD are shown in figures 3.7 and figure 3.8 respectively. It should be noted that the fields are reasonably uniform in these regions.

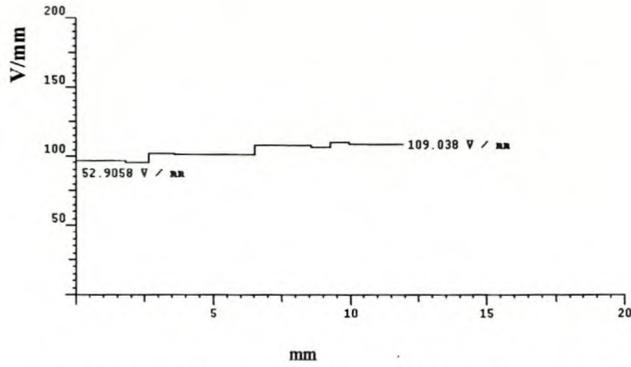
**Figure 3.8:** Electric field strength for path C to D at 19kV without a void [1].

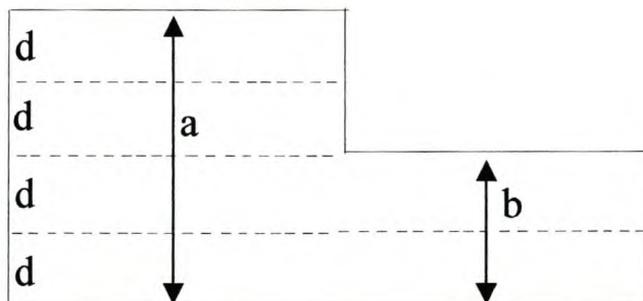
**Figure 4.1:** A schematic diagram of an image of an object of widely varying thickness [2].

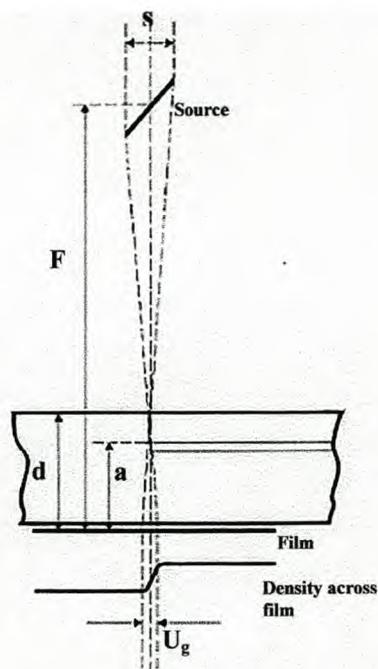
**Figure 4.3: Geometric unsharpness** ( $s$  is shown large for clarity) [2].

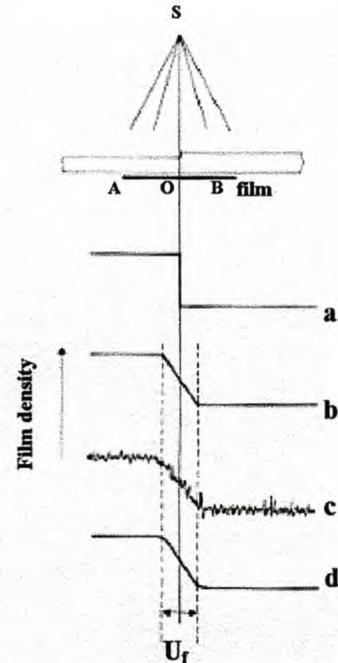
**Figure 4.4: Film unsharpness [2].**  
The density curves are magnified along the X-axis for clarity.  
(a) density distribution across image of sharp edge, assuming  $U_f=0$ ,  
(b), (c) and (d) density distribution due to film unsharpness.  
(a) theoretical; (c) with grain; (d) smoothed.

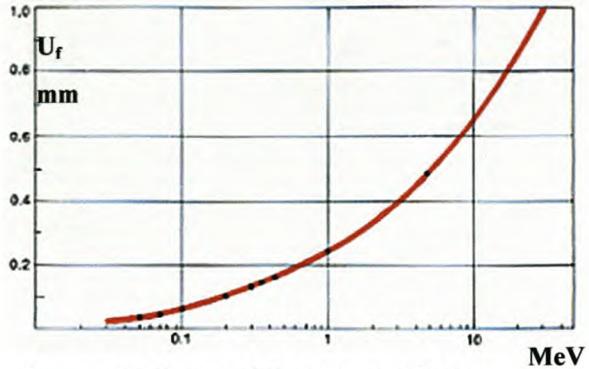
Figure 4.5: Curve of  $U_f$  against radiation energy, for typical radiographic film (experimental) [2].

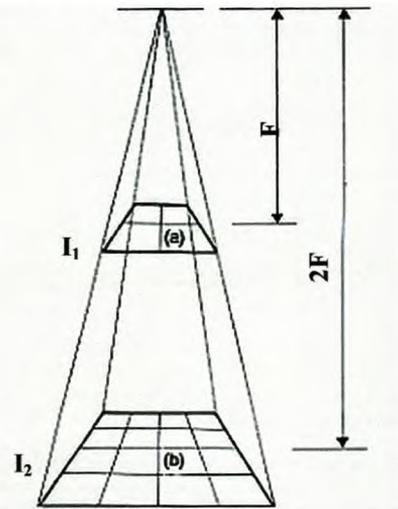
Figure 4.6: Inverse Square law [2].

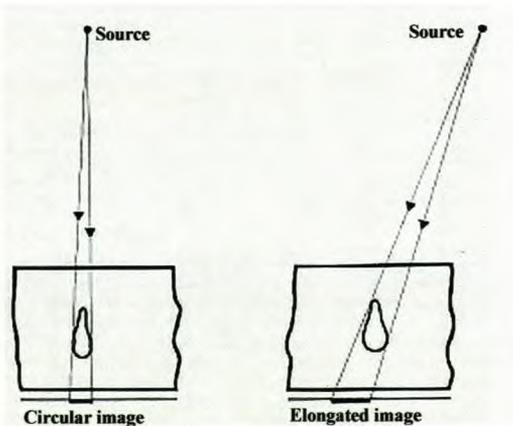
Figure 4.7: Distortion of image of elongated void due to radiation beam

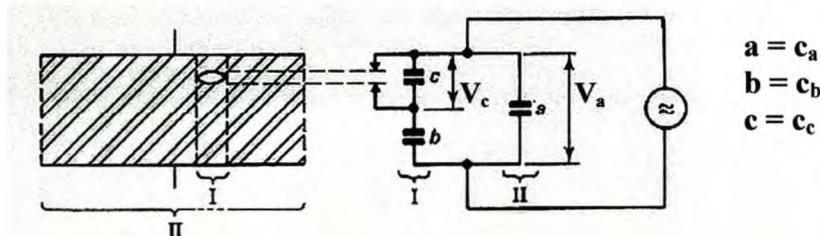
Figure 4.8: A dielectric circuit [5].

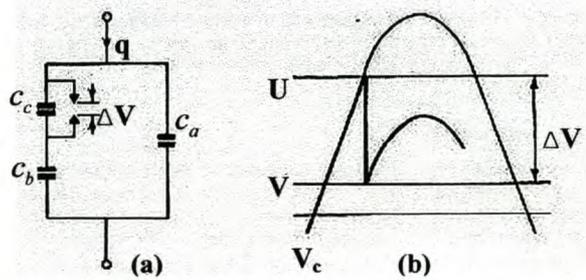
**Figure 4.9: Relationship between the apparent charge and the energy  $p$  of the discharge [5].**

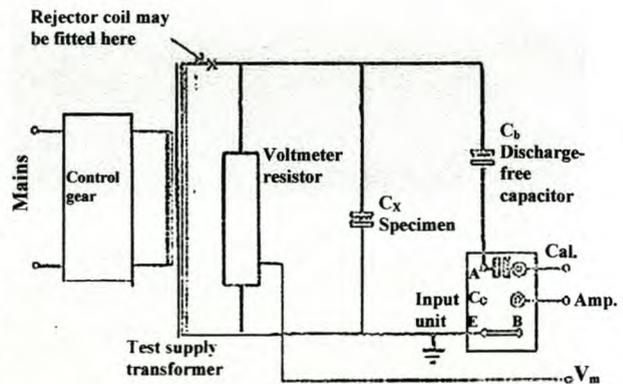
Figure 4.11: E.R.A. Standard PD detector circuit [9].

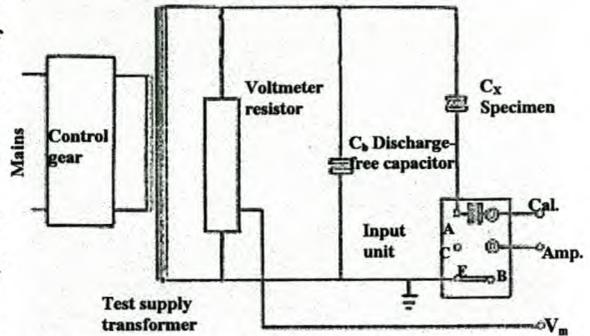
Figure 4.12: E.R.A. Modified PD detector circuit [9].

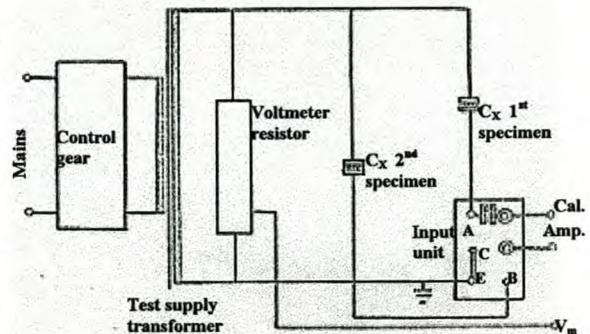
Figure 4.13: E.R.A. Balanced PD detector circuit [9].

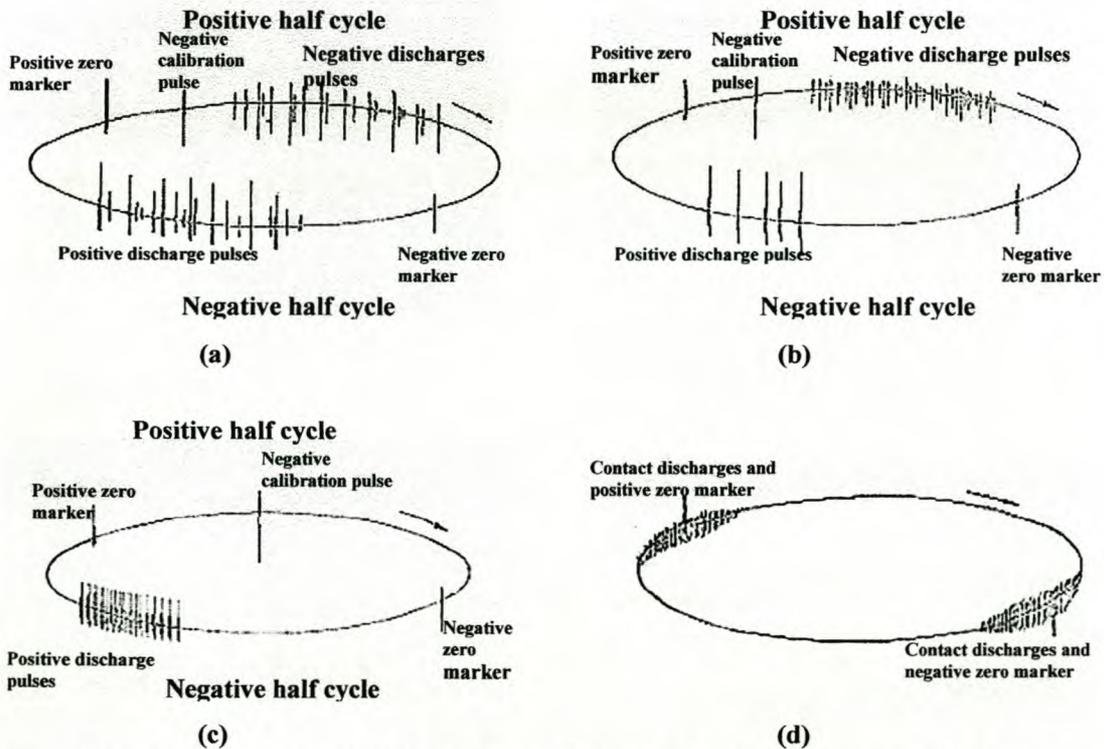
Figure 4.14: (a) Discharges in voids in insulation; (b) Discharges in voids bounded on one side by conductor and the other by dielectric; (c) Corona discharges; (d) Contact discharges in a capacitive circuit [9].

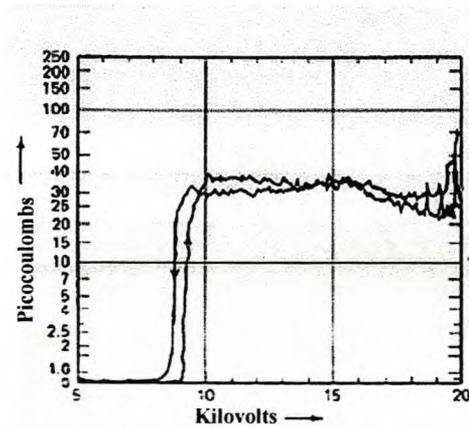
**Figure 4.15:** X-Y diagram of a void of limited dimensions, e.g. some square millimetres by 0,5 mm thickness [5].

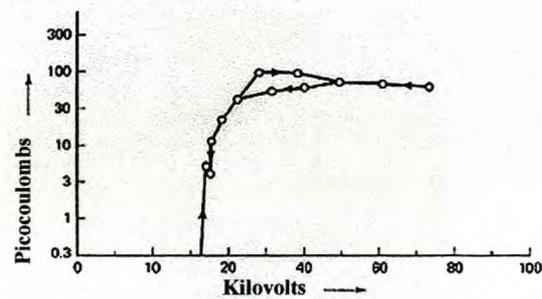
**Figure 4.16:** X-Y diagram of a discharge in a more extended void [5].

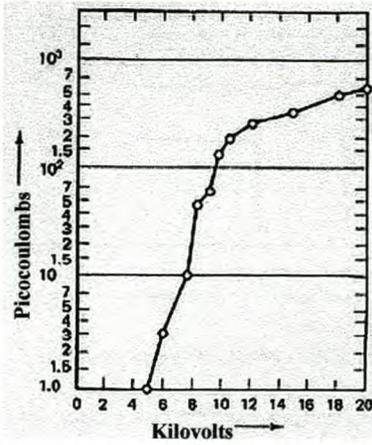
**Figure 4.17:** X-Y diagram of a surface discharge, discharges in a large gap or a long interface [5].

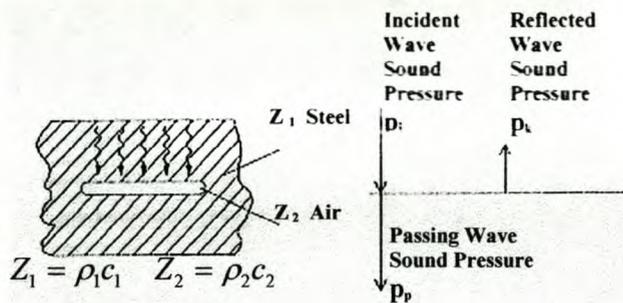
**Figure 4.19: Wave reflection at an interface [11].**

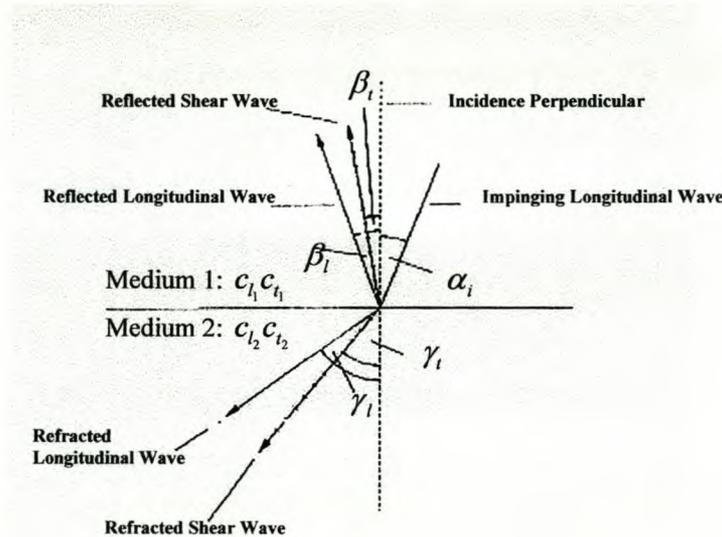
Figure 4.20: Refraction of a Longitudinal wave [11].

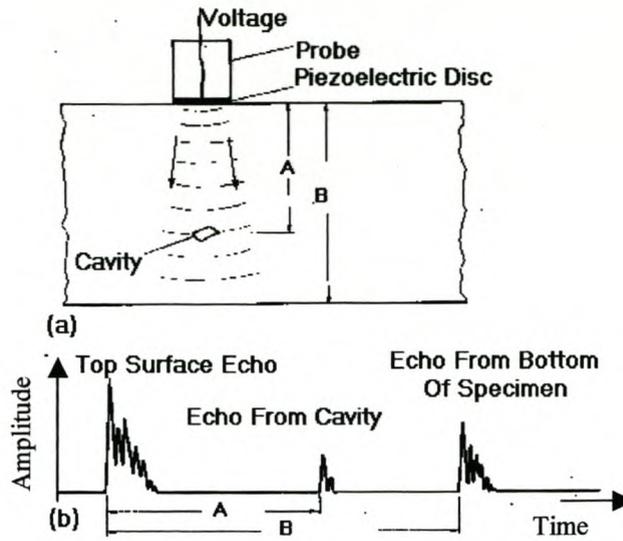
Figure 4.21: Basic principle of ultrasonic testing with a compressional probe, (a) set-up (b) standard A-scan display.

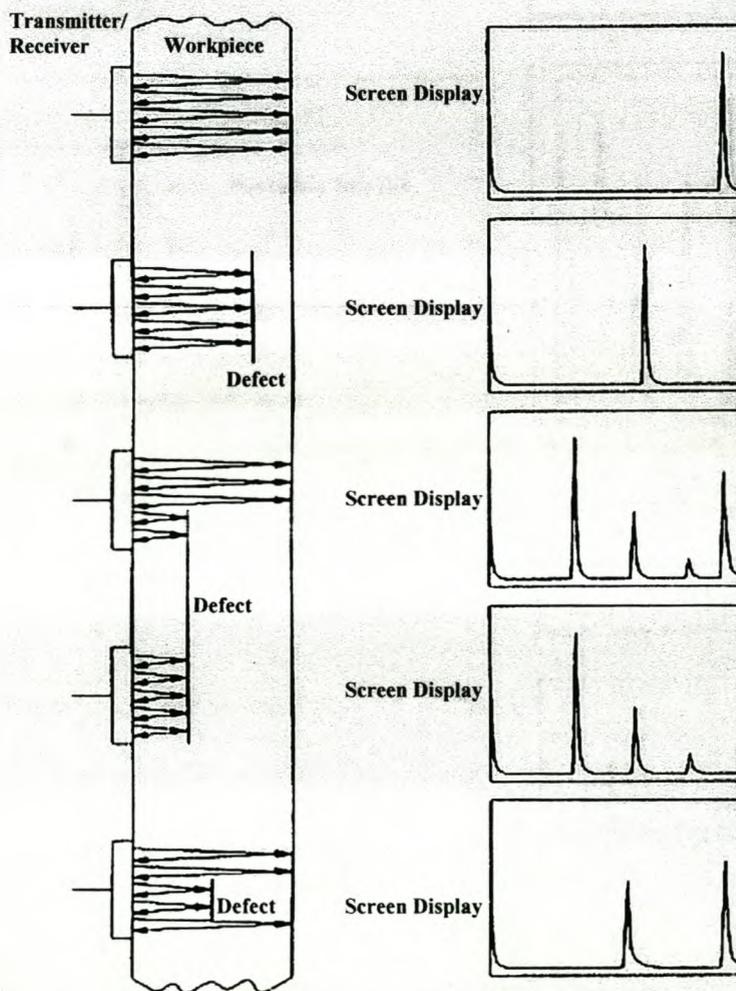
Figure 4.22: Pulse-Echo Method illustrated with the corresponding oscilloscope display [11].

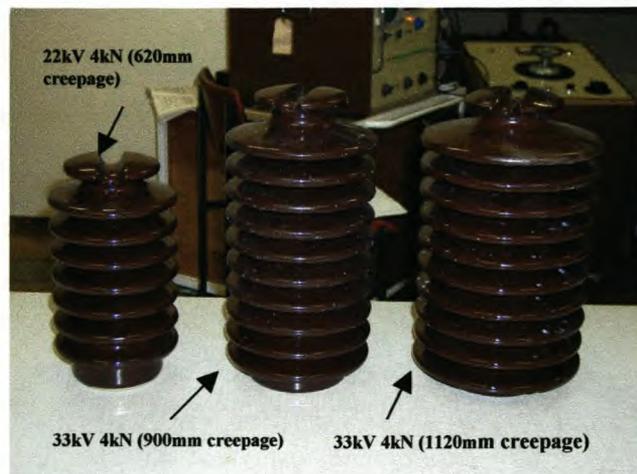
**Figure 5.1:** Three types of capless porcelain line post insulator samples donated by the manufacturer.

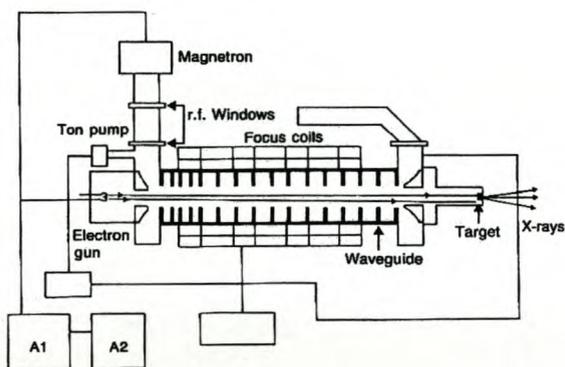
Figure 5.2: Linear electron accelerator [5].

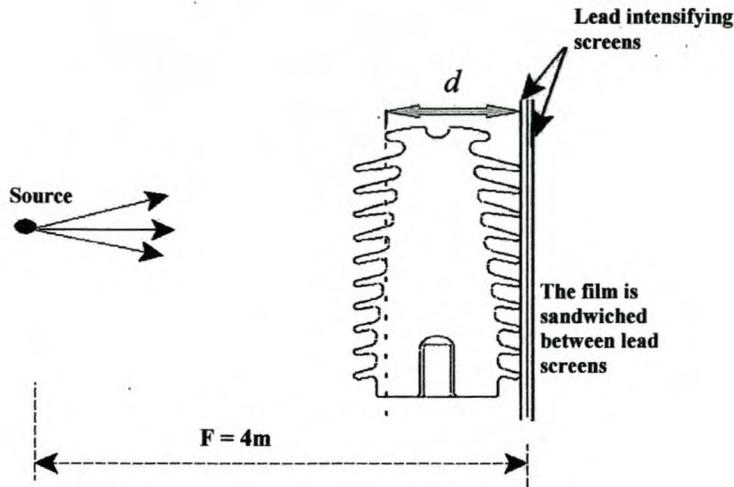
Figure 5.3: Schematic diagram of the X-ray set-up indicating the defect-to-film distance measurement.

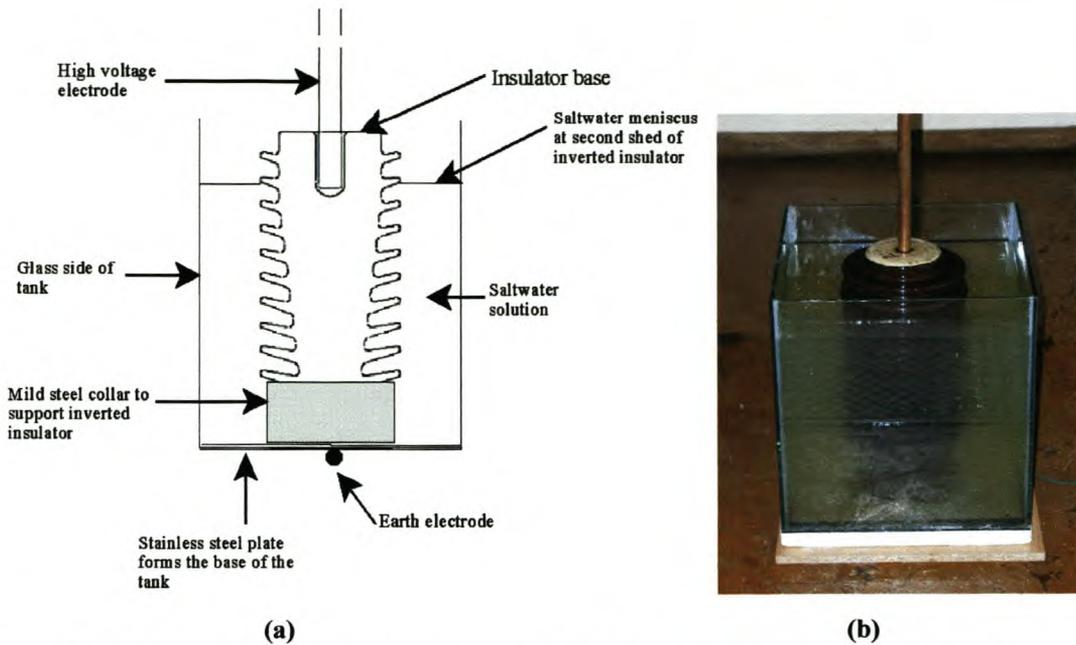
**Figure 5.4: Insulator inverted in a glass tank filled with a saturated saltwater solution so that only two sheds are exposed above the surface of the solution. (a) schematic diagram and (b) photograph.**

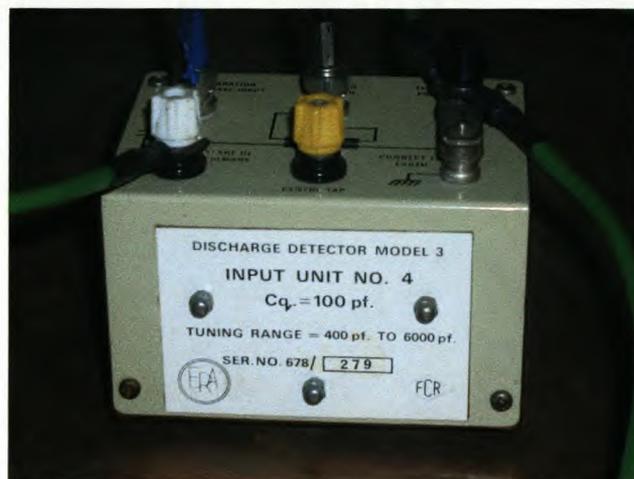
Figure 5.5: Typical E.R.A. Input Unit used in the detection circuit.

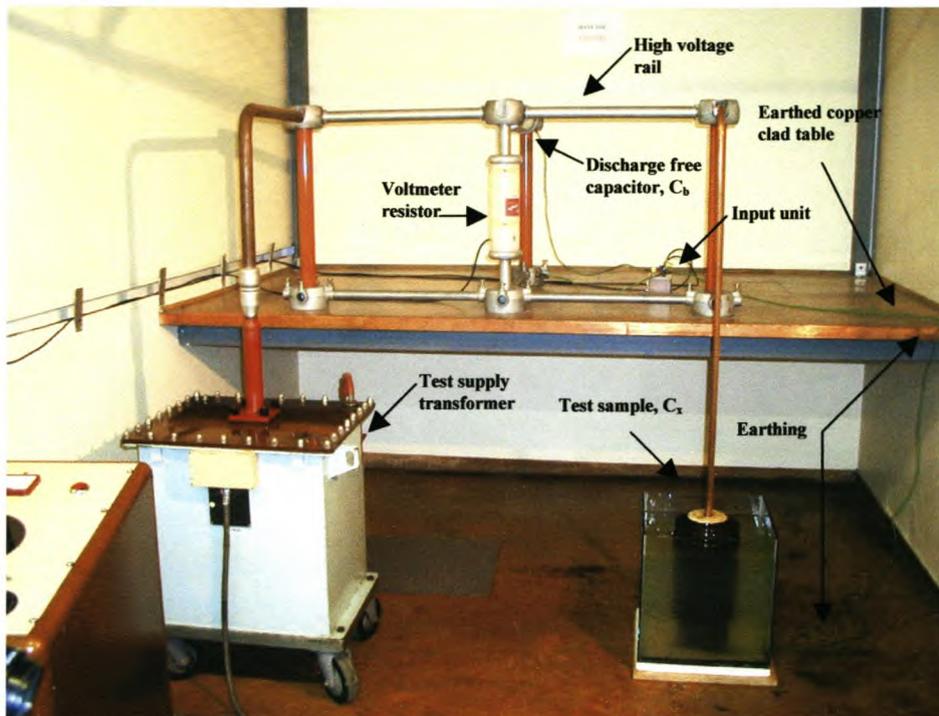
Figure 5.6: Standard PD Detection circuit with high voltage components and earthing visible.

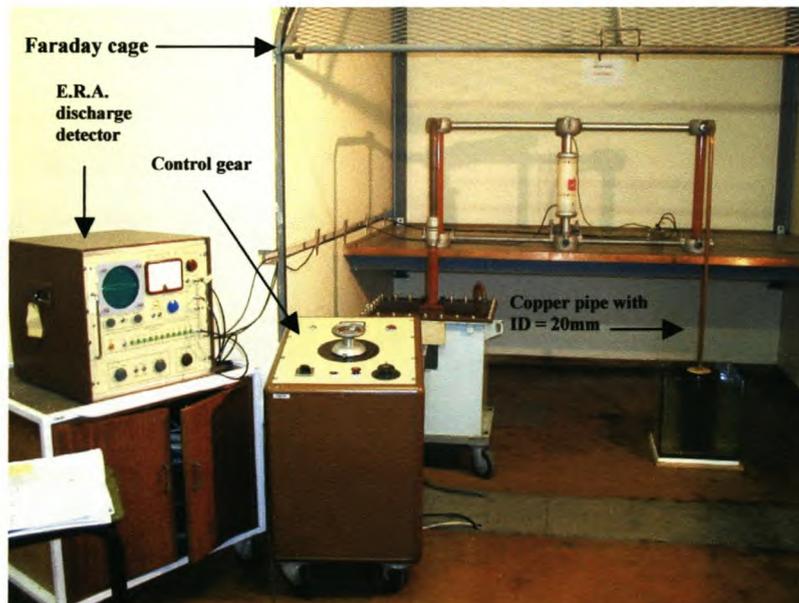
Figure 5.7: Standard PD Detection circuit with E.R.A. Discharge Detector Model 3 and Control Gear clearly visible in the foreground.

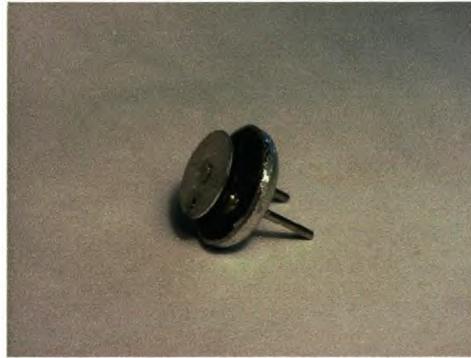
**Figure 5.9: Dismantled 40kHz ultrasonic burglar alarm transducer.**

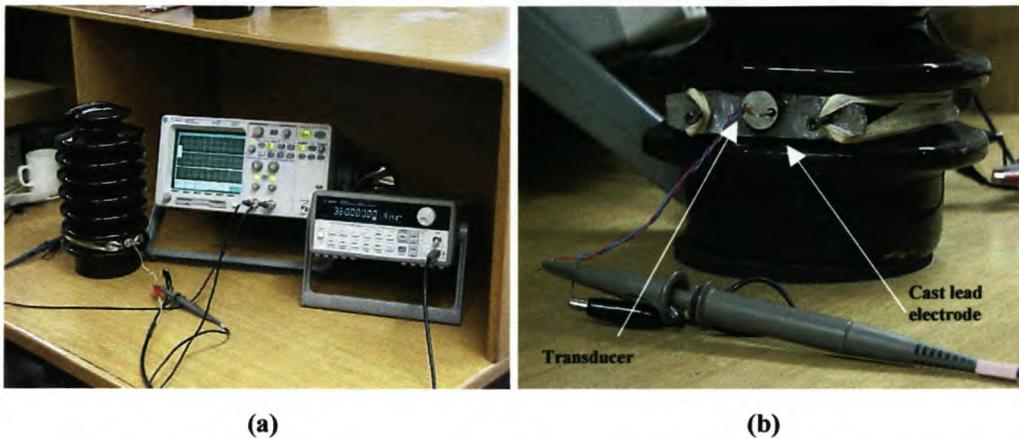
Figure 5.11: Change of flight experiment with transmitter and receiver mounted on separate lead electrodes each geometrically  $180^\circ$  apart on the insulator circumference. (a) experimental set-up and (b) close up of a lead electrode with the transducer mounted on it.

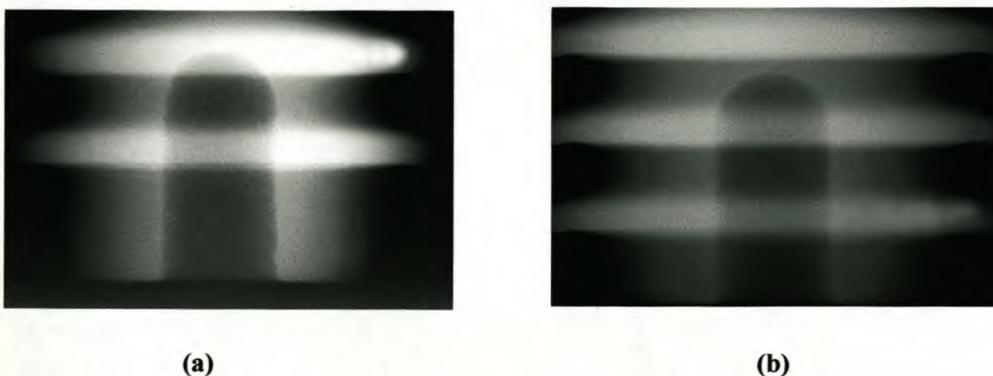
**Figure 6.1: X-ray images of (a) 22kV 620mm creepage and (b) 33kV 1120mm creepage insulators showing the position of their insert holes relative to the insulator sheds with no metal inserts fitted.**

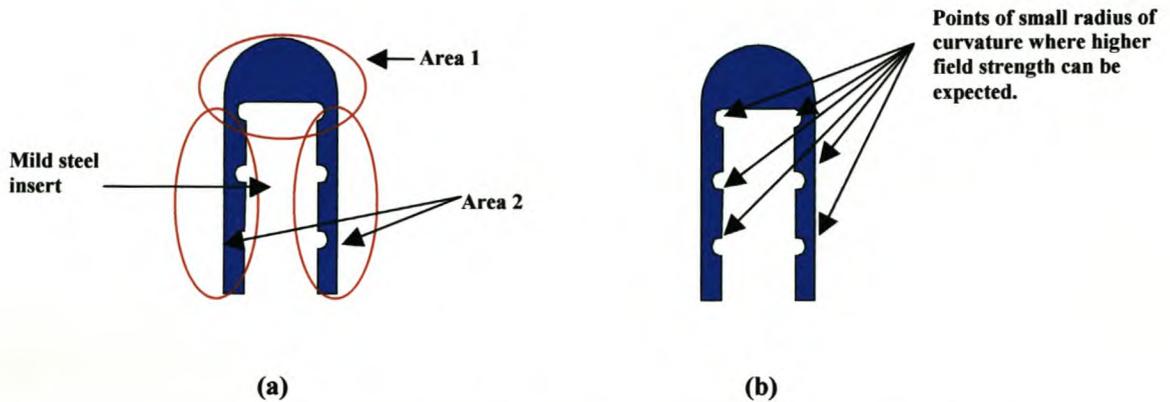
**Figure 6.2:** Artistic impression of the embedded electrode portion showing, (a) focus areas within the sulphur cement used to give the location of voids and (b) points of small radius of curvature on mild steel insert.

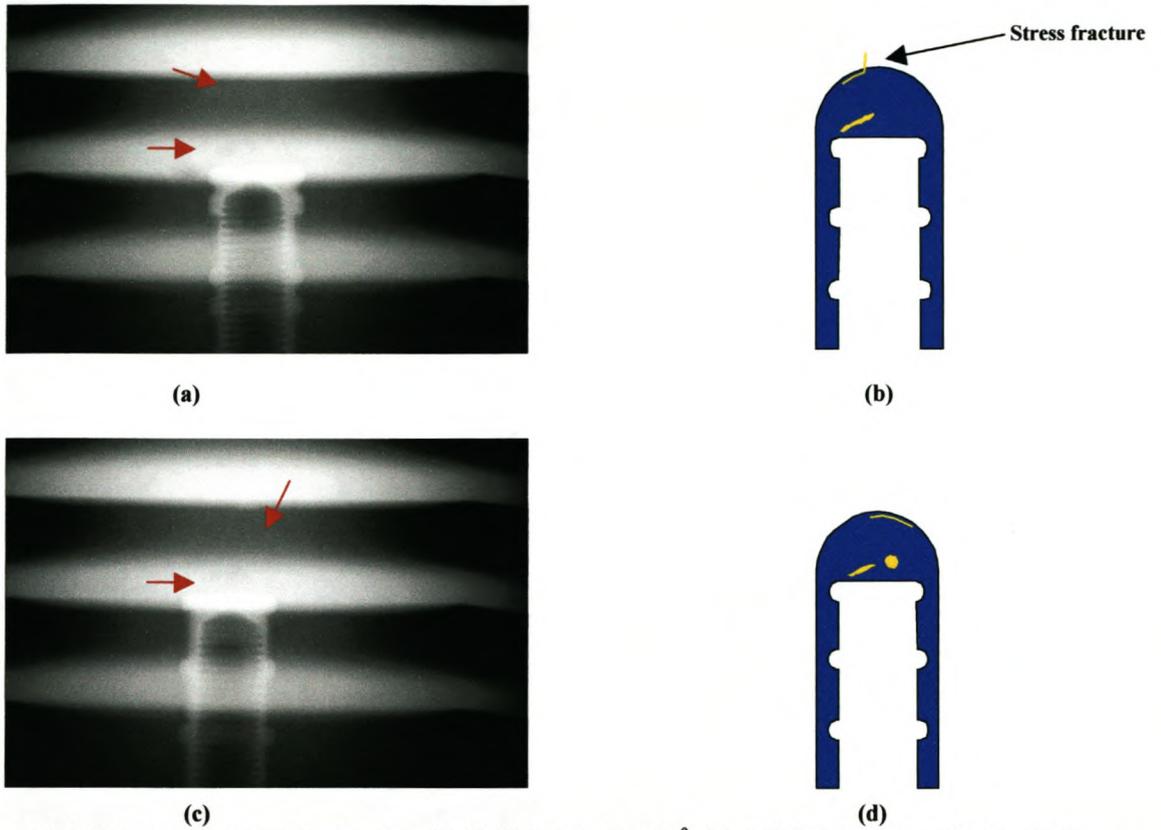
Figure 6.4: X-ray image of sample insulator 3. (a) digital image at  $0^\circ$ , (b) artistic impression of embedded electrode area at  $0^\circ$ , (c) digital image at  $90^\circ$ , (d) artistic impression of embedded electrode area at  $90^\circ$ .

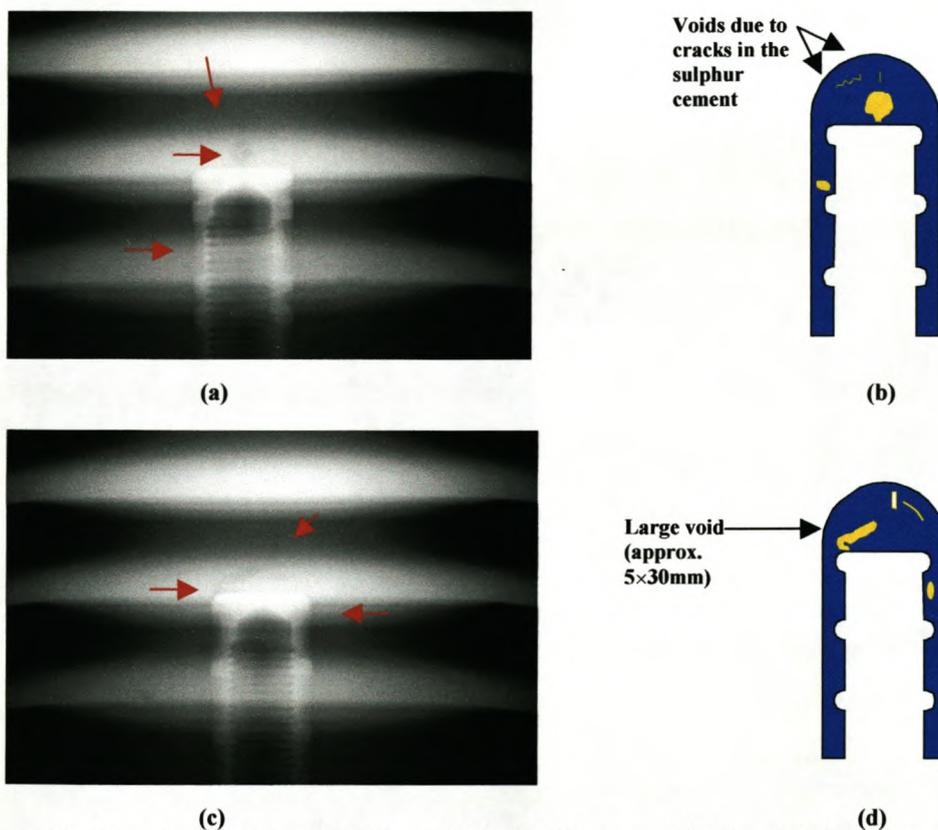
Figure 6.5: X-ray image of sample insulator 4. (a) digital image at  $0^\circ$ , (b) artistic impression of embedded electrode area at  $0^\circ$ , (c) digital image at  $90^\circ$ , (d) artistic impression of embedded electrode area at  $90^\circ$ .

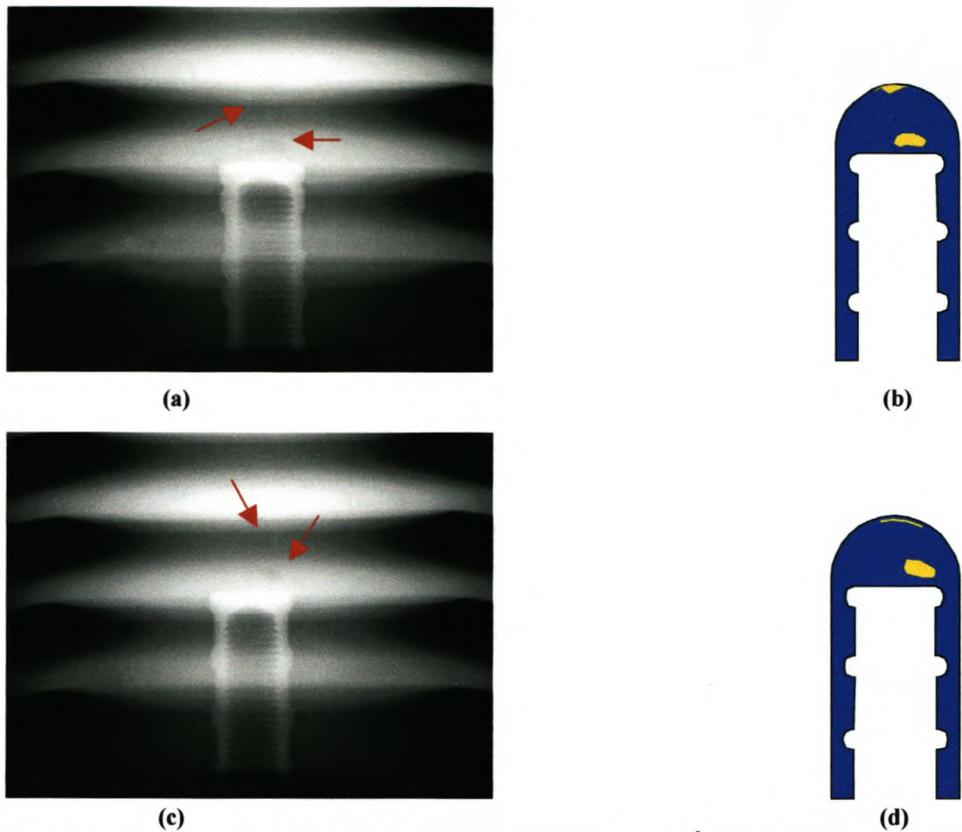
Figure 6.6: X-ray image of sample insulator CX2. (a) digital image at 0°, (b) artistic impression of embedded electrode area at 0°, (c) digital image at 90°, (d) artistic impression of embedded electrode area at 90°.
