# **Non-Destructive Testing of Capless Porcelain Line Post Insulators to Detect Internal Defects**

Leslie Borrill

Thesis submitted for the Masters Degree in Engineering Sciences at the  
University of Stellenbosch

December 2003

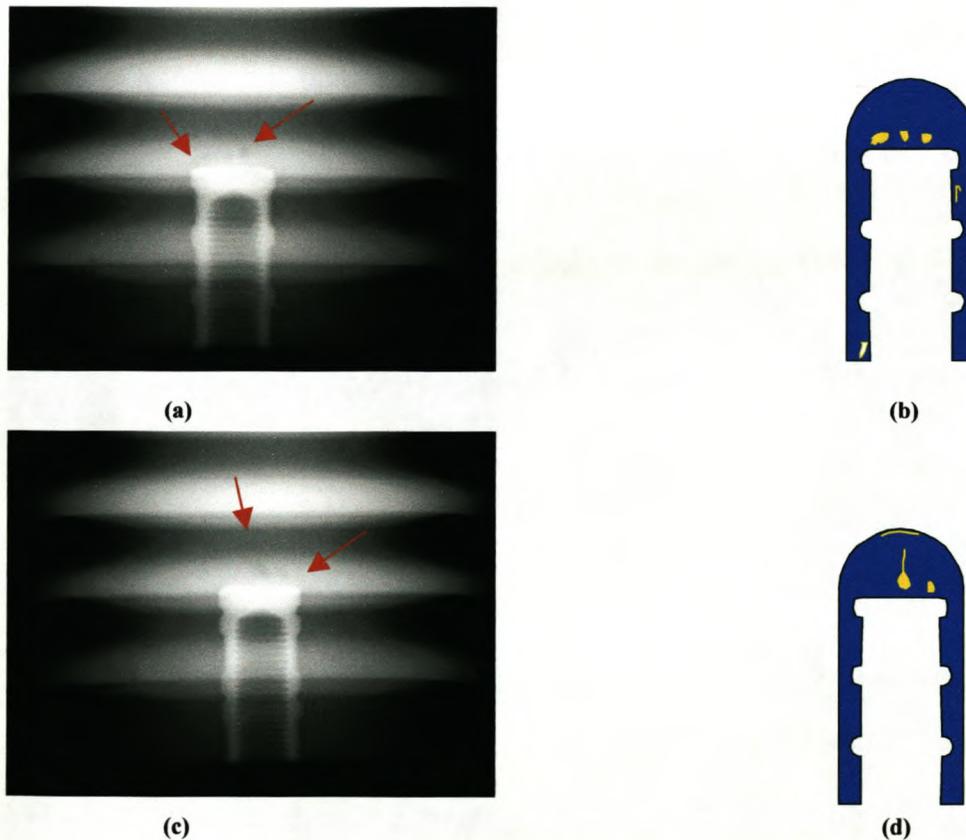
Figure 6.7: X-ray image of sample insulator CX1. (a) digital image at 0°, (b) artistic impression of embedded electrode area at 0°, (c) digital image at 90°, (d) artistic impression of embedded electrode area at 90°.

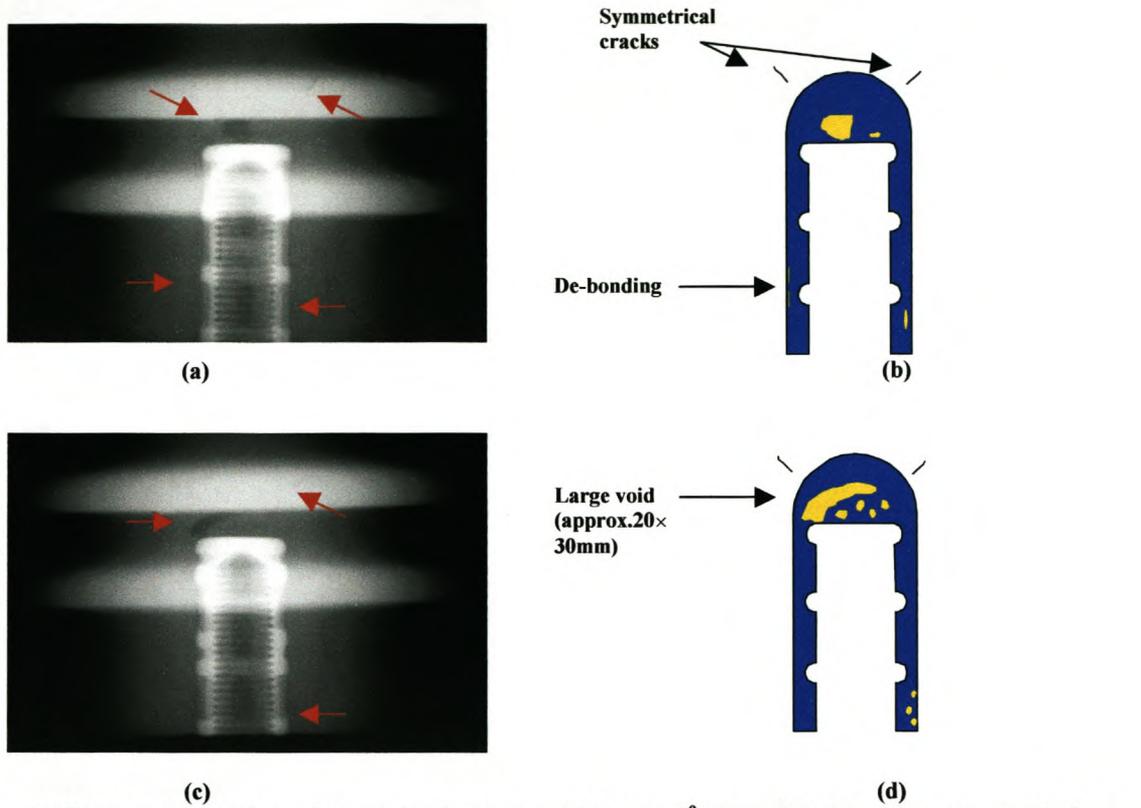
Figure 6.8: X-ray image of sample insulator A. (a) digital image at  $0^\circ$ , (b) artistic impression of embedded electrode area at  $0^\circ$ , (c) digital image at  $90^\circ$ , (d) artistic impression of embedded electrode area at  $90^\circ$ .

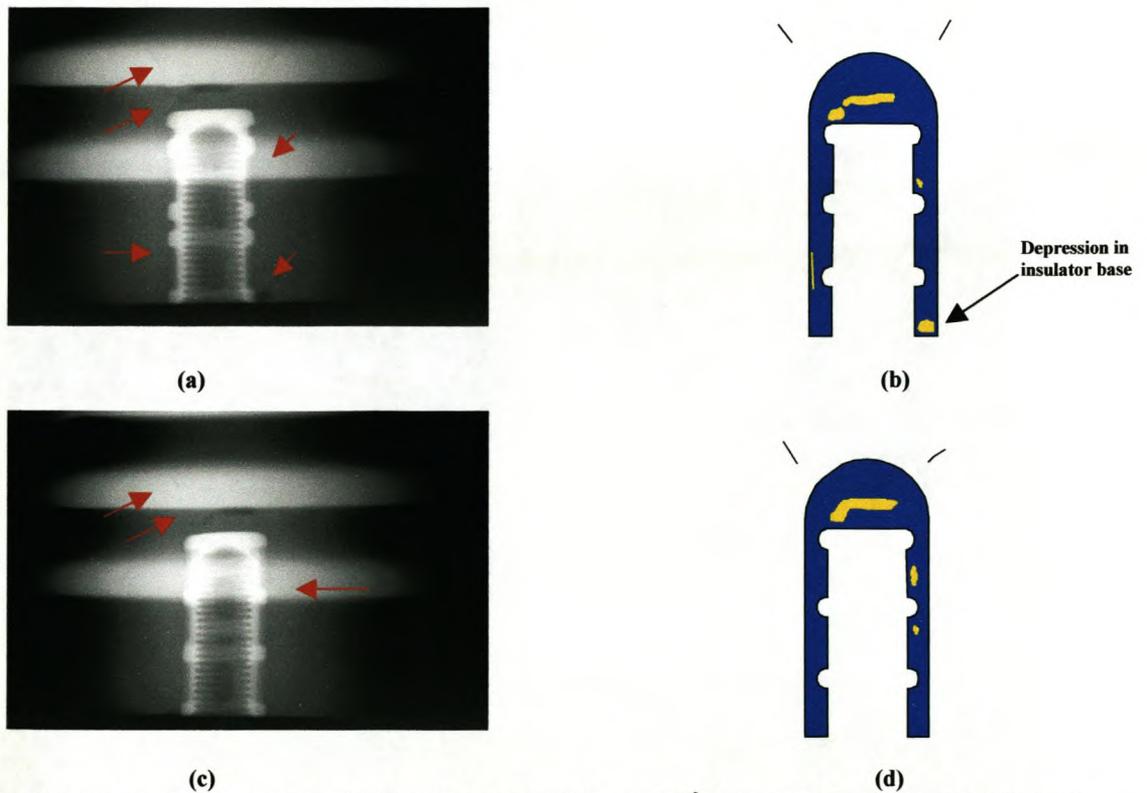
Figure 6.9: X-ray image of sample insulator B. (a) digital image at  $0^\circ$ , (b) artistic impression of embedded electrode area at  $0^\circ$ , (c) digital image at  $90^\circ$ , (d) artistic impression of embedded electrode area at  $90^\circ$ .

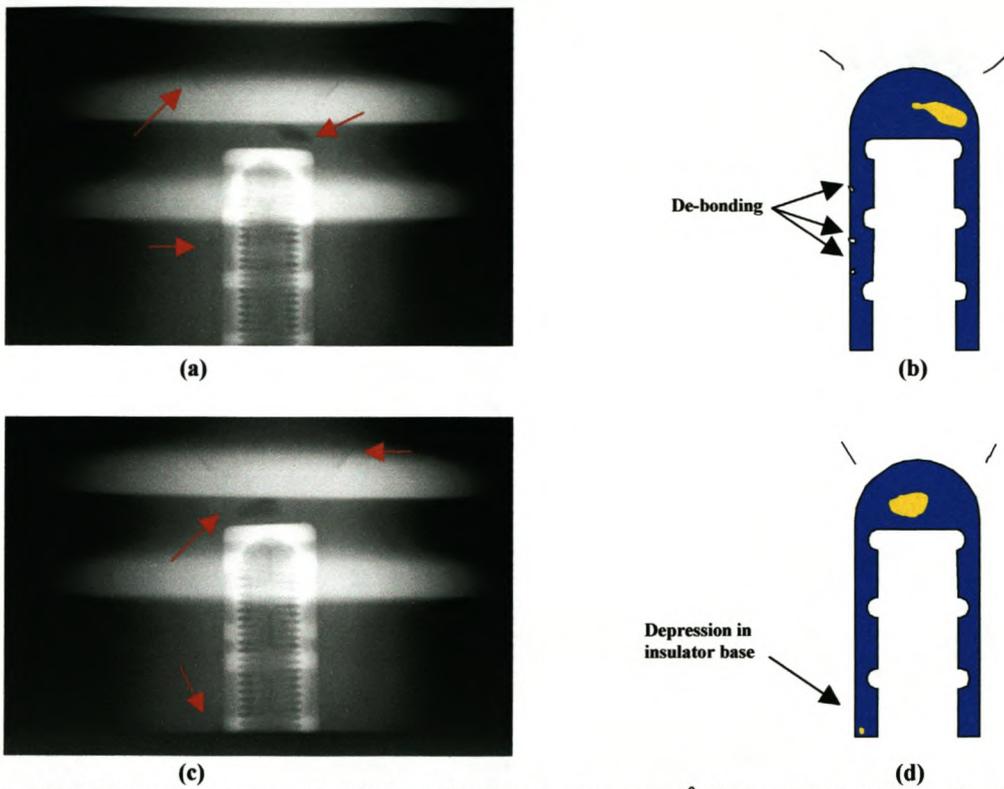
Figure 6.10: X-ray image of sample insulator C. (a) digital image at  $0^\circ$ , (b) artistic impression of embedded electrode area at  $0^\circ$ , (c) digital image at  $90^\circ$ , (d) artistic impression of embedded electrode area at  $90^\circ$ .

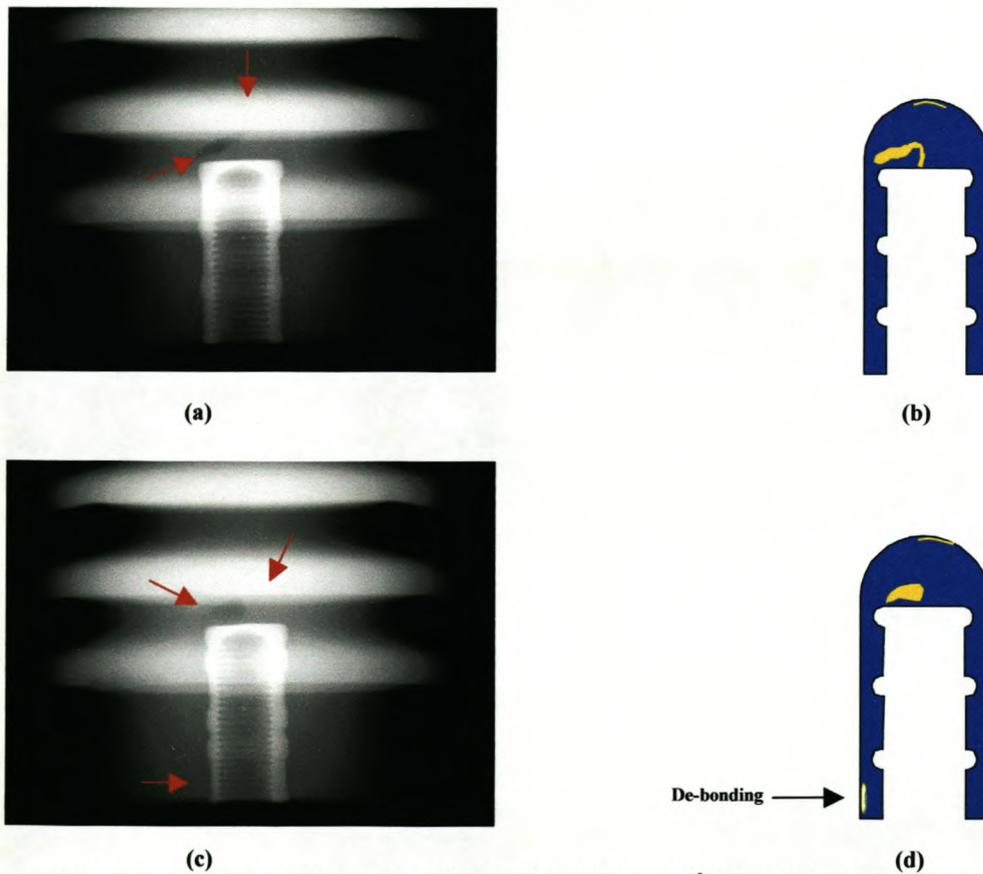
Figure 6.11: X-ray image of sample insulator CX. (a) digital image at  $0^\circ$ , (b) artistic impression of embedded electrode area at  $0^\circ$ , (c) digital image at  $90^\circ$ , (d) artistic impression of embedded electrode area at  $90^\circ$ .

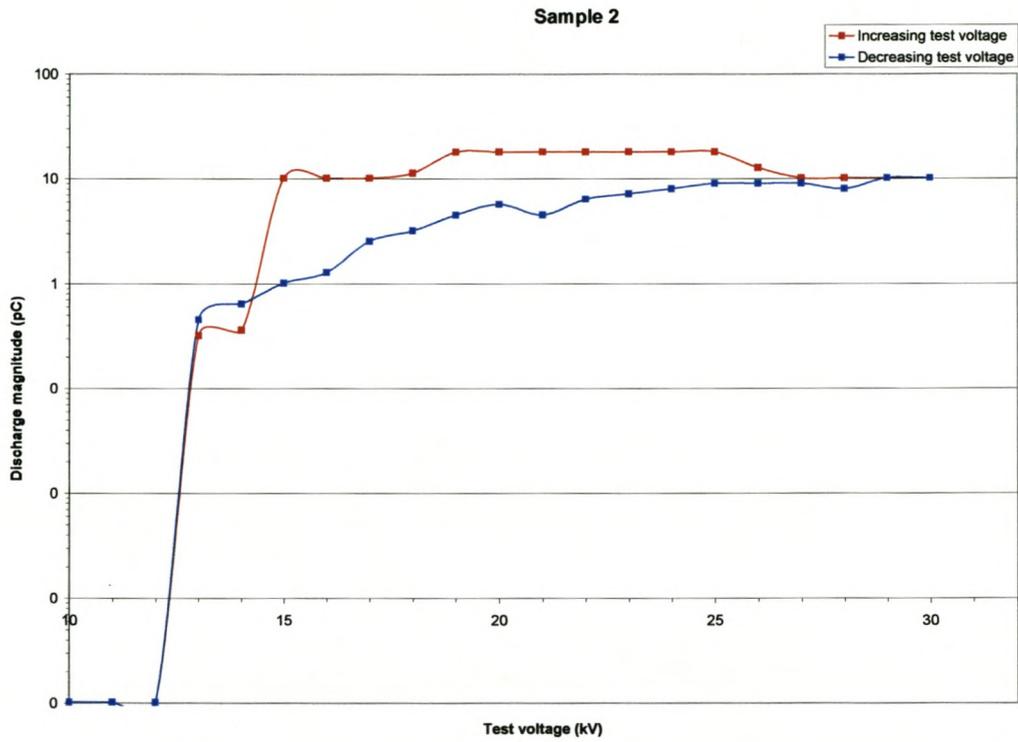
Figure 6.12: X-Y diagram of PD in insulator sample 2.

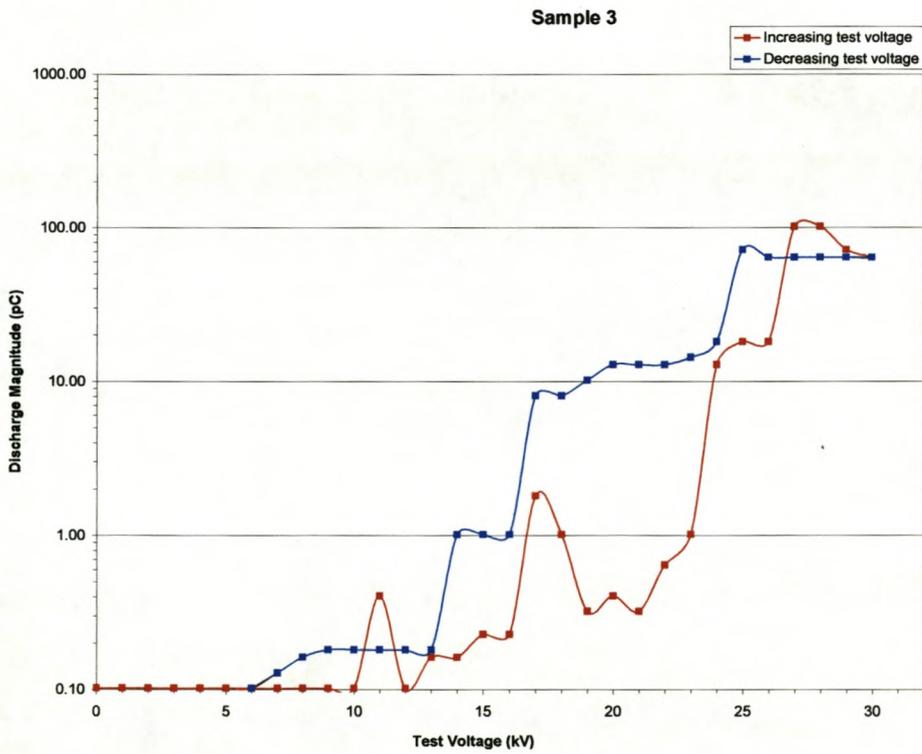
Figure 6.13: X-Y diagram of PD in insulator sample 3.

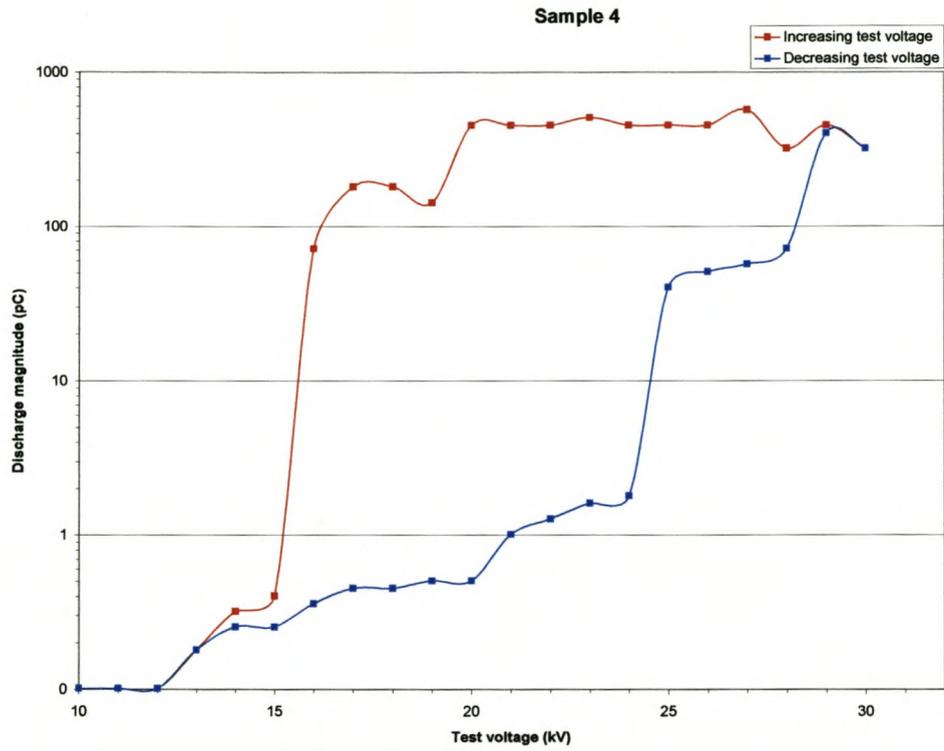
Figure 6.14: X-Y diagram of PD in insulator sample 4.

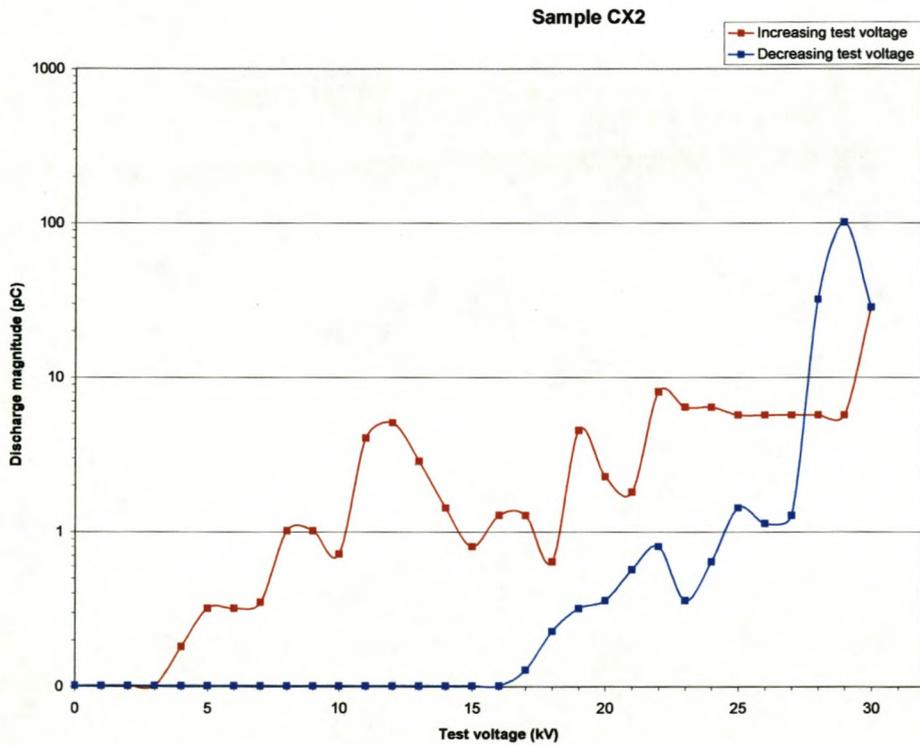
Figure 6.15: X-Y diagram of PD in insulator sample CX2.

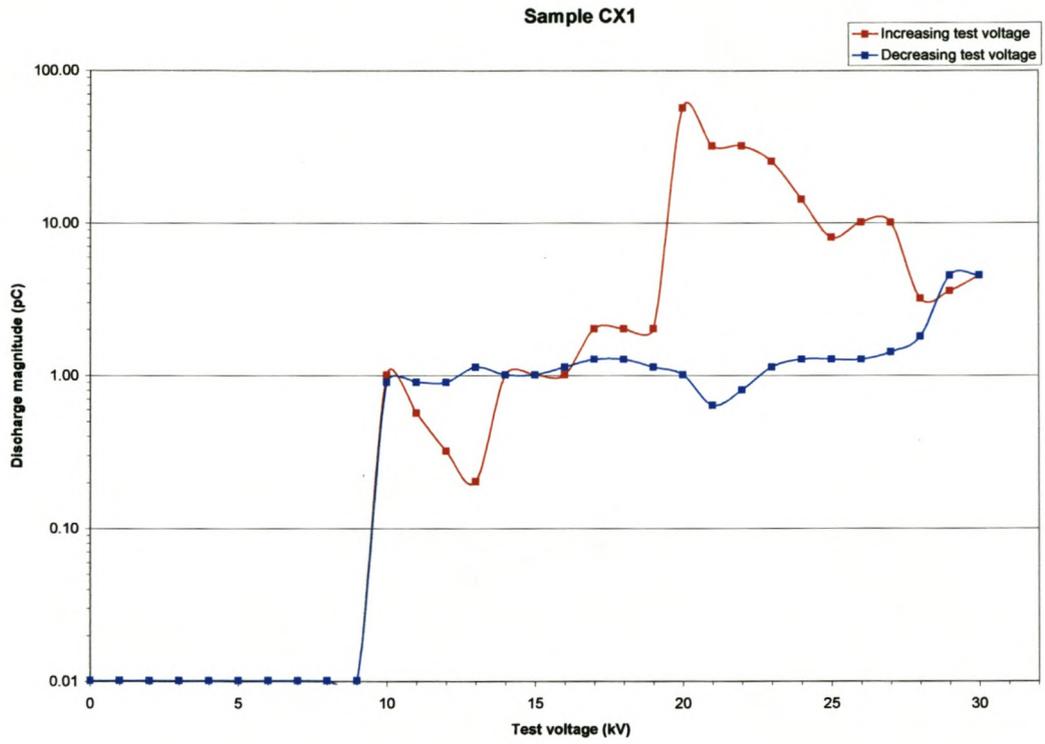
Figure 6.16: X-Y diagram of PD in insulator sample CX1.

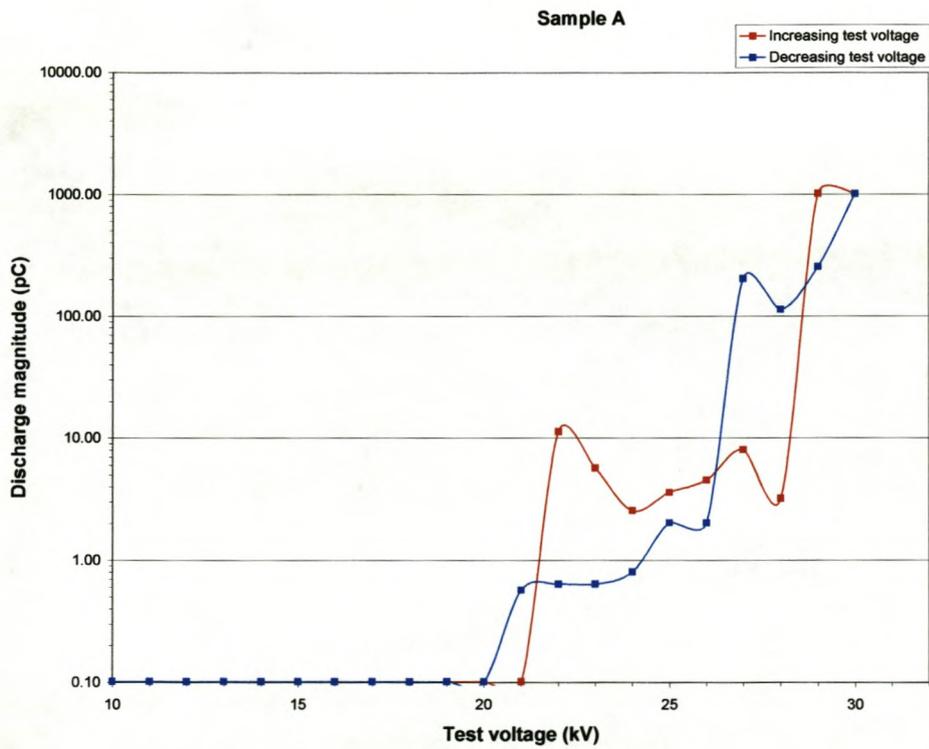
Figure 6.17: X-Y diagram of PD in insulator sample A.

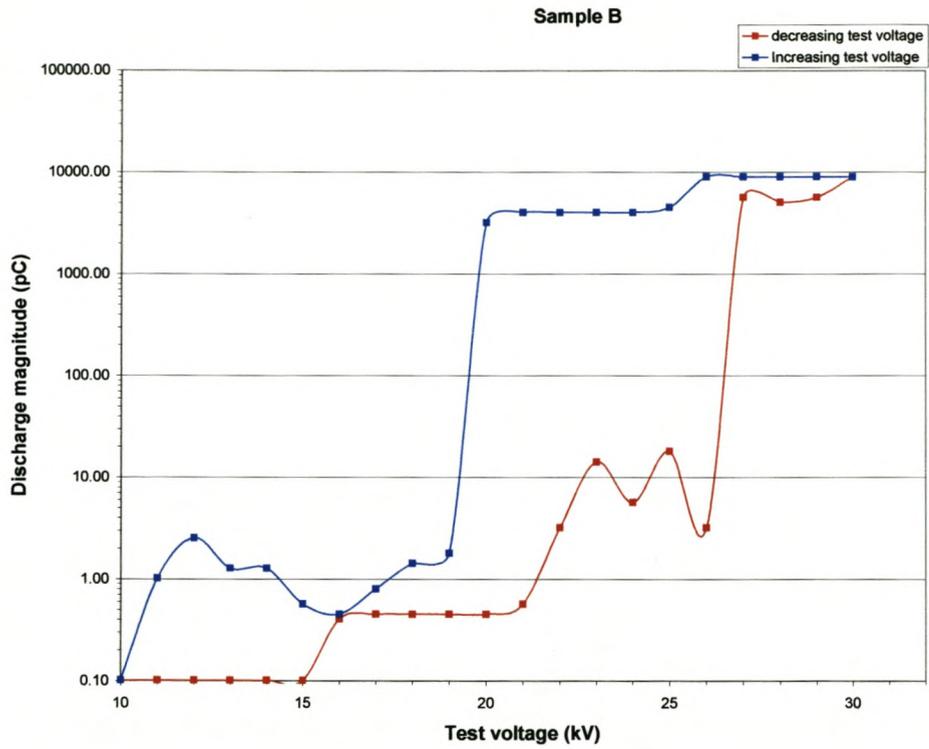
Figure 6.18: X-Y diagram of PD in insulator sample B.

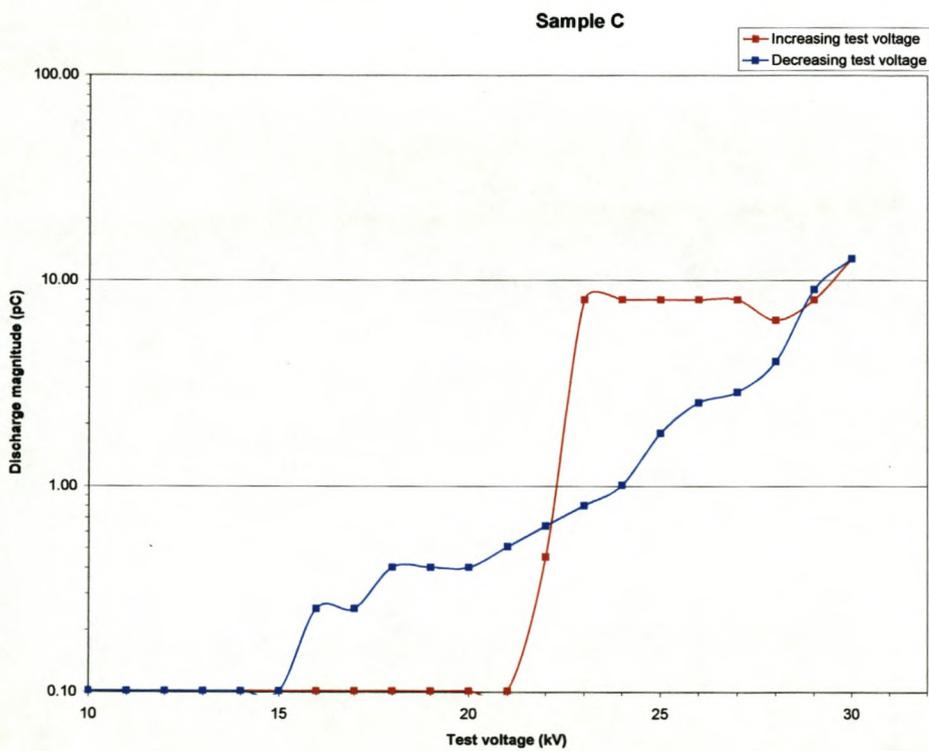
Figure 6.19: X-Y diagram of PD in insulator sample C.

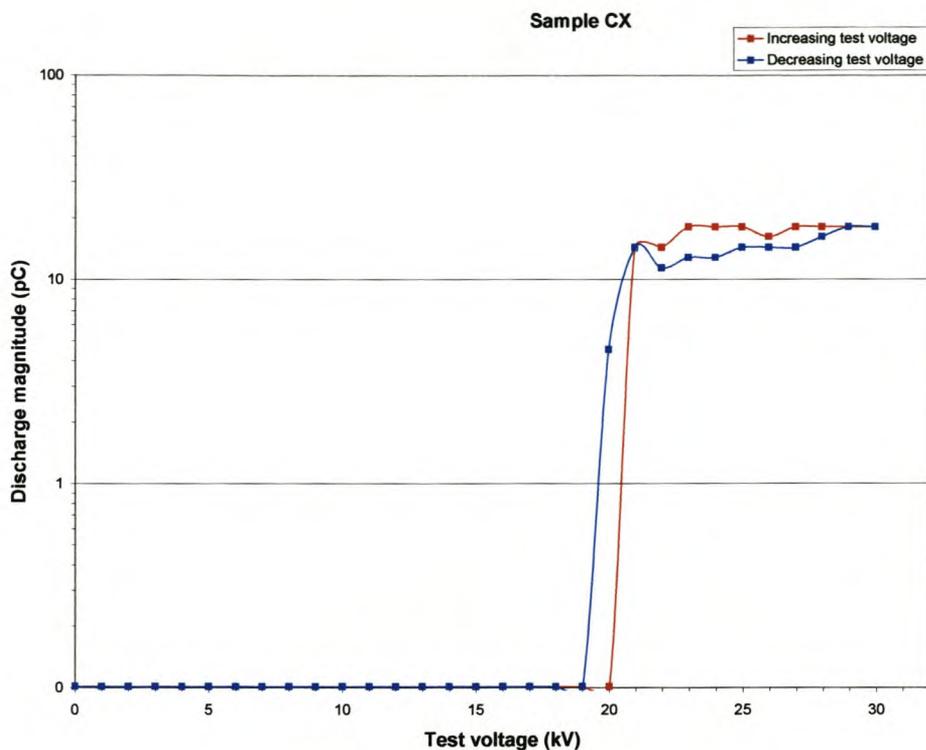
Figure 6.20: X-Y diagram of PD in insulator sample CX.

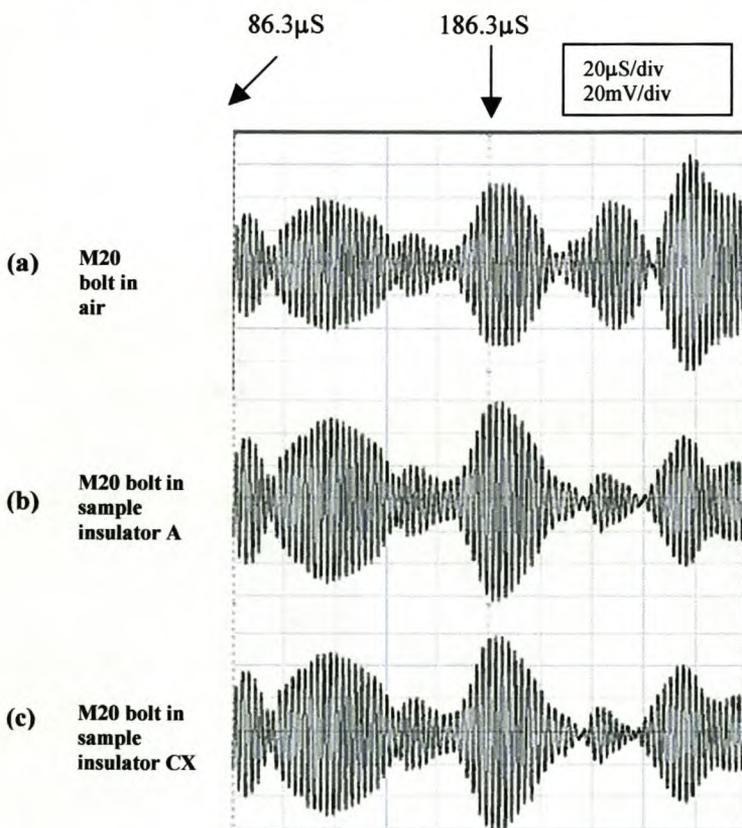
**Figure 6.21: Oscilloscope traces of the reflected waves received by the receiver transducer for (a) M20 bolt in air, (b) M20 bolt in sample insulator A and (c) M20 bolt in sample insulator CX.**

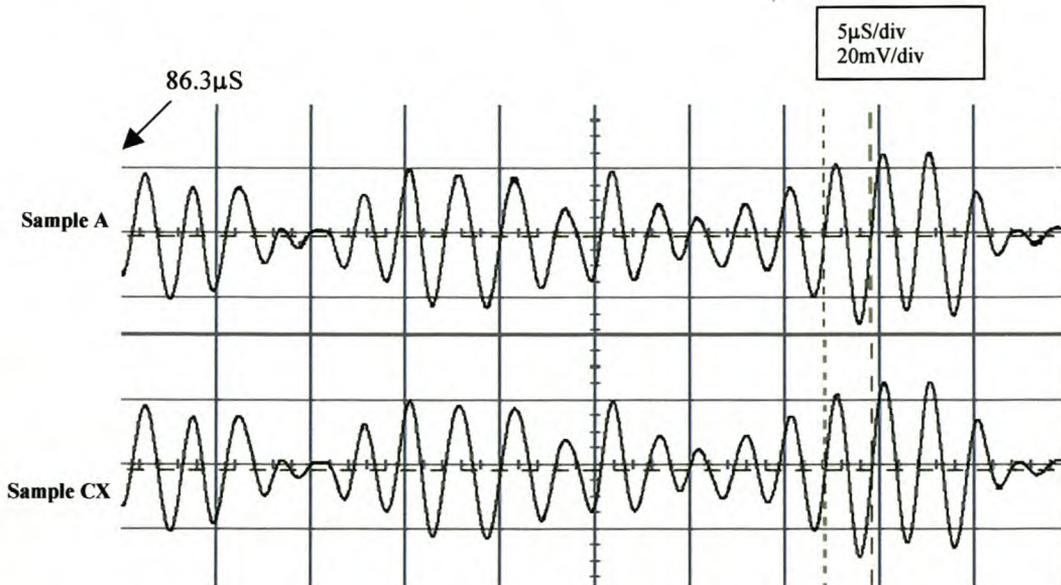
Figure 6.22: Zoom of the first 2.5 time divisions of figure 6.21.
