The identification and modelling of rockfalls for protection measures in the Western Cape

by
Shivana Surujbally

*Thesis presented in fulfilment of the requirements for the degree of Master of Engineering
in the Faculty of Engineering at Stellenbosch University*

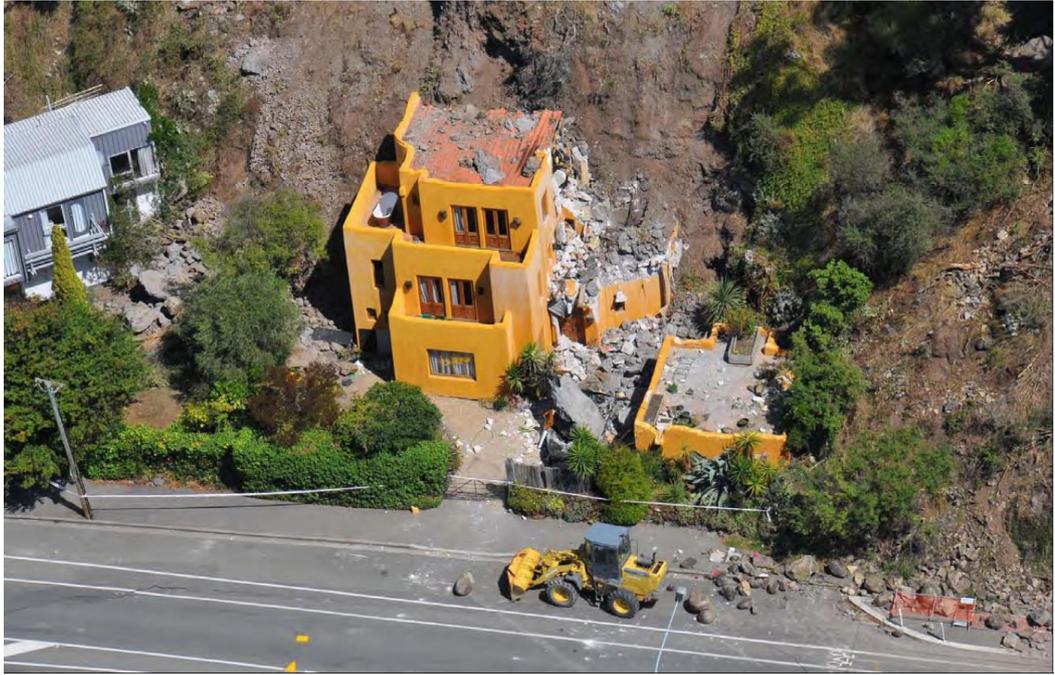
Figure 2.8: Rockfall on to house at 116A Main Road, Radcliffs (GNS Photo-GTH_5823), (Dave, 2011).

Ground motion as a result of an earthquake is a common occurrence in underground mining as well as in mountainous terrain. Depending on the size of the seismic activity, a rockfall can range from a single rock to a massive landslide. The earthquake that occurred in 2011 in Christchurch, New Zealand, measured 6.2 on the Richter scale and caused rockfalls, some of which damaged houses (Wyllie, 2015).

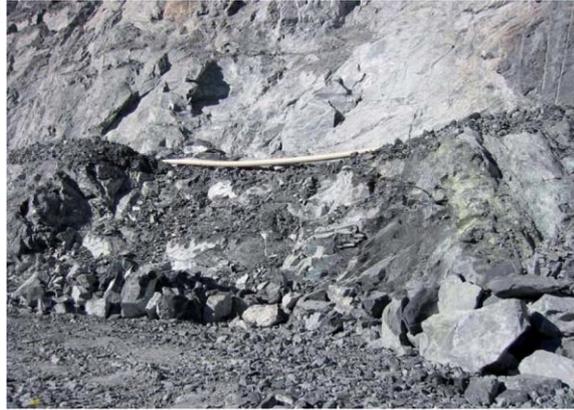
Figure 2.18: Location where the berm was lost (Geobruigg, 2008).

The Mount Keith Nickel operation North of Leinster in Western Australia experienced rockfall problems above a ramp. The initial solution to the problem was to create a berm, however, the berm collapsed in one section exposing the ramp to rockfalls (Geobrugg, 2008). See Figure 2.9. In this case, the ramp was required for the life of the pit and tecco mesh was used to stabilise the area.

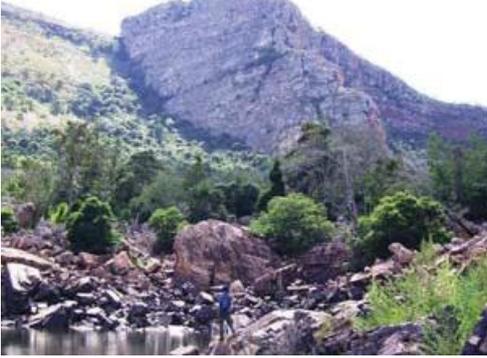
<p>The towering quartzite cliff failure scarps above the dammed Mutale River, Soutpansberg mountains. Past seismicity, toe undercutting and rock shear failure occurred.</p>

Singh et al., (2011) completed a detailed report listing a number of areas that have experienced landslides including rockfalls. Some examples include the quartzite cliff failure scarp above the Mutale River, Soutpansberg Mountains, and the sandstone/mudstone intact blocks dipping into failed slope at steep angles and the occurrence of a rock shear failure, widespread rockfall scree below the distinct Clarens Formation Cliffs in the uKhahlamba Drakensberg Mountains and a paleo feature formed by a rock avalanche 20000 years ago in the vicinity of Lake Fundudzi.

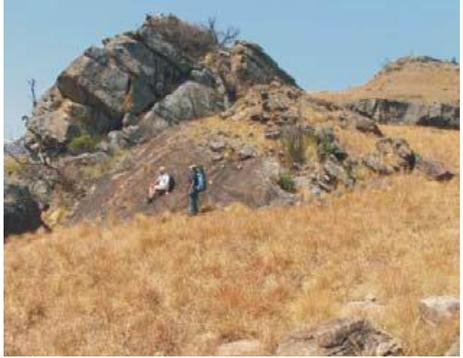
<p>Large folded sandstone/mudstone intact blocks dipping into failed slope at steep angles form part of the Meander Stream paleo- landslides debris.</p>

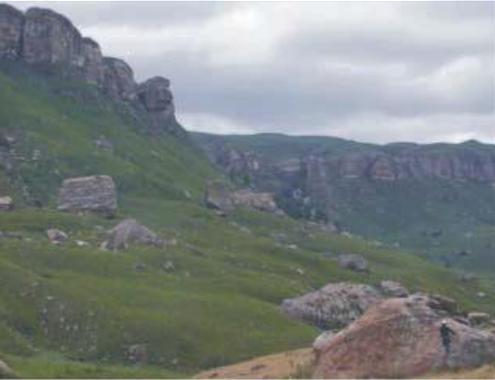
<p>Widespread rockfall scree characterises many slopes below the distinct Clarens Formation Cliffs in the uKhahlamba Drakensberg mountains.</p>

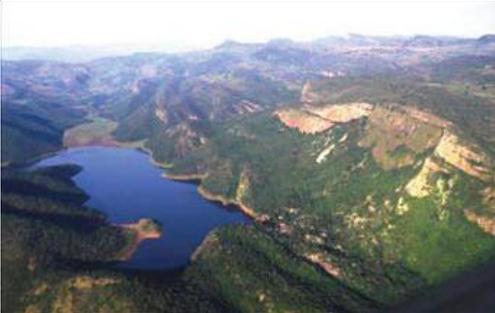
<p>Aerial view of Lake Fundudzi: A paleo feature formed by a rock avalanche 20000 years ago –(Van der Waal, 1987, G Chiliza, 2008).</p>

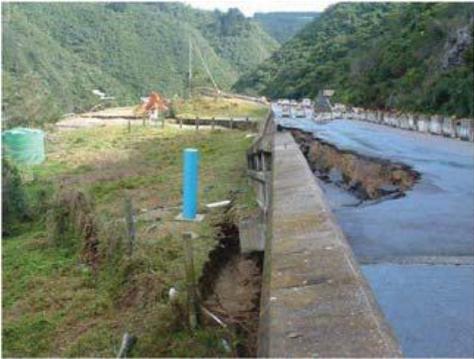
<p data-bbox="355 891 845 1070">Kaaimans Pass: August 2006: Failure site - Highway, House on the left and railway below affected (M Mohlabane, BKS)</p>

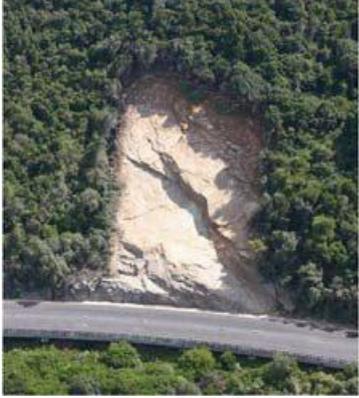
<p data-bbox="869 891 1388 1025">Kaaimans Pass: Failure 2 site – dip slope translational type failure (M Mohlabane, BKS)</p>

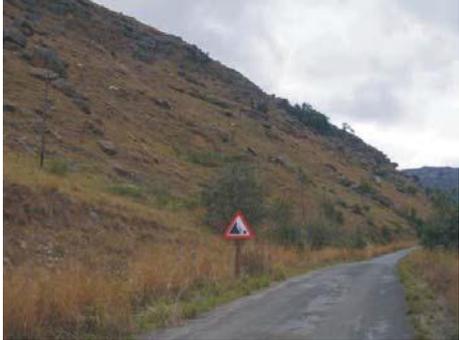
<p data-bbox="355 1505 845 1585">Ongoing rockfalls in Highmoor Nature Reserve.</p>

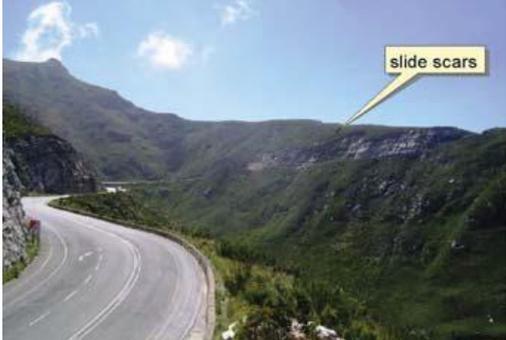
<p data-bbox="869 1505 1388 1585">Outeniqua Pass: N12 highway, January 2011</p> <p data-bbox="869 1630 1372 1664">Large rockslides caused road closure.</p>

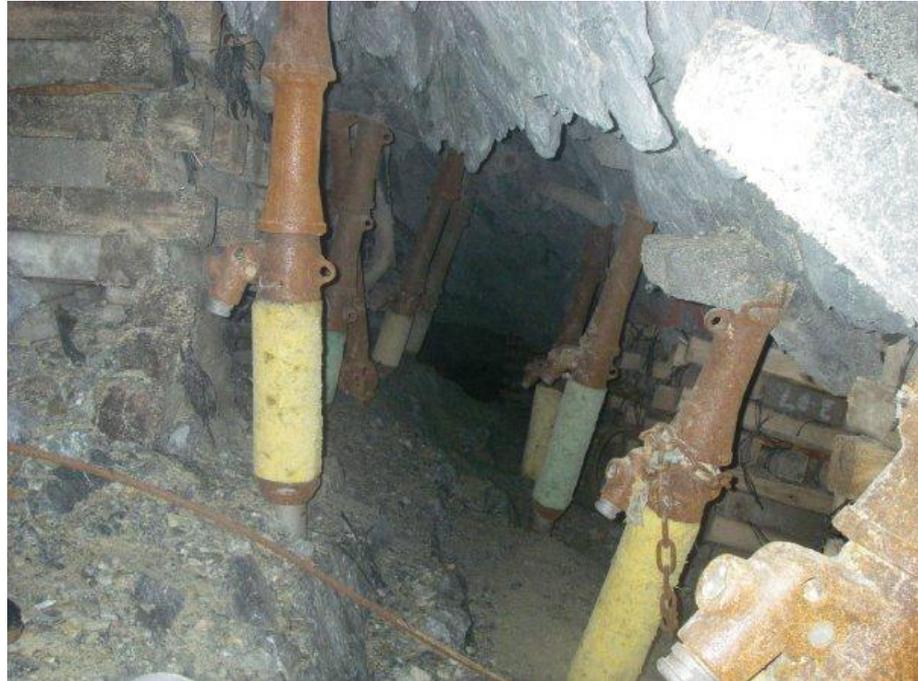
Figure 2.21: Rockprops installed at 3 shaft at Goldfields, Kloof Mine (S. Surujbally, 2007).

Whilst working on a gold mine as a trainee rock engineer, the researcher was subject to a number of rockfall incidents. The steeply dipping hanging wall can be seen in Figure 2.21 supported by rockprops. The orebody mined for gold at this shaft occurs in the quartz pebble conglomerate of the Witwatersrand Basin. This is a clear example of the dangerous underground mining conditions as a direct

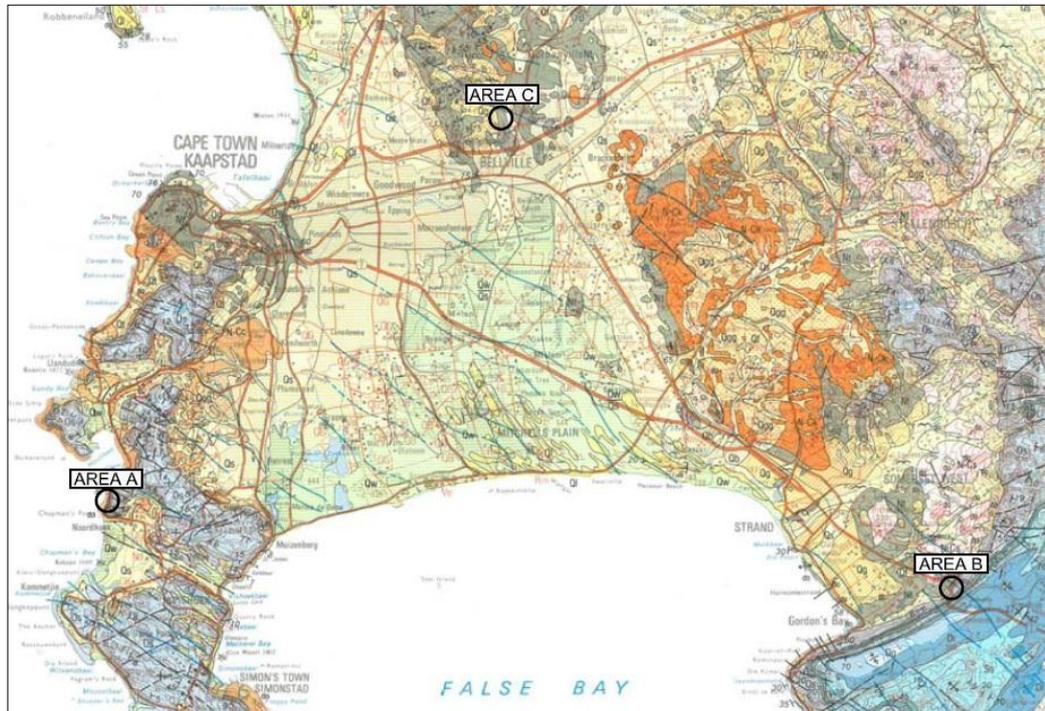
Figure 3.8: Geology of the Western Cape (3318 Cape Town 1990, 1:250 000; Geological Survey)

The general geology of the Western Cape is presented in Figure 3.8 with the study areas shown in black.

The Malmesbury Group (grey) is one of the oldest deposits in the Western Cape and South Africa. It covers roughly 20 000km² around the Cape Town area. The stratigraphy of the Malmesbury Group is poorly known due to the Cape Supergroup (light purple) overlying a large extent of it. The Cape Supergroup comprises sandstones, shales and quartzites of the Palaeozoic age. These formations vary in thickness and lie unconformably upon older formations and are overlain unconformably by the basal beds of the Karoo Supergroup (Haughton, 1969). The Cape Peninsula pluton forms the bedrock of the major part of the peninsula but is mostly covered by the Table Mountain sandstone of the Cape

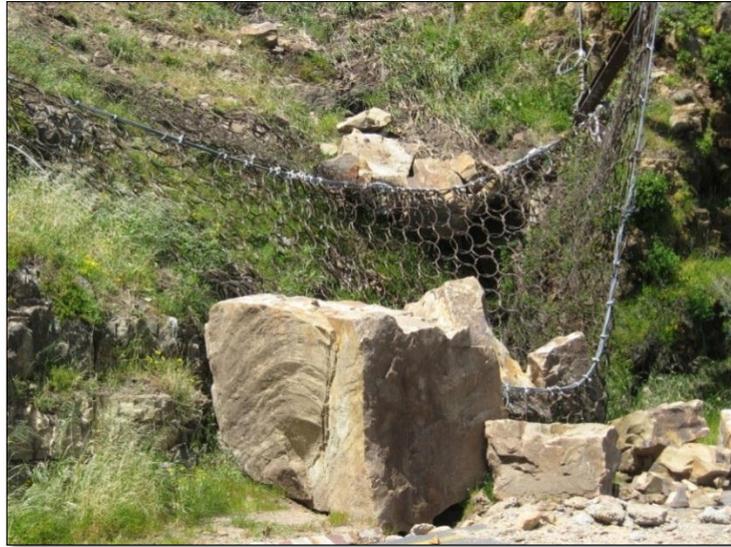
The image below shows a massive sandstone block that intersected catch fence 15 and landed just short of the road. The angular nature of the block indicates that

this block released from the Cape Supergroup higher up and was not part of the talus boulders that are scattered across the mountain.

Figure 3.12: Large boulders breaching catch fence 15. (Photo by S. Surujbally 2007)

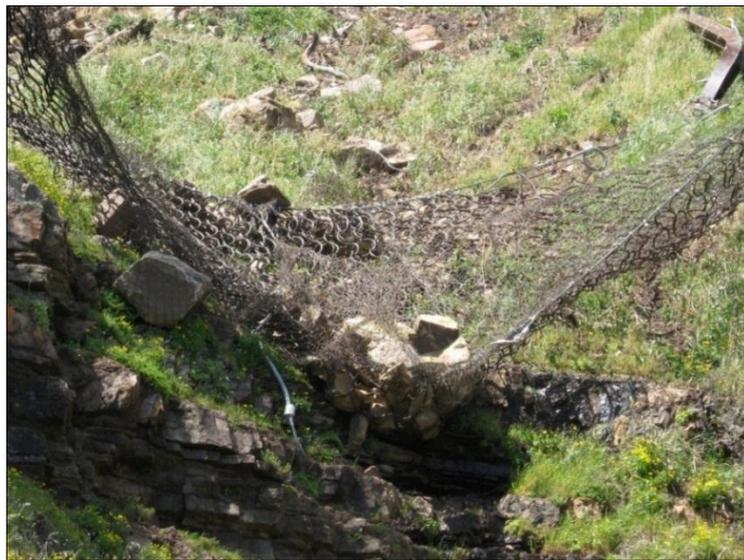
Figure 3.13 shows multiple boulders caught in catch fence that has been breached. Catch fence 15b actually is located directly above catch fence 15 and was, therefore, Figure 3.12 as well. Breaching two catch fences slowed down the block and, therefore, it did not go further and land on the road.

Figure 3.13 Multiple boulders breaching Catch Fence 15B (Photo by S. Surujbally 2007)

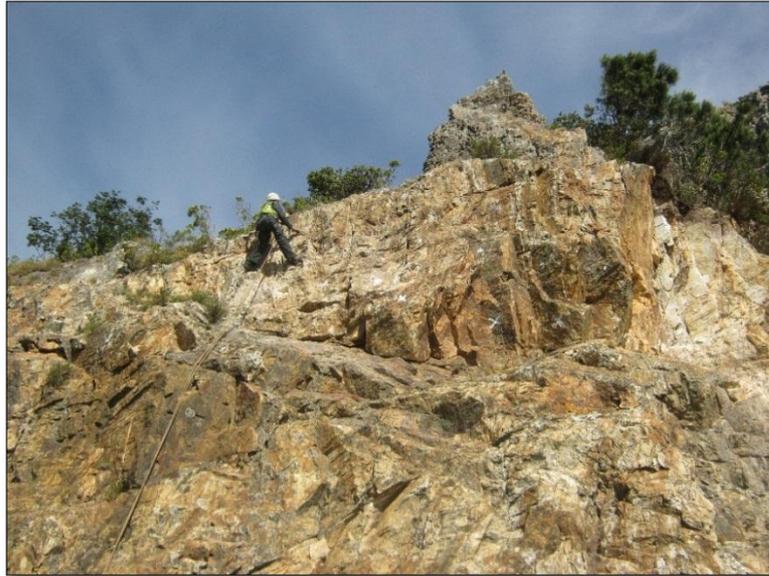
The area where fresh, light brown rock can be seen just below the rope access person and towards the right of the figure is the location where the large wedge released from and landed on the road. The remaining wedge was seen to be a potential problem in the near future and was stabilised using rock bolts.

Figure 3.14: Area where the wedge was released and landed on the road, remaining wedge required stabilisation (Photo by S. Surujbally 2012).

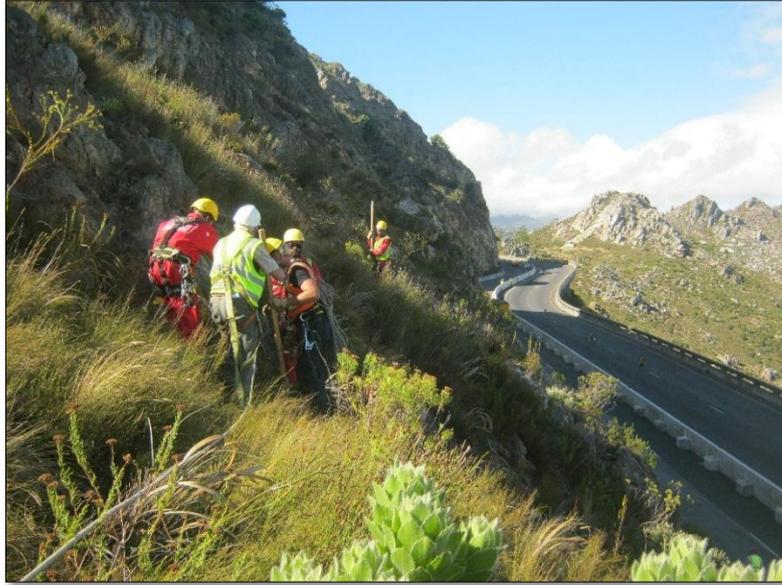
Further site inspections concluded that there was a need for stabilisation and rockfall mitigation for a larger area along the pass. The figure below shows a team of rope access personnel assisting the engineer with the setting out of the catch fence.

Figure 3.15 Visual inspection of the site and setting out of catch fence (Photo by S. Surujbally 2013).

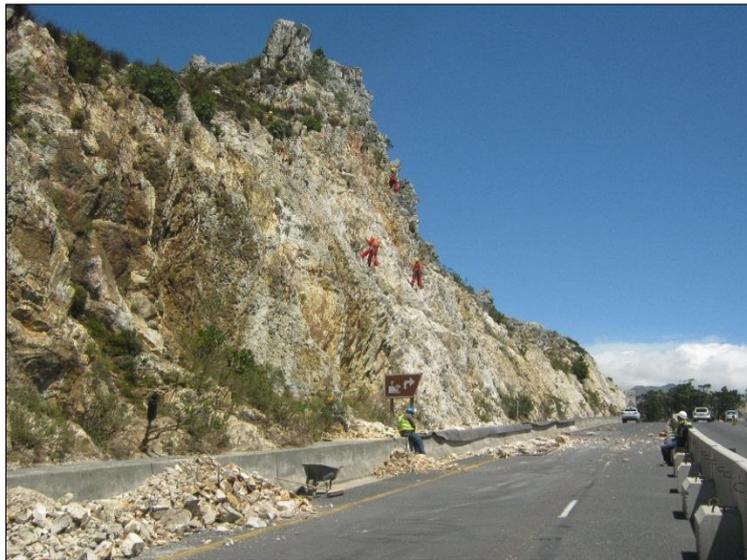
The geology of the area seen in Figure 3.16 was highly to completely weathered and required a thorough inspection and barring down of potentially loose material before pinned mesh could be installed. During the process a block bounced across the four lanes and landed on the southern side of the road reserve, confirming that if these blocks were left on the rock face, they would come down over time and may result in disastrous consequences for motorists.

Figure 3.16: Barring down of loose rocks from the cutting face by rope access team (Photo by S. Surujbally 2012).

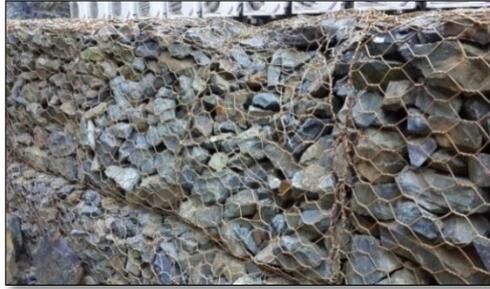
Slope side of Gabion Wall

A steep, high cliff that used to be a quarry forms the backdrop to this building complex. A large rock released and impacted the gabion wall causing damage to it. The figures below show both sides of the gabion wall whereby the impact was significant enough to create a bulging effect on the outside of the wall.

Figure 3.17: The gabion wall that was damaged during the rockfall (Photos by S. Surujbally 2015).

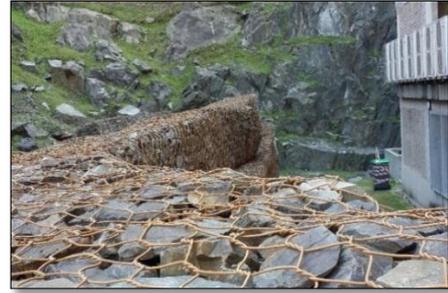
Gabion Wall bulging on the outside

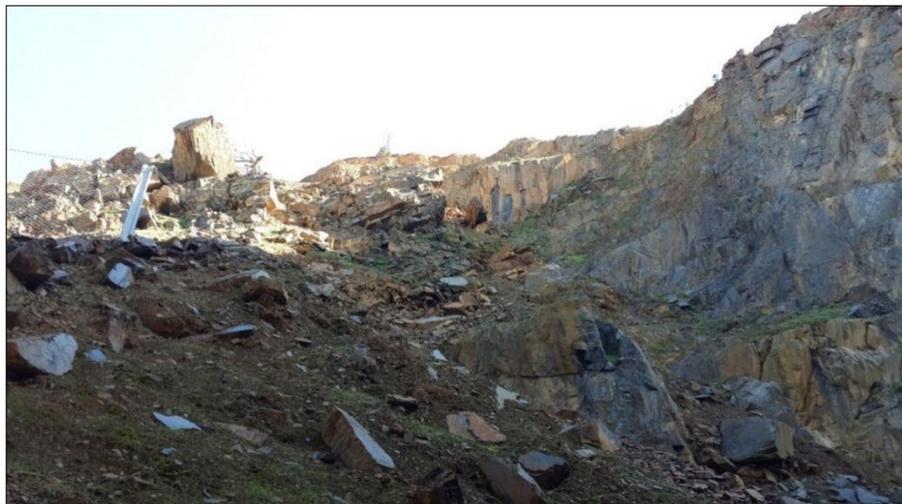
This figure shows the old quarry face which is described above with potential loose boulders.

Figure 3.18: Area of concern for potential rockfalls (Photo by S. Surujbally 2015)

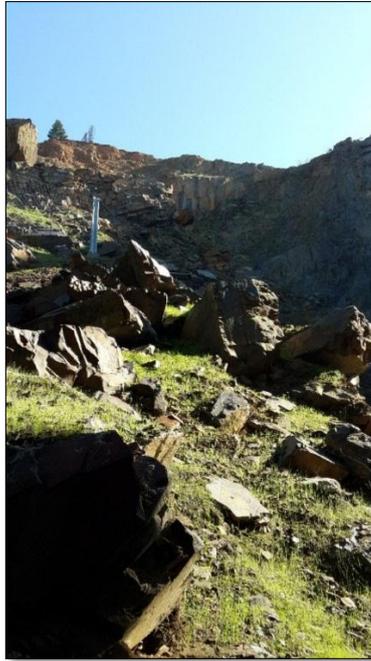
A few specific larger boulders were identified to be a possible rockfall problem and these were modelled separately and will be discussed in the next chapter.

**Figure 3.19: Area modelled for potential 10m³ rockfall in “S” sections
(Photo by S. Surujbally 2015)**

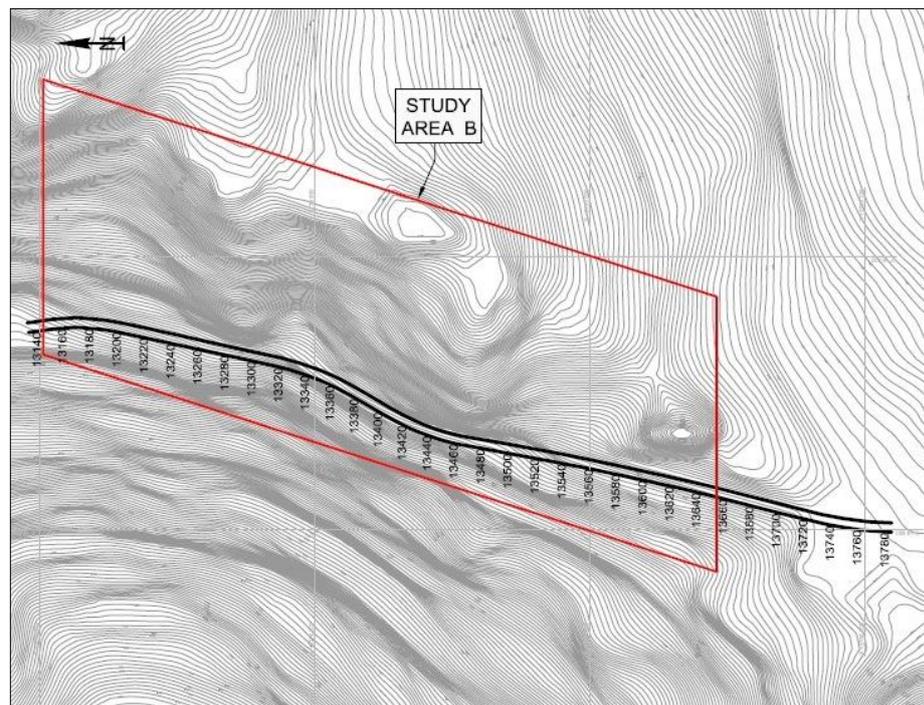
Figure 3.21: Terrestrial Survey of the Study Area B

The closely spaced contour lines show the steepness of the mountain face above the roadside cutting which would create a slope surface for rockfalls with high kinetic energies depending on the slope length (Figure 3.21). Rockfalls that tend to originate from higher up on a mountain face will gravitate towards the gulleys resulting in a change in trajectory direction. The concentric circles define the mountain tops with the valleys in-between creating an undulating surface.

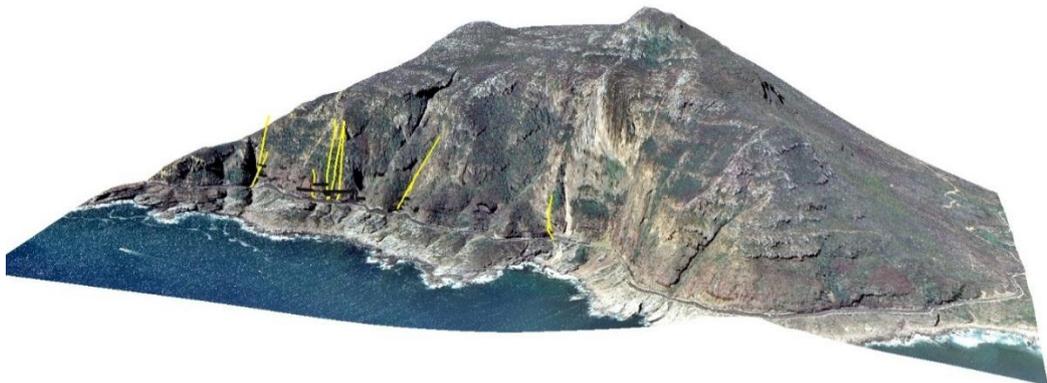
Figure 4.6: 3D View of the site looking North (Exported from ArcGIS 10.0).

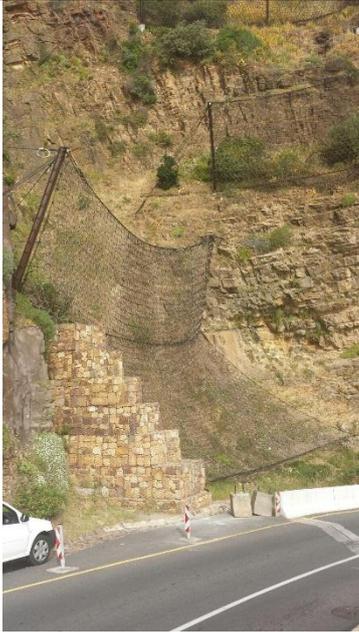
Catch Fence 2a

Figure 4.14: Rockfall mitigation measures for Chapman's Peak Drive (Photos by David Esau, 2015)

Following the rain damage event that has been modelled in this research study and based on the rockfall database, an upgrade called “Schedule C” was undertaken in 2009. Figure 4.14 shows images of the catch fences as they are today post upgrade. Catch fence 2a experienced a block bouncing below the catch fence and impacting the road structure, this catch fence was upgraded by attaching additional ring nets to the bottom of the catch fence and draping it to cover the gap area. This became locally known as the “trampoline”. Catch fence 8a was found to function as designed and coupled with a detailed site inspection showed no indication requiring an upgrade in fence capacity.

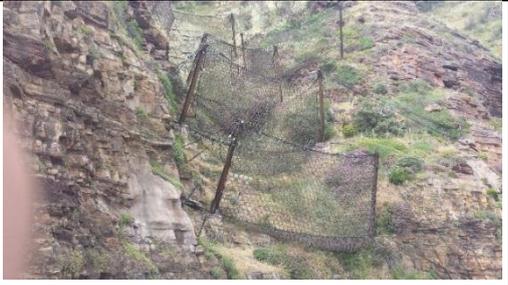
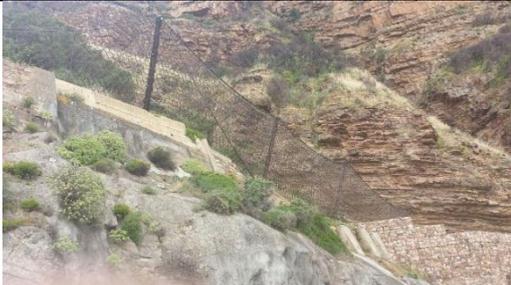
Catch Fence 15	Catch Fence 30

The gulley area above catch fence 30 has been active in the past. The last field of the fence has constantly filled up and at times even breached it. This fence was upgraded to a 2000kJ fence before the 2007 rain damage event. This area has since appeared to have stabilised.

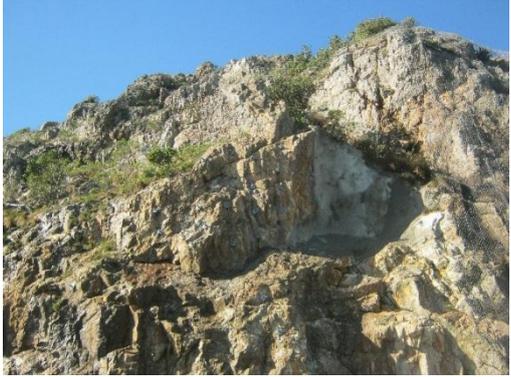
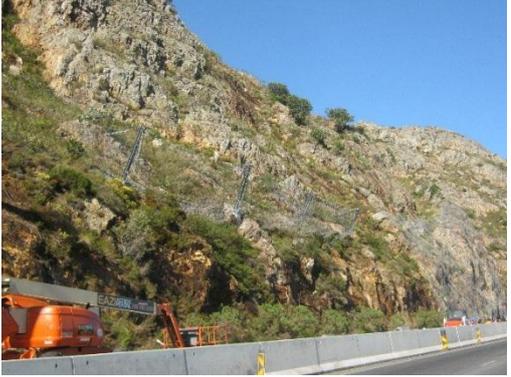
Stabilised Wedge	Catch Fence 1

Completed Rockfall Mitigation Measures for Site B

As mentioned in chapter 2, rainfall plays a significant role in rockfall occurrences, particularly in the Western Cape. Since the completion of this project, one major rainfall event occurred in November 2013, however, no significant rocks were found to be in the catch fences. Since the Western Cape and the rest of South Africa are experiencing a drought in 2015, there is a high probability that when the drought ends, that this area may experience rockfalls of a significant size and the catch fence capacities can be confirmed on site. Figure 4.15 shows the completed catch fences as they were installed in July 2013.

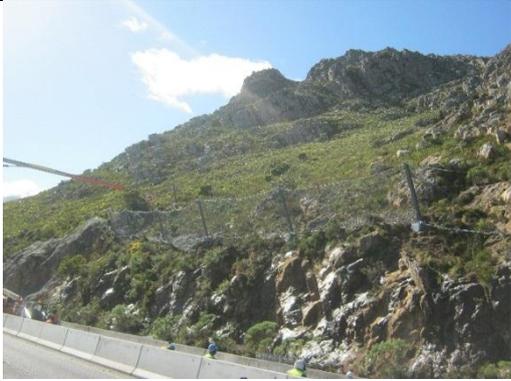
Catch Fence 2	Catch Fence 3

Figure 4.15: Rockfall mitigation measure for Site B: Sir Lowry's Pass (Photos by S, Surujbally, 2013)

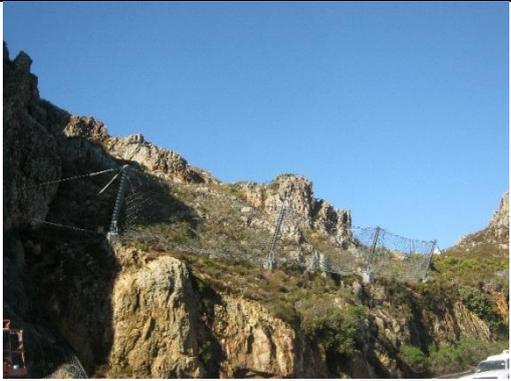
Catch Fence 4	Catch Fence 5

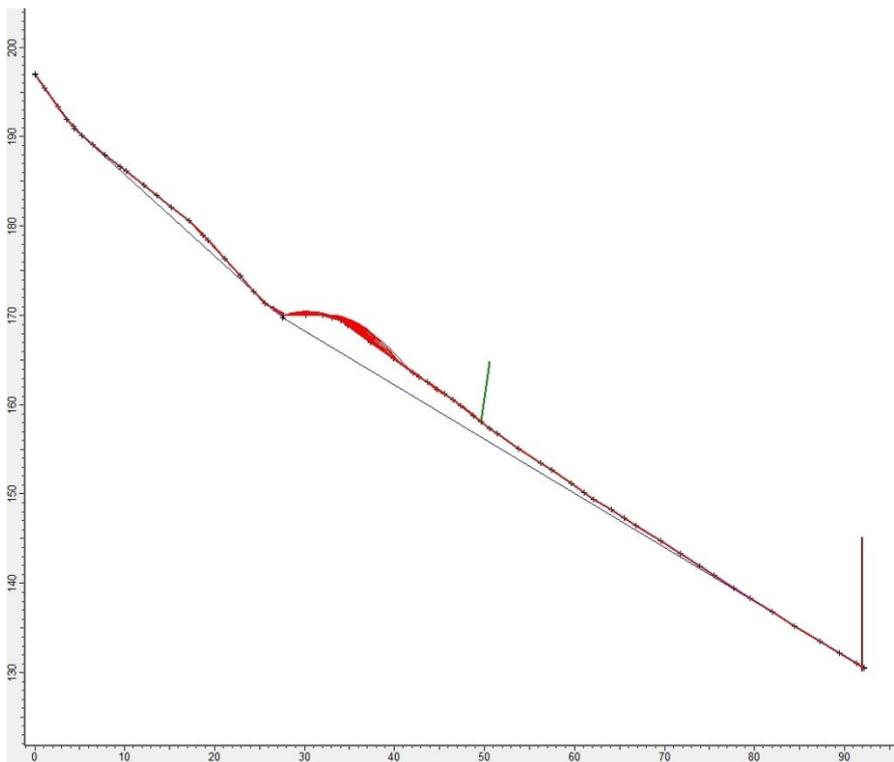
FIGURE 1.8: Rockfall simulation trajectories along 15A
