A STUDY OF SAFETY AND SECURITY OF PEDESTRIANS TRAVELLING TOWARDS THE BELLVILLE, CLAREMONT AND MITCHELLS PLAIN PUBLIC TRANSPORT INTERCHANGES IN THE CAPE TOWN MUNICIPAL AREA

*A thesis presented in fulfilment of the requirements for the degree of
Master of Engineering in Civil Engineering in the Faculty of Engineering
at Stellenbosch University*

M.Eng Civil (Transportation)

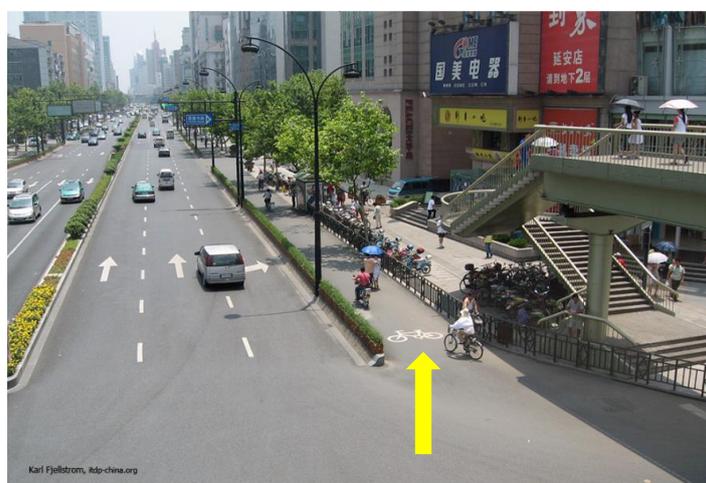
Figure 2-6: Dedicated rickshaw lane

To prevent and restrict scattered and haphazard movement, Figure 2-6 below shows how the government made enough space to accommodate the Rickshaw mode of transport within the roadway.

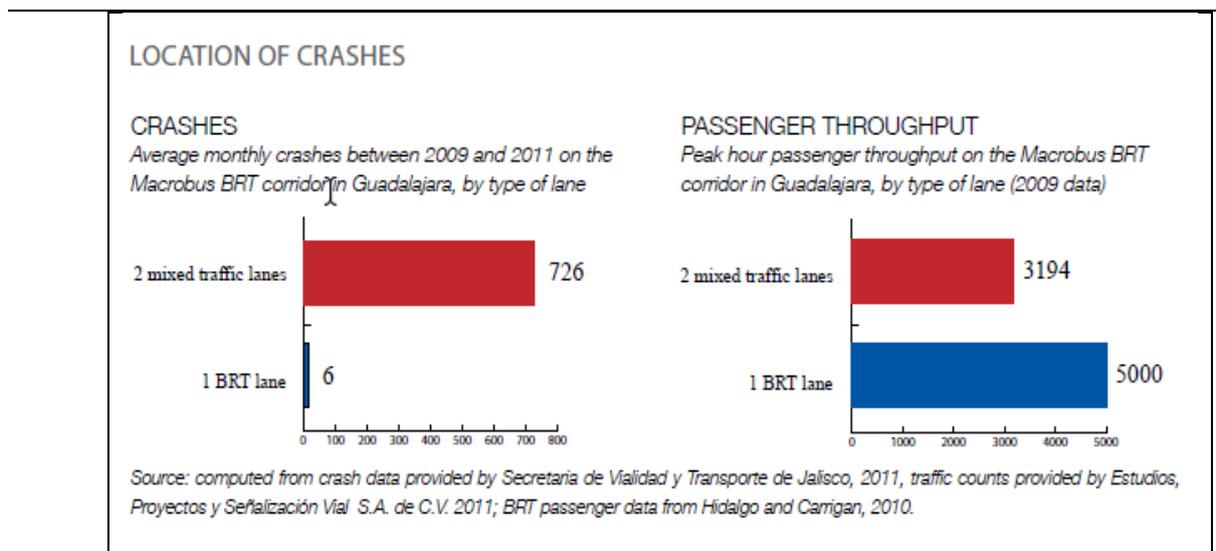
Figure 2-8: Number of crashes vs the passenger output during BRT lane pilot

Figure 2-7 below, shows a comparison between the number of crashes and passenger output using the first pilot Bus rapid transit (BRT) lanes. The graph on the left compares the crashes between mixed traffic to 1 BRT lane. The crashes reduced by almost 99%. The passenger output increases substantially when looking at the number of passengers moved in two mix lanes of traffic compared to 1 BRT lane.

Although the BRT network was not fully constructed, the implementation of an incomplete system did not cause major disruptions. The graphs show the improvement of the system. This indicates that the pedestrian's perception and buy-in are critical to the success of the infrastructure. Before the construction was complete people used the system because of safety and security advantages and well as other outputs experienced like comfort and reduced travel time.

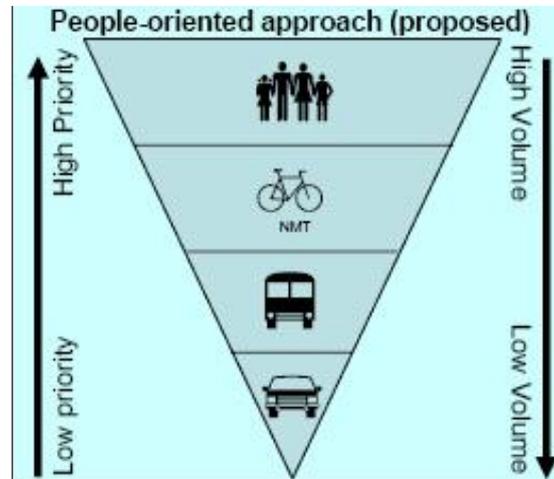
Figure 2-12: The hierarchy of transportation nodes

Using the model below illustrated in Figure 2-12, as a guideline, the priority will move from vehicle to pedestrian but will still provide public transport with the required ROW.

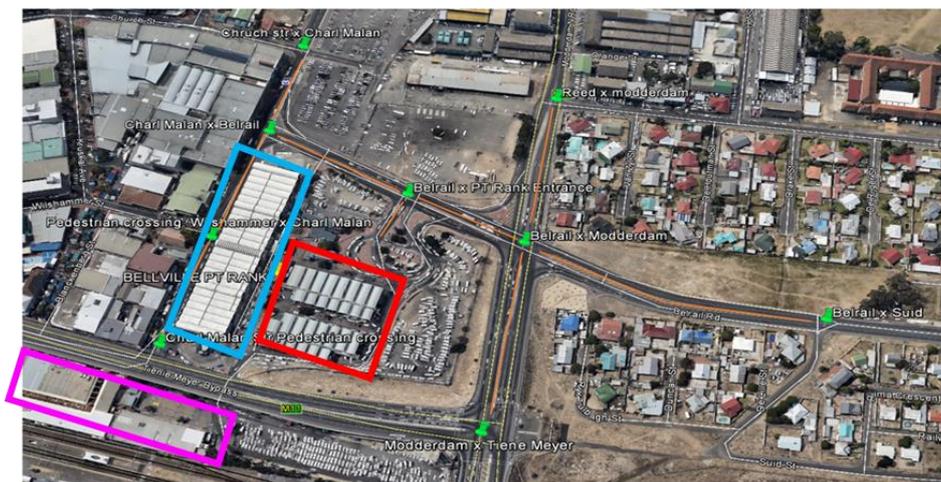
Figure 4-1: Aerial view of Bellville PTI

Figure 4-1 below shows an aerial view of the Bellville PTI. The image has been colour coded to indicate the different elements of the PTI. The green pins show the intersections and the orange lines indicate the links between the intersections being investigated. The three different sections have also been colour coded: Red-Taxi, Blue-Bus and Purple-Train.

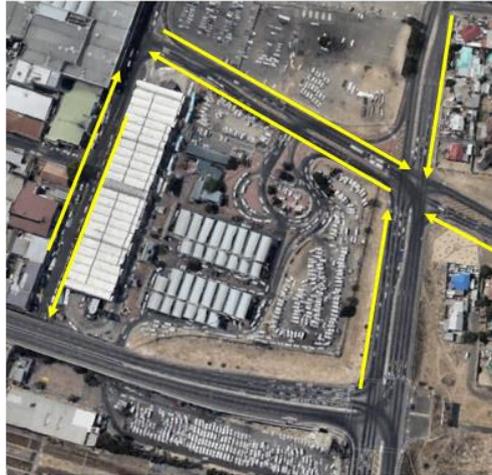
Figure 4-2: Main pedestrian movement at Bellville

Figure 4-2 shows the dominant commuter routes at Bellville PTI. These routes were observed during the site visit and displayed on an aerial photo of the area. Since the PTI has a fence along the boundary pedestrians are forced to walk to the front of the PTI and enter from one direction.

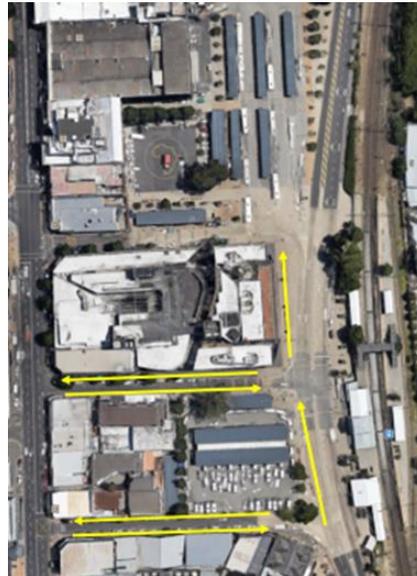
Figure 4-4: Main pedestrian movement around Claremont PTI

direct route to access the PTI from the Main Road as well as from the train station. Since their area around the PTI is developed, the pedestrian routes are pre-set along with the road geometry.

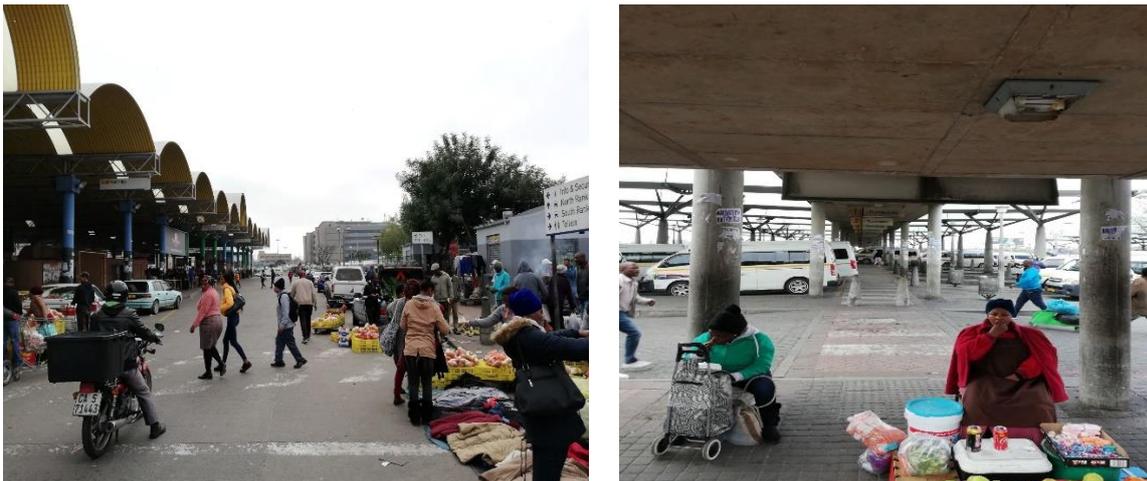
Figure 5-12: Condition of the pedestrian crossing at Bellville PTI

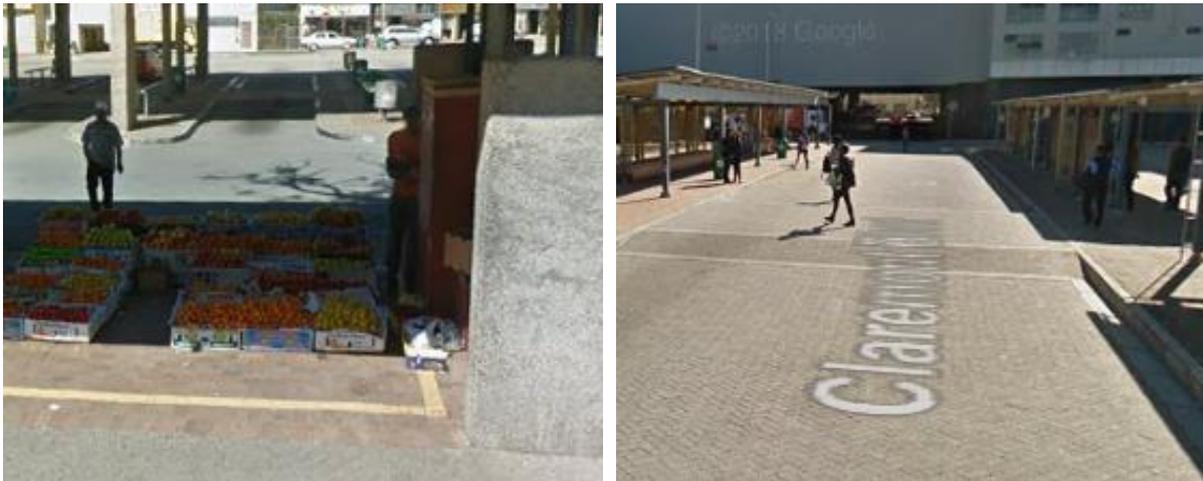
Figure 5-13: Raised pedestrian crossings at the Claremont PTI

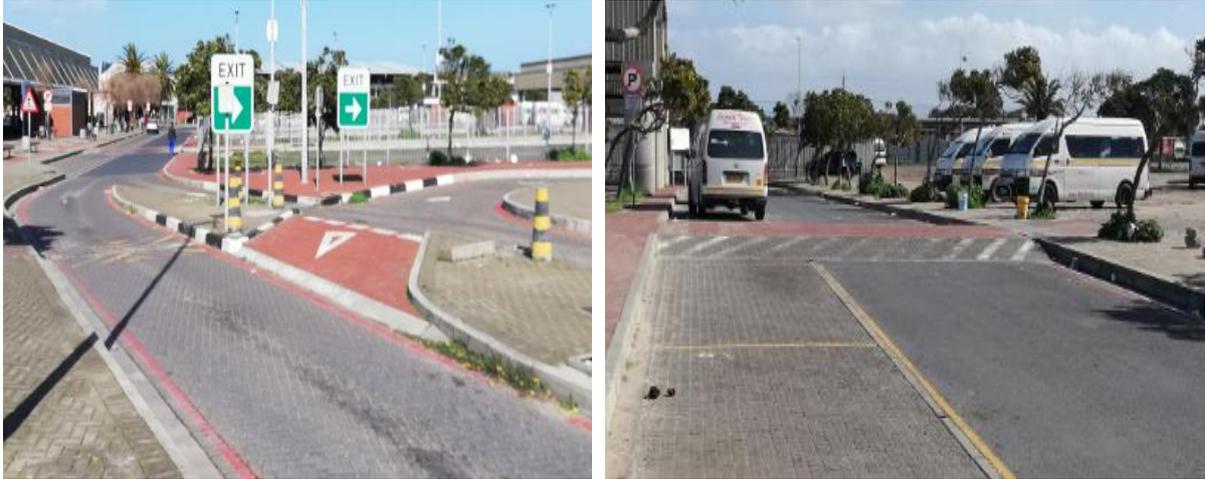
Figure 5-14: Examples of a raised pedestrian crossing at the MP PTI

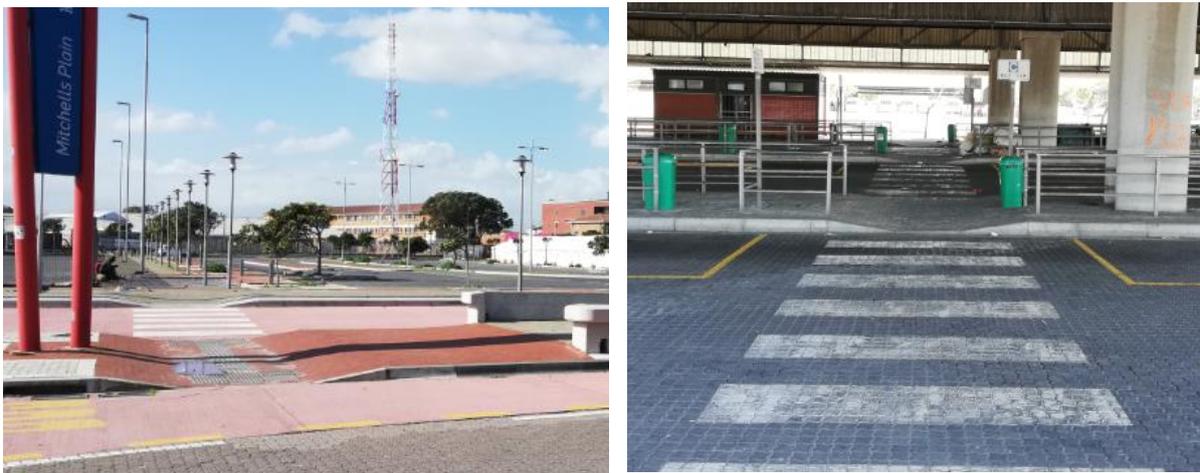
Figure 5-15: Condition of the pedestrian facilities at the MP PTI

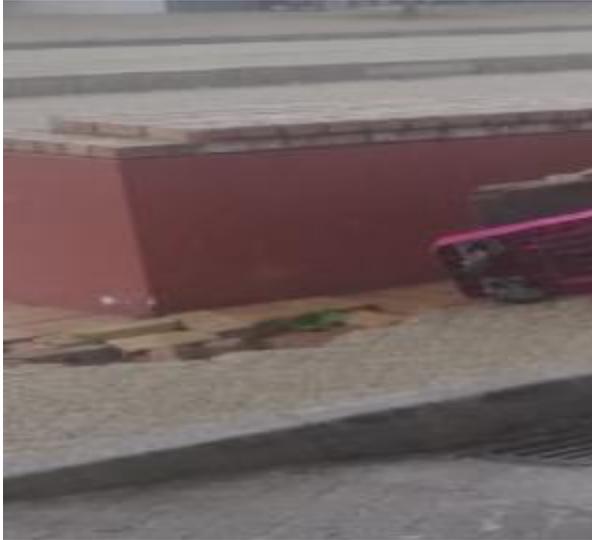
Figure 5-19: Deformation of the Sidewalk at Claremont PTI

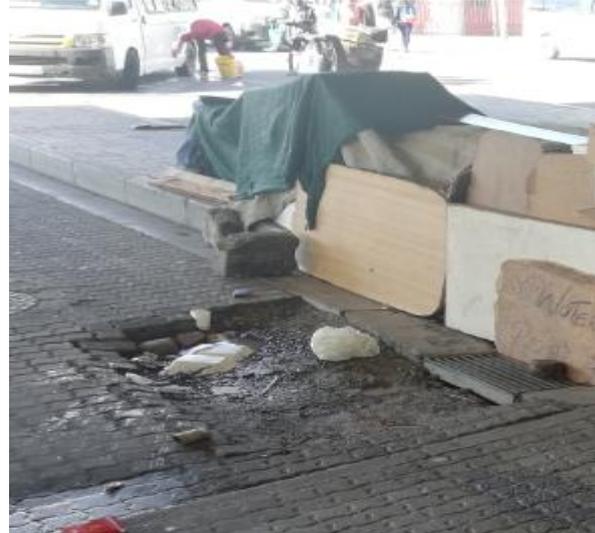
Figure 5-20: Deformation from poor drainage at the MP PTI

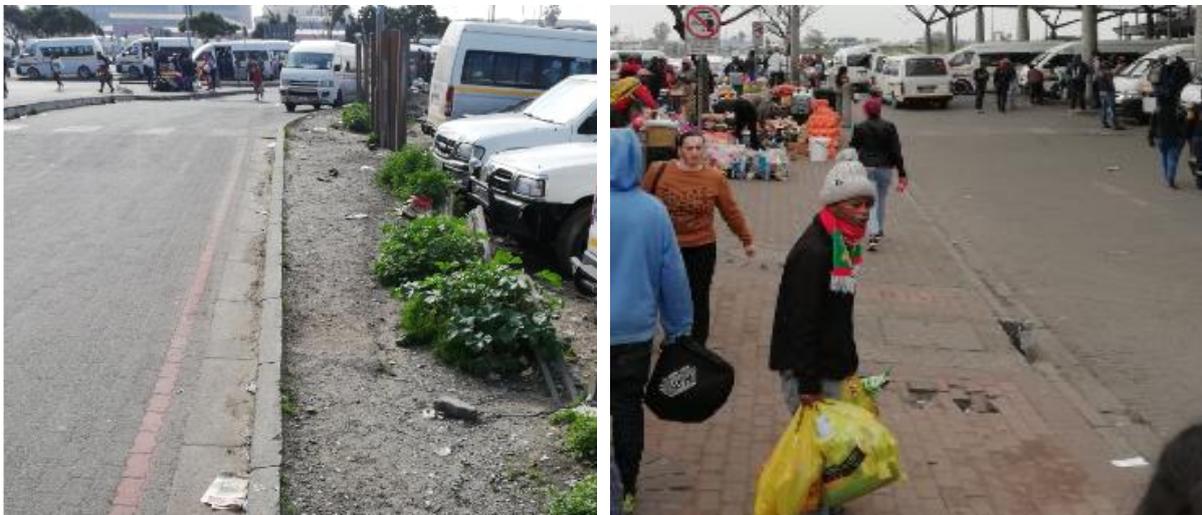
Figure 5-21: Deformation and condition of the pedestrian facilities at the Bellville PTI

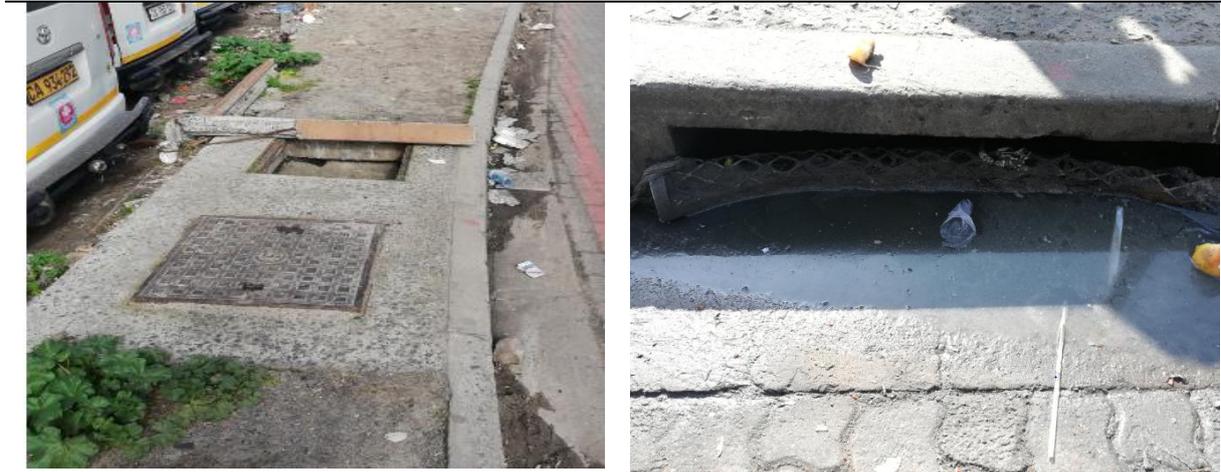
Figure 5-22: Pedestrian tripping hazards

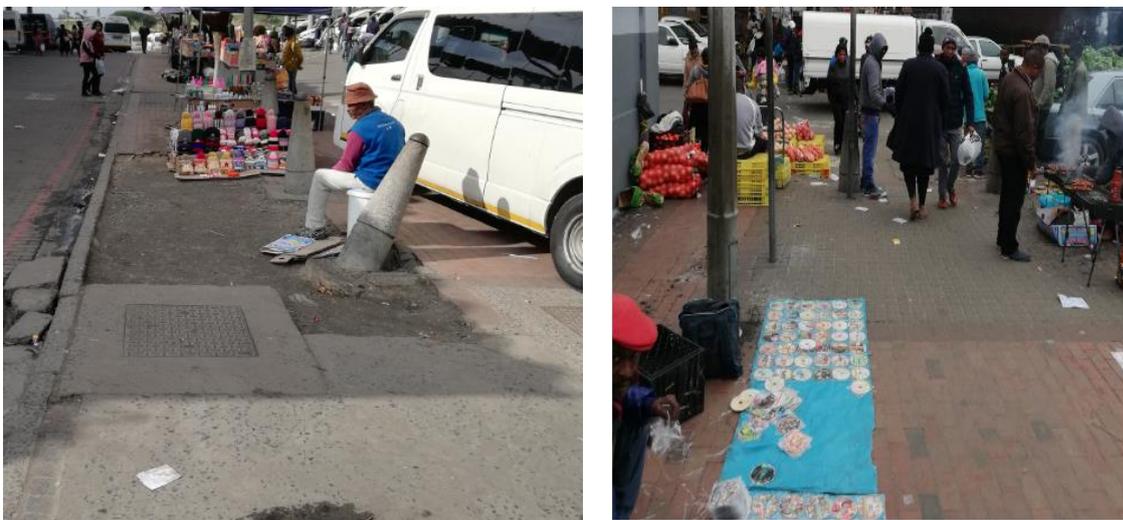
Figure 5-23: Different materials used in shared space

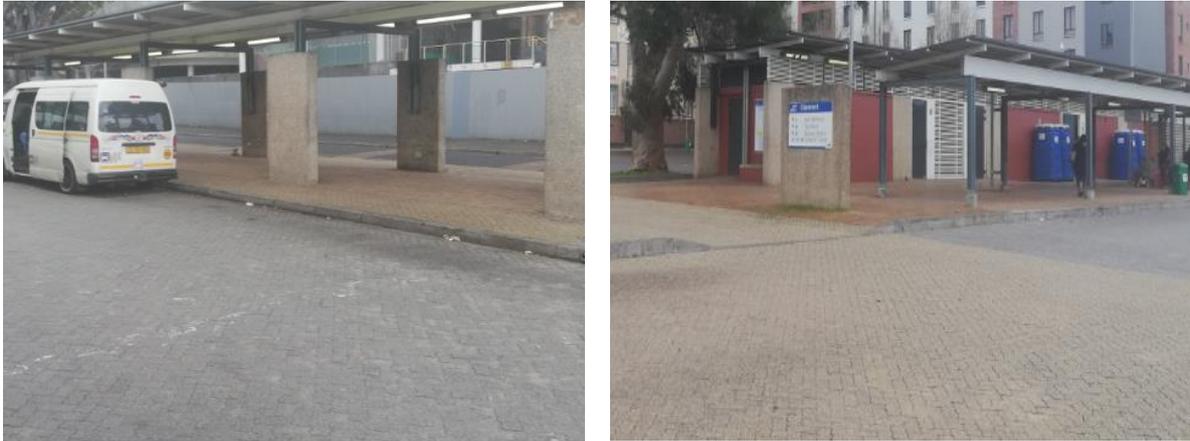
Figure 5-24: Colour paving blocks showing ROW at the Claremont PTI

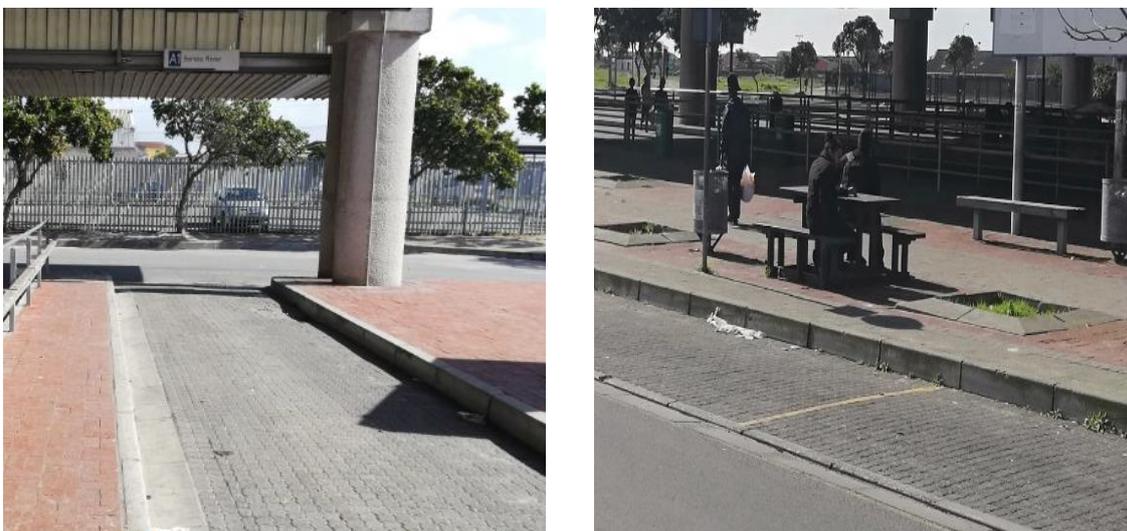
Figure 5-25: Colour paving bricks indicating ROW at the MP PTI

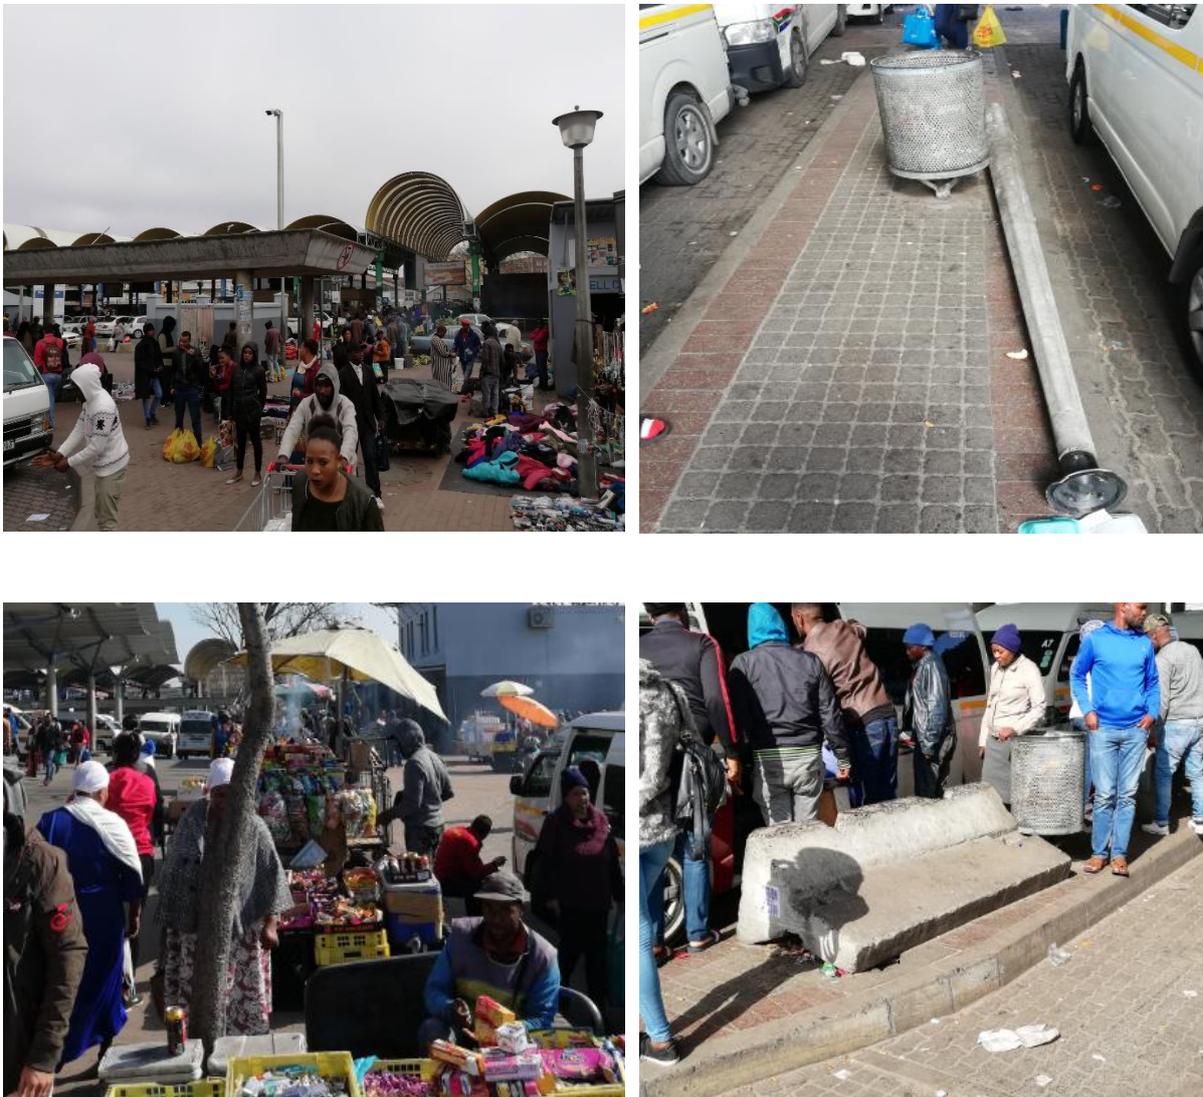
Figure 5-26: Obstructed pedestrian facility around the Bellville PTI

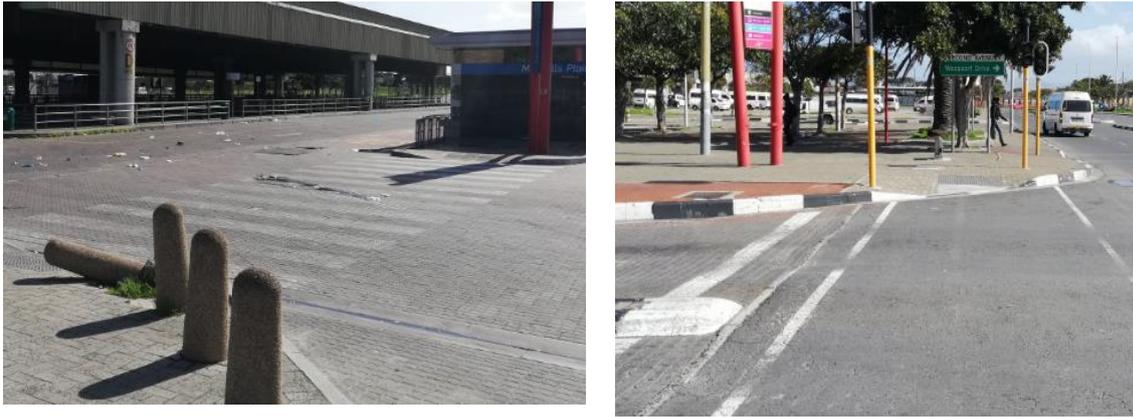
Figure 5-27: Road marking at the Bellville, Claremont and Mitchells Plain PTI's

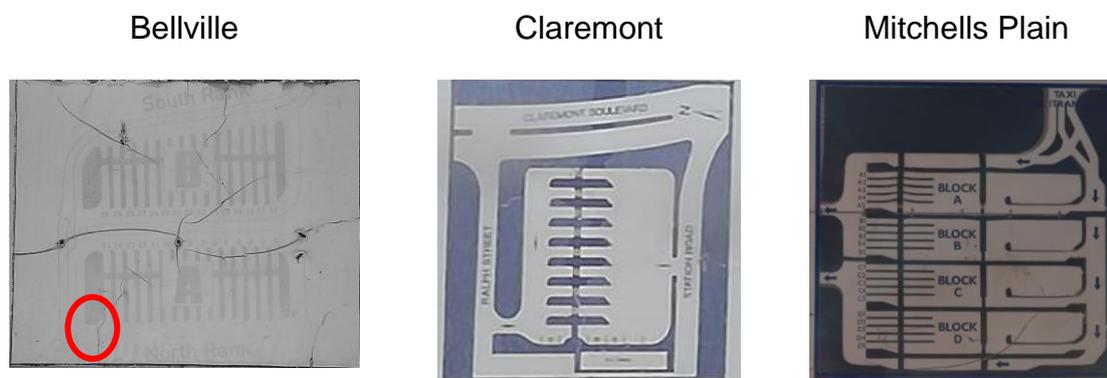
Figure 5-31: Schematic presentation of the three PTI's being investigated
