Investigation into the influence of electrode material on the IEC Inclined Plane test procedure (IEC 60587) when applied for Direct Current (DC) voltages

Thesis presented in partial fulfilment of the requirements for the degree
Master of Engineering (Electrical) in the Faculty of Engineering
at Stellenbosch University

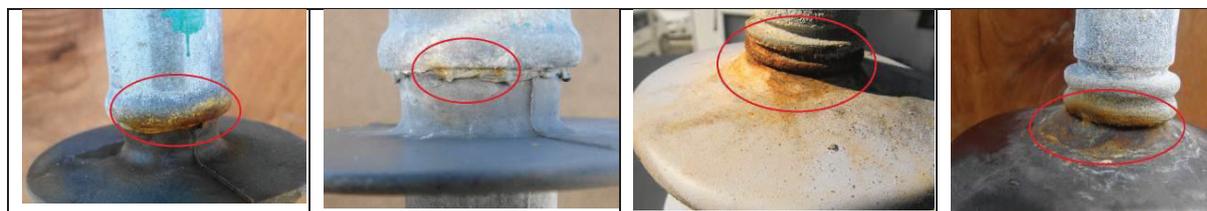
corrosion. Under DC +, corrosion was observed on the live end fitting, whereas under DC -, corrosion was noted on the ground end fitting.

Figure 2-1: Corrosion of earth end fitting under DC - energisation [21].

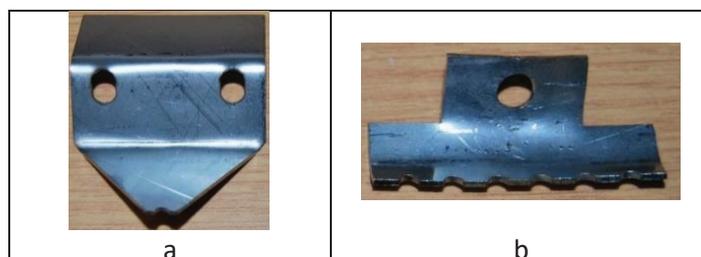
The steel electrodes, shown in Figure 3-1, were manufactured, as per the standard, from grade 302 stainless steel. They were 0.5 mm thick and weighed on average 14 and 4 grams for the top and bottom electrodes, respectively.

Figure 3-1: Stainless steel top (a) and bottom (b) electrodes.

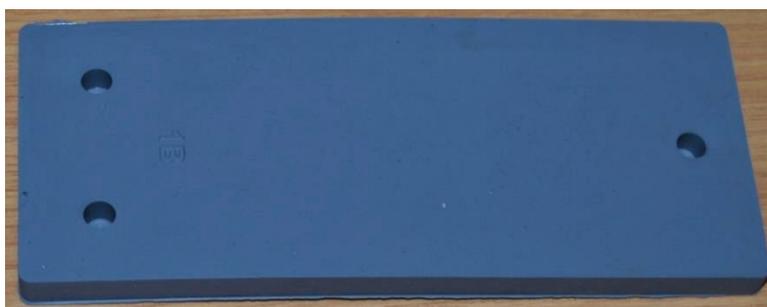
*Figure 3-3: HTV SR test sample.*

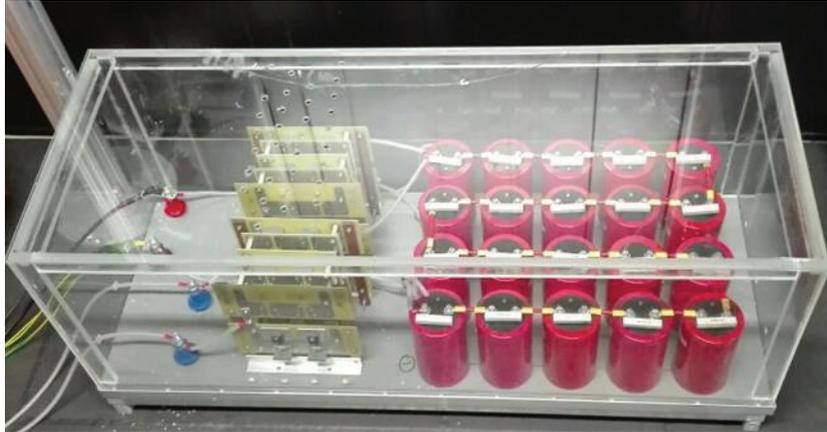
The high-voltage DC-bus capacitor C_{DC} was rated for 165 μ F, 9 kV. The capacitor consisted of twenty smaller 3300 μ F, 450 V electrolytic capacitors that were series stacked as shown in Figure 4-3 (b). To ensure that the voltage across the capacitors remains balanced, 33 k Ω resistors were placed in shunt with each capacitor. A discharge resistor R_B and discharge switch S_1 was placed in shunt with C_{DC} as a safety mechanism to discharge the capacitor when the test chamber was not in operation. The voltage measurement was taken across the DC-bus capacitor. The completed rectifier and capacitor bank is shown in Figure 4-4.

Figure 4-4: Completed DC rectifier and capacitor bank.

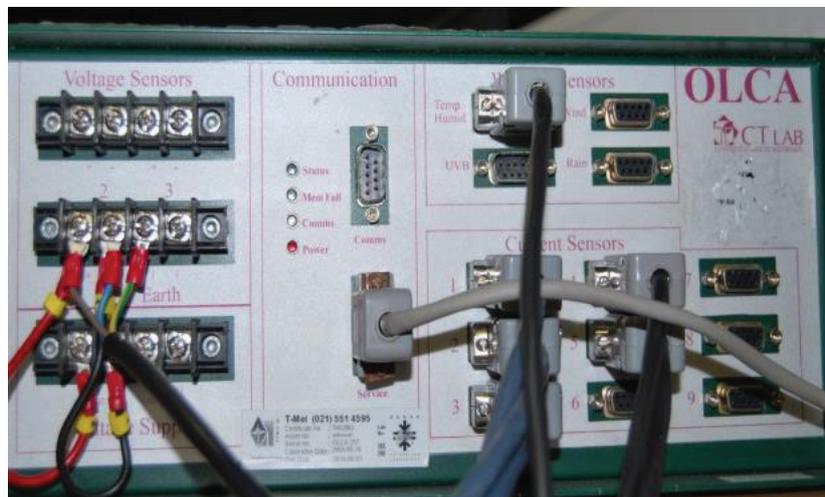
Figure 4-5: Photograph of OLCA logger.

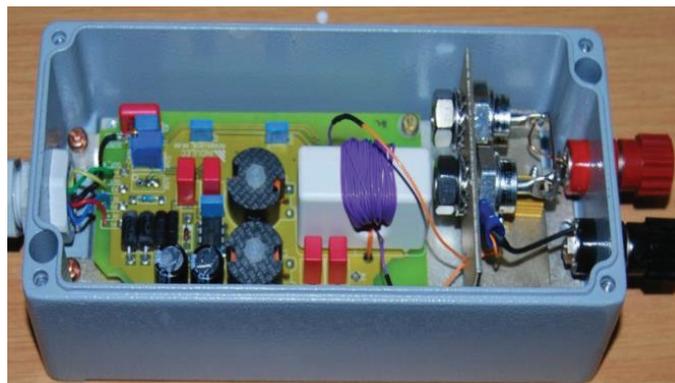
Figure 4-6: Photograph of Leakage current sensor.

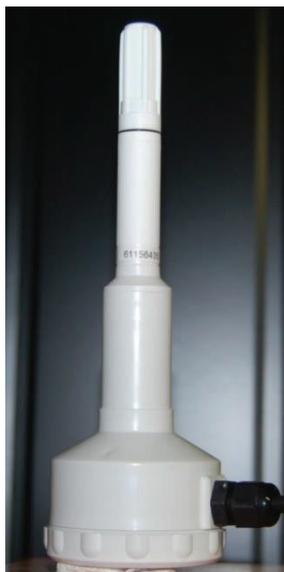
Figure 4-7: Temperature and humidity sensor.

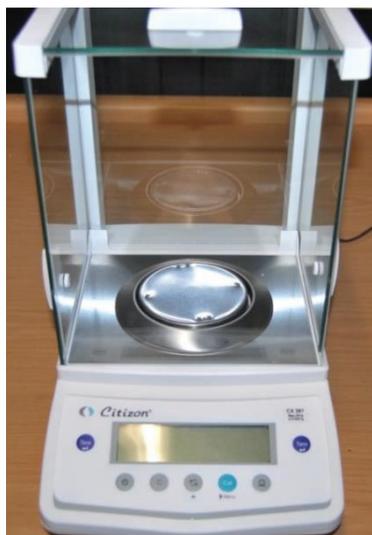
In order to measure minute weight difference pre and post-test, an accurate scale with sufficient resolution was required. A Citizen CX301 precision balance, shown in Figure 4-8, with a weight capacity of 300 grams and a resolution of 0.0001 grams, was utilised to measure the weight difference of the SR test samples as well as the steel and carbon glass electrodes, before and after each test.

Figure 4-8: Precision scale for weighing of test samples and electrodes.

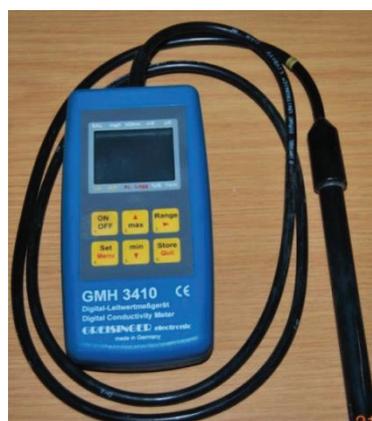
Prior to each test, the resistivity of the contaminant was checked to ensure that it conformed to the requirement of $3.95 \Omega\text{m}$ at 23°C . This was done using a Greisinger GMH 3410 digital conductivity meter, shown in Figure 4-9 below.

Figure 4-9: Conductivity meter.
