**A RIVER HEALTH ASSESSMENT OF SELECTED SOUTH-WESTERN CAPE RIVERS:
INDEX OF HABITAT INTEGRITY, WATER QUALITY AND
THE INFLUENCE OF SURROUNDING LAND USE**

Thesis presented in partial fulfilment of the requirements for the degree of
Master of Science at the University of Stellenbosch

December 2003

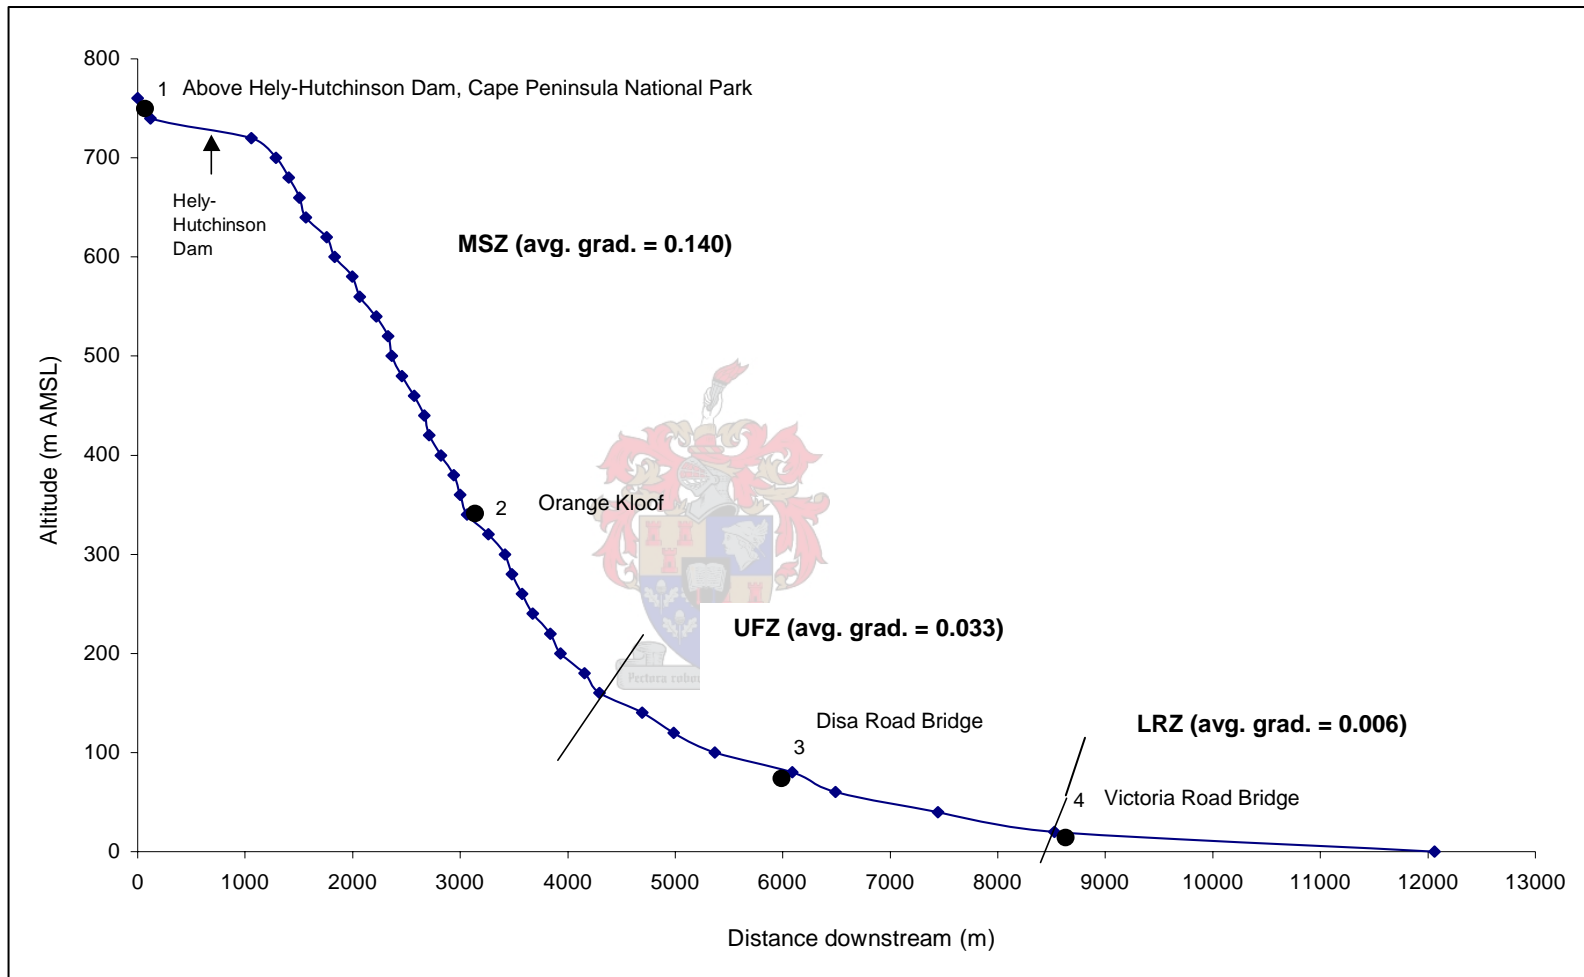
Figure 2.1. Hout Bay River Profile showing geomorphological zones (MSZ = Mountain Stream Zone, UFZ = Upper Foothill Zone, LRZ = Lowland River Zone), the average gradient (avg. grad) of each zone and sampling sites 1-4)

The gradient of the reaches in which Sites 1 and 2 are found, are 0.255 and 0.144 respectively. Although the gradient of Site 1 is 1.77 times steeper than the MSZ's gradient of 0.140, both the gradients for Sites 1 and 2 can be classified as MSZ. Both Sites 1 and 2 thus appear to be representative of the MSZ of the Hout Bay River.

Although Sites 1 and 2 are situated in the same geomorphological zone (Figure 2.1), Figures 2.2 and 2.3 together with Table 2.2, show that the physical characteristics of the two sites differ considerably. Firstly, the riparian vegetation at Site 2 consists of large Afromontane Forest trees, which is very different to the open Mountain Fynbos vegetation present at Site 1. Secondly, where waterfalls are absent at Site 1, they occur at Site 2 and thirdly, large boulders instead of the bedrock and cobbles at Site 1, dominate the substrate at Site 2. However, the characteristics of Site 2 are typical of mountain stream sites found in gorge formations (Wadson *pers. comm.* 2003a).

The middle zone of the Hout Bay River has a gradient of 0.033 (Figure 2.1) and thus, according to Table 2.1 should be classed as a Transitional Zone. However, from field visits, it was found that this

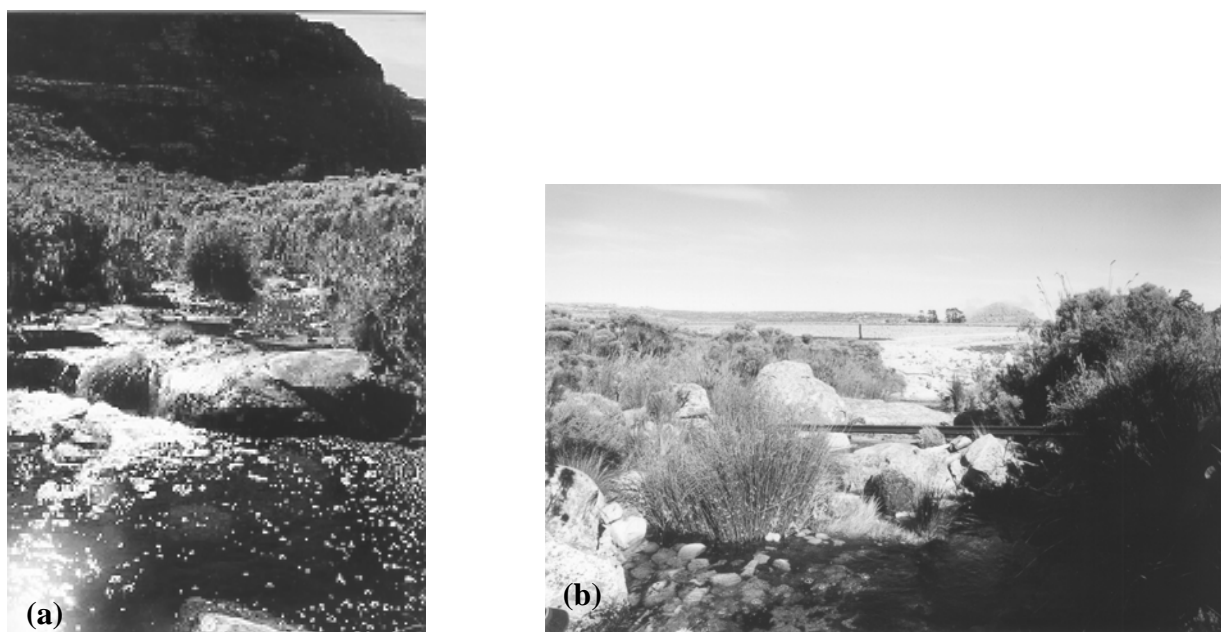
Figure 2.2. (a) Upstream and (b) downstream of Hout Bay River Site 1 (Hely-Hutchinson Dam)

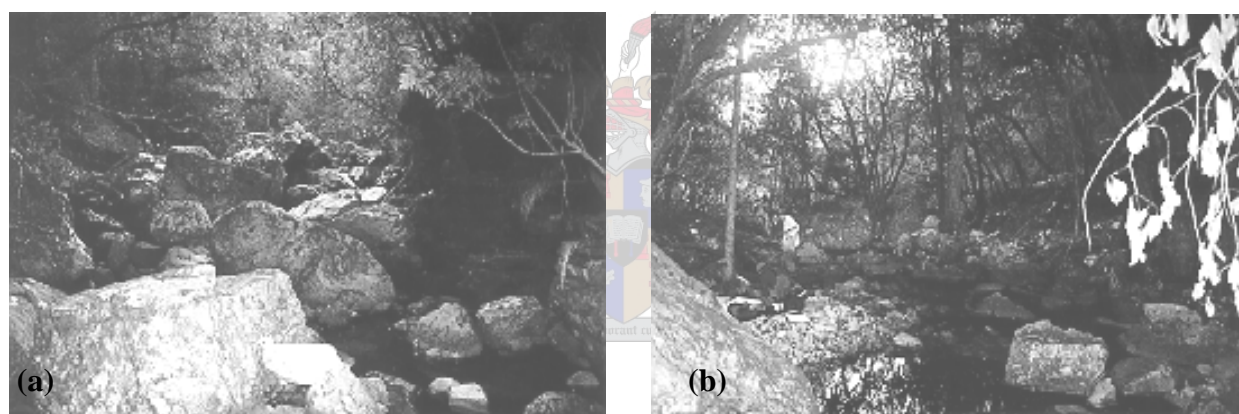
Figure 2.3. (a) Upstream and (b) downstream of Hout Bay River Site 2 (Orange Kloof)

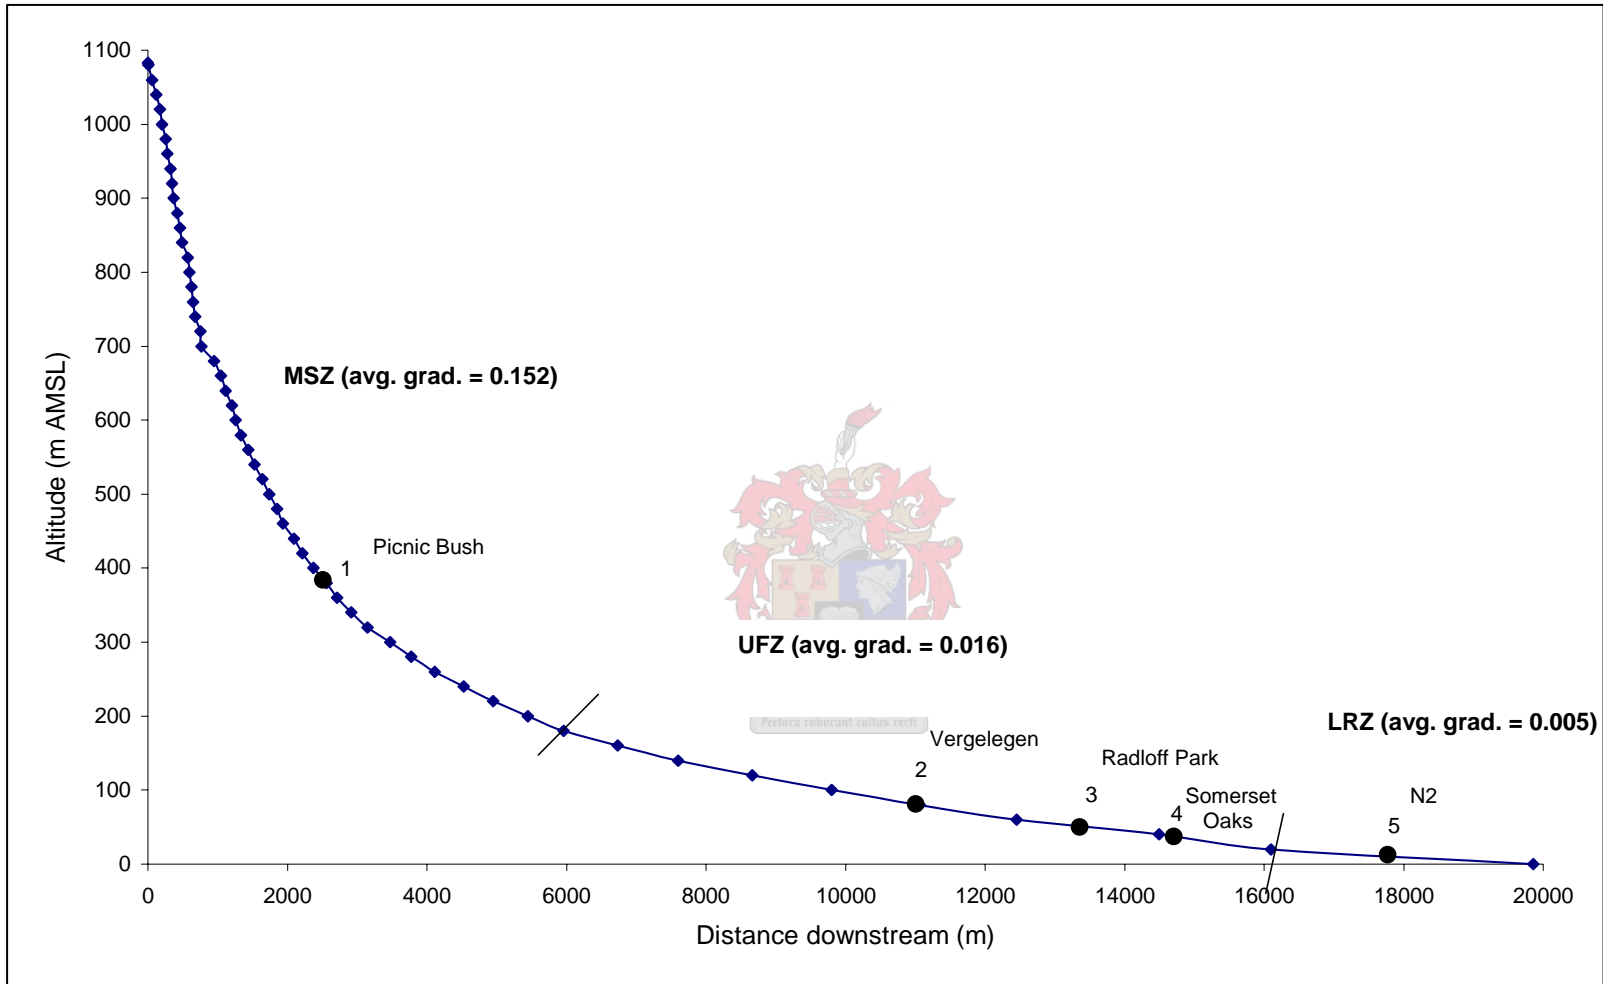
Figure 2.6. Lourens River Profile showing geomorphological zones (MSZ = Mountain Stream Zone, UFZ = Upper Foothill Zone, LRZ = Lowland River Zone), the average gradient (avg. grad.) of each zone and sampling sites 1-5)

From the initial survey it appeared that the MSZ seemed relatively unimpacted and surrounded by natural vegetation. Site 1, Picnic Bush (Figures 2.6 and 2.7, Table 2.3), was chosen to represent the MSZ because, firstly, it is the top most easily accessible point along the Lourens River. Secondly on reaching Site 1 the Lourens River has passed from its source through the Hottentots Holland Nature Reserve and into the upper regions of Lourensford Estate, where indigenous vegetation is still dominant. Therefore, up to this point the river has hardly been impacted by anthropogenic activities. Therefore, Site 1, being surrounded almost entirely by natural vegetation and being relatively unimpacted itself, was considered to be representative of the relatively unimpacted MSZ of the Lourens River.

Site 5 (N2) (Figures 2.6 and 2.11; Table 2.3) was selected as the representative site for this LRZ because: firstly, the physical characteristics of Site 5 are typical of the river in this zone, and secondly, situated below Somerset West town centre, a light industrial area and more residential suburbs, Site 5 is representative of the majority, if not all, of the impacts occurring in the LRZ of the Lourens River.

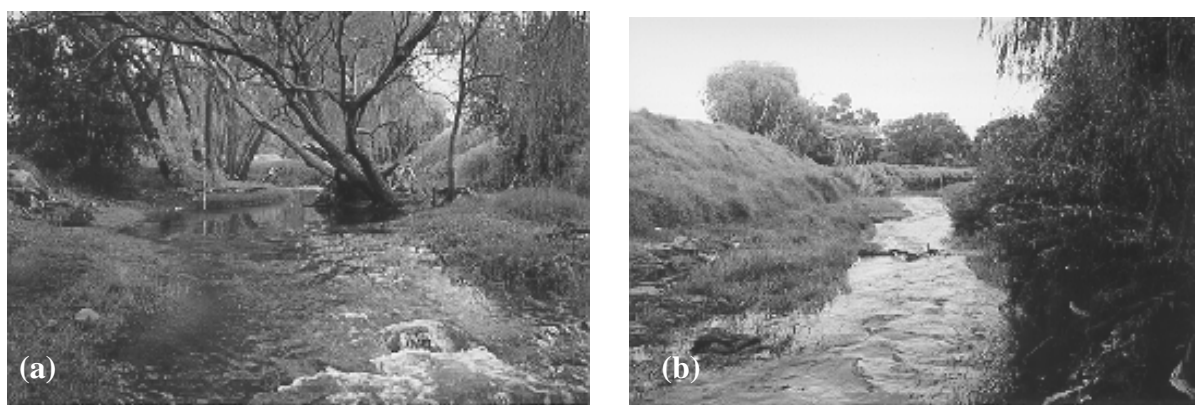
Figure 2.11. (a) Upstream and (b) downstream of Lourens River Site 5 (N2)

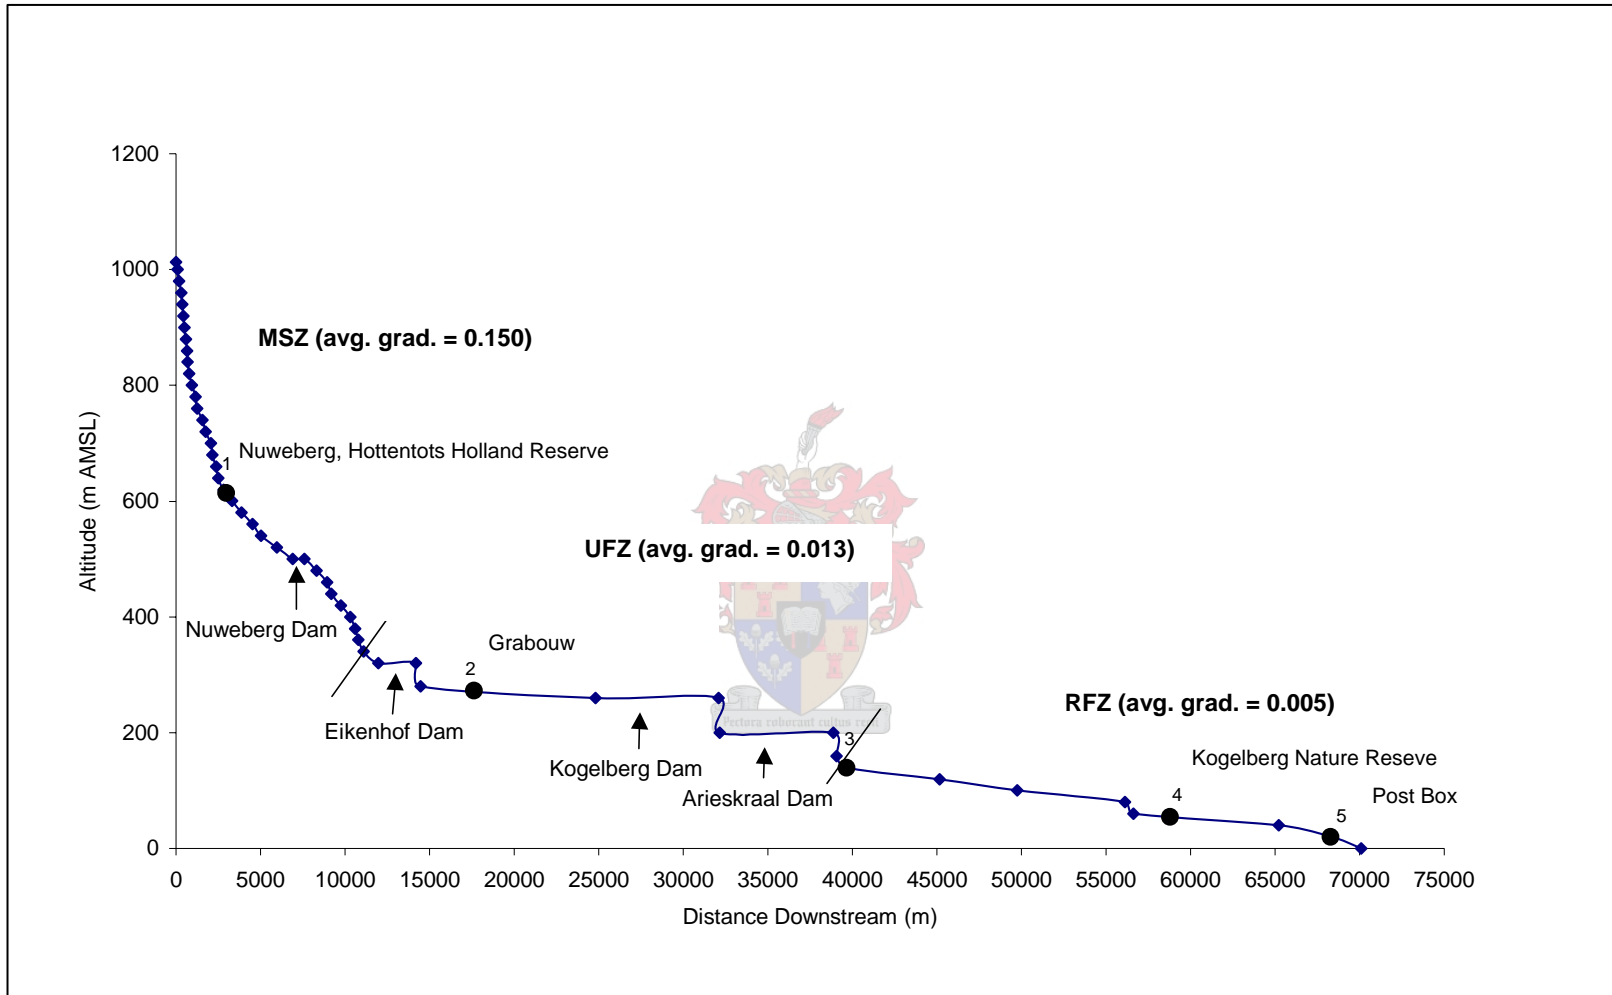
Figure 2.12. Palmiet River Profile showing geomorphological zones (MSZ = Mountain Stream Zone, UFZ = Upper Foothill Zone, RFZ = Rejuvenated Foothill Zone), the average gradient (avg. grad.) of each zone and sampling sites 1-5)

According to Chapter 1, the Palmiet River in this UFZ is impounded first by Nuweberg and Eikenhof Dams (Figure 2.12) as it passes through forestry and agricultural areas before entering the town of Grabouw. After Grabouw the river passes through more agricultural land and is impounded by the Kogelberg, Appelthwaite and Arieskraal Dams, after which it flows through more agricultural and forestry areas before entering the Kogelberg Nature Reserve.

As shown in Figure 2.12, Site 4 (Figure 2.16; Table 2.4) is situated towards the middle of the RFZ. This site was, therefore, chosen to represent the upper and middle reaches of the RFZ. Situated below the confluence of the heavily agriculturalised Krom River tributary, this site also reflects its upstream impacts on this section of the Palmiet River.

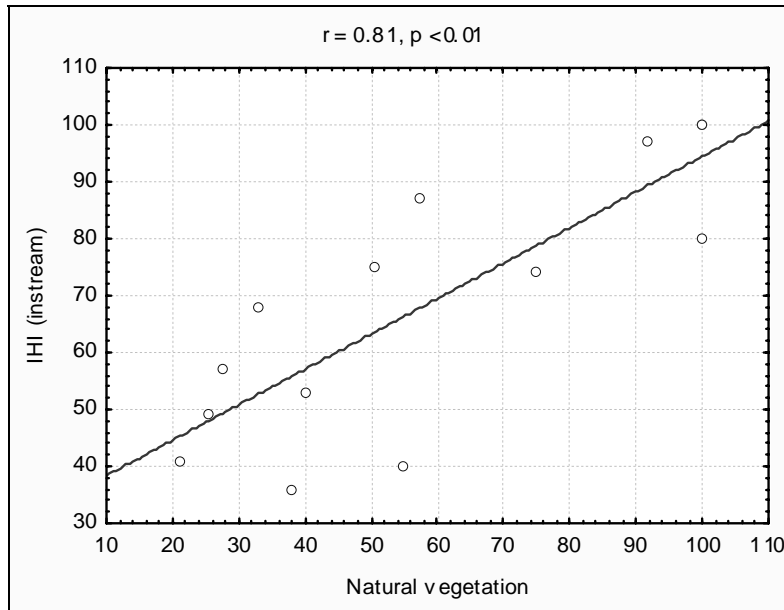
Figure 4.4. Correlation between instream habitat integrity and natural vegetation occurring at a regional scale
