**Investigation into Possible Mechanisms of Light
Pollution Flashover of 275kV Transmission Lines as
a Cause of Unknown Outages**

**Thesis presented in fulfilment of the requirements for the degree of
Master of Engineering at the University of Stellenbosch**

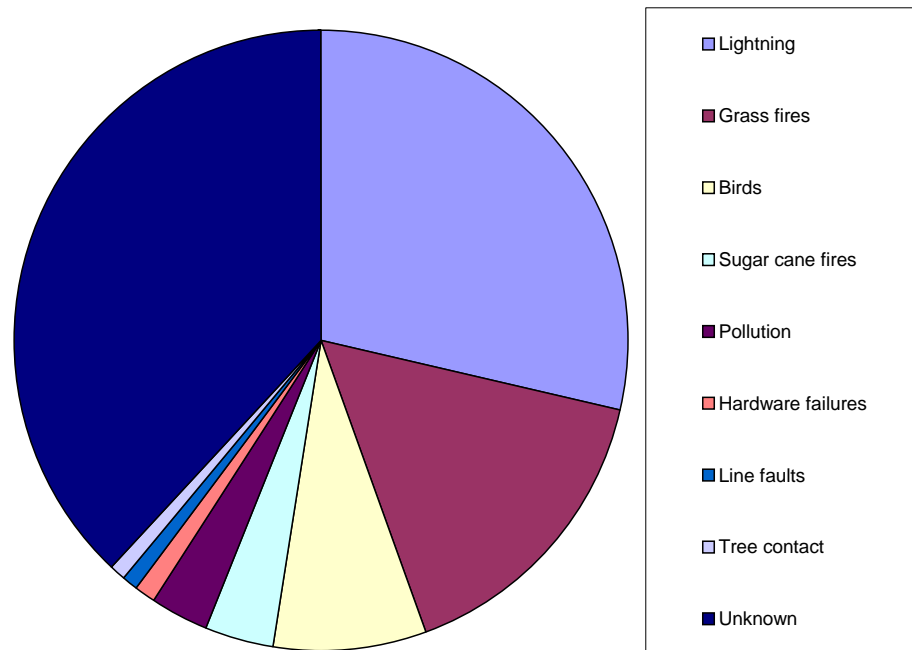
Figure 1.1: Classification of faults between 1993 & 1998 [Britten 1999]

Extensive fault statistics are kept up to date. An analysis of these statistics is given in Figure 1.1. Note that the largest number of faults on the MTS has occurred in the “unknown” category. Although some of the causes of faults in this group have since been identified, it can be stated that the reporting error here is about 10-15% of the total number of faults. This implies that the range of unknown faults is probably some 23 to 38% of the total number of faults. Lines contributing significantly to the overall number of faults arising from unknown causes have become known as “rogue” lines.

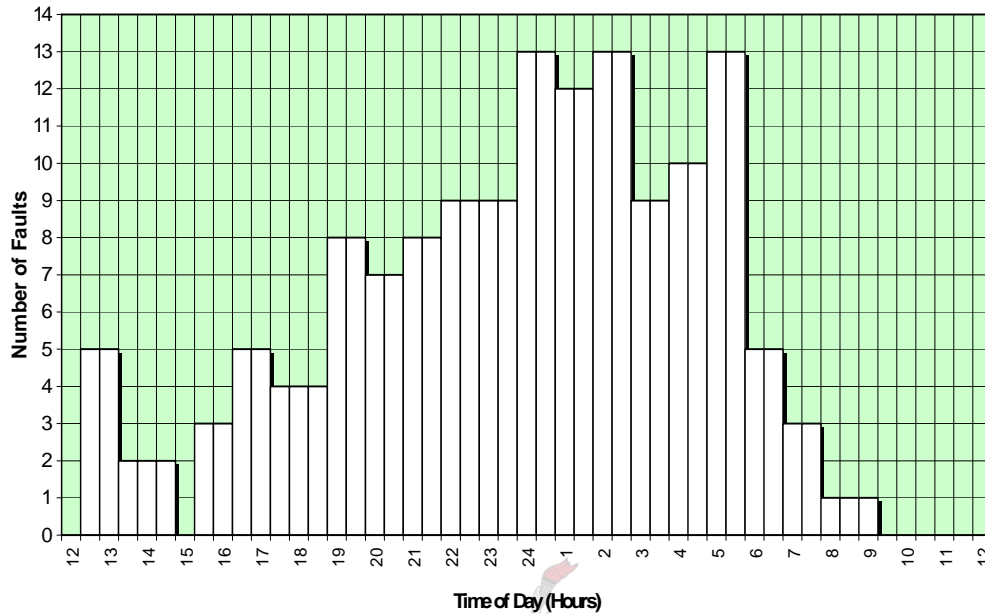
Figure 1.2: Histogram of fault times for several major rogue lines
 (Note: Sample is 143 faults from 10 lines.) [Britten 1997]

- (a) The problem lines occur in many diverse geographical areas of South Africa from dry to moist climates, near sea level to high altitude.
- (b) Some 20% of all faults (i.e. about 50% of these anomalous faults) occur between about 22:00 and 06:00. The fact that as birds are not generally active during this period, it is concluded that another factor must be responsible for these flashovers. (See figure 1.2)

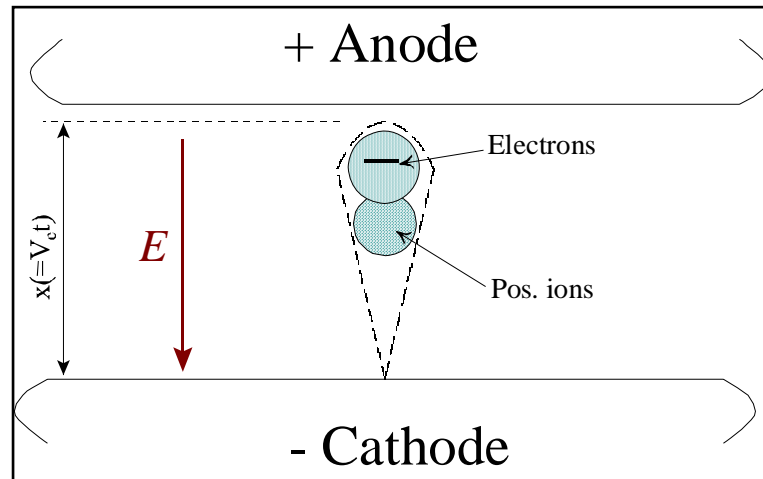
Figure 2.1: Distribution of charge carriers in an avalanche

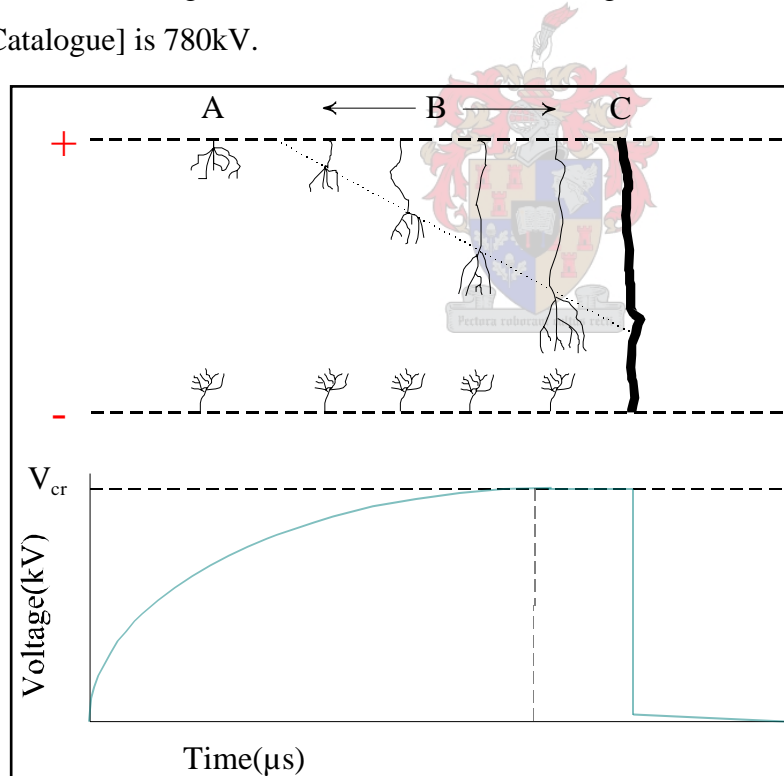
Figure 2.2: Pre-breakdown Corona and sparkover w.r.t. time [Ryan]

(A – initial streamer corona B – Leader growth phase C – Breakdown)

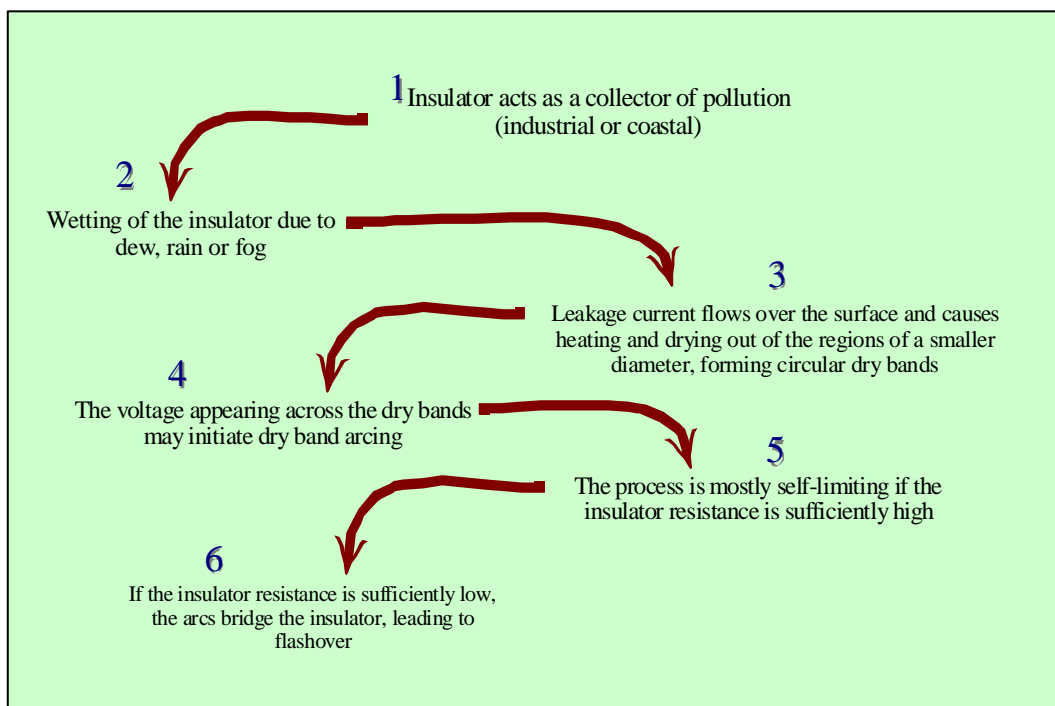
Figure 2.3: Schematic of events leading to contamination flashover [Guror]

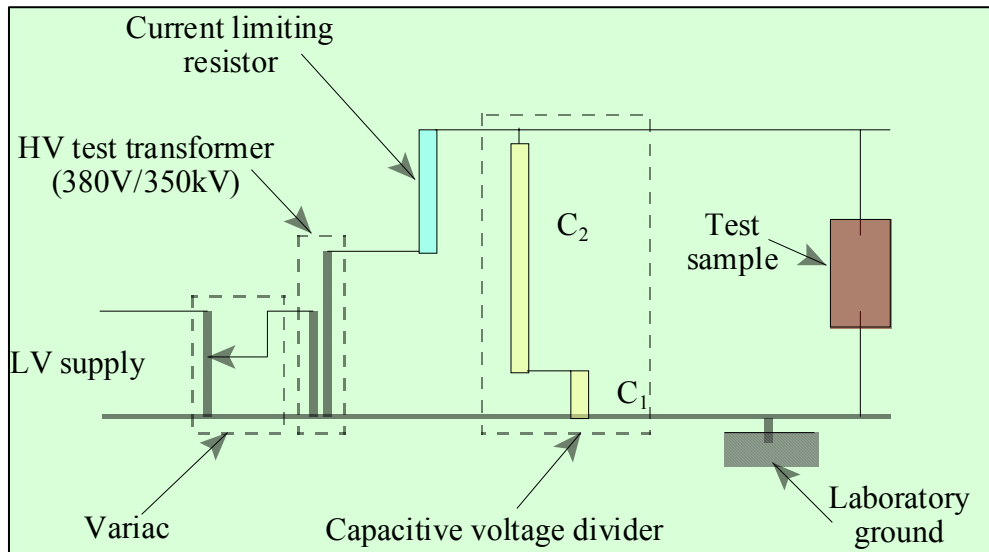
Figure 3.1: Schematic diagram showing the connection of the 350kV test transformer

The flashover tests were done by inserting the 4-disc insulator string as a test sample, as seen in Figure 3.1. The use of a 4-disc string is because of the limitation of the voltage source of the high voltage laboratory.

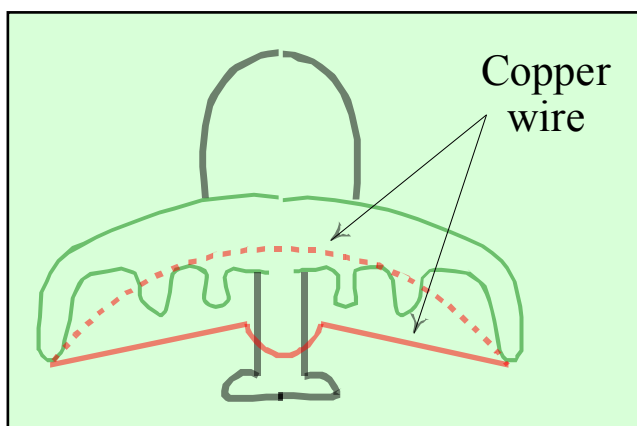
Figure 3.2: Glass insulator with copper wire wound around pin and connected to outer diameter

The fact that the bottom sides of insulator discs are more polluted than the top of the discs, as discussed in section 1.3, was simulated by shorting out the bottom of the insulator discs using copper wire as shown in Figure 3.2. The copper wire was wound around the pin and around the outer diameter of the individual insulator. This was done for a number of discs in different positions in the string.

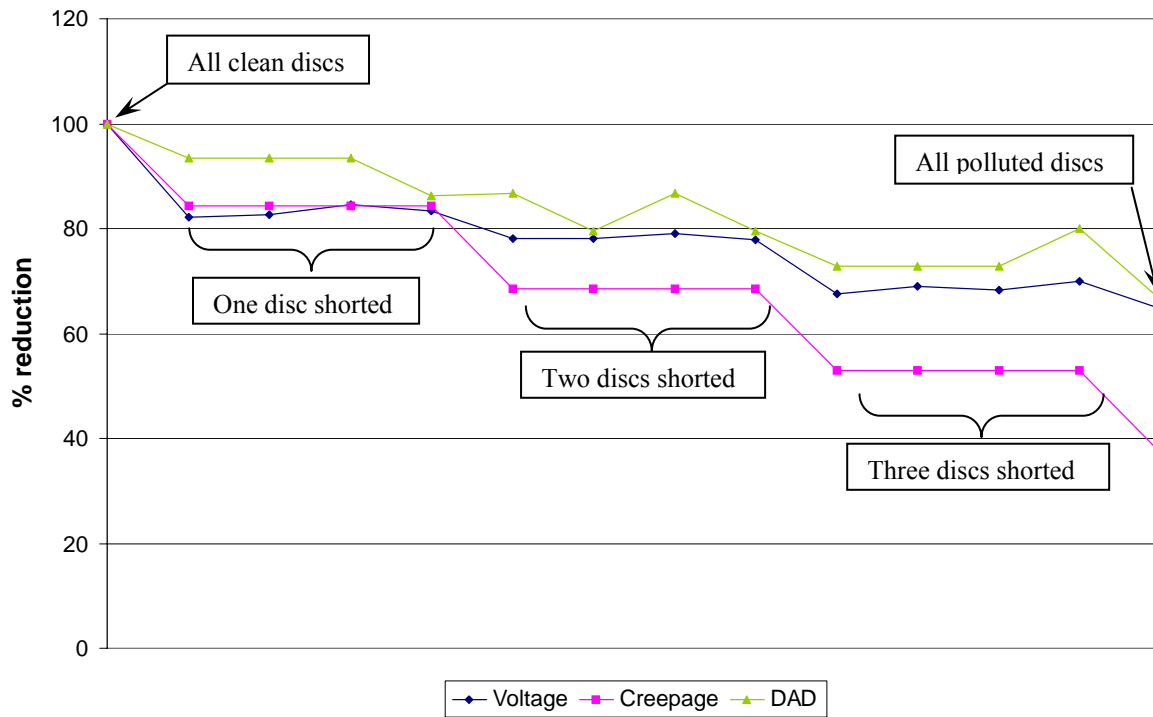
Figure 3.3: Average % reduction in creepage distance, dry arc distance (DAD) and flashover voltage for number of discs partially shorted

In Figure 3.3 the percentage reduction in flashover voltage is shown together with the percentage reduction in creepage distance and dry arcing distance (DAD) of the insulator string.

The dry-arc distance is defined as the shortest path through the air from the ground end to the live end. It will be noted that in the case of the partially shorted disc there is a correlation between the voltage reduction and the reduction in creepage distance.

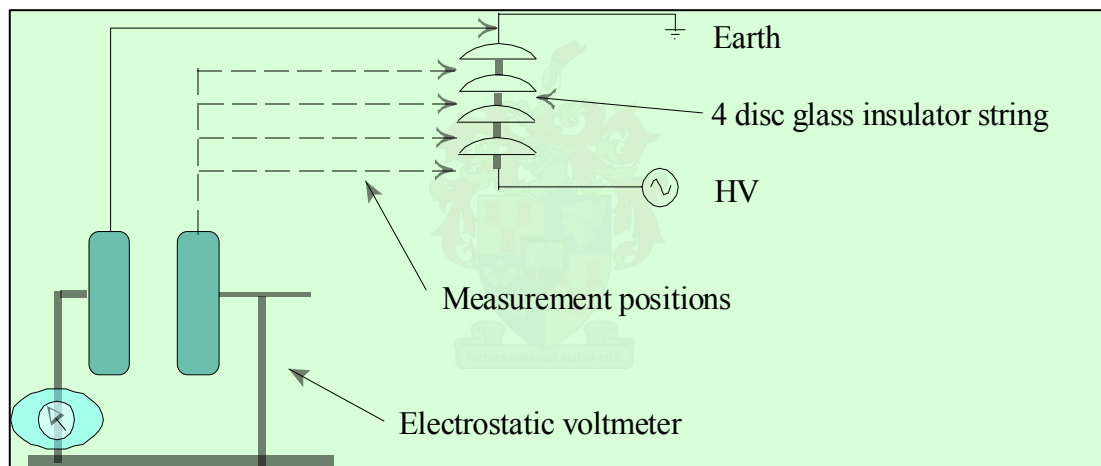
Figure 3.4: Schematic diagram of voltage measurement setup

The setup used for the voltage measurement tests is as displayed in Figure 3.4.

In the above setup, an electrostatic voltmeter (ESVM) is used to measure the voltage between each of the disc positions to ground, as illustrated in Figure 3.5. An electrostatic voltmeter was used as it has a high input impedance (small capacitance) and is assumed that the voltmeter does not affect the measurement. As in the flashover tests, some of the discs were shorted underneath using two conductive agents:

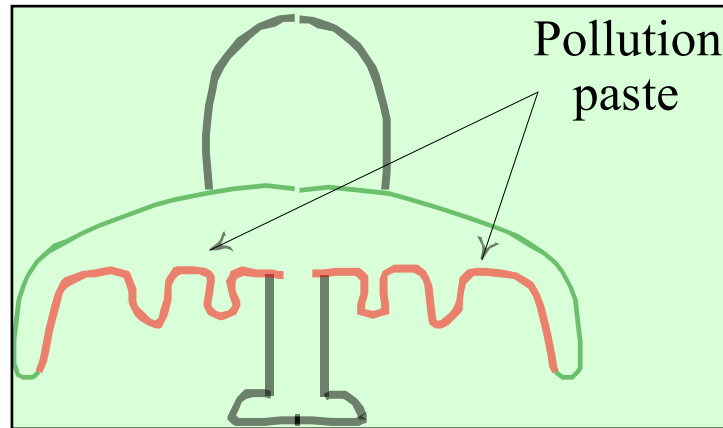
Figure 3.5: Glass insulator with pollution paste at the bottom of the disc

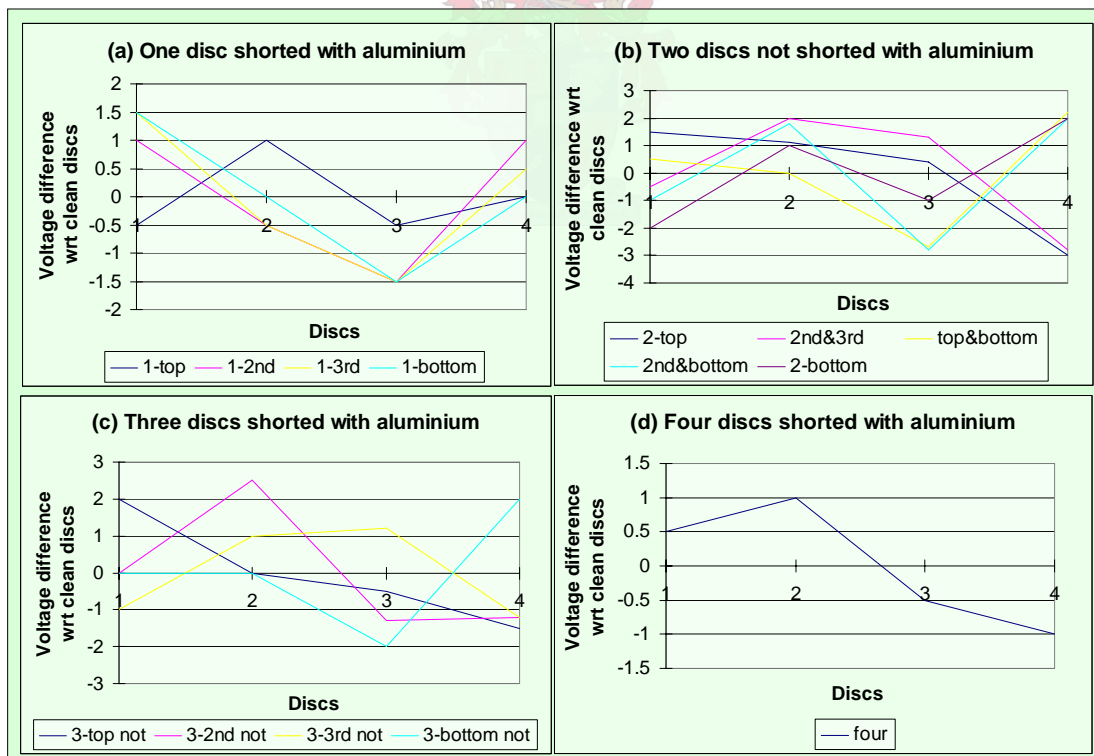
Figure 3.6: Graphs of ESVM readings with some amount of the discs shorted underneath with aluminium foil

Strips of aluminium foil were attached to the underside of the insulators, as was done with the copper wire in the flashover test (section 3.1.1). The results are represented in Figure 3.6 where the deviation of the measured values obtained on the “polluted” strings are given with respect to those of the string with clean discs.

When specific discs in the insulator string is polluted by both types of pollutants, a change in voltage across the specific discs is observed. This change is approximately not more than 4% of the total voltage across the string, and thus not very significant in terms of this experiment. This could however be different for longer insulator strings within a tower window, due to a higher applied voltage, and different electric field

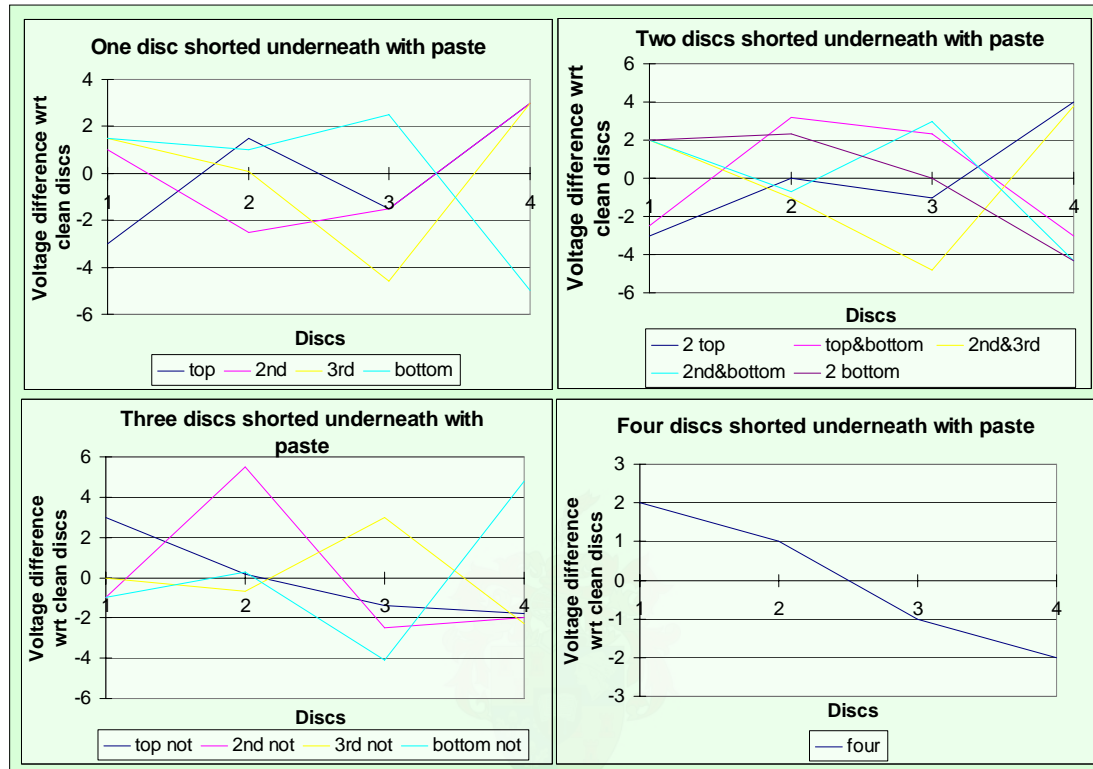
Figure 3.7: Graphs of ESVM readings with some amount of discs shorted underneath with pollution paste

A paste consisting of kaolin and salt was applied to the bottom side of the discs to represent a light pollution layer. The results of the voltage measurements in the case where the paste was used are represented in Figure 3.7.

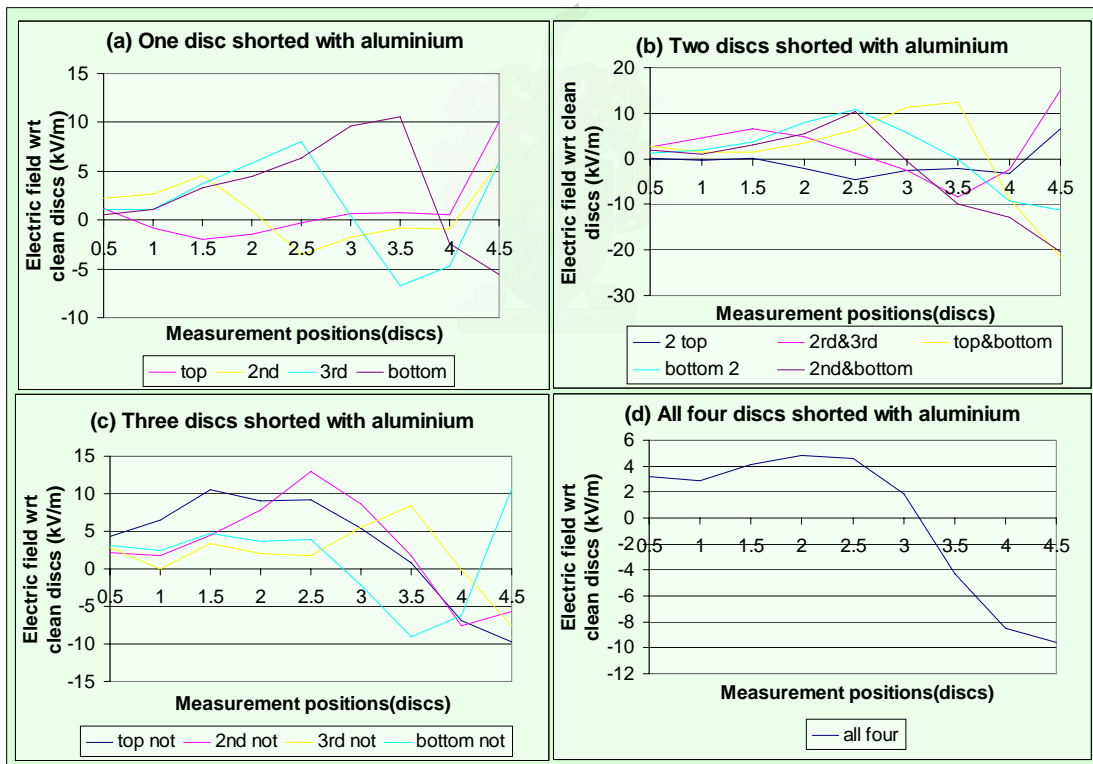
Figure 3.9: Graphs of electric field readings with some amount of discs shorted underneath with aluminium foil

electric field of a clean insulator string and polluted ones. Graphs for the electric field using aluminium foil as a conductive agent is illustrated in Figure 3.9, and pollution paste is shown in Figure 3.10.

With one disc shorted, the reduction in field strength across polluted discs is $\pm 33\%$, and the increase in field strength over the clean disc is $\pm 17\%$. The tests performed with two discs shorted indicates a reduction of $\pm 66\%$ in field strength across discs with pollution present, and an increase across the clean discs of $\pm 33\%$. Having three discs shorted produced reduction of $\pm 33\%$ across polluted insulators, and an increase of $\pm 33\%$ across the clean discs is observed. With all four discs polluted, the field strength distribution has less deviation from the values of the clean insulator string.

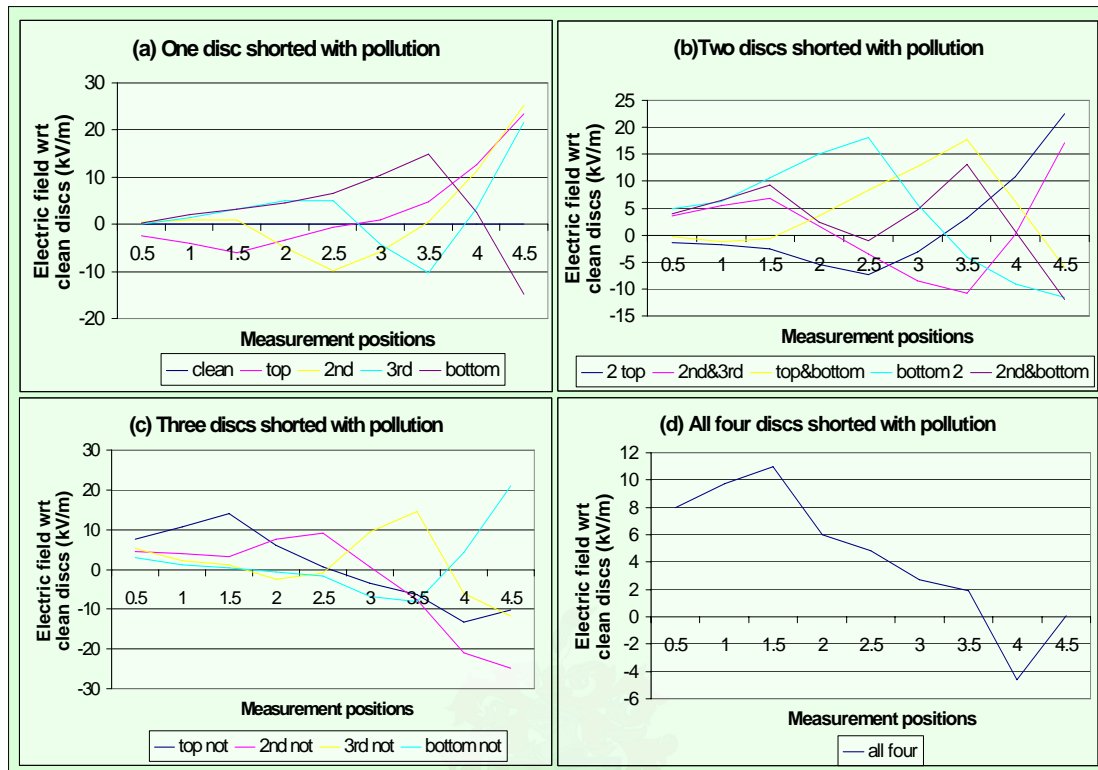
Figure 3.10: Graphs of electric field readings with some amount of discs shorted underneath with pollution paste

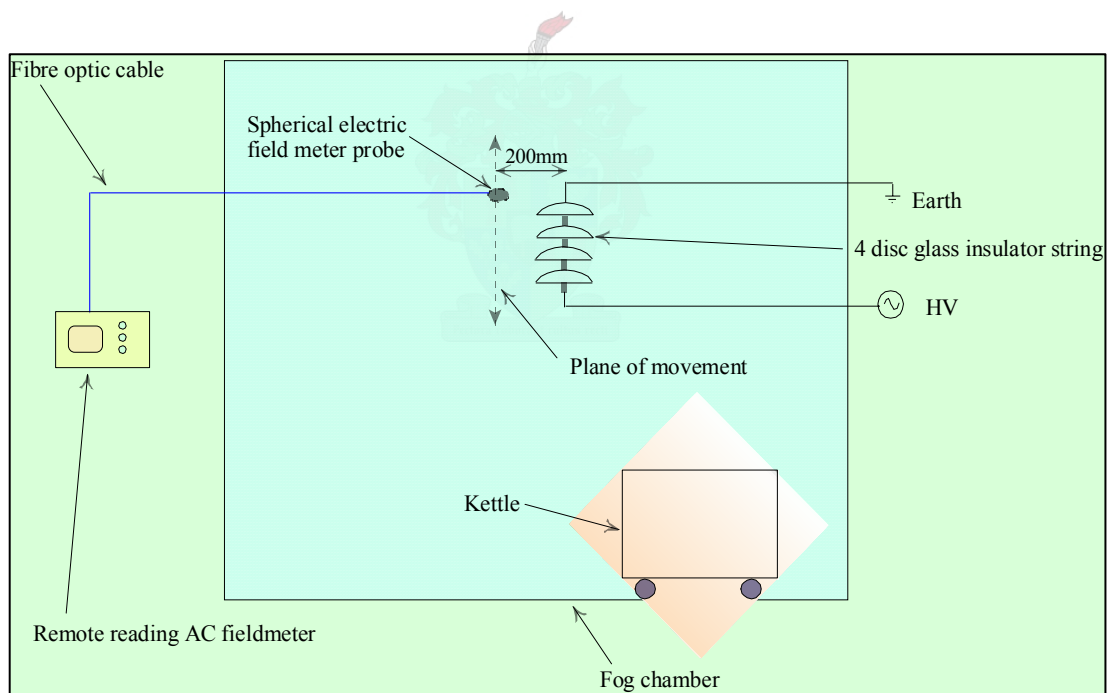
Figure 3.11: Schematic diagram of fog chamber setup

The spherical probe was protected from excessive exposure to humidity by covering it with a Latex covering, which would keep it water tight, yet have no adverse effect on the electric field measurements.

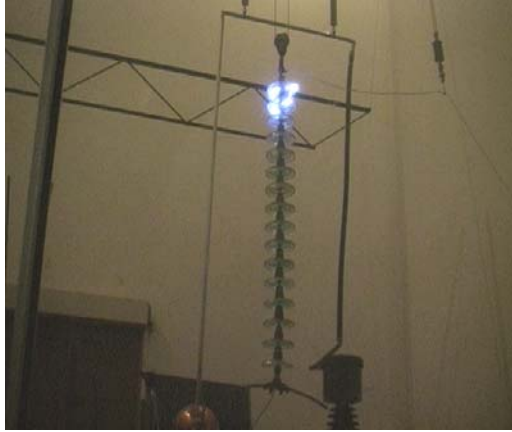
Figure 3.12: Local flashover across the two clean discs at the dead end.

For the flashover tests, the supply voltage was slowly increased until local flashover occurred across the two clean discs.

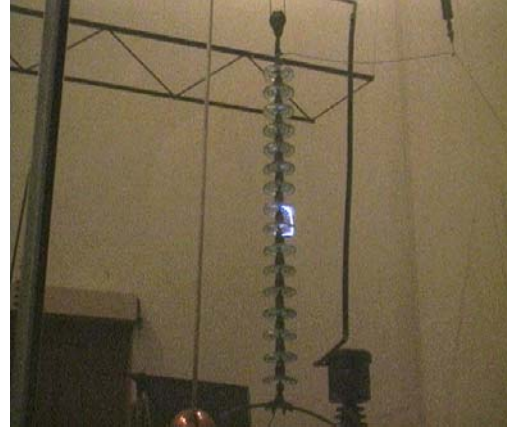
Figure 3.13: Local flashover across the two clean discs in the middle

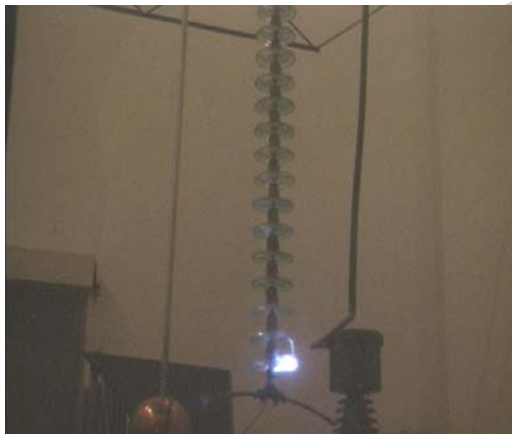
Figure 3.14: Local flashover across the two clean discs at the live end.

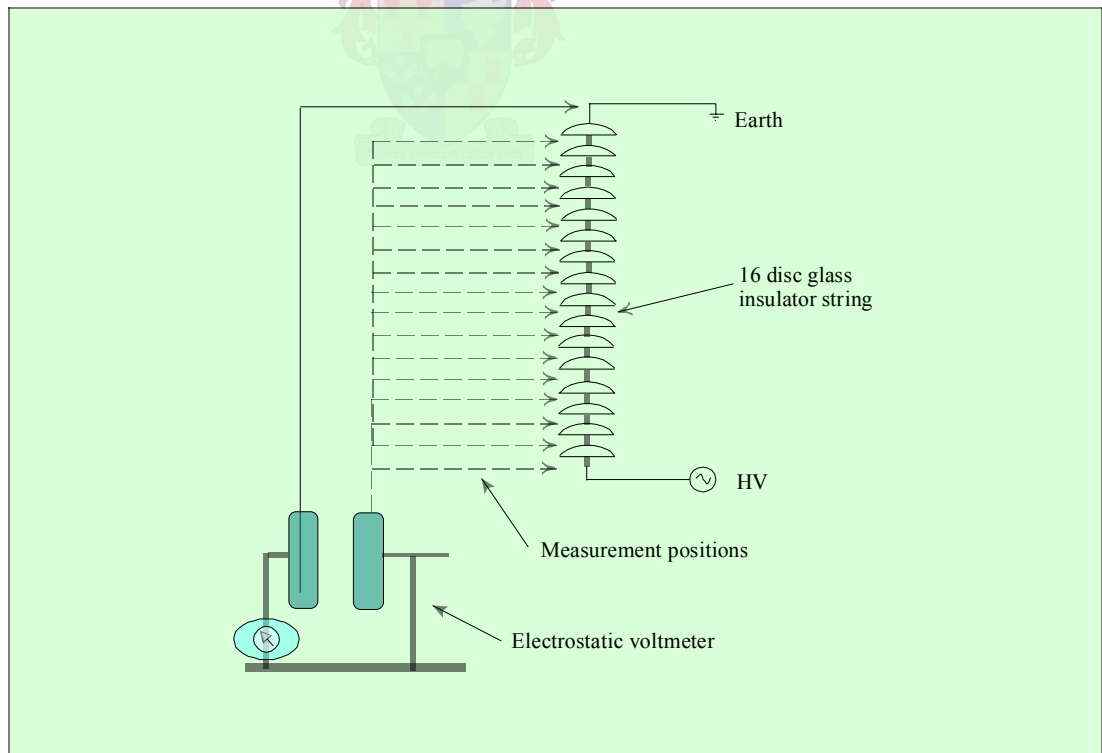
Figure 3.15: Schematic diagram of voltage measurement along insulator string

- i. The voltage across the insulator string was measured using an electrostatic voltmeter, having an input capacitance that was considered negligible compared to that of a single disc. The setup for this test is illustrated in Figure 3.15.

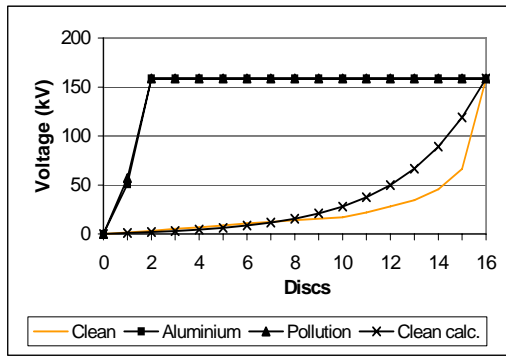
Figure 3.17: Voltage distribution over the insulator string with the clean discs at the dead end (disc 1 is at the dead end)

- a. For the two clean discs inserted at the dead end (top), the voltage and electric field measurements are shown in Figures 3.17 and 3.18.

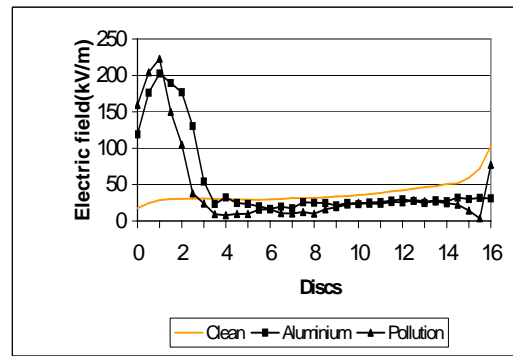
Figure 3.18: Electric field along the insulator string with the clean discs at the dead end (disc 1 is at the dead end)

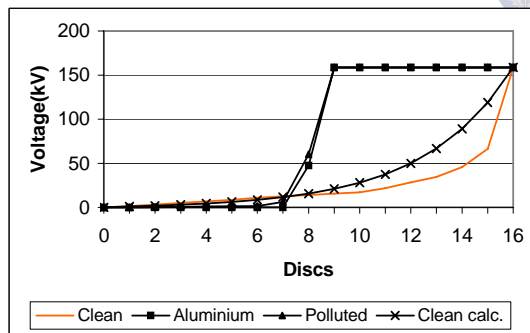
Figure 3.19: Voltage distribution over the insulator string with the clean discs in the middle (disc 1 is at the dead end)

- b. Next, the two clean insulator discs were shifted from the grounded end to the middle of the insulator string. Here, too, the voltage to ground across each insulator was measured, as well as the electric field strength around the string. These are illustrated by Figures 3.19 and 3.20.

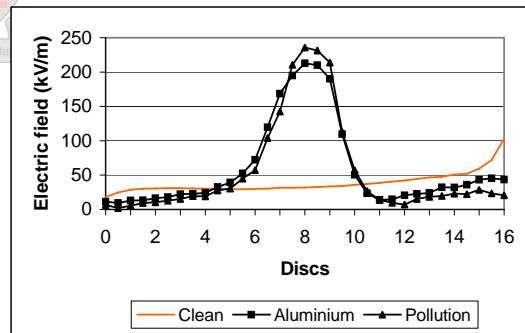
Figure 3.20: Electric field along the insulator string with the clean discs in the middle (disc 1 is at the dead end)

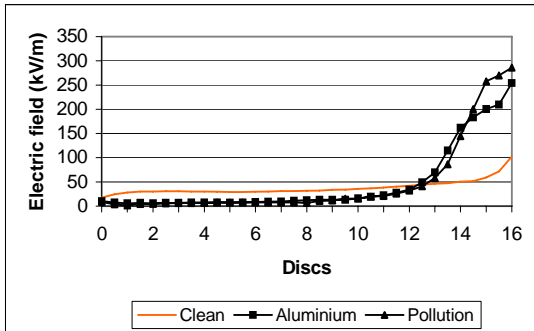
Figure 3.21: Voltage distribution over the insulator string with the clean discs at the live end of the insulator string (disc 1 is at the dead end)

measurements were obtained. These results were obtained and are shown in Figures 3.21 and 3.22.

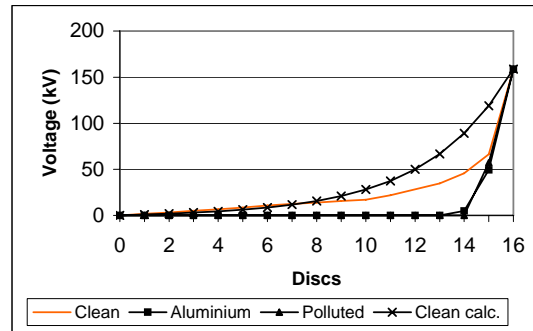
Figure 3.22: Electric field along the insulator string with the clean disc at the live end of the insulator string (disc 1 is at the dead end)

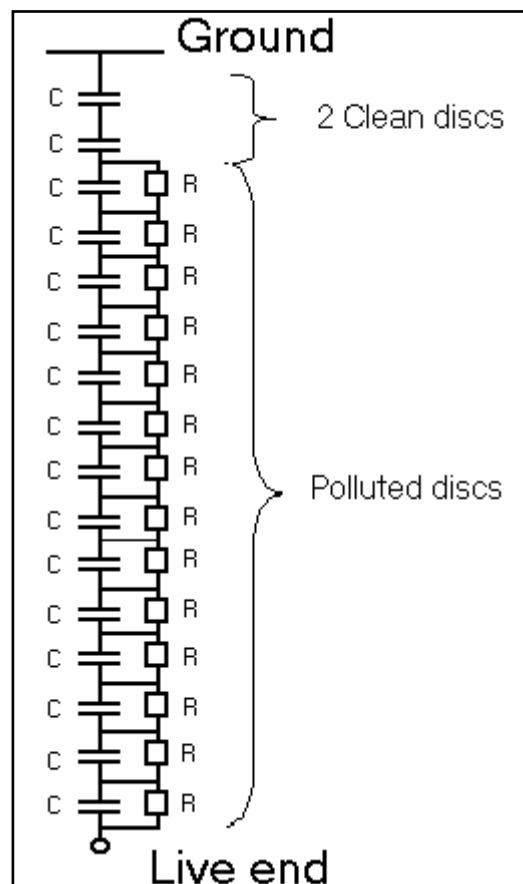
Figure 3.23: Equivalent diagram for 16-disc insulator string with the clean discs at the ground end

The measured voltage and electric field distribution across the 16-disc insulator string clearly indicates that field enhancement occurs across the two clean discs. This is to be expected as the pollution layer in fact “applies” the full voltage across the two clean discs. In each of the three cases considered, the flashover voltage across the two discs is 159 kV. As the dry power frequency flashover voltage of a single disc of the type used here is 72 kV, it is obvious that the two discs will flash over. This was

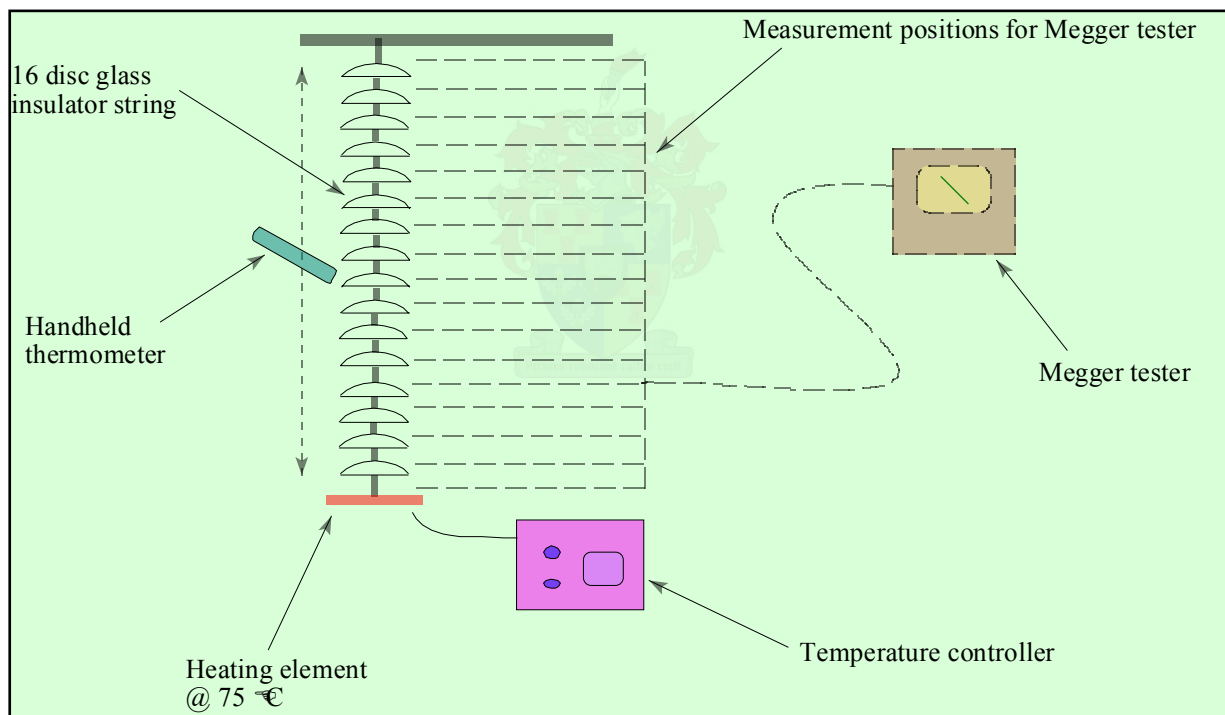
Figure 3.24: Experimental setup of temperature and resistance readings

The experimental setup is shown in Figure 3.24.

Resistance measurements were taken concurrently with the temperature readings, as illustrated in Figure 3.24. These measurements were taken using a Megger and measuring across the individual glass discs in the insulator string. The results of the measurements are shown in Figure 3.27.

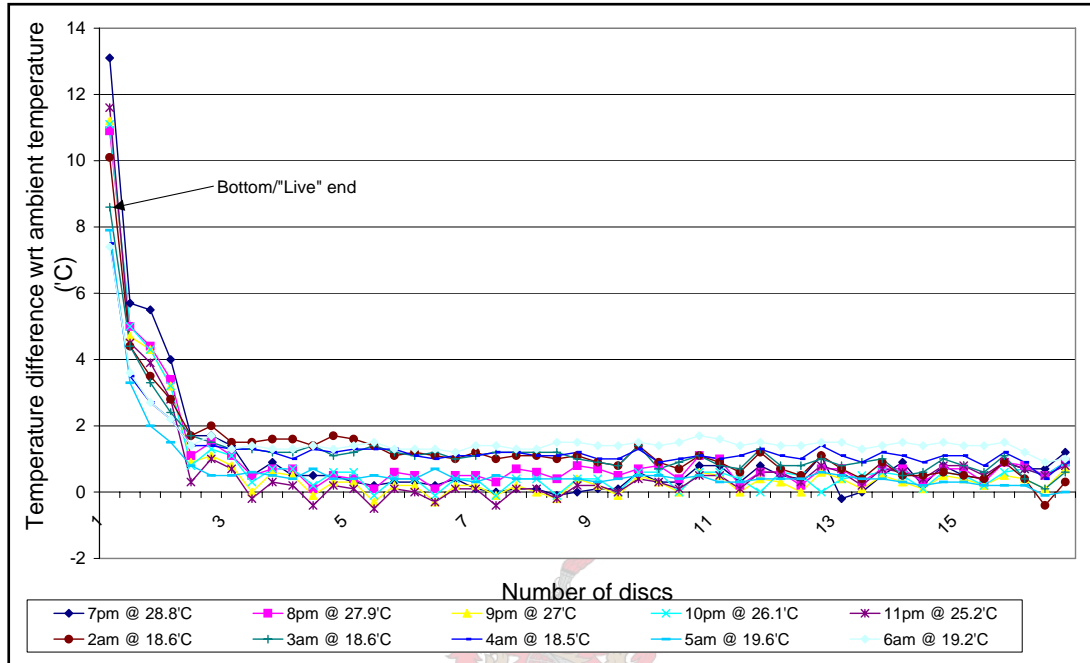
Figure 3.25: Temperature readings with conductor at 75°C

The results of the tests are shown in Figures 3.25 and 3.26.

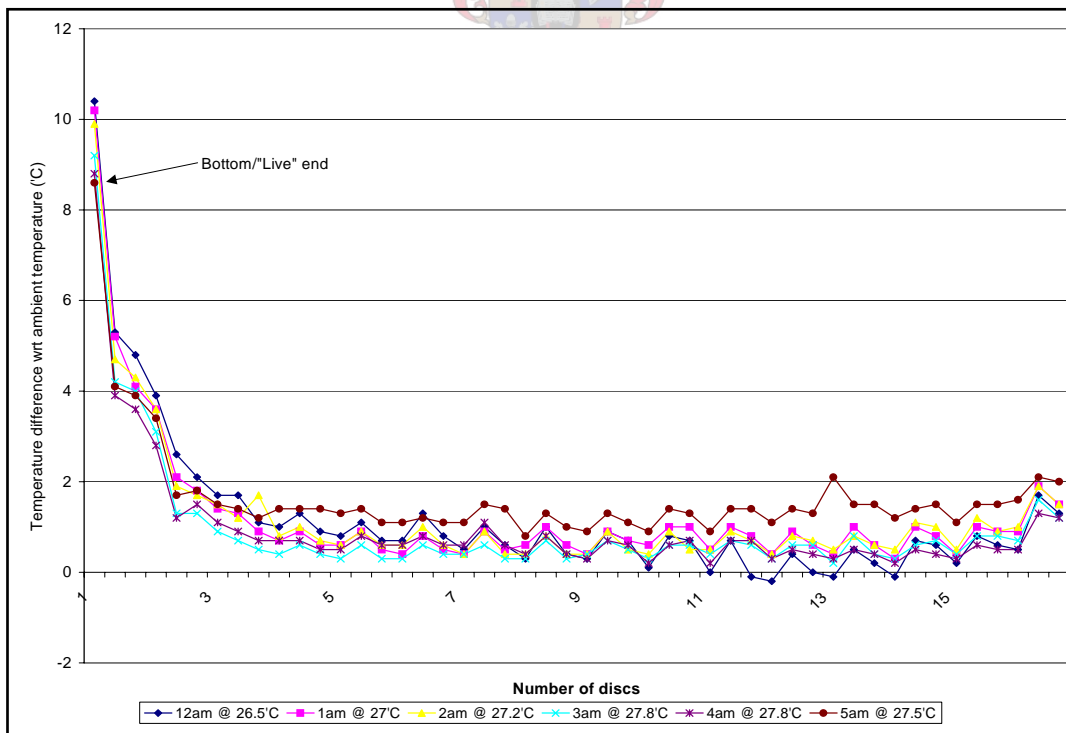
Figure 3.26: Temperature readings with conductor at 60°C

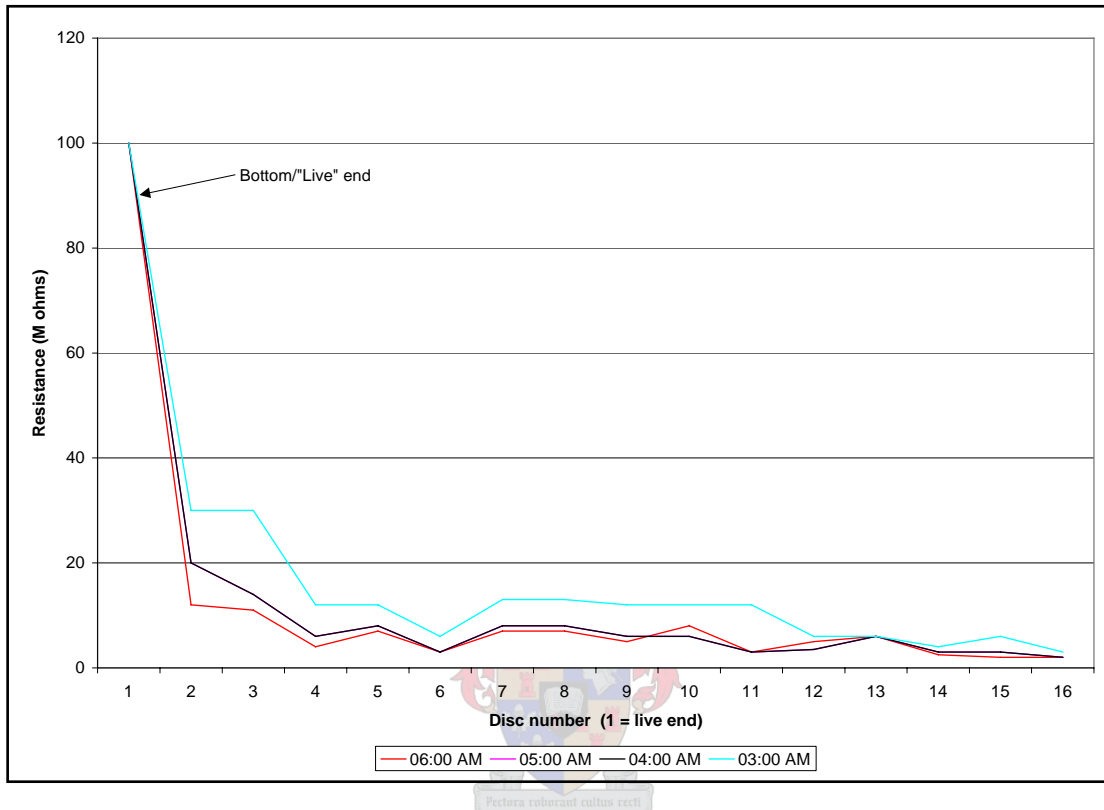
Figure 3.27: Resistance measurements with conductor at 75°C

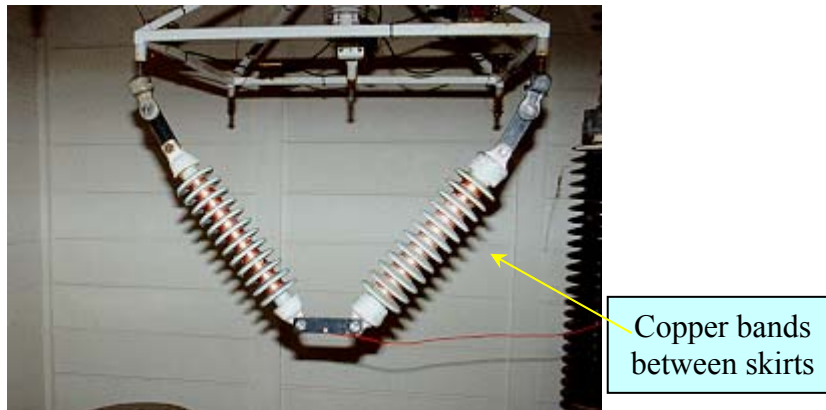
Figure 3.28: Experimental setup of the 25kV traction insulators

As it was quite difficult performing tests on a 32-disc V-string insulator, it was decided to construct a small-scale model of the insulator. This was achieved by using two 25kV traction insulators, and coupling it in the shape of a typical V-string insulator, as shown in Figure 3.28 below. The caps and pins of a normal glass insulator string were simulated using copper bands.

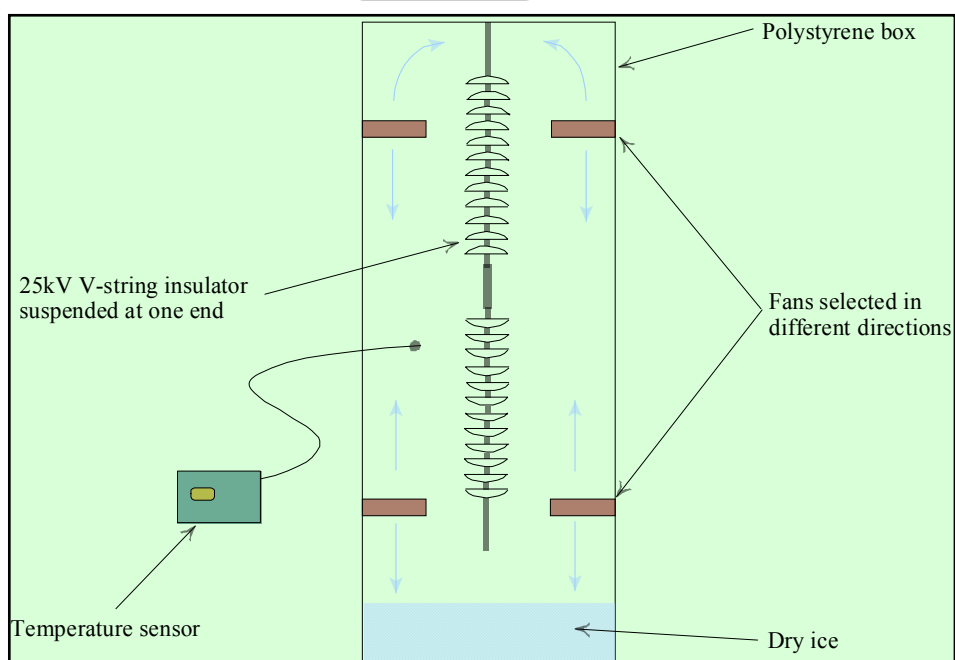
Figure 3.29: Experimental setup of the dry-ice chamber

Using this theory, a dry-ice chamber was constructed as shown in Figure 3.29. Dry ice was deposited at the bottom of the chamber, and air was circulated via four fans. Regular temperature readings were taken to ensure the air in the chamber was sufficiently regulated to a value well below that of the dew point temperature.

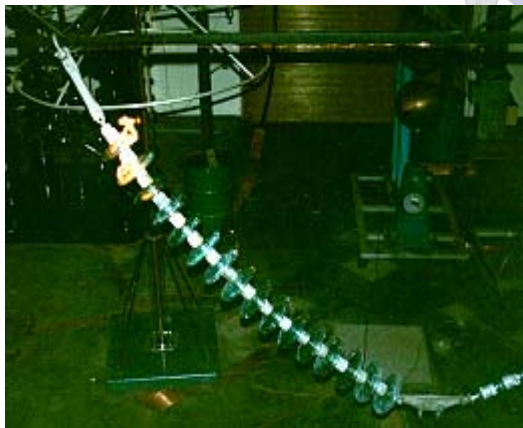
Figure 3.30: Arc initialisation

The supply voltage was then slowly increased until local flashover occurred across the two clean discs. From the resultant arc (Figures 3.30 & 3.31) it was observed how convection “pushed” the arc upwards towards the top earth plane.

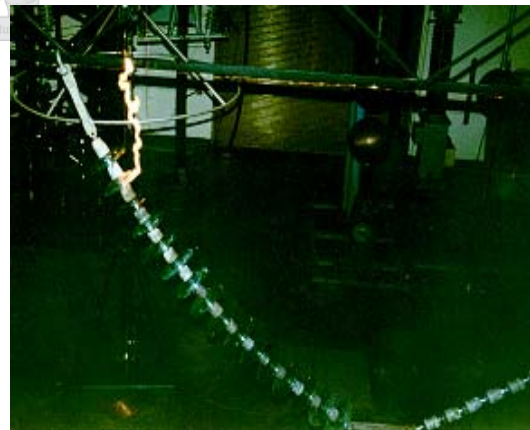
Figure 3.31: Convection of arc

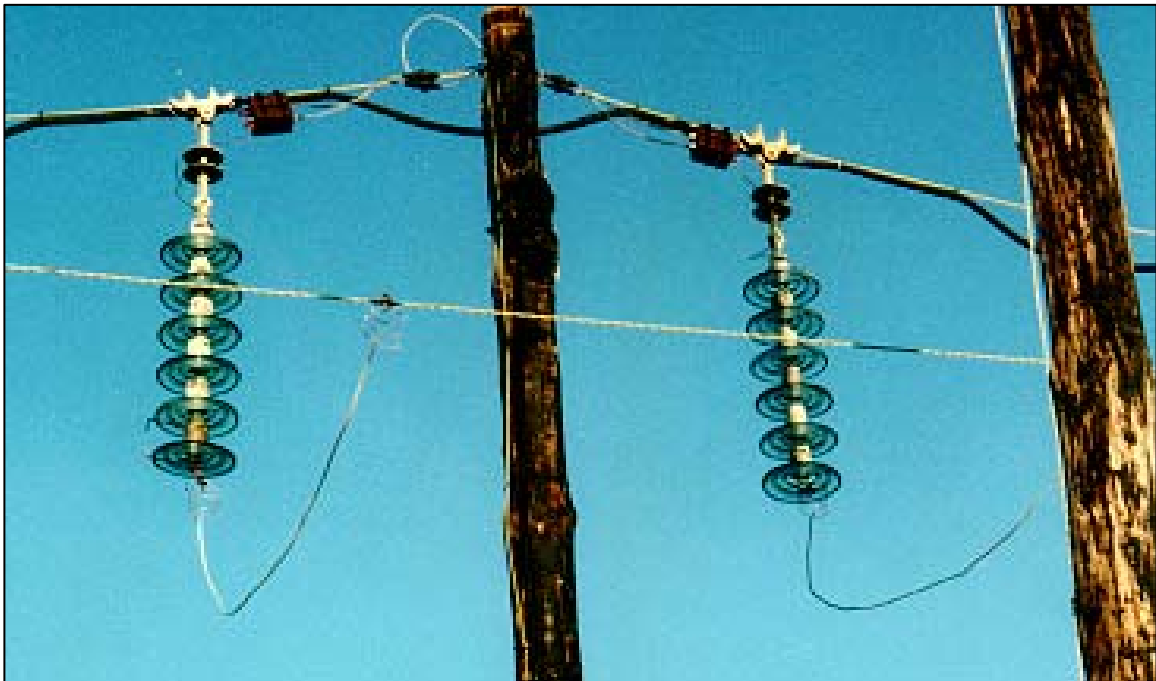
Figure 4.2: Actual setup at KIPTS

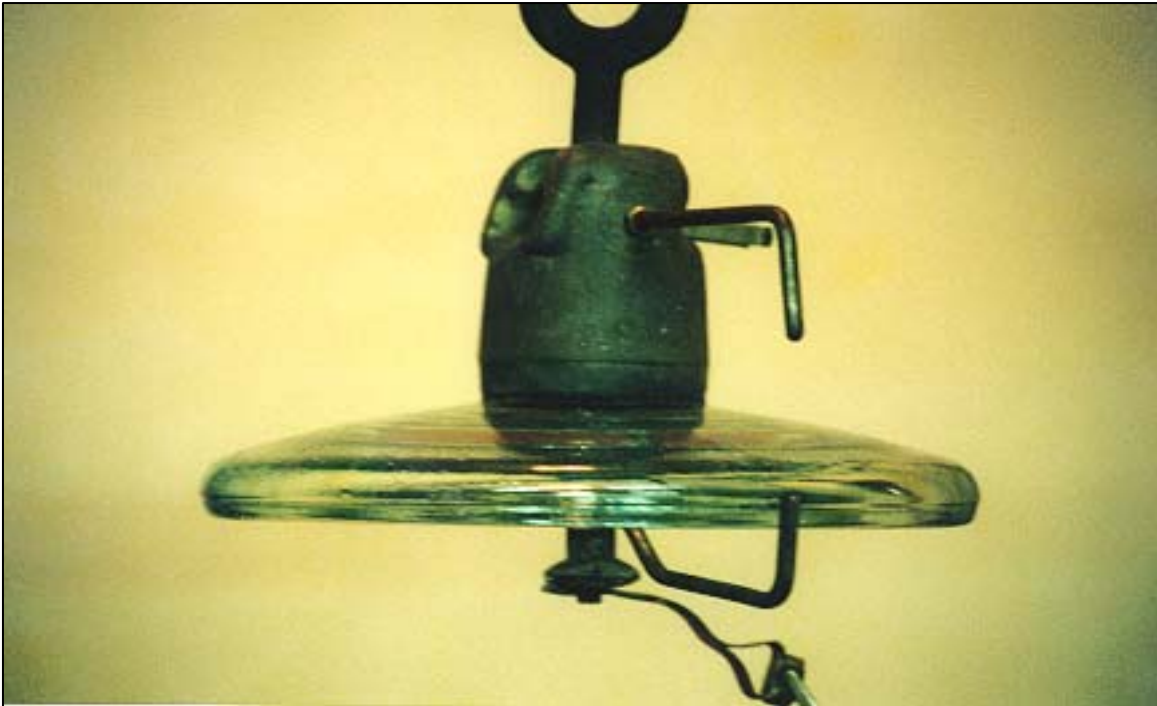
Figure 4.3: Spark gap used in experiment

The configuration in string B is implemented by applying silicone grease on the disc at the live end and by fitting a spark gap across this last disc (Figure 4.3). The gap was set to flash over at a voltage of 32 kV, to ensure that it would flash over when 80% of the phase to ground voltage appears across the gap.

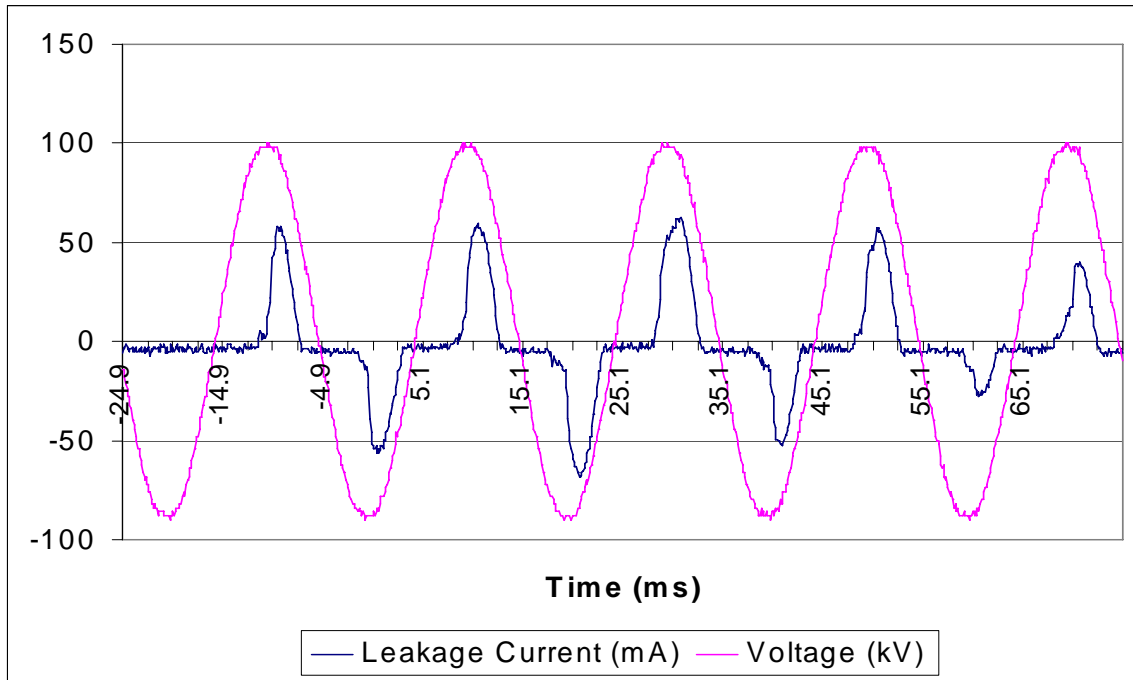
Figure 4.4: Leakage current over string A – oscilloscope
