**Investigation into Possible Mechanisms of Light
Pollution Flashover of 275kV Transmission Lines as
a Cause of Unknown Outages**

**Thesis presented in fulfilment of the requirements for the degree of
Master of Engineering at the University of Stellenbosch**

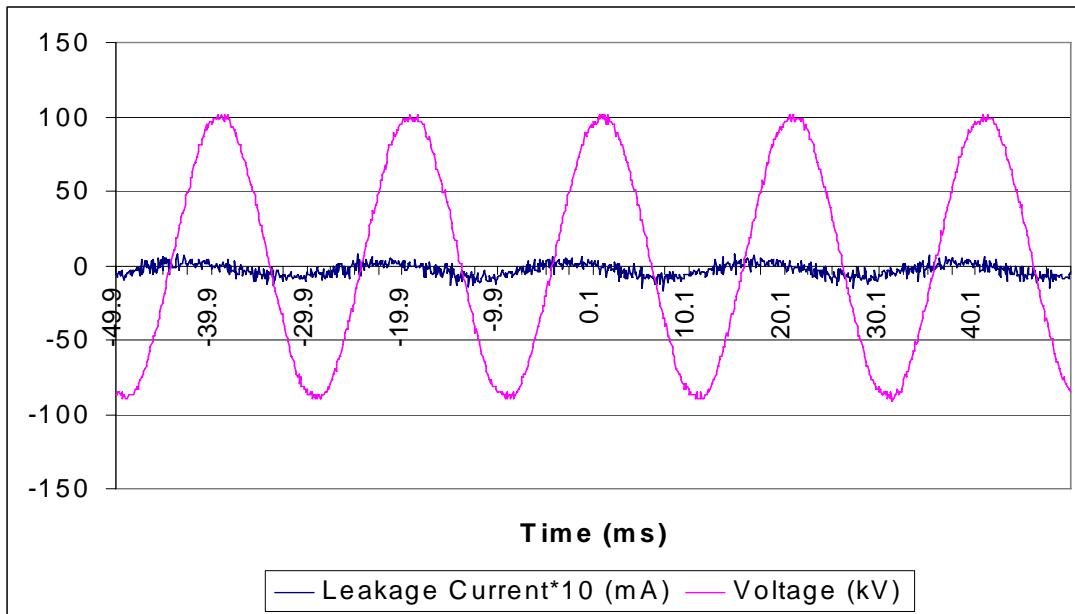
Figure 4.6: Small capacitive leakage current over string B – oscilloscope

The leakage current over string B was different to that observed over string A. A very small capacitive current was observed (Figure 4.6) flowing continuously over the insulator surface.

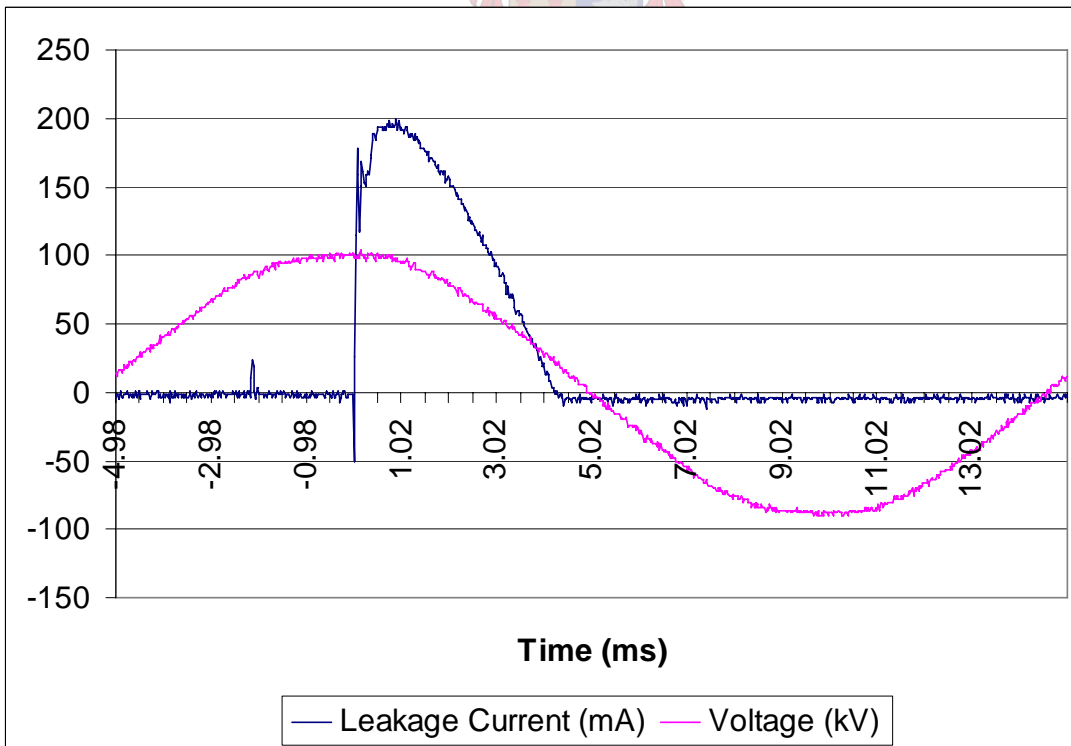
Figure 4.7: Spark gap flashover on string B - oscilloscope

However, on rare occasions, the spark gap would flash over, and the following waveform is observed (Figure 4.7).

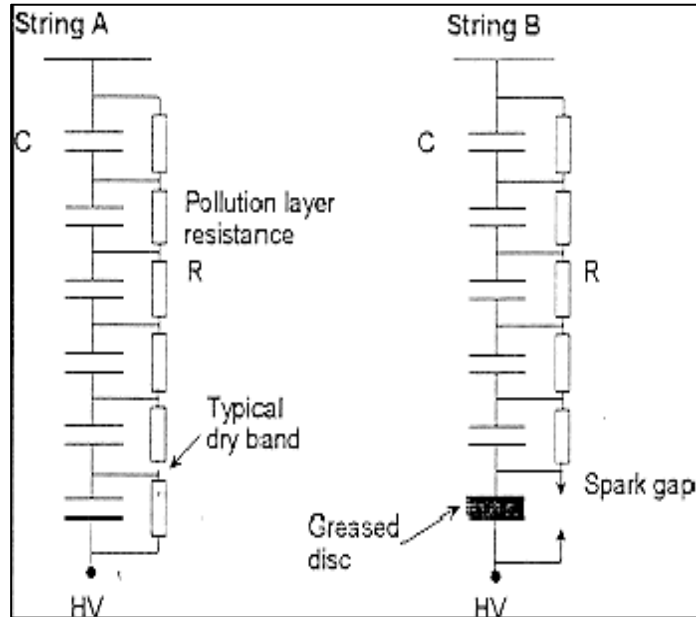
Figure 4.8: Equivalent diagram of the two insulator strings

The equivalent circuits of the two strings are depicted in Figure 4.8.

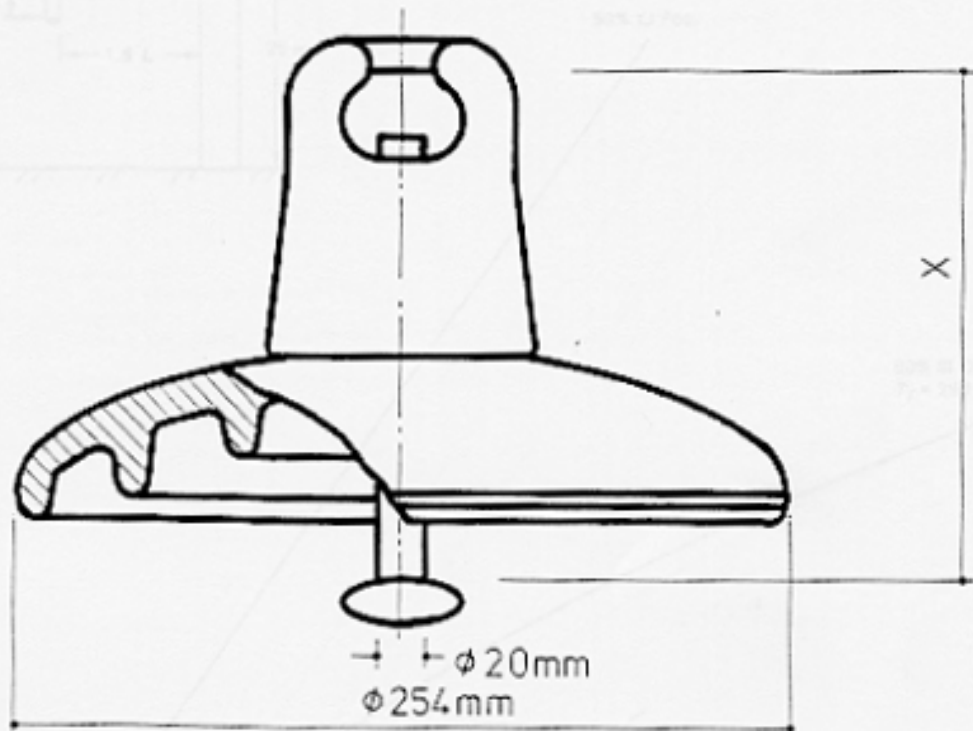
U120BS/20

INSULATOR TYPE
INSULATING MATERIAL
COUPLING METHOD
LOCKING DEVICE

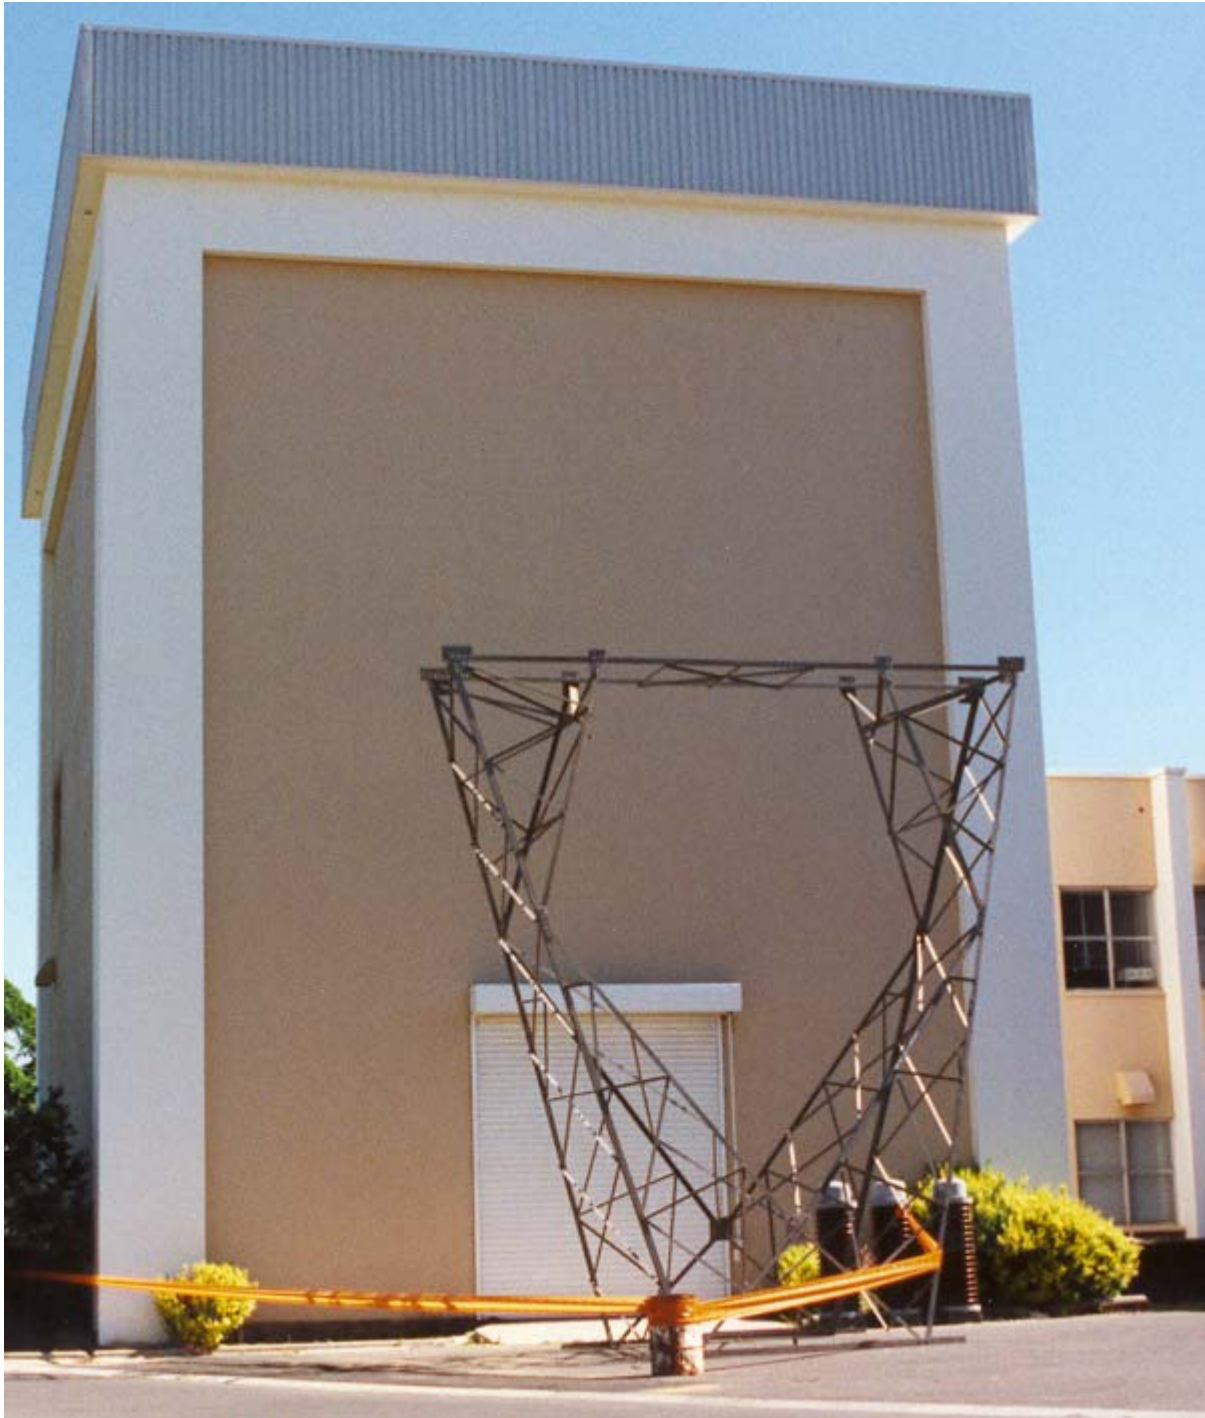
Figure B.1: 275kV tower window set up outside the High Voltage Laboratory
