The Impact of Wave Slamming Induced Vibration on Human Factors and Equipment on-board the S.A. Agulhas II

*Thesis presented in partial fulfilment of the requirements for the degree
of Master of Engineering (Mechanical) in the Faculty of Engineering at
Stellenbosch University*

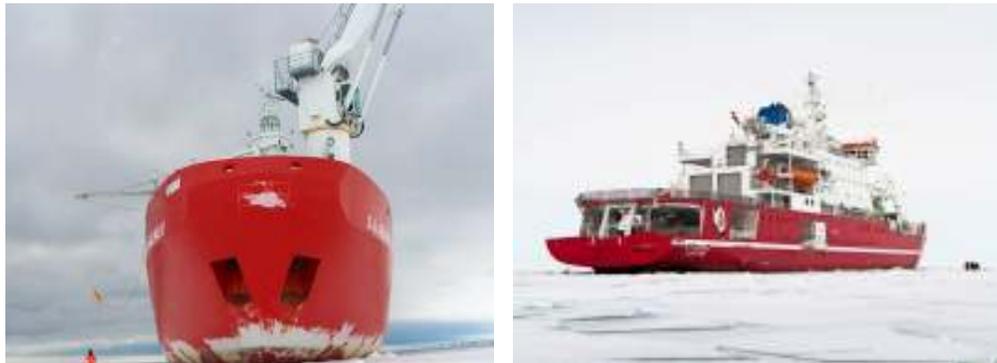
**Figure 1.1: The hybrid design of the S.A. Agulhas II a) rounded bow
b) flat stern**

Wave slamming is one of the consequences of this hybrid design which can be critical for both the structure and well-being of the people on-board. It can be described as the exposure of a vessel structure (bow, stern or hull bottom) to large forces due to wave impacts for a short duration of time (Kapsenberg, 2011). This event occurs when the vessel's bow or stern emerges from a wave and re-enters the water with a heavy impact (ABS, 2011). Slamming loads are considered to be higher than any other wave loads and the impacts can damage the ship structure (Bertram, 2012). Besides the harmful effects on the structure, slamming can also affect human comfort and performance as well as cause damage to the equipment on-board (Constantinescu *et al.*, 2009). However, this phenomenon has remained understudied especially in terms of human factors.

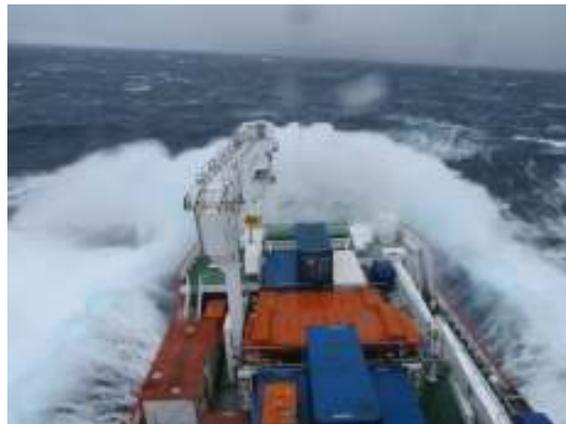
Figure 2.1: The S.A. Agulhas II during a bow slamming incident (Soal K, 2014)

Slamming is a complex topic vexing shipbuilders and designers alike. It can be described as the exposure of a vessel structure (bow, stern or hull bottom) to large forces due to wave impacts for a short duration of time (Kapsenberg, 2011). Figure 2.1 depicts a bow slam as the bow of the S.A Agulhas II hits the water surface during a slamming incident.
