Maintenance engineering standards  
to fulfil the legal duty of  
road authorities towards safe roads

*Dissertation presented for the  
Degree of Doctor of Philosophy  
Faculty of Engineering  
Stellenbosch University*

March 2016

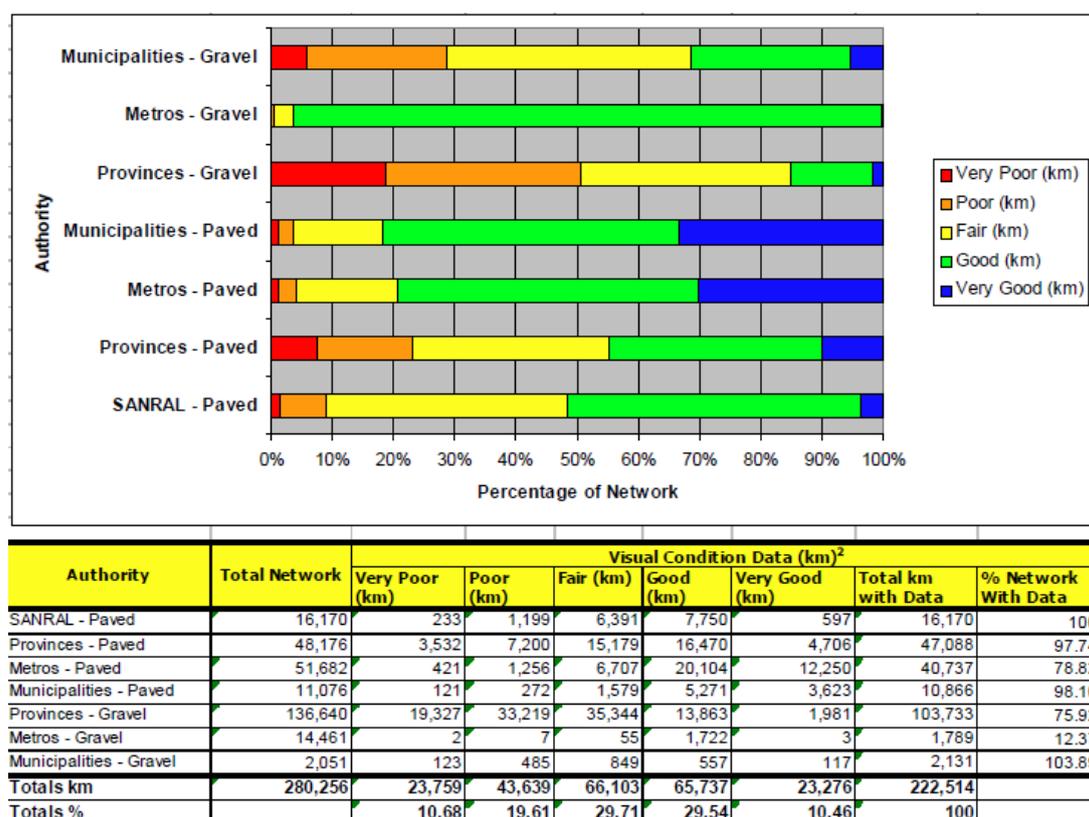
The condition (based on visual assessment procedures) of the road network is illustrated by Kannemeyer in a diagram shown in Figure 2-1 (Kannemeyer, 2009). The important feature of this condition report is that the condition of the provincial paved roads, from which most legal claims originate, is significantly poorer than the paved roads under control of SANRAL and the municipalities.

Figure 2- 1 : Road visual condition summary (2009)

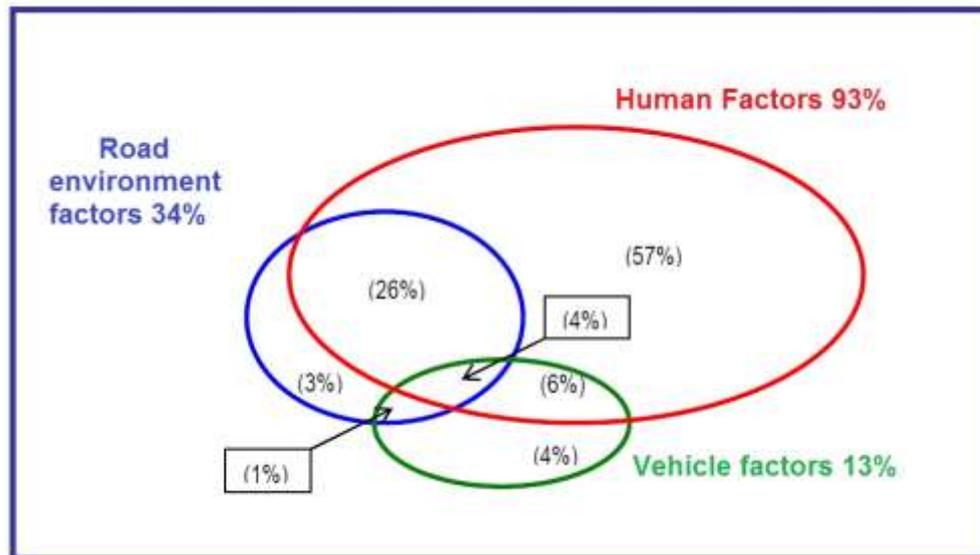
These causes are presented as the primary causes. The top four causes are human factors and the next two vehicle factors. The list excludes road elements, but Wolhuter states that despite the road environment factors (with reference to Figure 2-2) contributing 34% to the causes of accidents, road designers (also road authorities in general) cannot shrug their shoulders and blame all on drivers (Wolhuter, 2015). This is especially true in maintenance, where hazardous conditions such as potholes should not develop on a road that was previously reasonably safe at high speed but became unsafe due to poor road conditions.

**Figure 2- 4: Factors contributing to crashes**

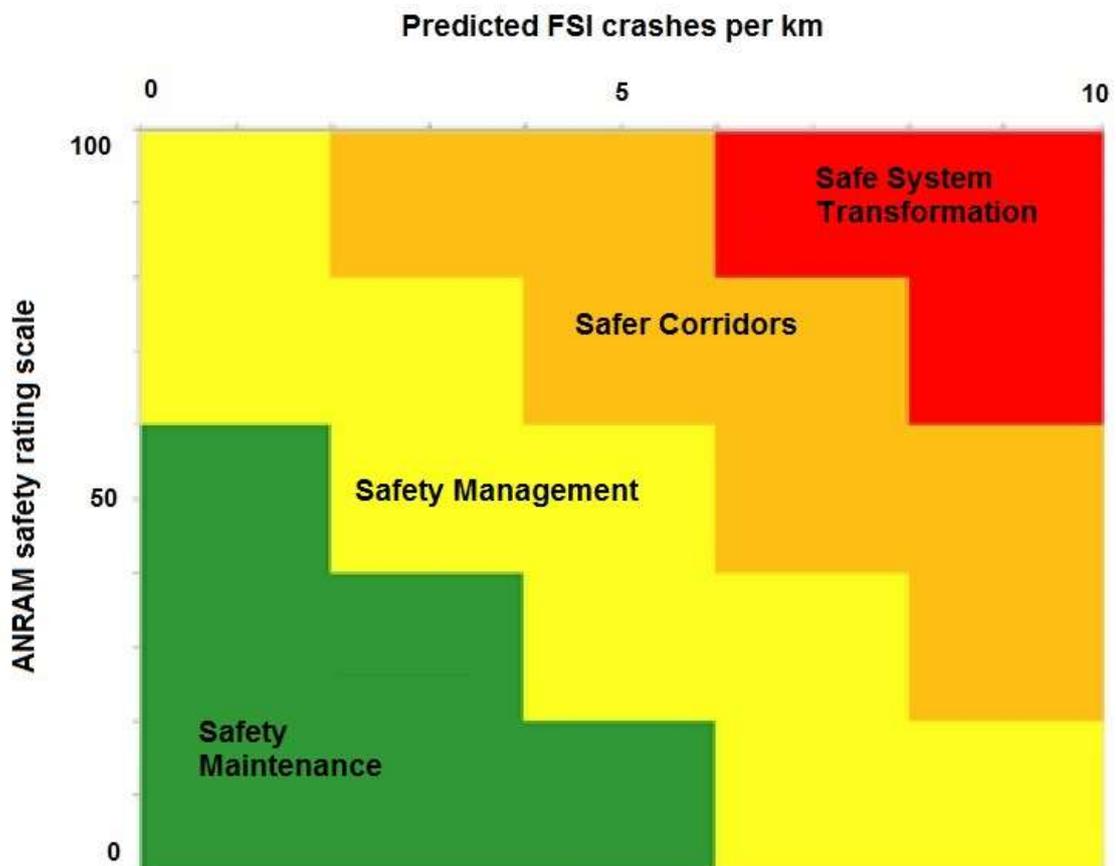
The risk matrix in Figure 2-2 shows the application of a risk assessment on roads. The collective risk of severe crashes is presented on the horizontal axis, as the predicted number of Fatal or Severe Injury (FSI) accidents per km. The individual risk is presented on the vertical axis, as the section-averaged total ANRAM Safety Rating Scale (SRS). The illustrative road categories are based on an Australian trial and are not transferable to the South African road safety environment. The bottom left green zone representing freeways with a low SRS and low predicted FSI accidents is, however, analogous to South African freeways and the risk management strategy in the green zone is to maintain the safety features. South African freeways are well-designed and the accident rates in fatalities per million Vehicle Km Travelled (VKT) are low. The right top zone in red represents hazardous roads: a high SRS value with high number of predicted FSI accidents. The risk management strategy aims to transform the roads to Safe System principles. It identifies which road types should be attended to as a priority and justifies the allocation of resources (Austroads, 2013a).

**Figure 2- 5: Risk matrix for the application of a risk assessment on roads**

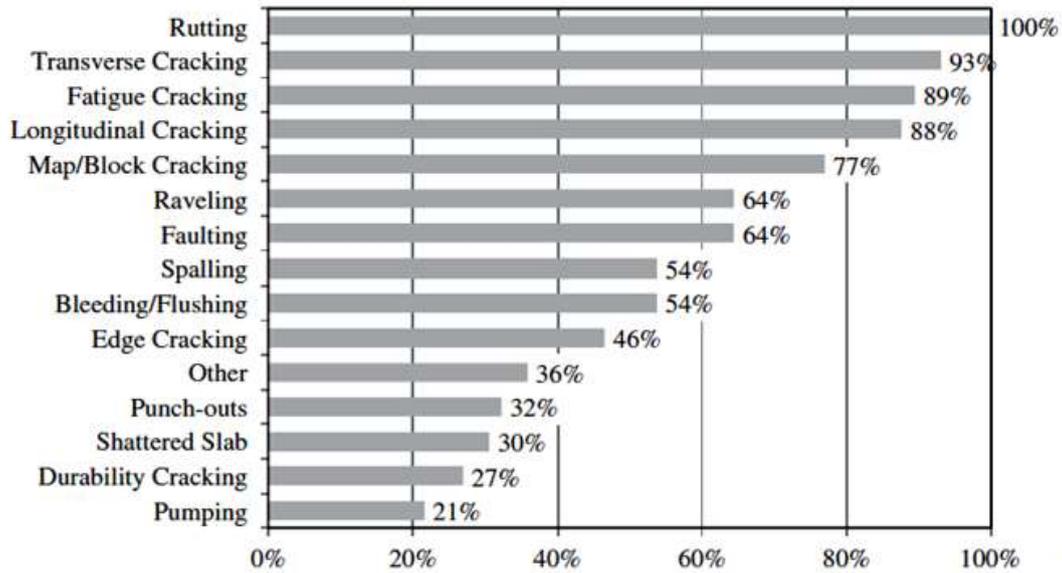
**Question: What pavement distress data does your agency collect?**

**Figure 2- 6: Pavement condition distress factors**

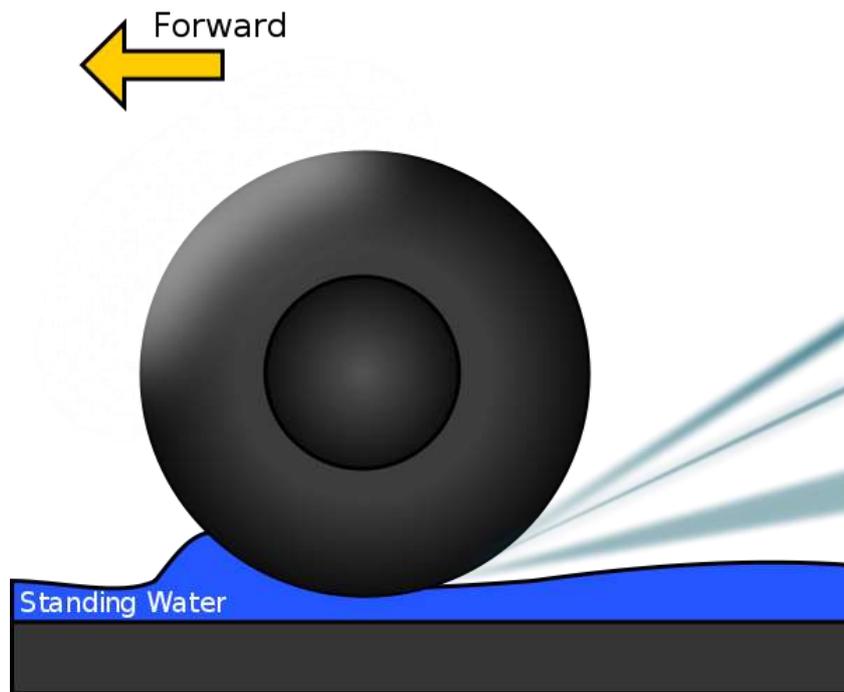
A further important aspect of macro-texture is the provision of space under the tyres to dissipate water during rain. Modern tyres have tread to assist with this, but hydroplaning (also referred to as aquaplaning) can occur if the depth of water on the road, in combination with other factors such as speed, length of the ponding, contact area and mass of the vehicle, exceeds a critical value. Figure 5-2 illustrates the lifting of a wheel when the hydrostatic pressure exceeds the contact pressure acting on the tyre (Nygardhs, 2003). The film of water can cause partial or total loss of contact between the tyre and the road surface.

**Figure 5- 2: Illustration of hydroplaning**

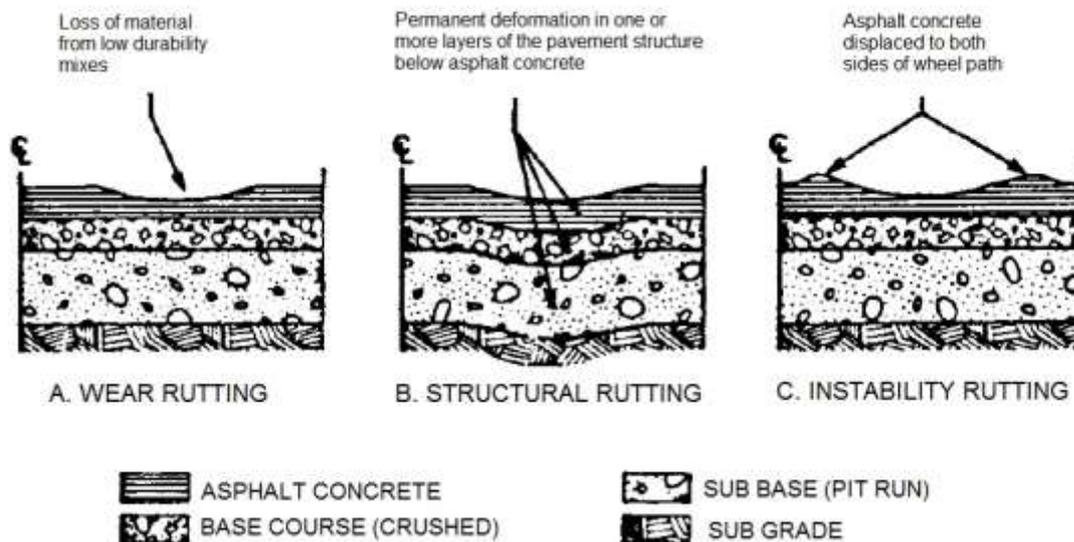
Wide and even shaped ruts indicate failure in the deeper layers, while narrow and sharp-edged ruts indicate upper layer failures (California Department of Transportation, 2014b; Simpson, 2003). These failure modes are illustrated in Figure 5-5.

**Figure 5- 5: Illustration of rutting modes**

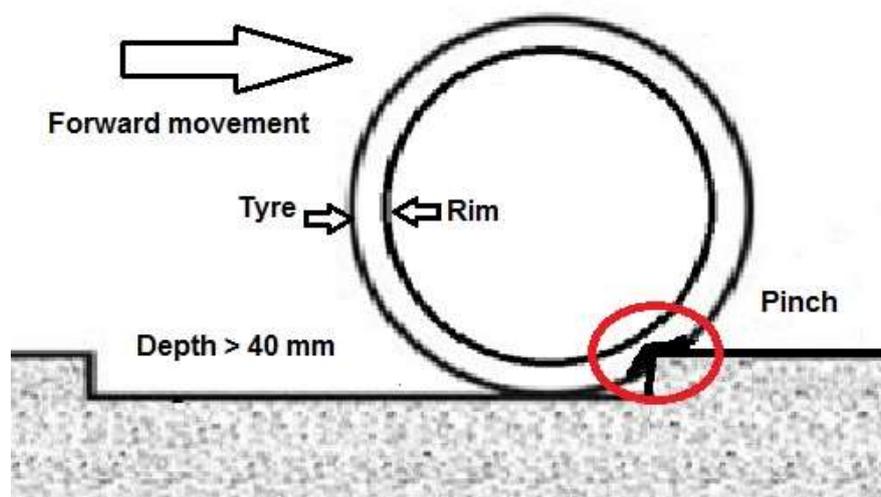
The threshold for damage to rims was closely approximated by hole depth or bump height equal to or greater than the rim ground clearance (RGC). Wambold, *et al* (2009) build on work by Zimmer and Ivey to relate pothole length, continuous depth and combinations of vehicle types and travel speeds. They concluded that a depth of 25 mm and length of 500 mm would be reasonably safe for small vehicles at low speeds. At the other high end of their scale, a pickup truck would experience unsafe conditions when the pothole is 140 mm deep and 2 500 mm long. The finding that for potholes of a specific dimension it becomes relatively safer at higher speeds is interesting, but of no importance from a safety point of view: the pothole sizes on a failed road will vary in length and the hazard will be dictated by the critical combination of speed, depth and length. The threshold for damage to rims was closely approximated by hole depth or bump height equal to or greater than the rim ground clearance (RGC). The critical combination of low-profile tyre at 100 km/h would be unsafe with pothole length of 400 mm and depth of 40 mm as illustrated in Figure 5-6 below. The shallow critical pothole depth for low-profile tyres is also true for motorcycles tyres at speed.

**Figure 5- 6: Critical pothole for low profile tyre**

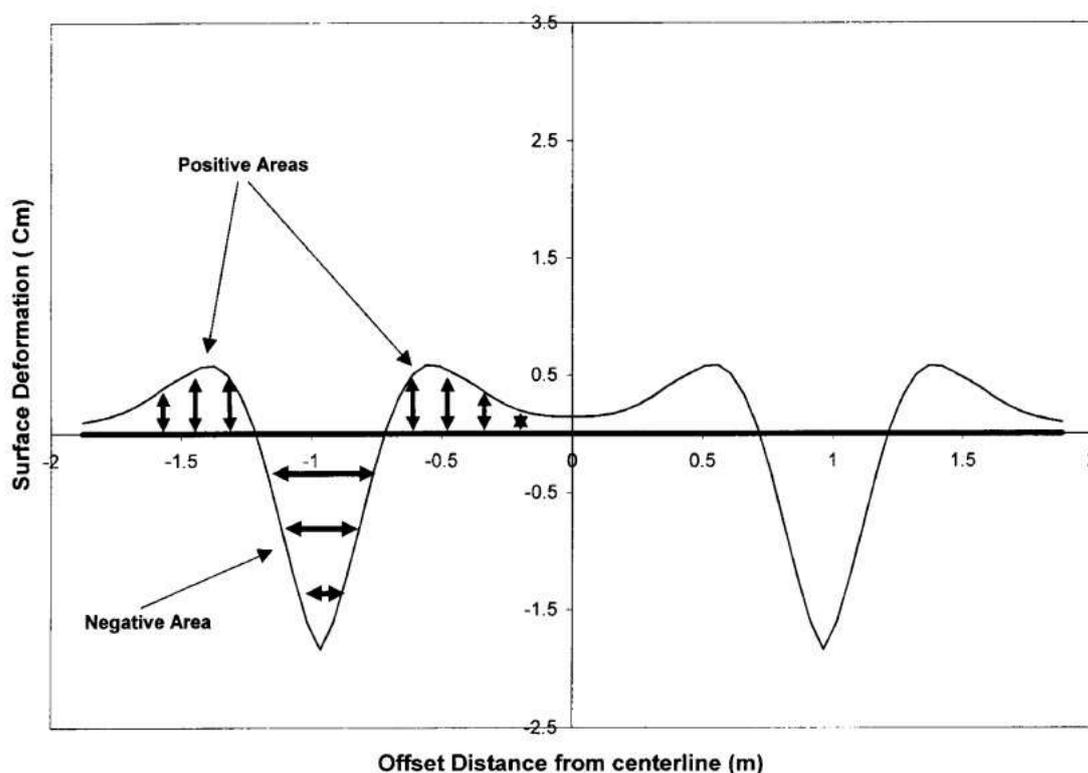
Shoving is localised displacement or bulging of pavement material in the direction of loading pressure. Shoving can be associated with ruts or potholes, where the material compressed and depressed in the wheel track is displaced to the side and bulges above the roadway level. This is illustrated in Figure 5-7 as the areas of positive surface deformation.

**Figure 5- 7: Surface deformation illustrating shoving**

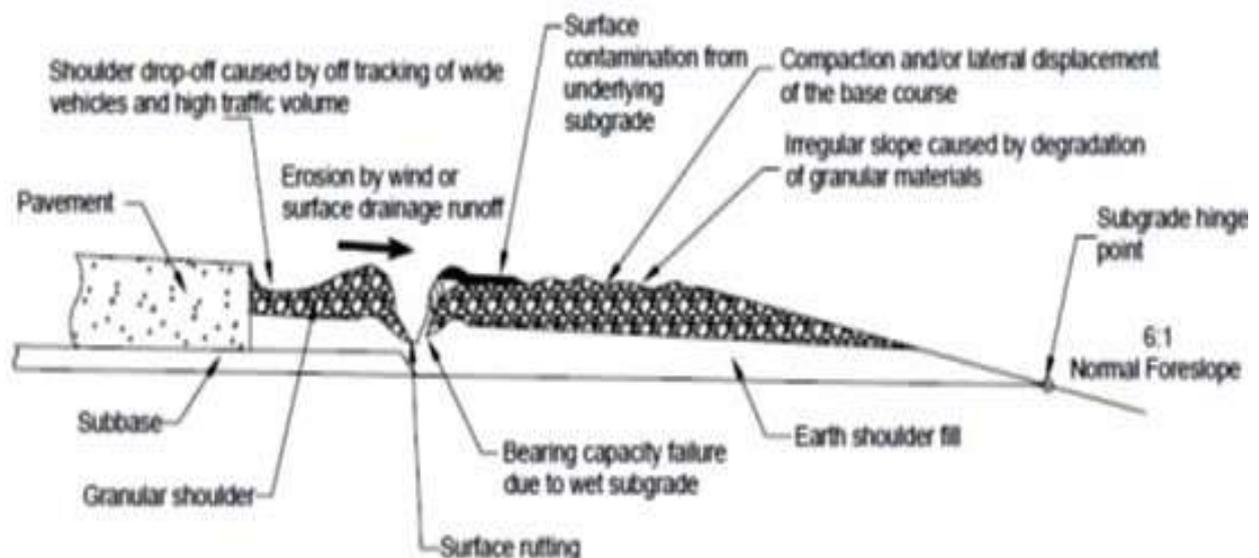
Edge drop-off is a condition that develops next to the sealed roadway surface (lane plus sealed shoulder) and the remainder of gravel shoulder provided in the road prism. It manifests as result of erosion of gravel material at the interface. Pavement edge drop-off is a vertical height difference between two adjacent roadway surfaces. The safety impacts of edge drop-off is not only in the depth and width of the drop-off, but also in the width of the sealed shoulder which determines the risk of a vehicle moving off the sealed road surface. The management of edge drop-off is influenced by the width of sealed shoulder as part of the recovery area. Edge drop-off must therefore be analysed in the context of the functions of road shoulders. Figure 5.8 illustrates the gravel shoulder conditions (White, *et al*, 2007).

Figure 5- 8: Illustration of gravel shoulder conditions

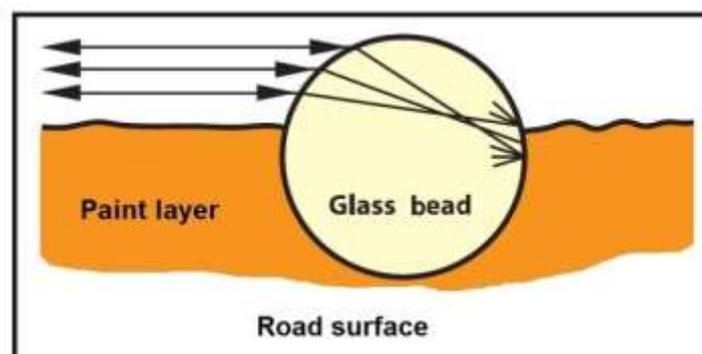
The lowest cost is obtained using road paint to the SANS 731-2 specification of a paint layer of minimum 0.42 mm (South African Bureau of Standards, 2006). The disadvantages of painted markings are that heavy traffic wears the paint off the road surface and their conspicuity is impaired when wet or dirty. Conspicuity when wet is problematic as the paint is covered with water and at night the lights of the vehicles are reflected forward on the film of water with no backwards reflection (retroreflection). To improve the performance of road markings, glass beads are mixed into the paint or spread on the wet paint immediately after spraying. The tops of the glass beads are exposed and allow light to enter and a portion of the light is reflected back towards the driver as indicated in Figure 5-9.

**Figure 5- 9: Retroreflectivity provided by glass beads in road paint**

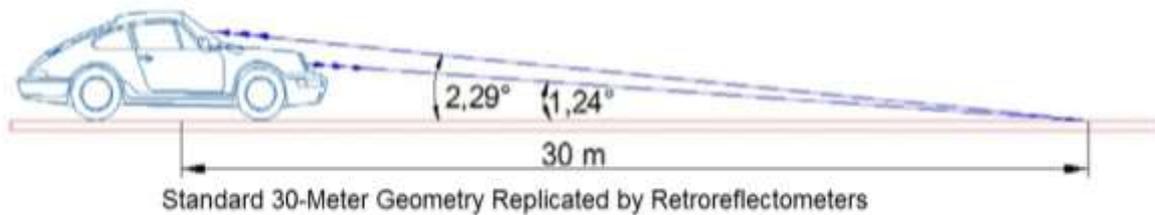
**Figure 5- 10: Driver's view of road markings**

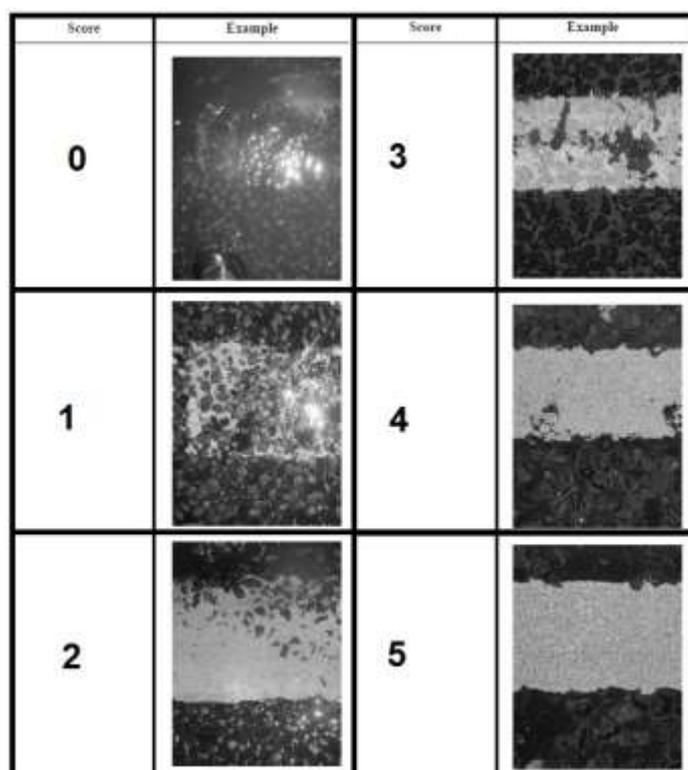
Assessment	Score
Non-existent	0
Barely visible	1
Visible, but has bare spots and low night time conspicuity characteristics	2
Marginal – some visible wear and/or fair night time conspicuity characteristics	3
Good night time conspicuity and very little wear	4
Good night time conspicuity and no wear	5

**Figure 5- 11: Images for visual assessment of road markings**

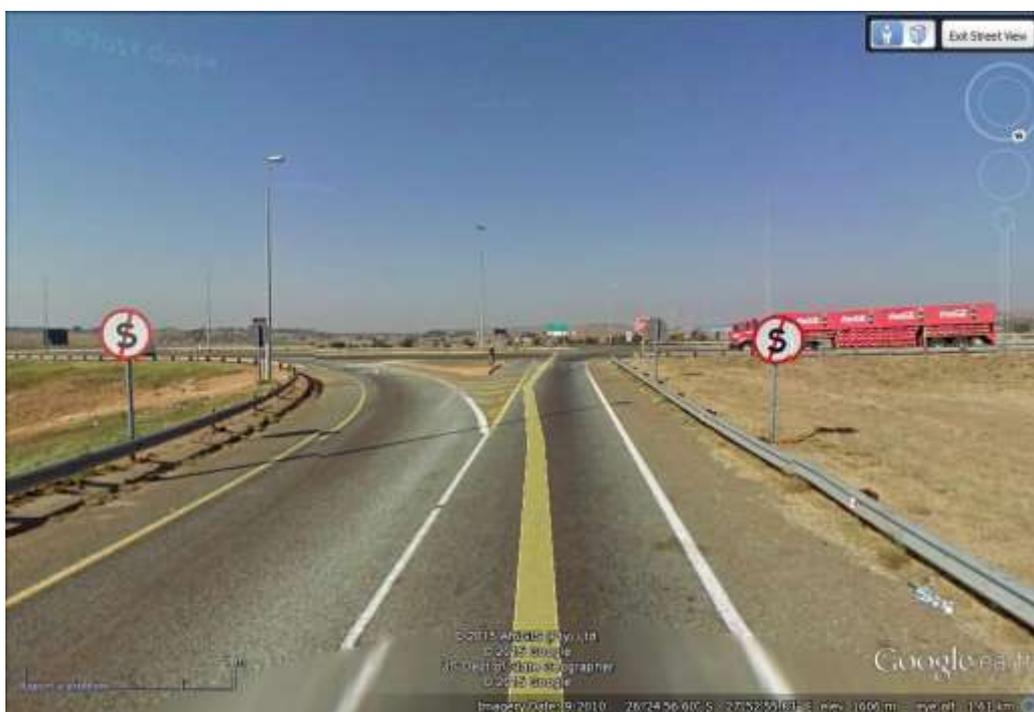
**Figure 7- 4:** du Toit: STOP sign right obscured by No-Entry sign

Note: No STOP sign of left-hand side of right-turn lane

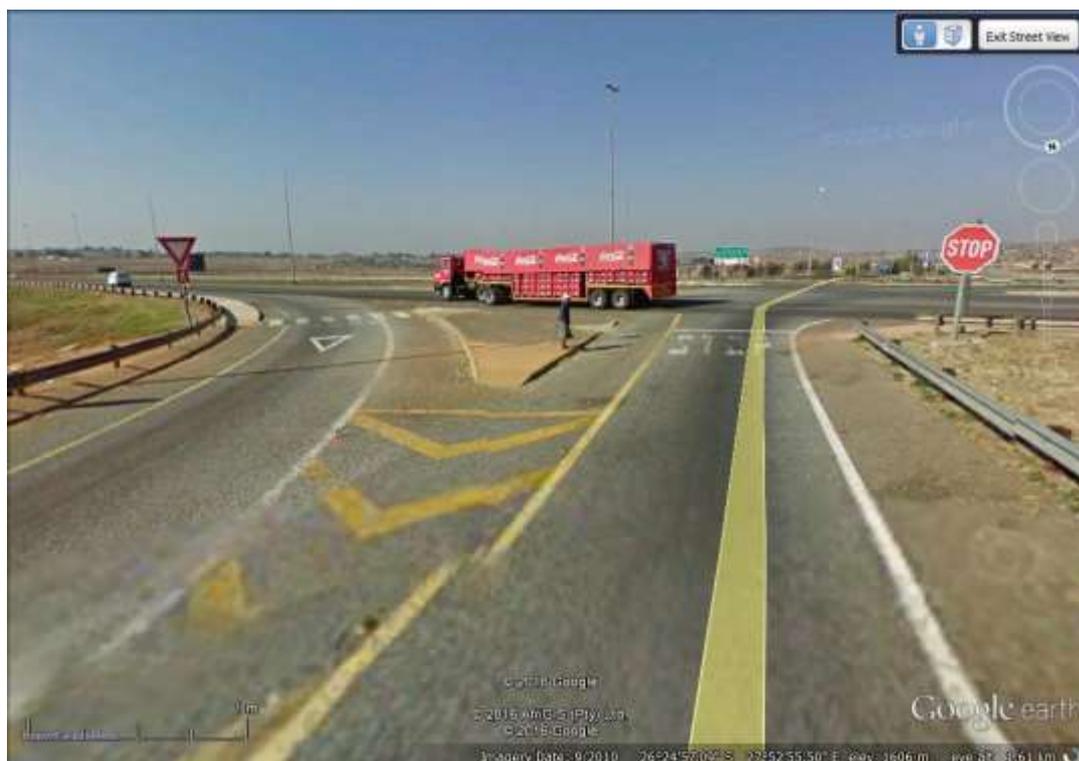
**Figure 7- 5:** du Toit: Hazard markers W401 and W402 missing on splitter island

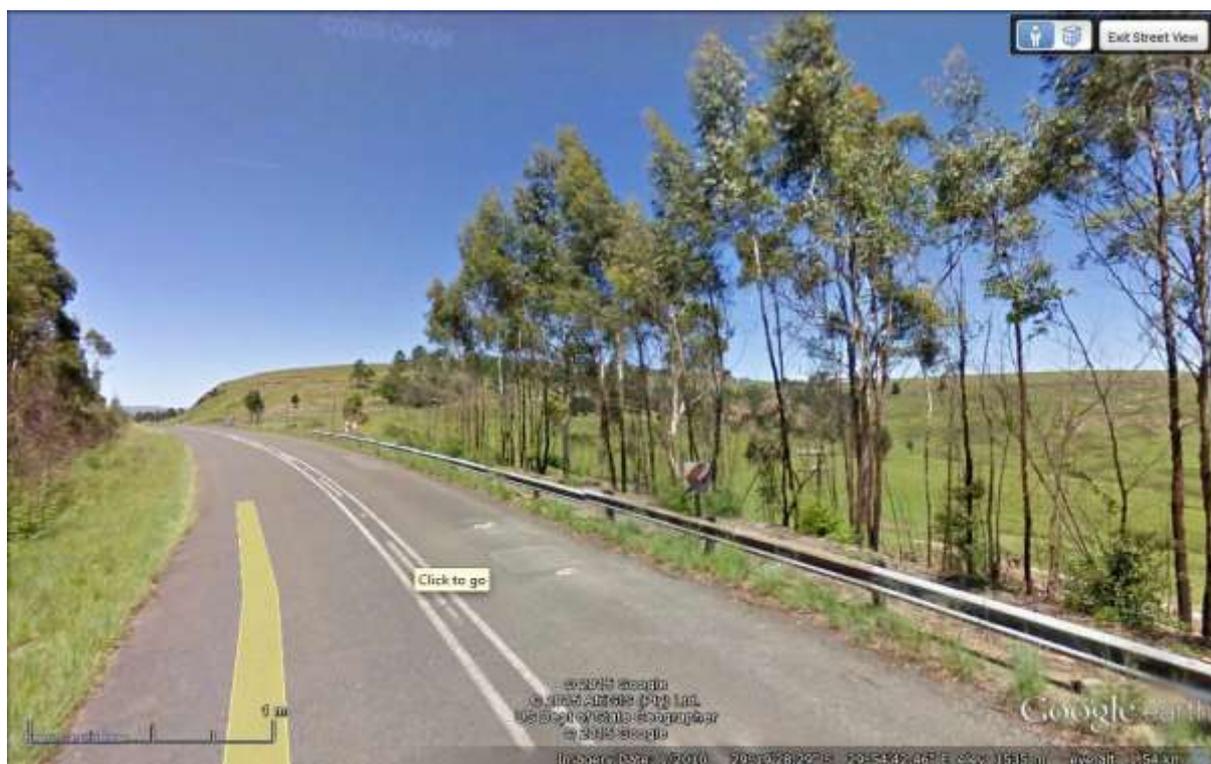
The road was repaired in 2004 after the accident. In 2010 the road again showed potholes in the curve where the accident happened.

**Figure 7- 6: McIntosh: 2010 Google Streetview of curve where accident happened**

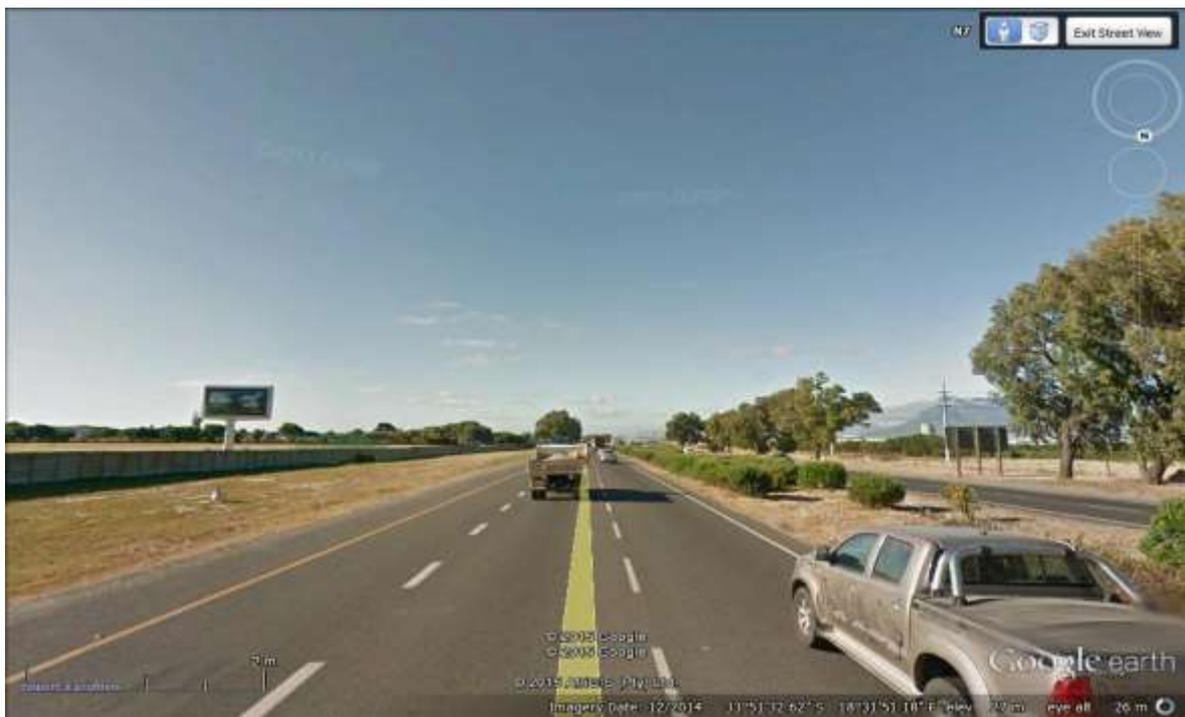
**Figure 7- 9: Gerber: View of shrubs in median in 2014**

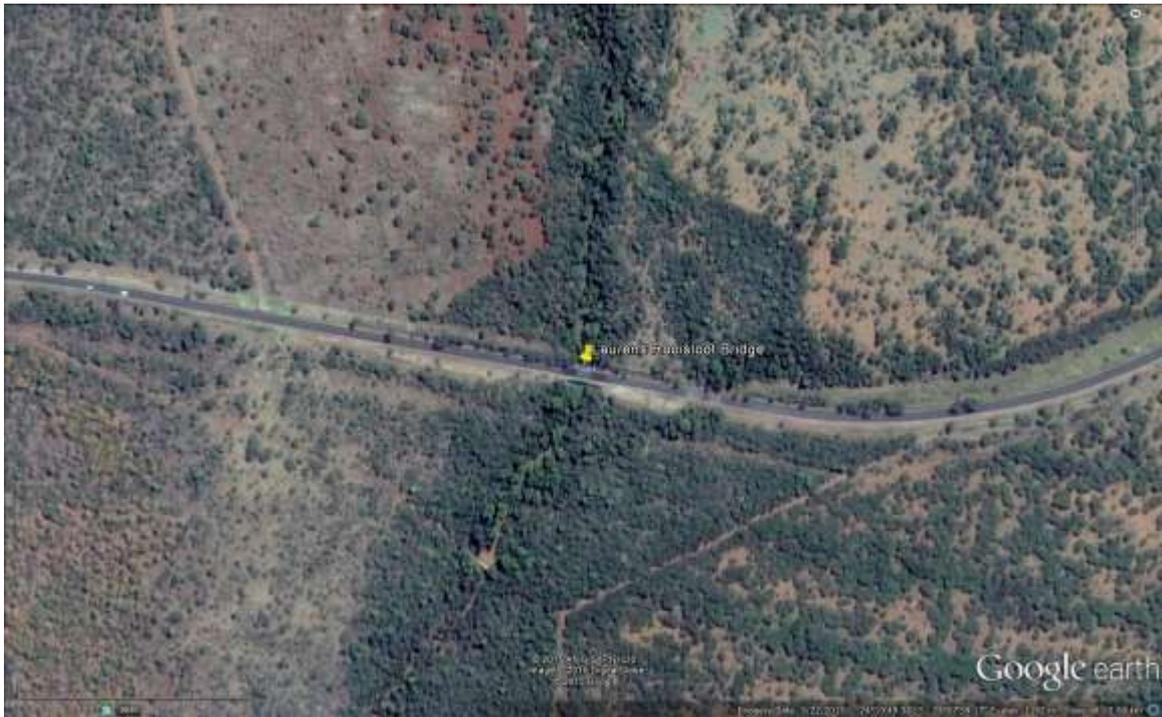
**Figure 7- 11: Laurens: Bridge with patches on approaches**

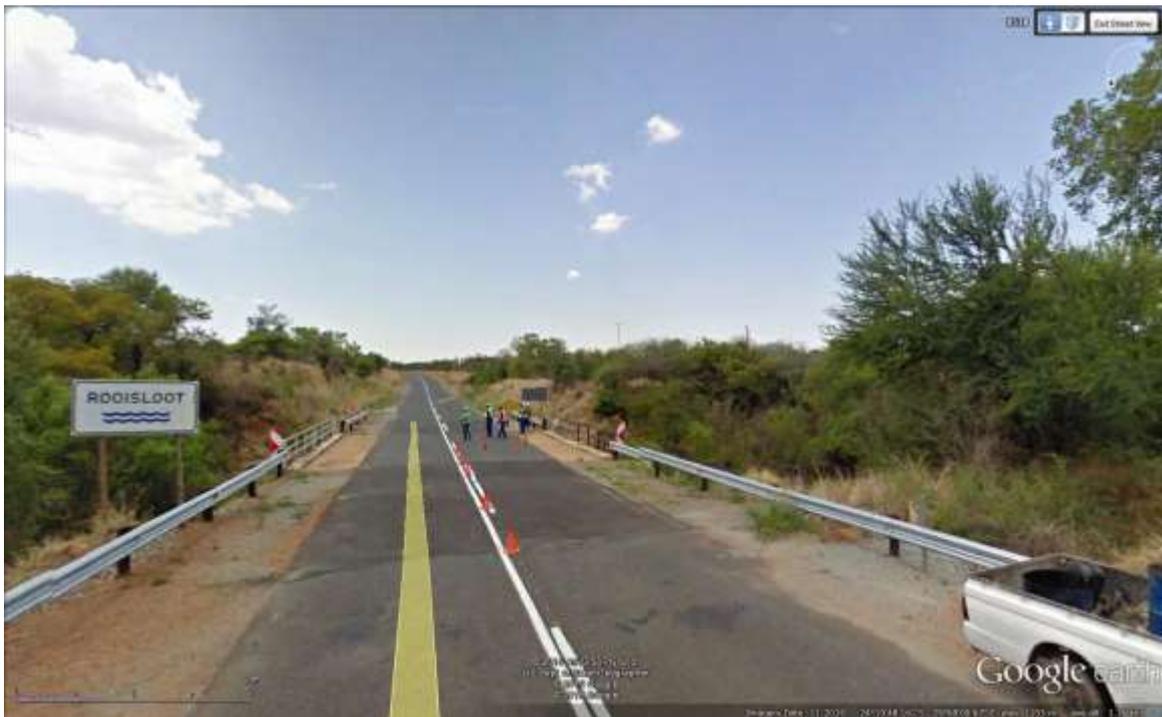
**Figure 7- 12: Laurens: Repairs to bridge approaches in 2010**

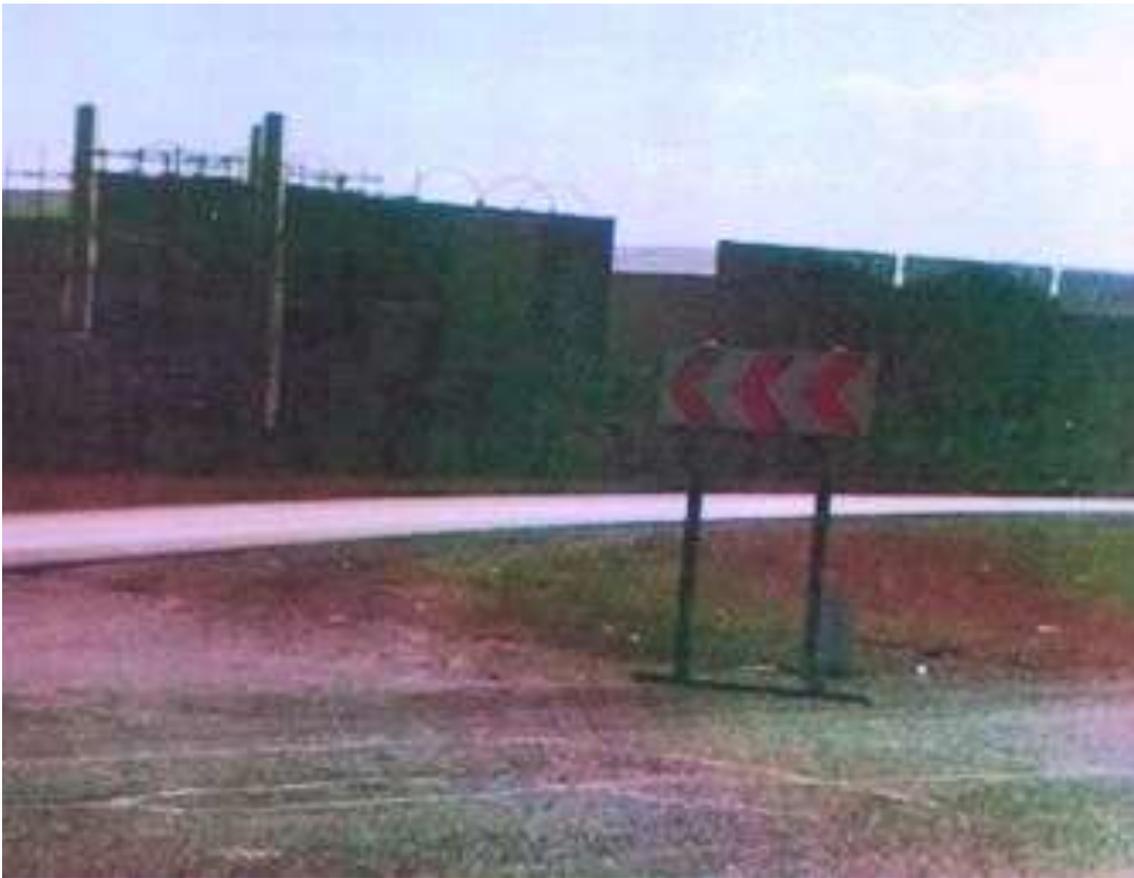
**Figure 7- 16: Schultz: Signs at time of accident**

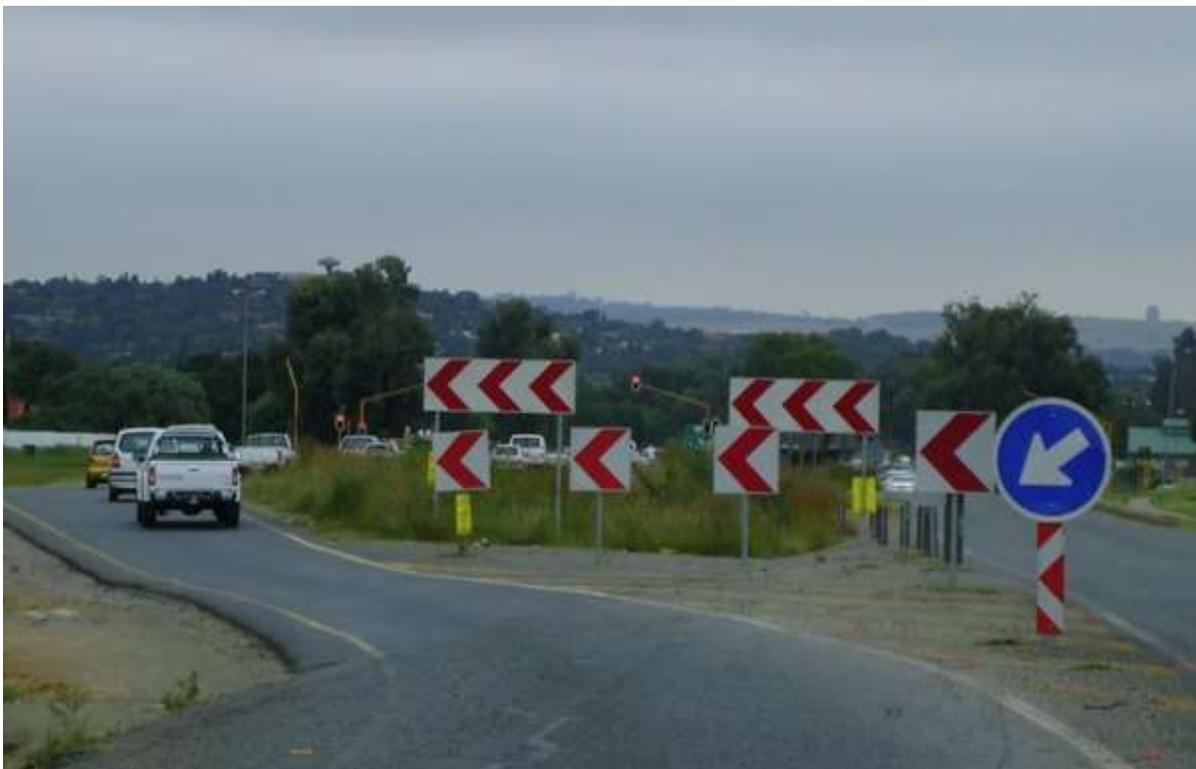
**Figure 7- 17: Schultz: Signage as reinstated 2011**

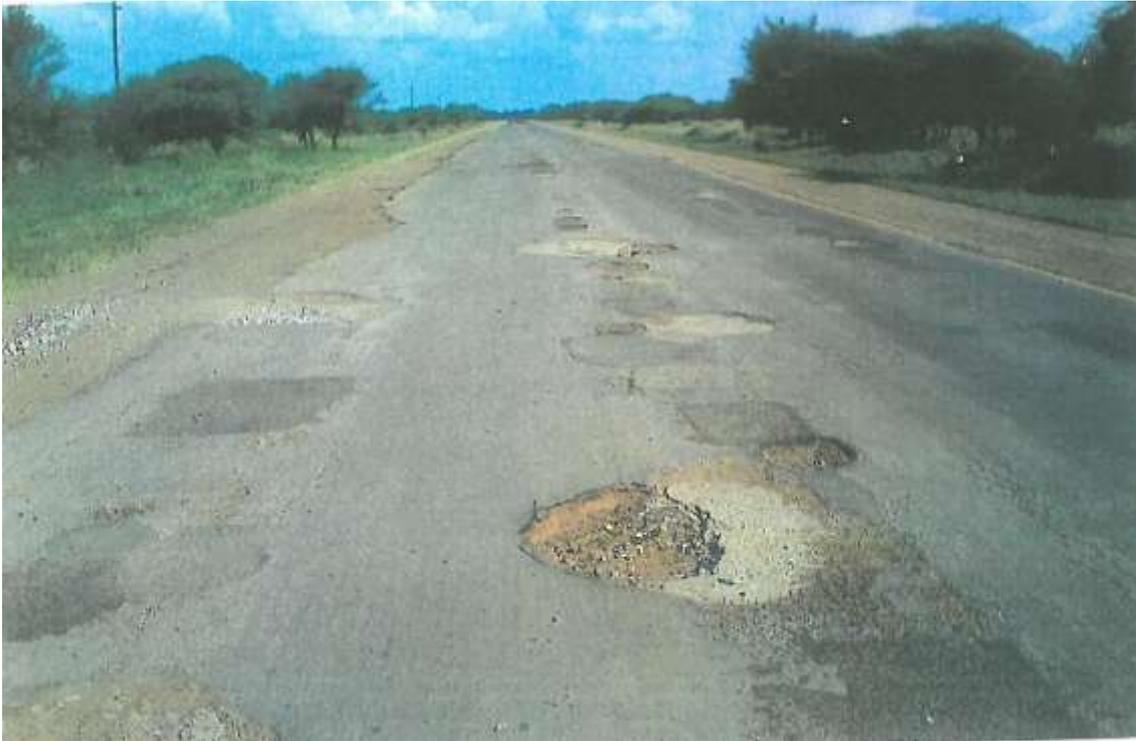
According to the experts of the plaintiff, the repair of potholes was a priority, both with regard to the safety of road users and the preservation of the structural integrity of the road. No evidence was led by the defendants to establish that by reason of the lack of funds the repair of potholes was neglected in favour of some other priority. Nor was there evidence to suggest the existence of a policy to select some potholes for repairs ahead of others and if so, the basis upon which such a selection was made. The inference of negligence on the part of the servants of the Department responsible for the inspection and repairs of potholes on this road is irresistible.

**Figure 7- 19: Matshoge: Potholes at time of accident**

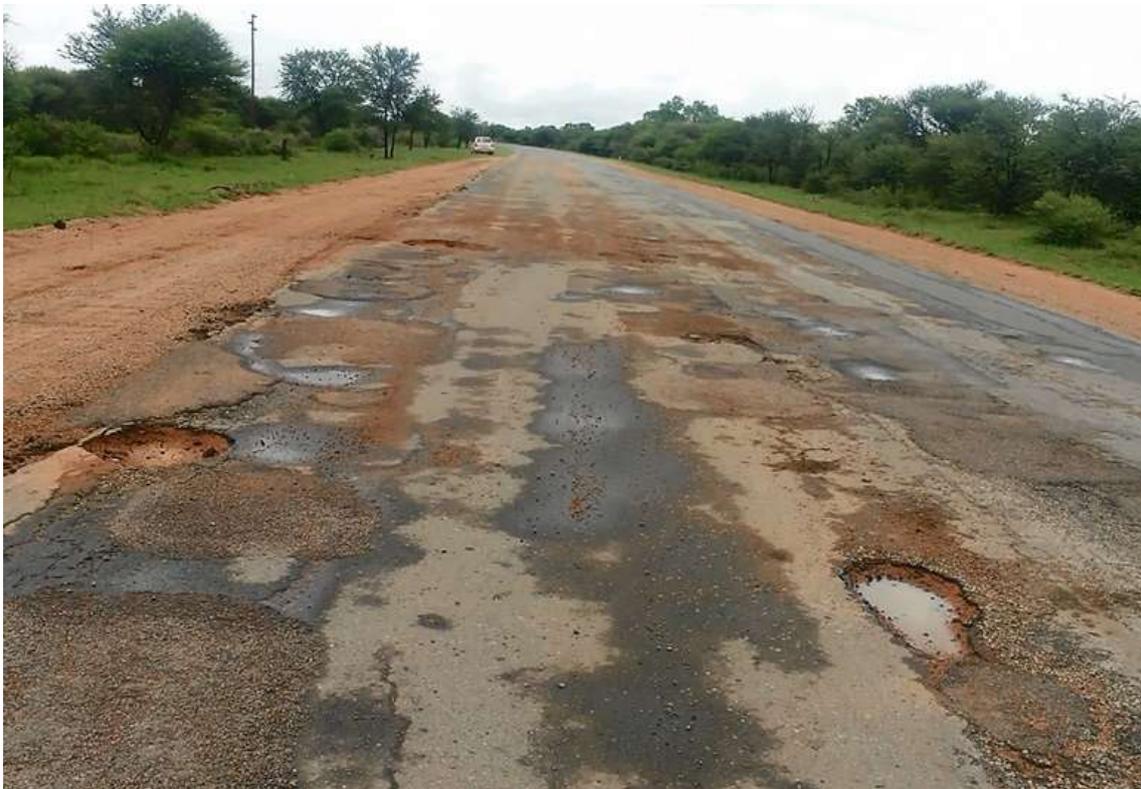
**Figure 7- 20: Matshoge: Potholes at time of site visit**

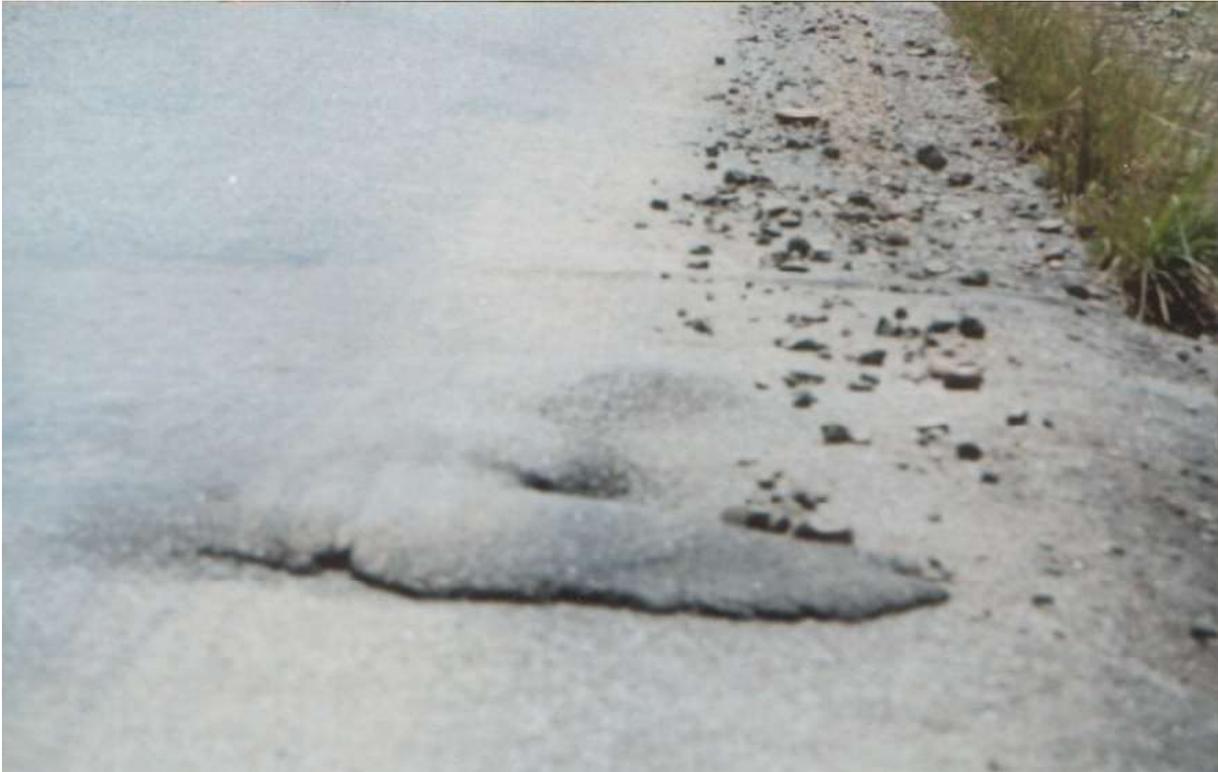
Outcome, citation if available	The province was found to be 60% negligent. Devonport v Premier Free State Province A216 2008 26 November 2009
Finding 1 Road environment	The protrusion (shoving) exceeded 30 mm height and was dangerous. The danger was foreseeable and could be repaired with little cost or inconvenience.
Finding 2 Signage	Signs should have been erected to warn of the road condition.
Conclusions	The extent of shoving exceeded 30 mm and the shape was rounded. This posed a danger to the cyclists as legitimate road user and was not visible due to the colour and shape blending in with the road. On the defendant's argument that the danger was obvious, van der Merwe J remarked: <i>"The logical conclusion of this argument is that the bigger the danger in a road, the more it would or should be apparent and therefore the less need to repair or warn against it. Once a hazard is recognised by a public authority such as the province in these circumstances, it cannot in my judgment be heard to say that injury was not reasonably foreseeable simply because the danger should be apparent to road users."</i>

**Figure 7- 21: Devonport: Shoving that caused accident**

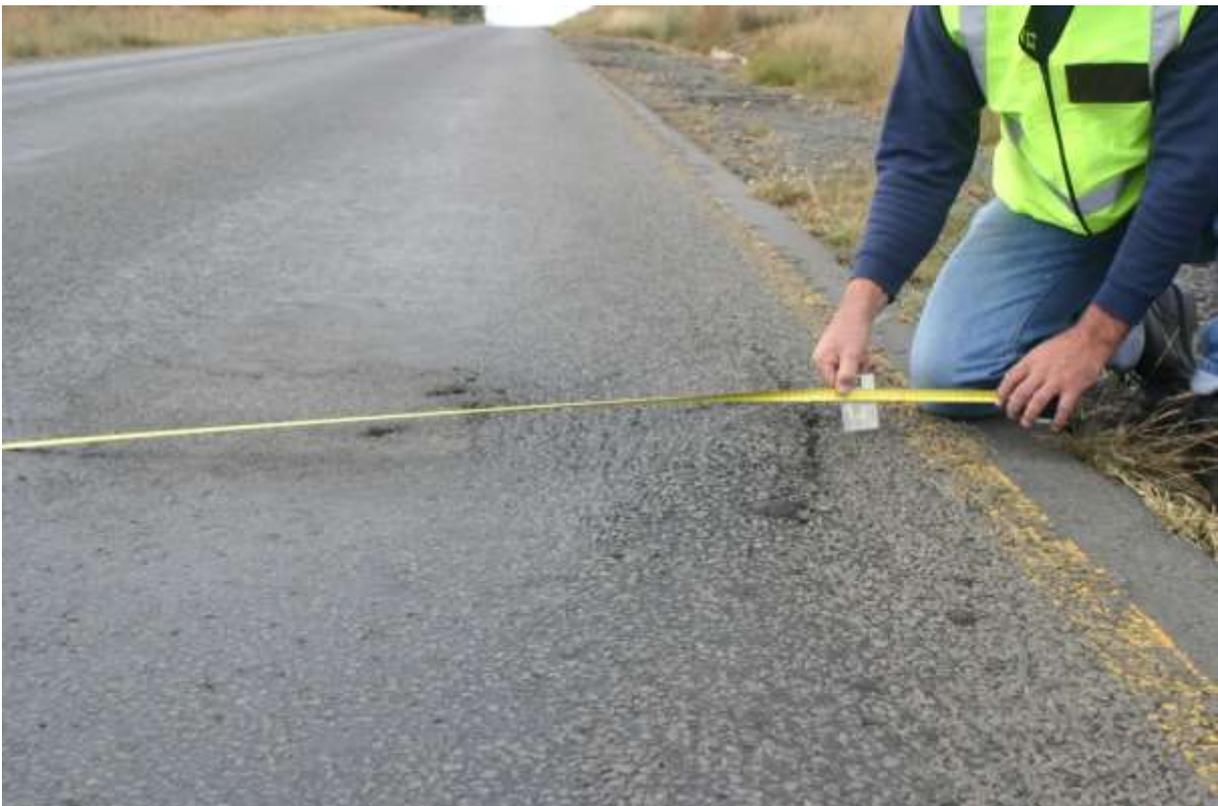
**Figure 7- 22: Devonport: Surface failure at location of accident observed on site visit**

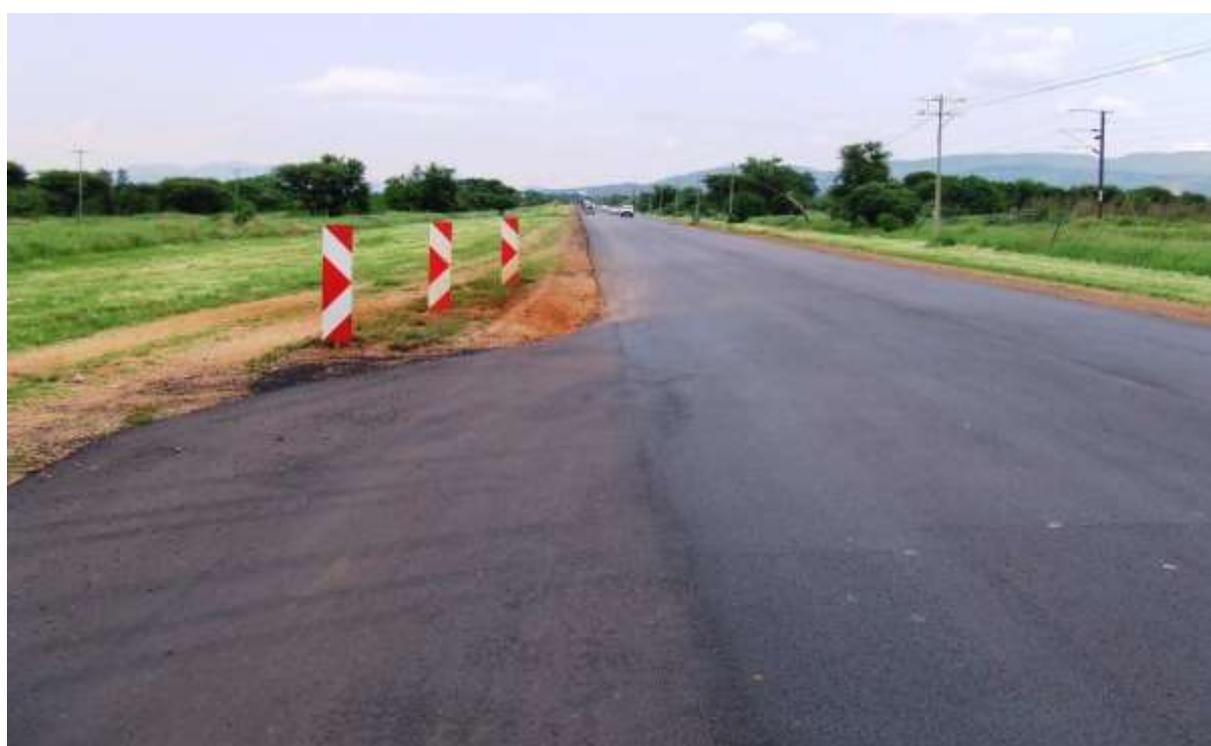
**Figure 7- 23: Herbst: Lane drop with no marking after resealing**

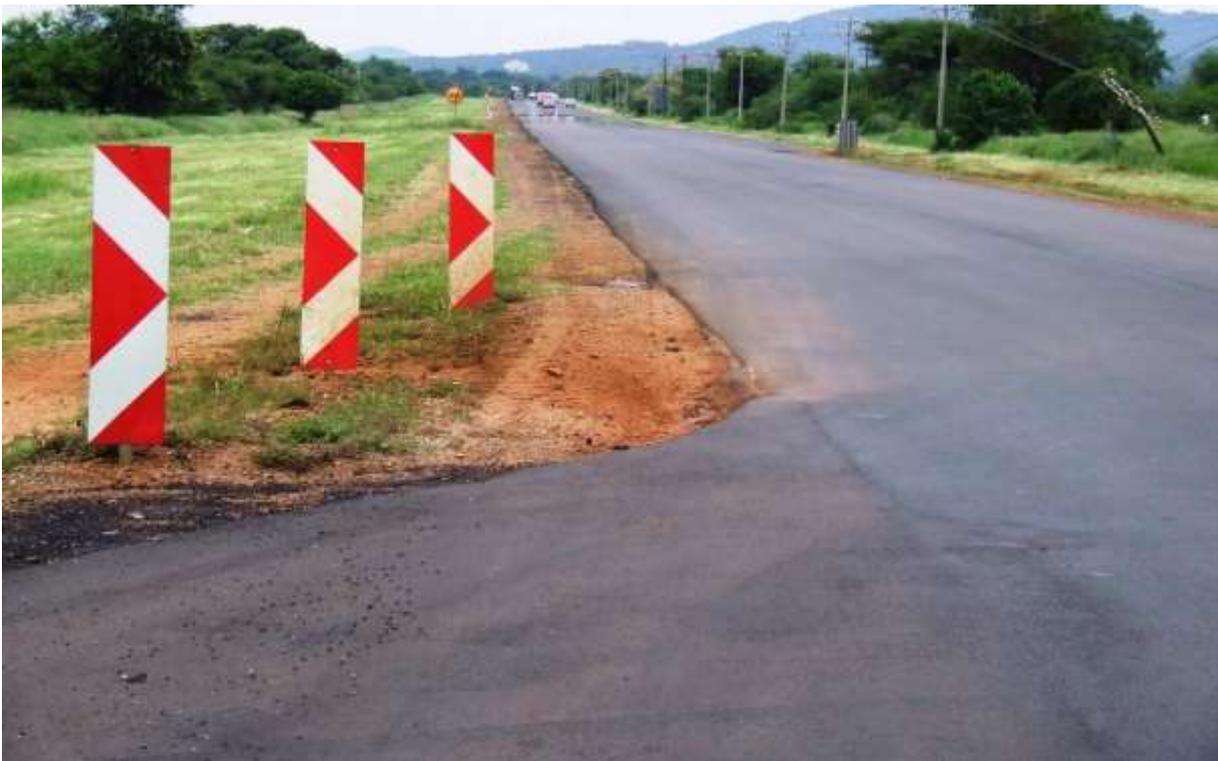
indicated. The pothole in the corner of the roadways was evidence of many vehicles clipping the gravel shoulder as they moved back to the through-lane too late. The RRM contractor did not fix the pothole, which was substantial and caused loss of control.
Finding 2 Maintenance procedures, reaction times	The RRM contractor should have fixed the pothole.
Finding 3 Signage	When maintenance work is being executed, the traffic control by means of signs and markings should be at a higher level as normal due to unexpected situations. The painted island taper should have been replicated by means of delineators.
Conclusions	Maintenance procedures such as resealing can result in dangerous conditions. The road authority should ensure a higher level of traffic control during the construction period as conditions change continuously.

**Figure 7- 25: Herbst: Pothole at end of lane**
