Maintenance engineering standards  
to fulfil the legal duty of  
road authorities towards safe roads

*Dissertation presented for the  
Degree of Doctor of Philosophy  
Faculty of Engineering  
Stellenbosch University*

March 2016

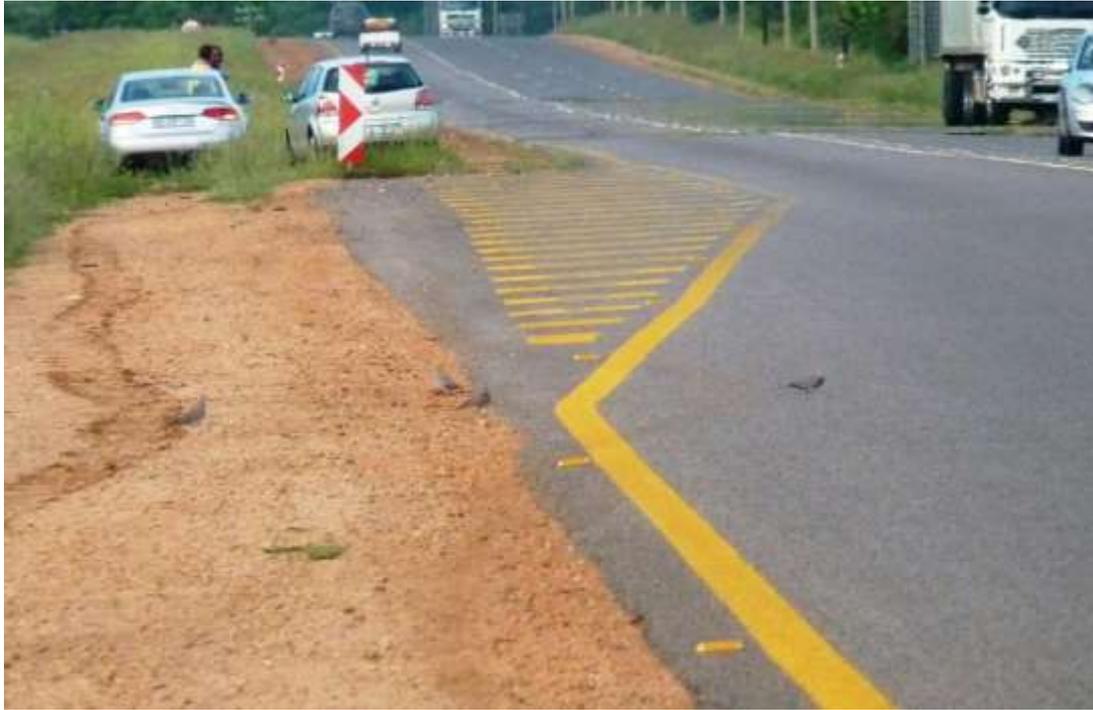
**Figure 7- 26: Herbst: Taper island over 200 m at lane drop**

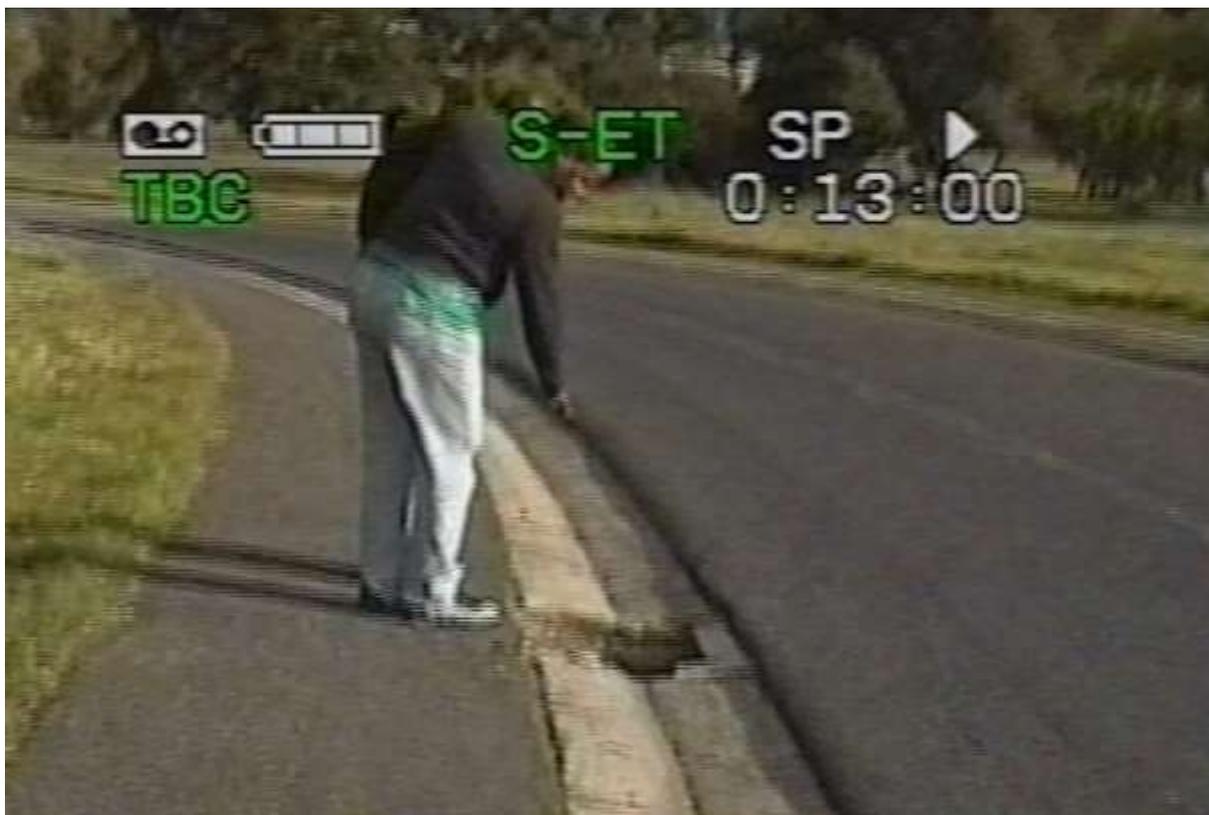
Figure 7- 28: Mothlapudi: Open drain as recorded the day after the accident

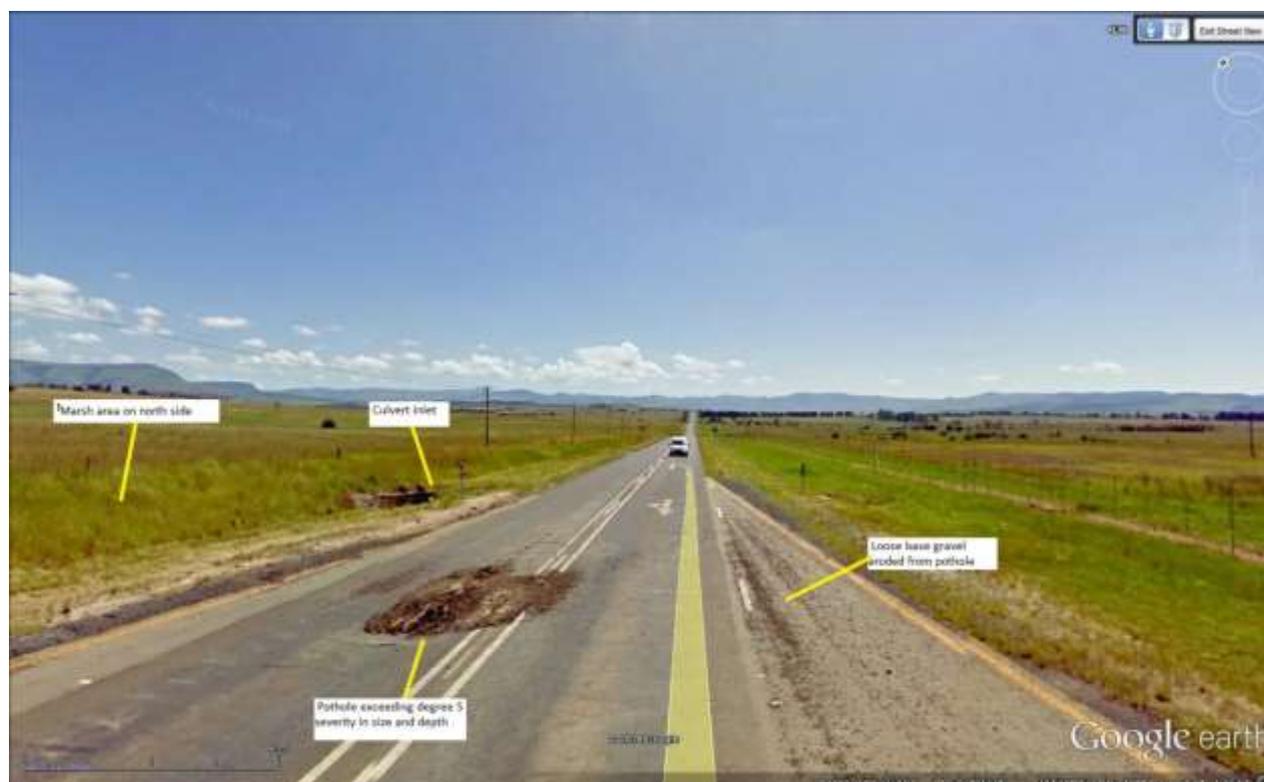
Figure 7- 29: Madonsela: Pothole on R38

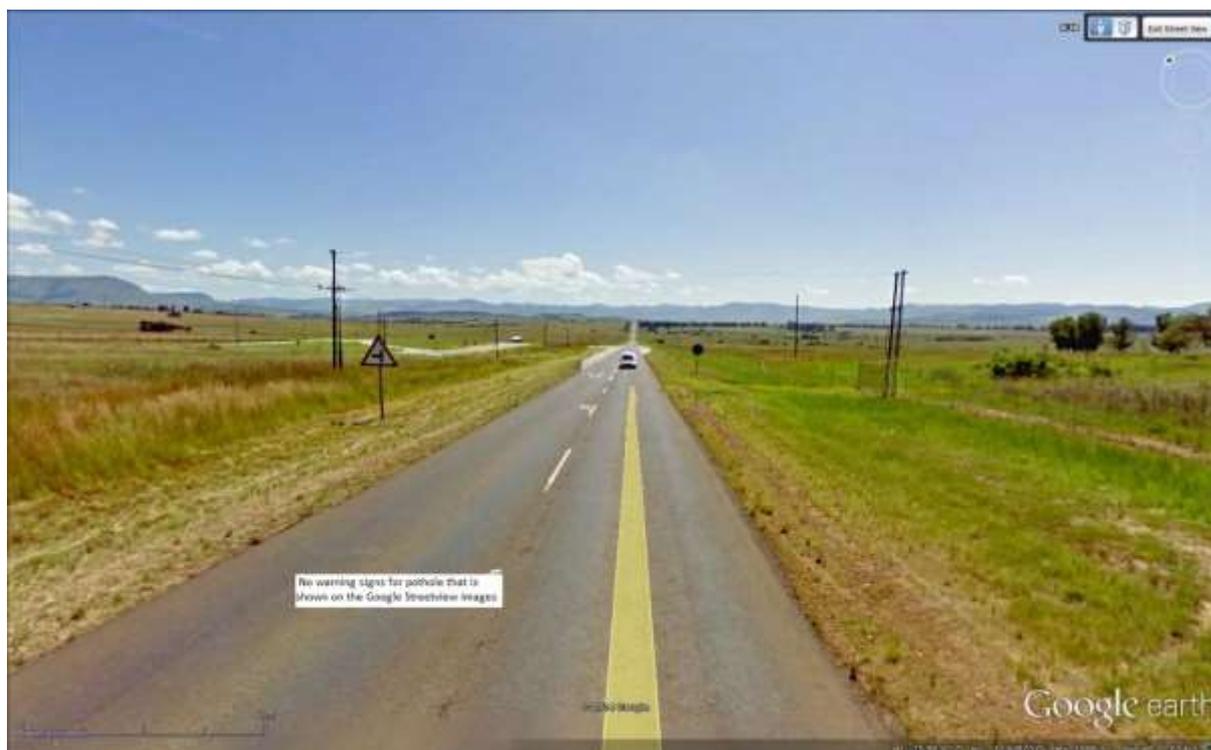
Finding 3 Signage	The contractor presented photographs of temporary signage on the approach to the pothole that would be adequate. Although not tested in evidence, it appeared that the signs were in place for the repairs the previous week or occasions and were taken down after the repairs.
Conclusions	The road authority and its independent contractors settled the claim in acknowledgement of their legal duty and negligence.  The dimensions of the pothole exceeded Degree 5 by far.  The superficial maintenance was done within contractual reaction time. The deep base failure to address fundamental causes was not done in a reasonable time and lead to recurring failures.  Adequate signage was not provided and maintained. Signage needed to be site specific, as a general warning of potholes at the start of the road section would not have had credibility due to the small potholes already repaired.

**Figure 7- 30: Madonsela: Lack of signage on approach to pothole on R38**

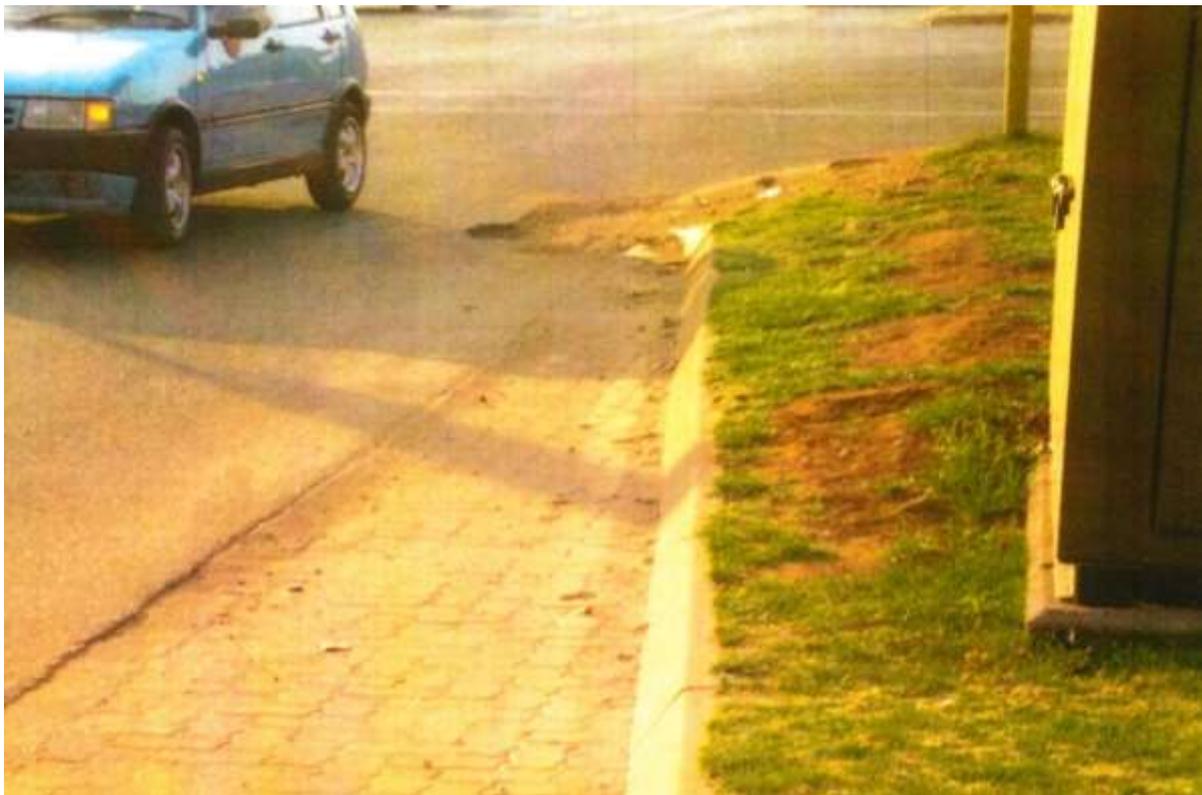
Pleadings	Unknown
Outcome,	Confidential settlement
Finding 1 Road environment	The size of the pothole was of a Degree 5 severity. In particular, the length was long enough for a tyre to fall in completely and the depth more that the tyre thickness.
Finding 2 Maintenance procedures and reaction times	A road such a Jean Avenue, an urban Class 2 road, should be inspected weekly. This is more so in a dolomitic area, where a few months after the investigation, a sink hole appeared over the full width of Jean Avenue and 10 m deep. This pothole had developed over a long period. Reaction time, if this pothole had been observed, was too slow.
Conclusions	The importance of this case is that road failures on the side of the travelled path / wheel track can present a significant hazard for bicycles and motorcycles.

**Figure 7- 31: Maritz: Pothole on Jean Avenue, Centurion**

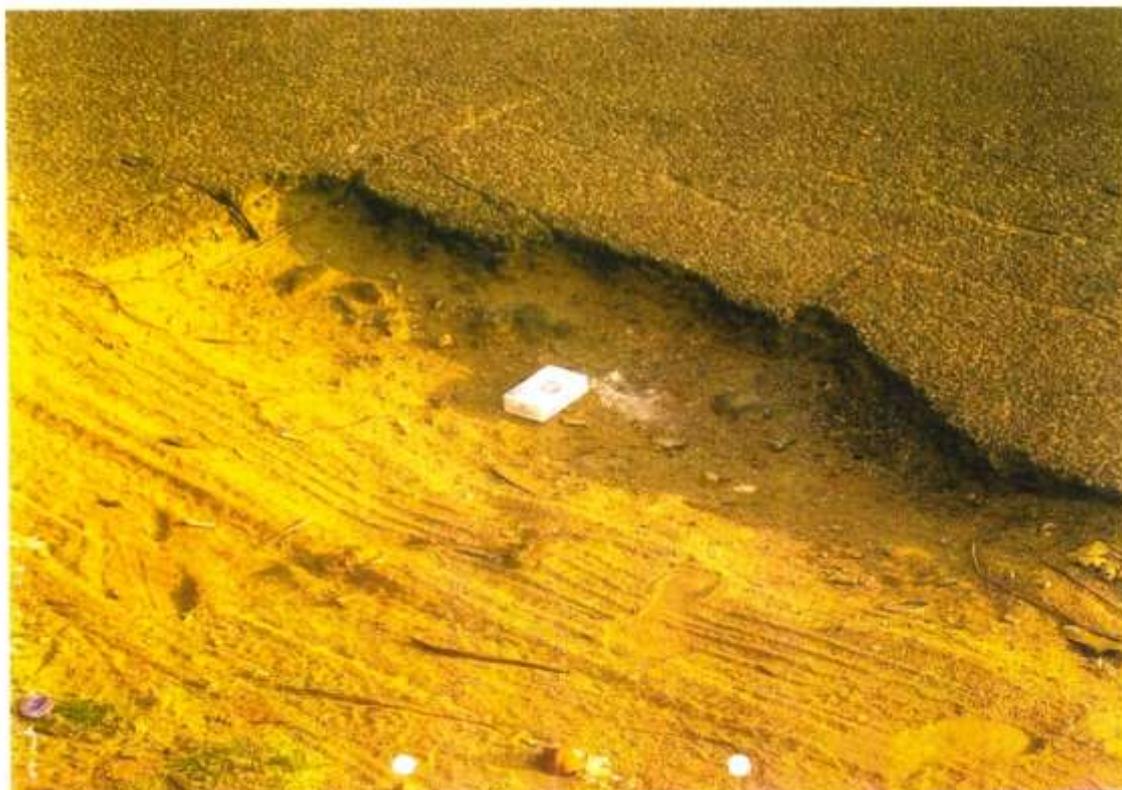
**Figure 7- 32: Maritz: Pothole sides and dimensions**

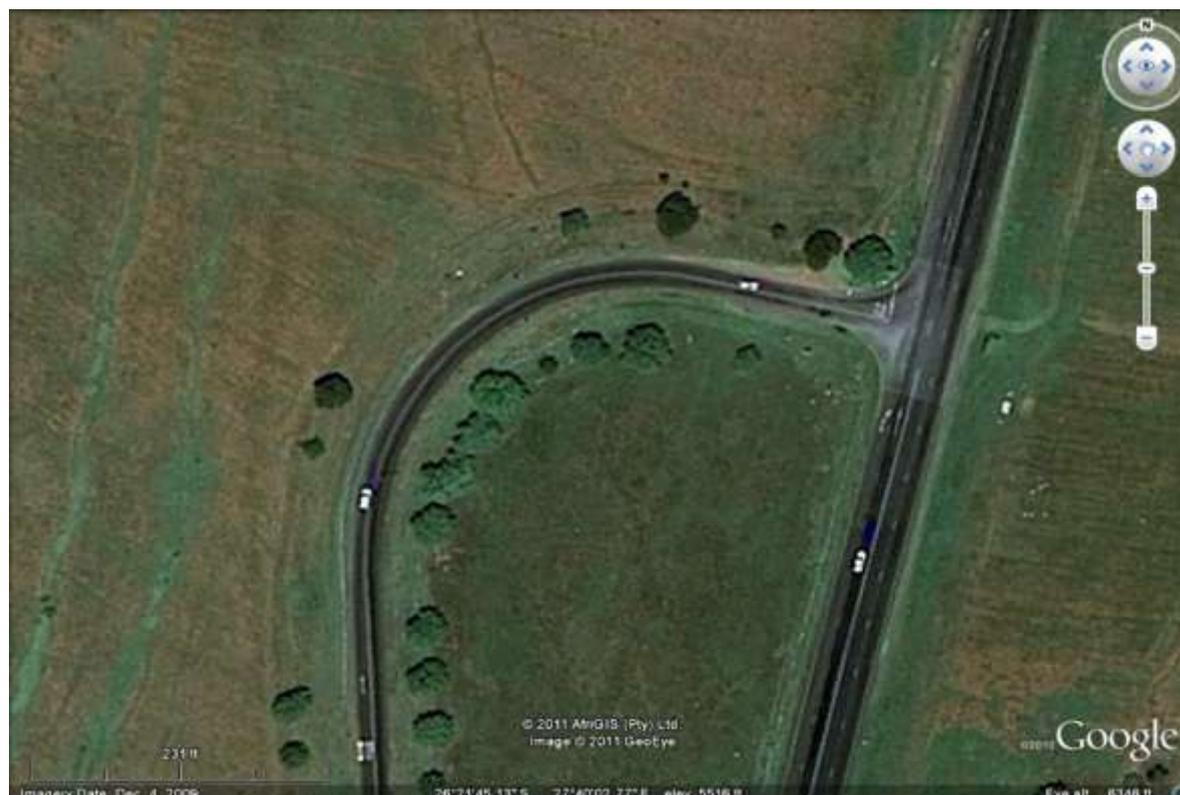
Conclusions	The 65 m radius curve in the road is severely substandard given the rural general speed limit of 100 km/h. The guardrail on the outside of the curve was approved at some point on either the design parameter or on accident history. Once a guardrail has been installed, it must be maintained. The fact that it is damaged often proves the need. Maintenance teams should report such hazardous locations and the obvious remedial measure would have been a speed limit of 40 km/h (design speed) 120 m before the start of the curve.

Figure 7- 33: Zentgraff: Curve where guardrail was not maintained

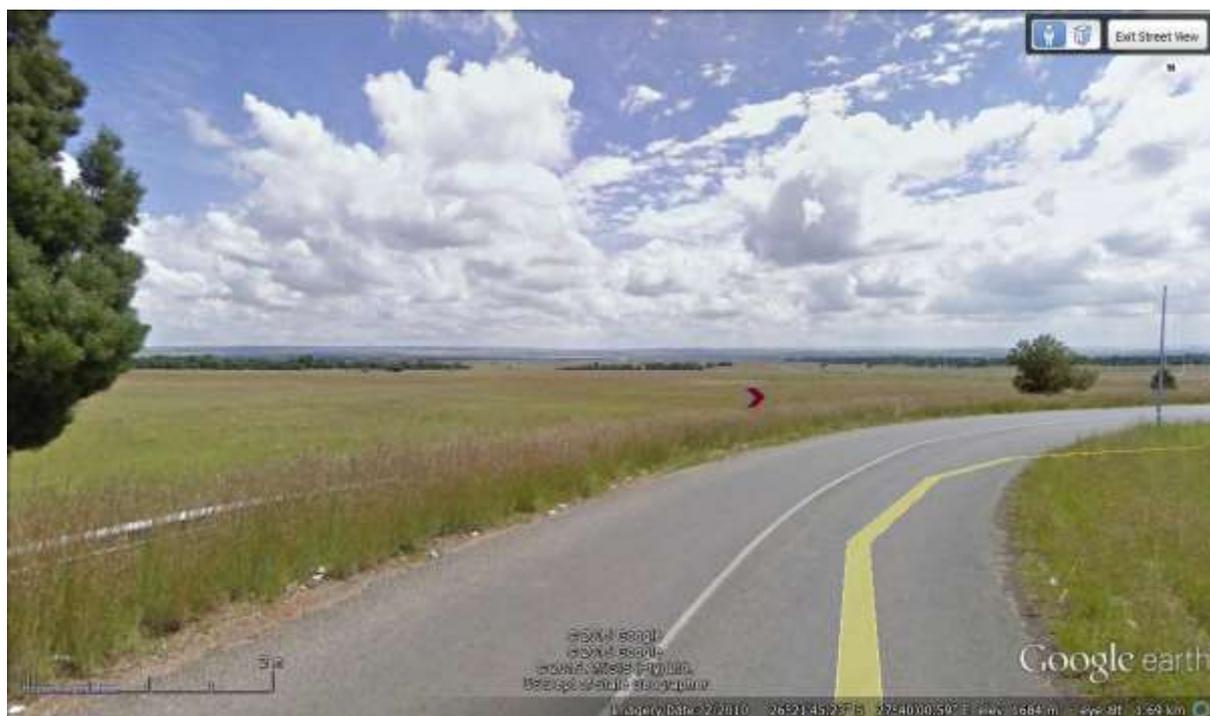
**Figure 7- 34: Zentgraff: Guardrail too low and partially down**

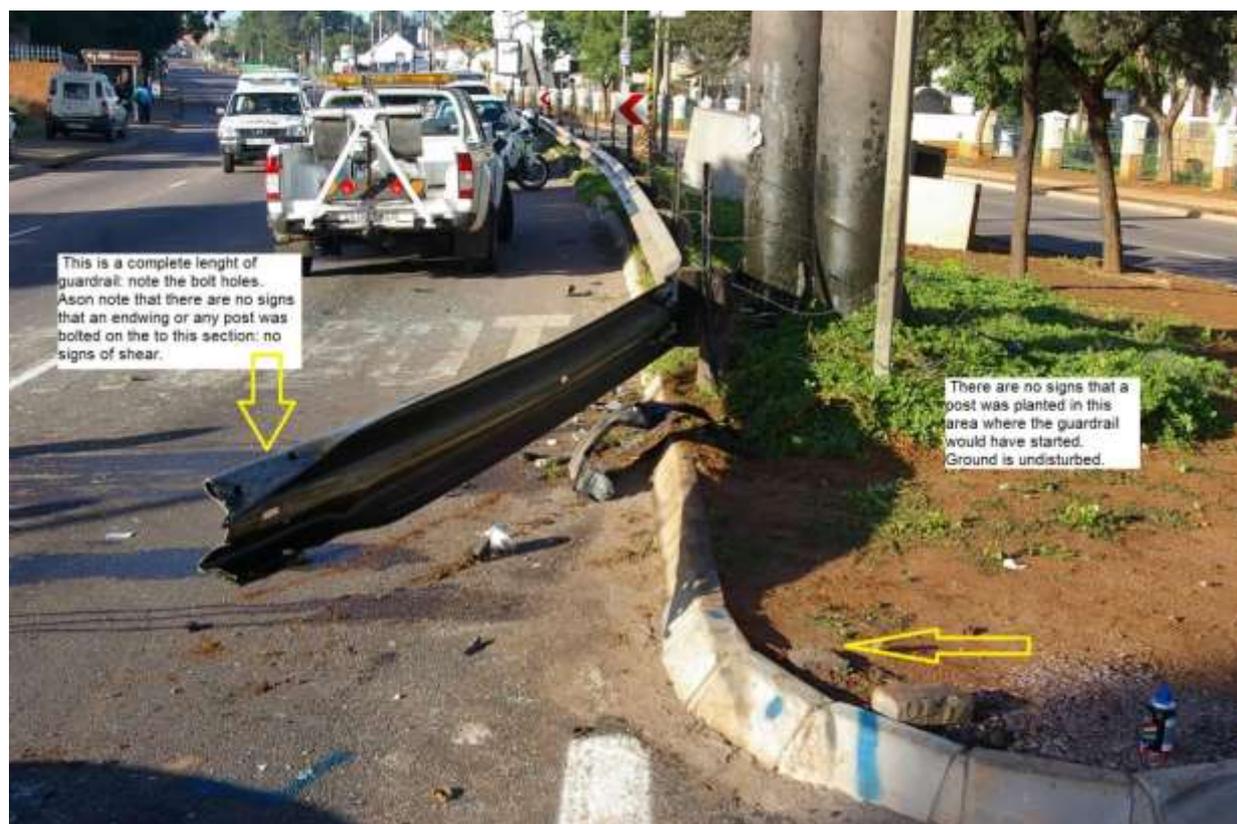
Figure 7- 35: Boshoff: Suspended guardrail end

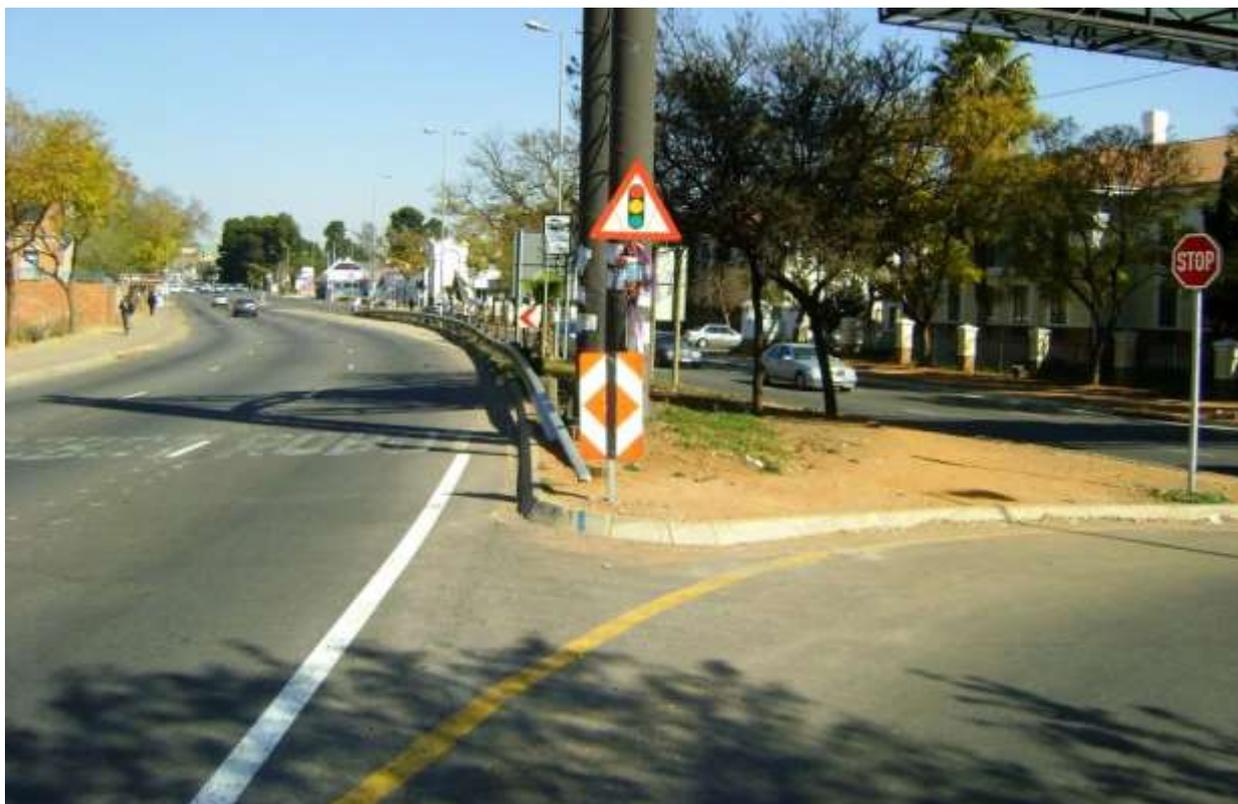
**Figure 7- 36: Boshoff: Guardrail end after remedial work**

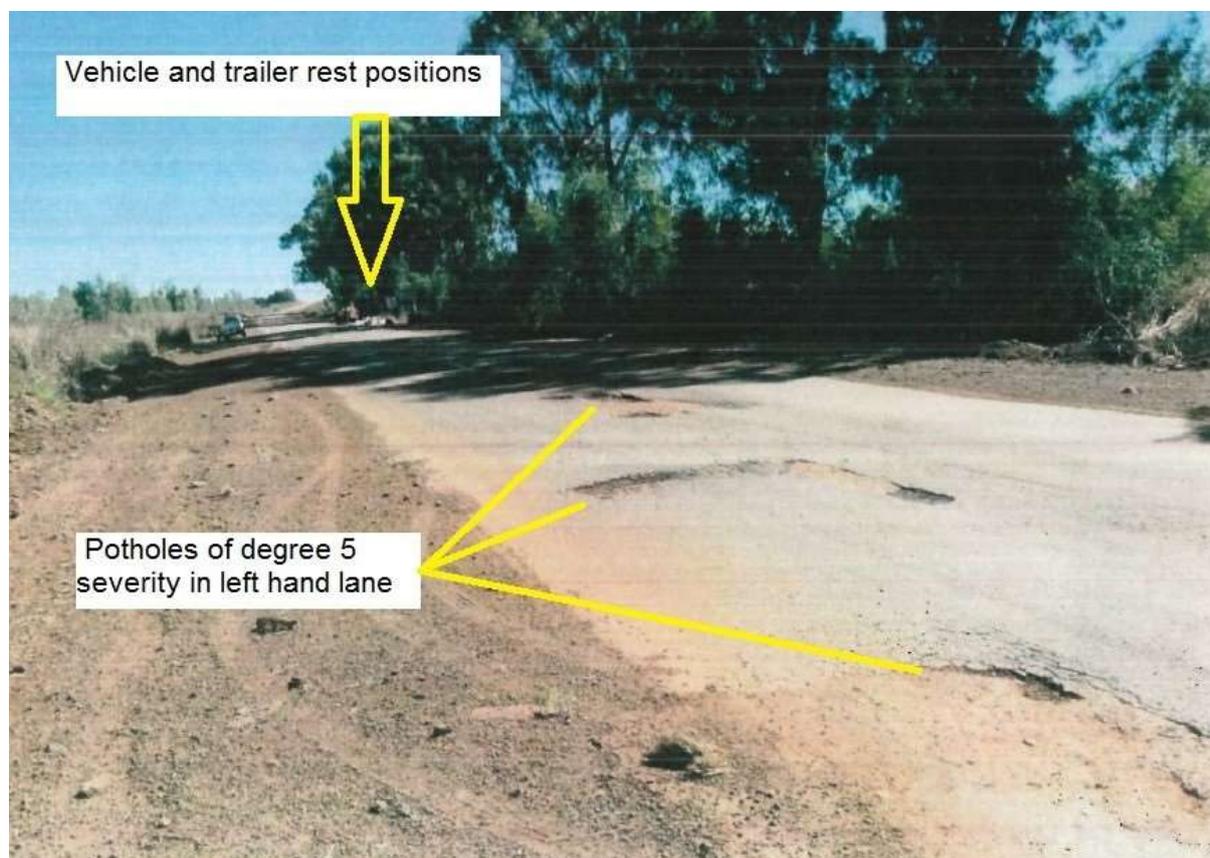
**Figure 7- 37: le Roux: Potholes on day of accident**

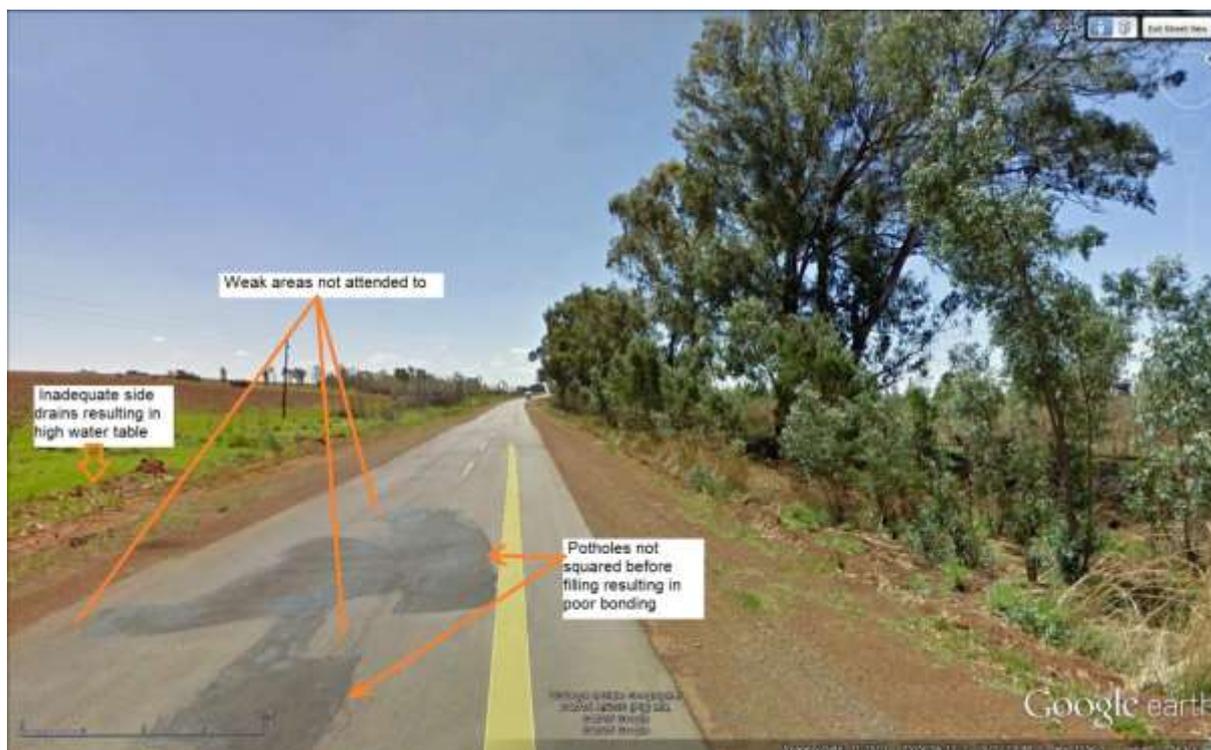
Figure 7- 40: le Roux: Repairs to the road

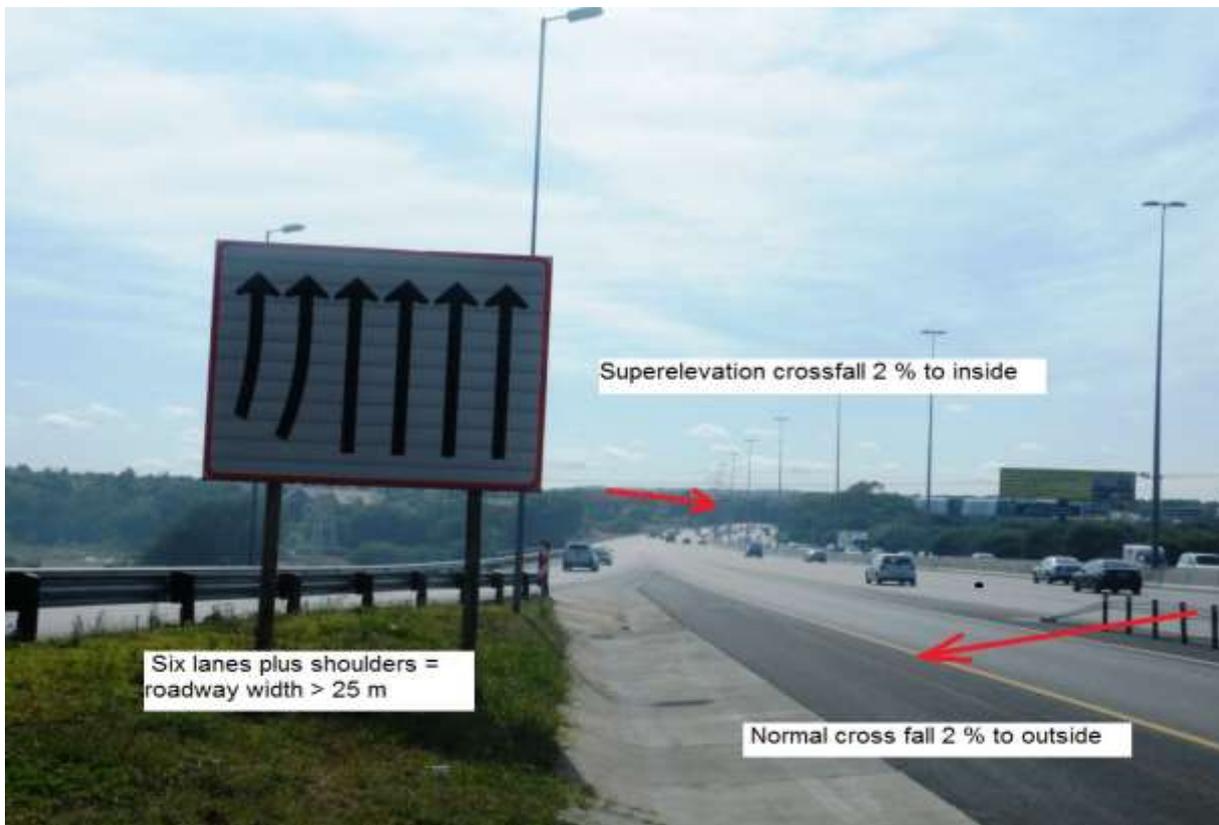
Figure 7- 42: December: Cross fall of road before and in curve

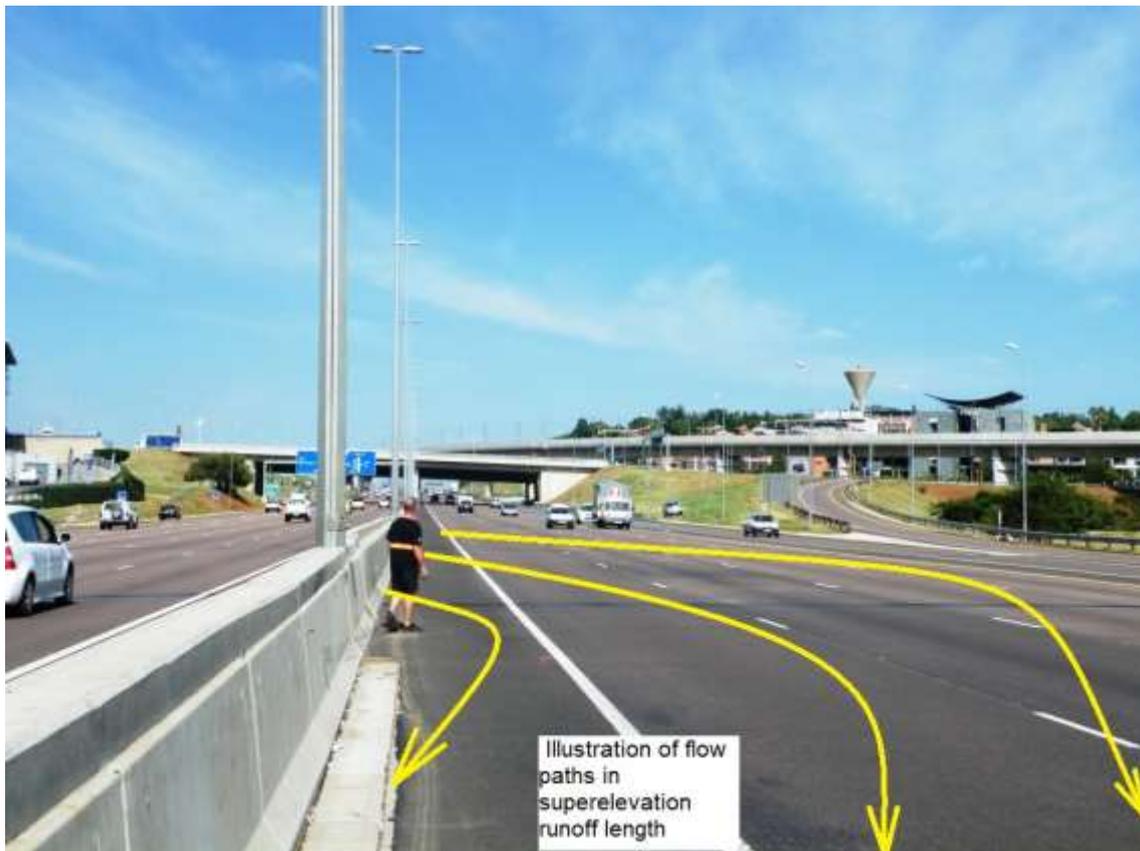
Figure 7- 43: December: Drainage paths in superelevation development

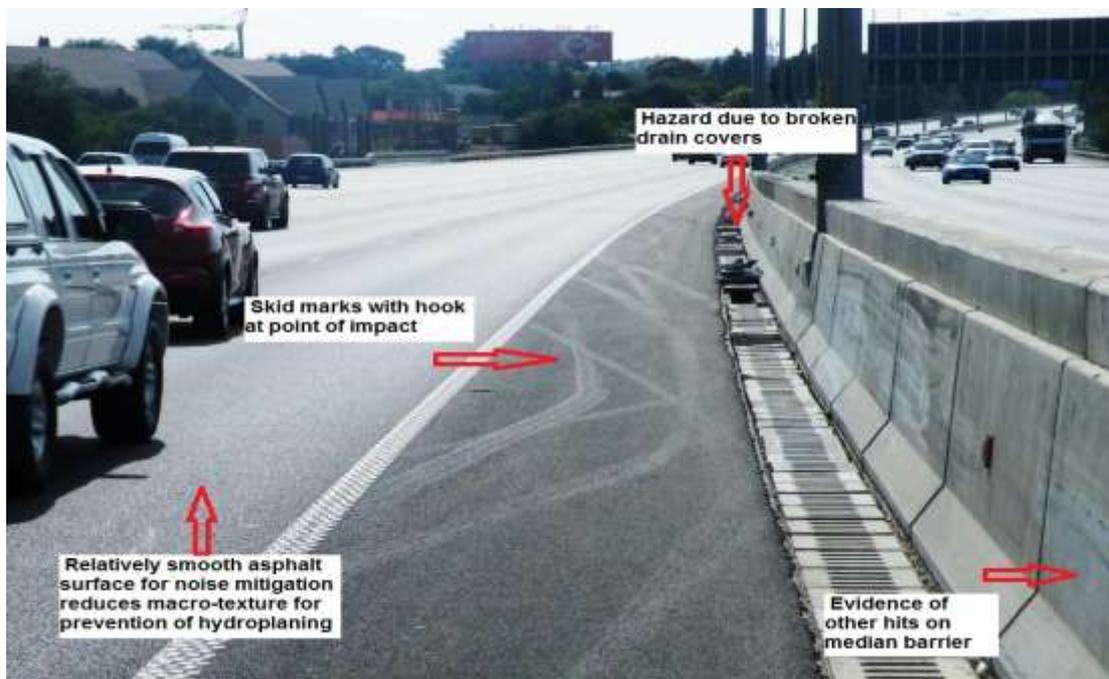
Figure 7- 44: December: Collision with median barrier

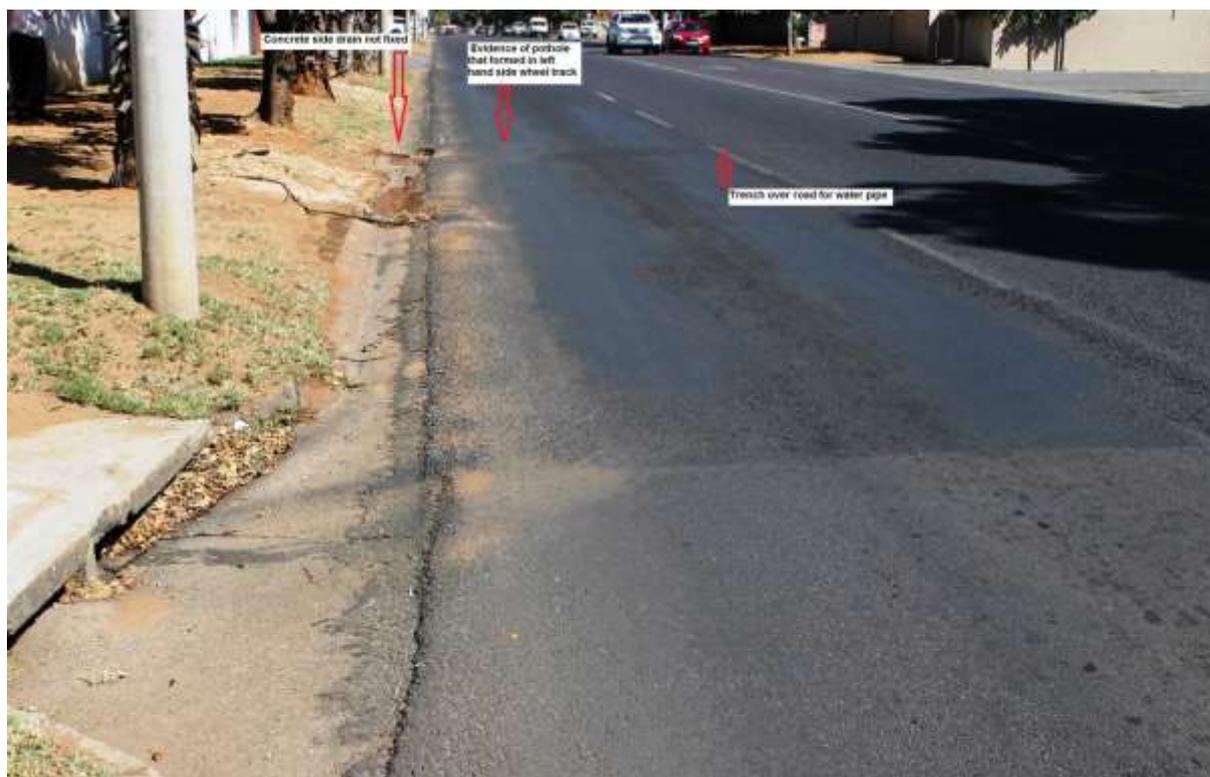
**Figure 7- 45: Pienaar: Pothole in wheel track after trench not reinstated**

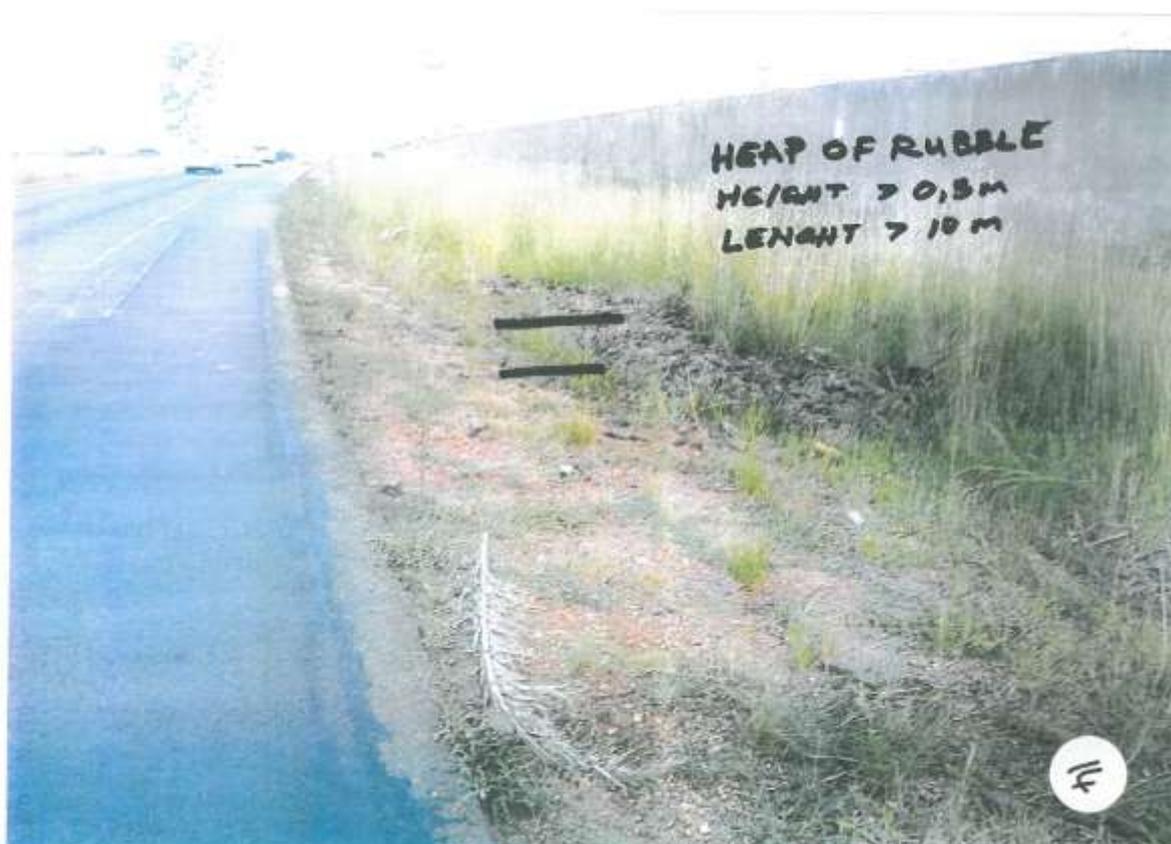
Figure 7- 46: Mathebathe: Debris on shoulder in clear zone

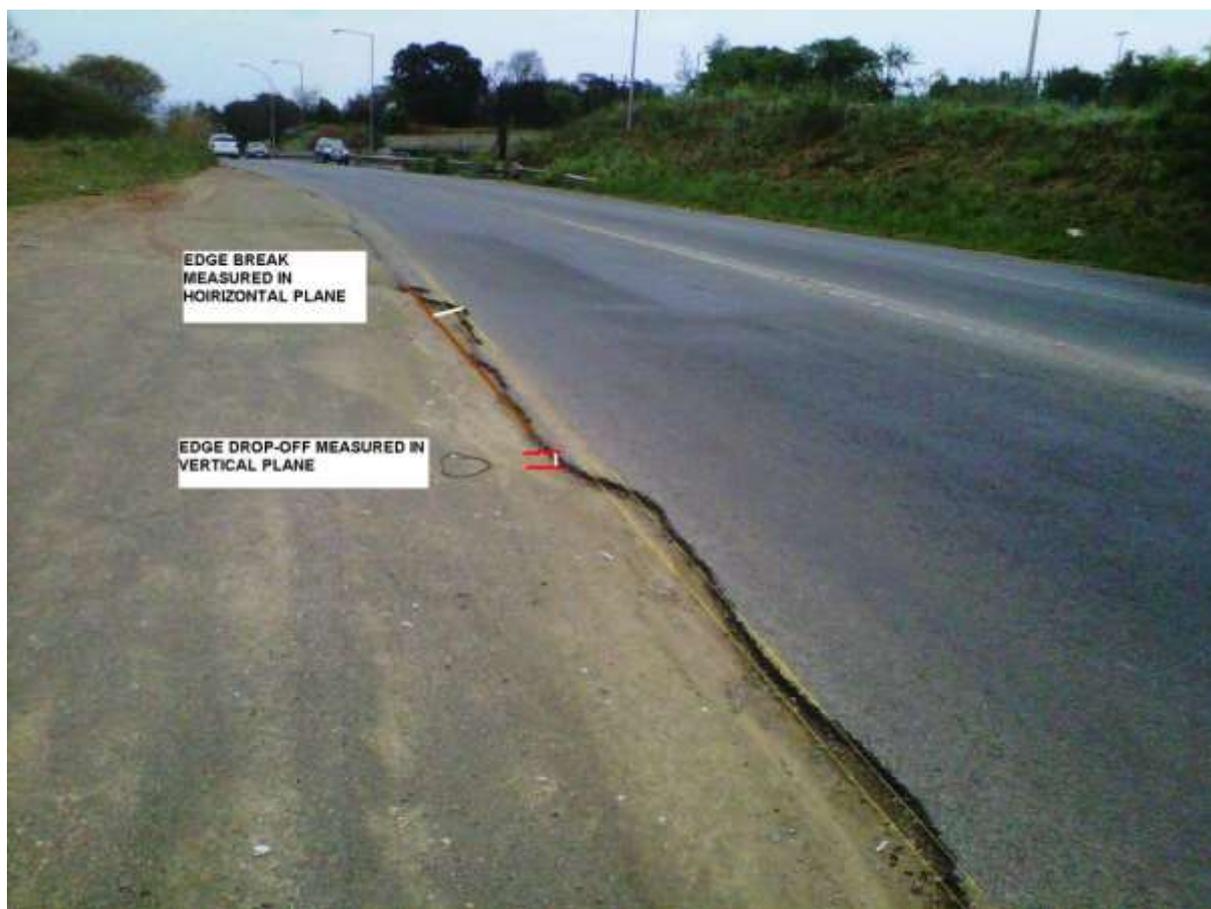
**Figure 7- 47: Deysel: Edge break and drop-off**

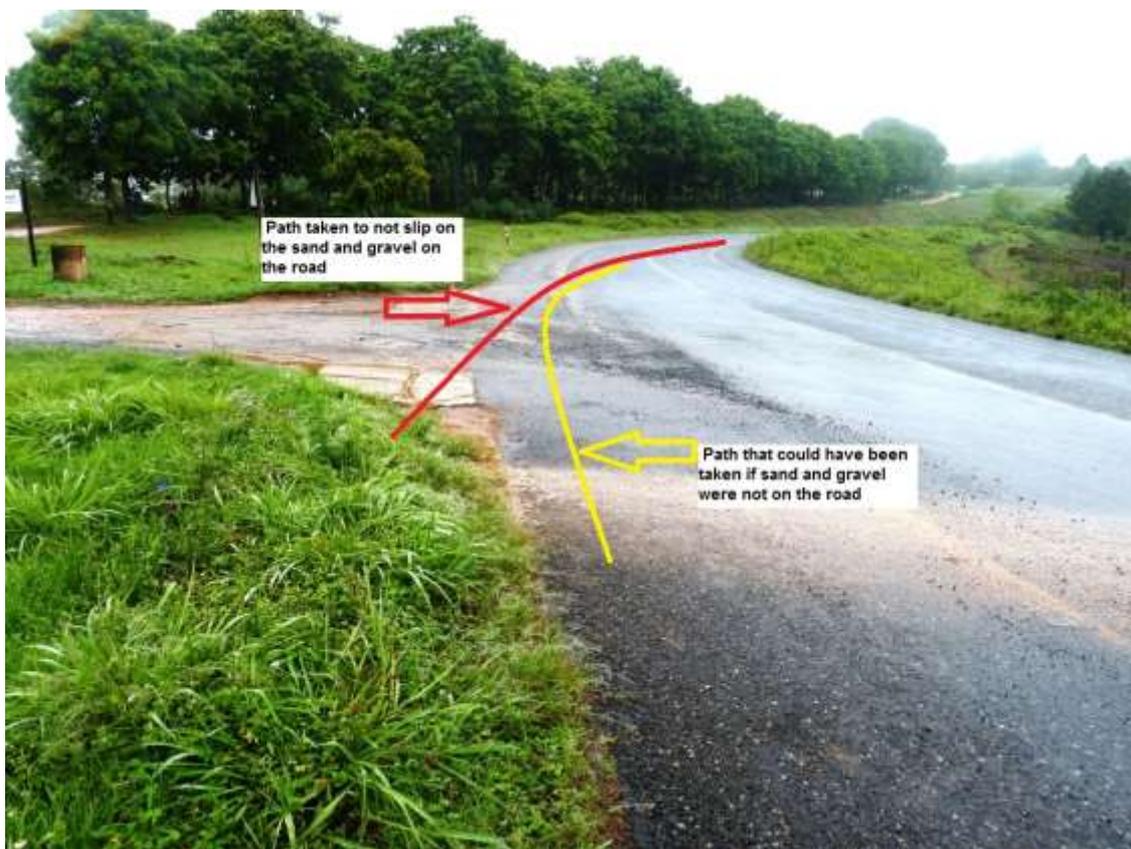
Figure 7- 49: van der Merwe: Gravel at Bergvliet access

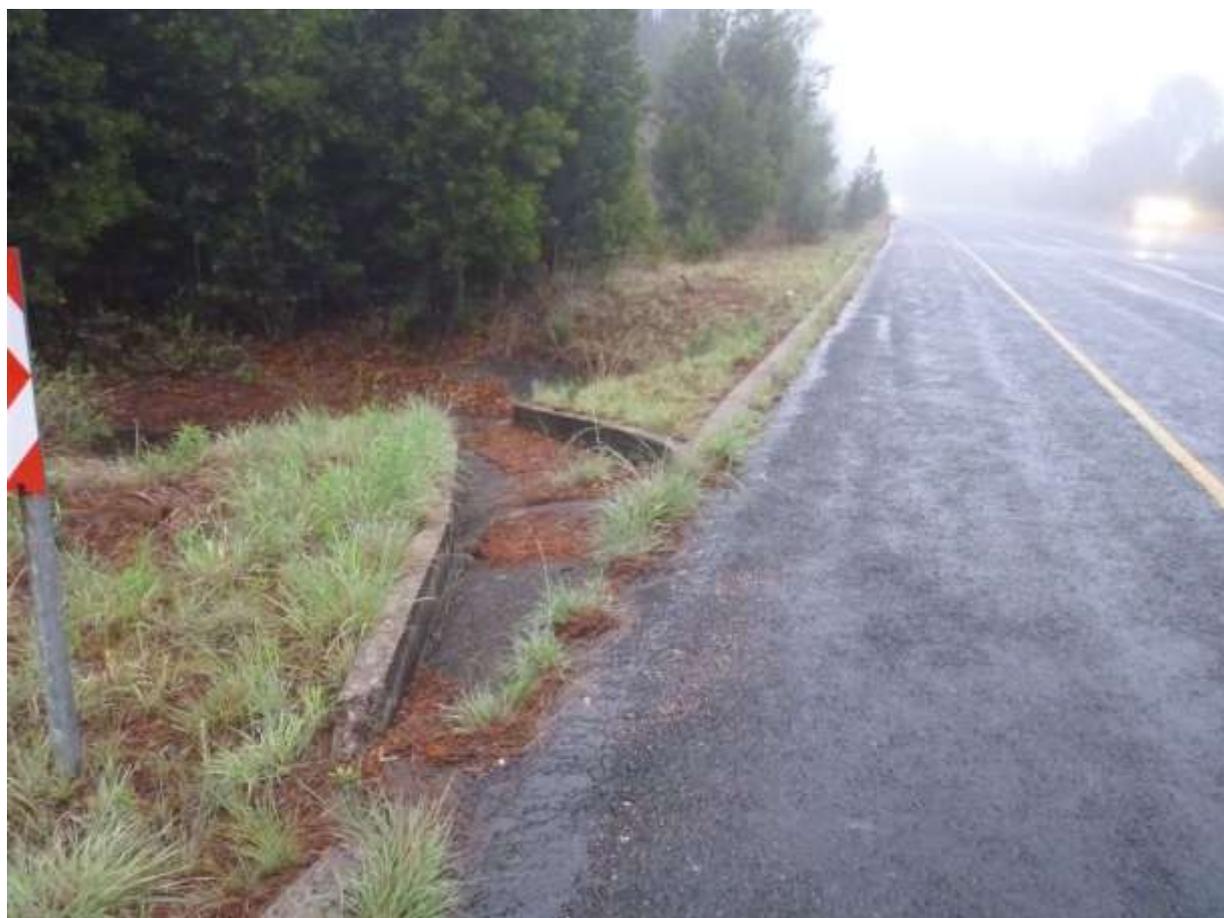
**Figure 7- 50: de Beer: Blocked down chutes**

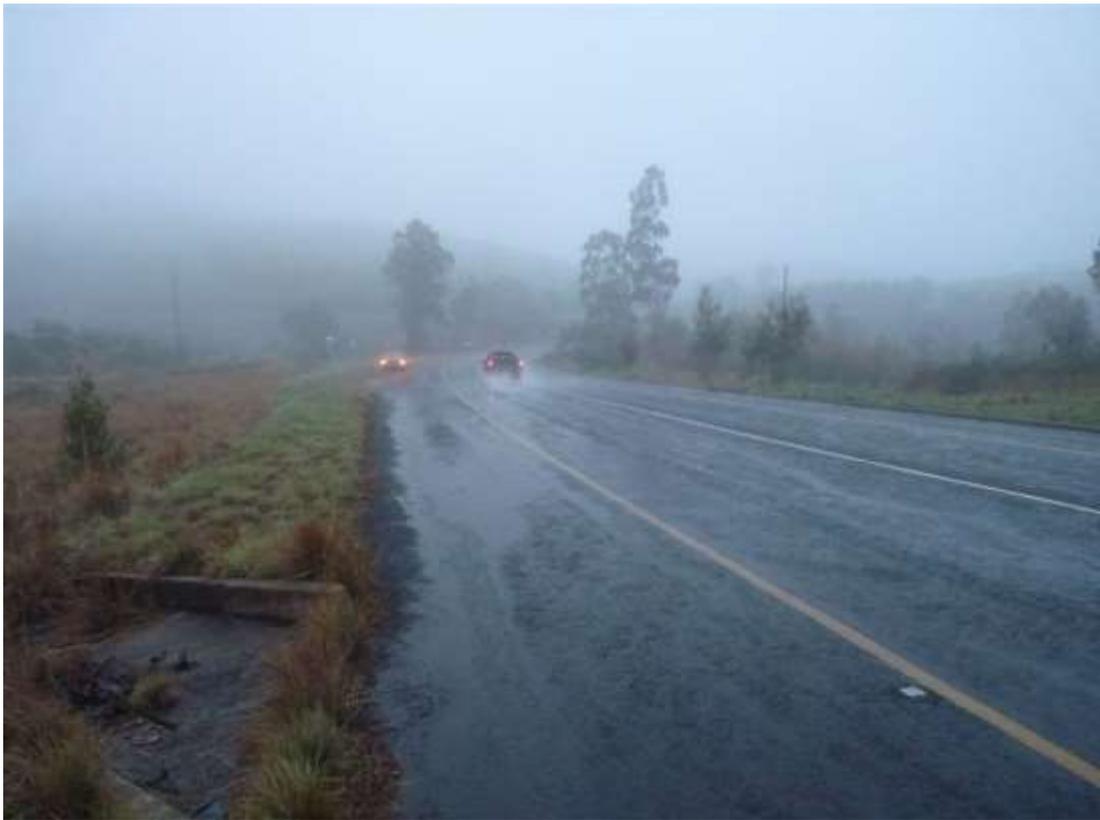
Figure 7- 51: de Beer: Drainage over road at superelevation development

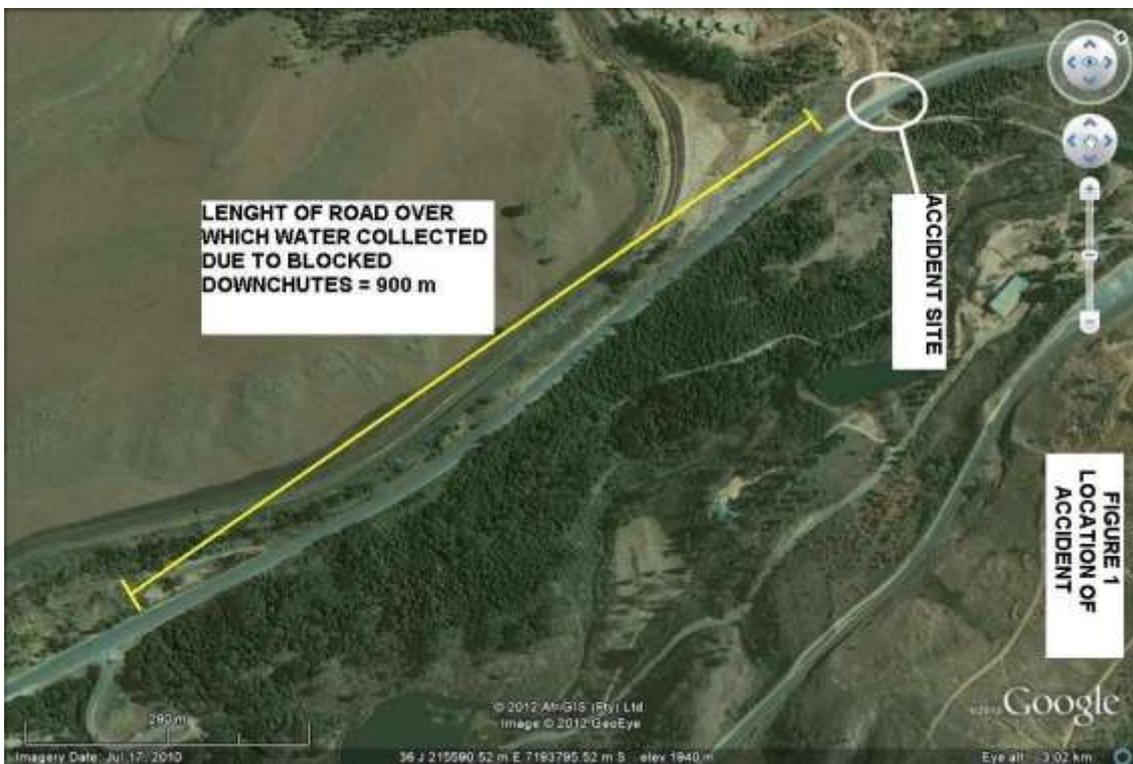
Figure 7- 52: de Beer: Length of drainage path

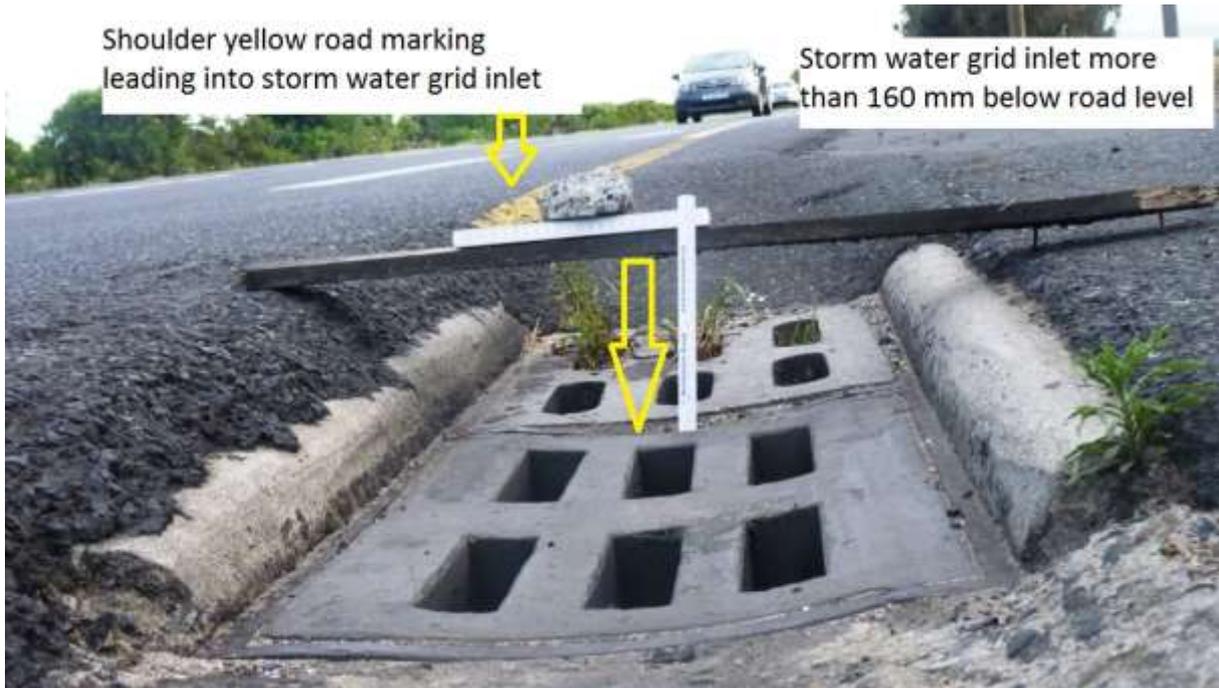
Figure 7- 55: Buijs: Drop-off due to asphalt build up at inlet grid
