Maintenance engineering standards  
to fulfil the legal duty of  
road authorities towards safe roads

*Dissertation presented for the  
Degree of Doctor of Philosophy  
Faculty of Engineering  
Stellenbosch University*

March 2016

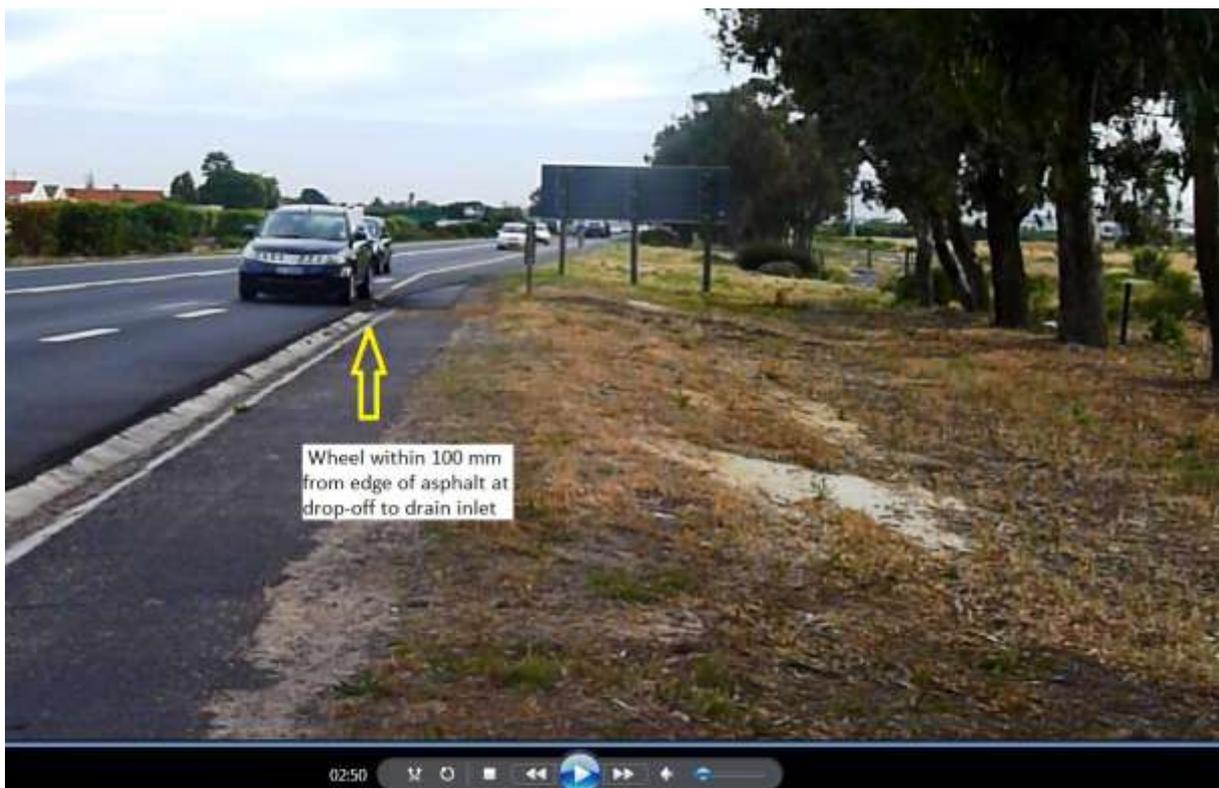
Figure 7- 56: Buijs: Hazardous drop-off on driving line

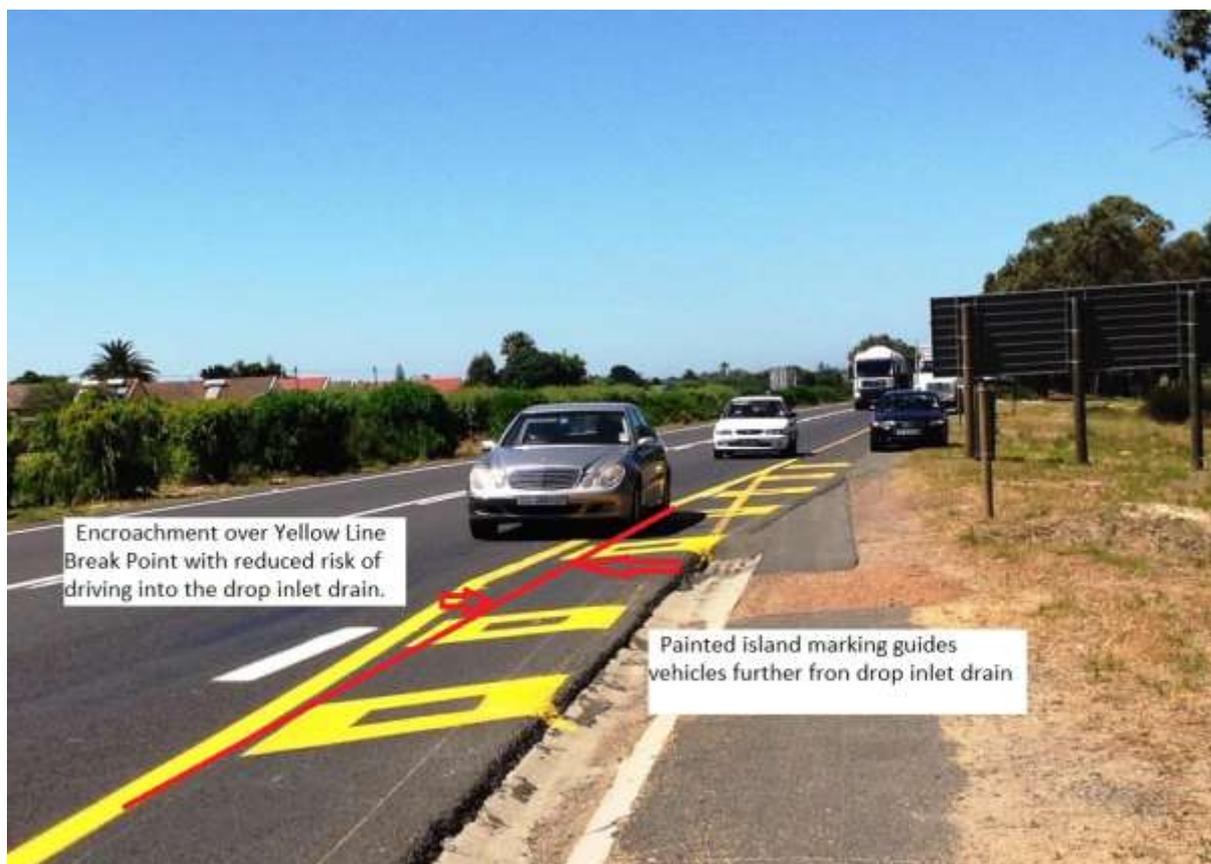
Figure 7- 57: Buijs: shift from hazardous drop-off with painted island

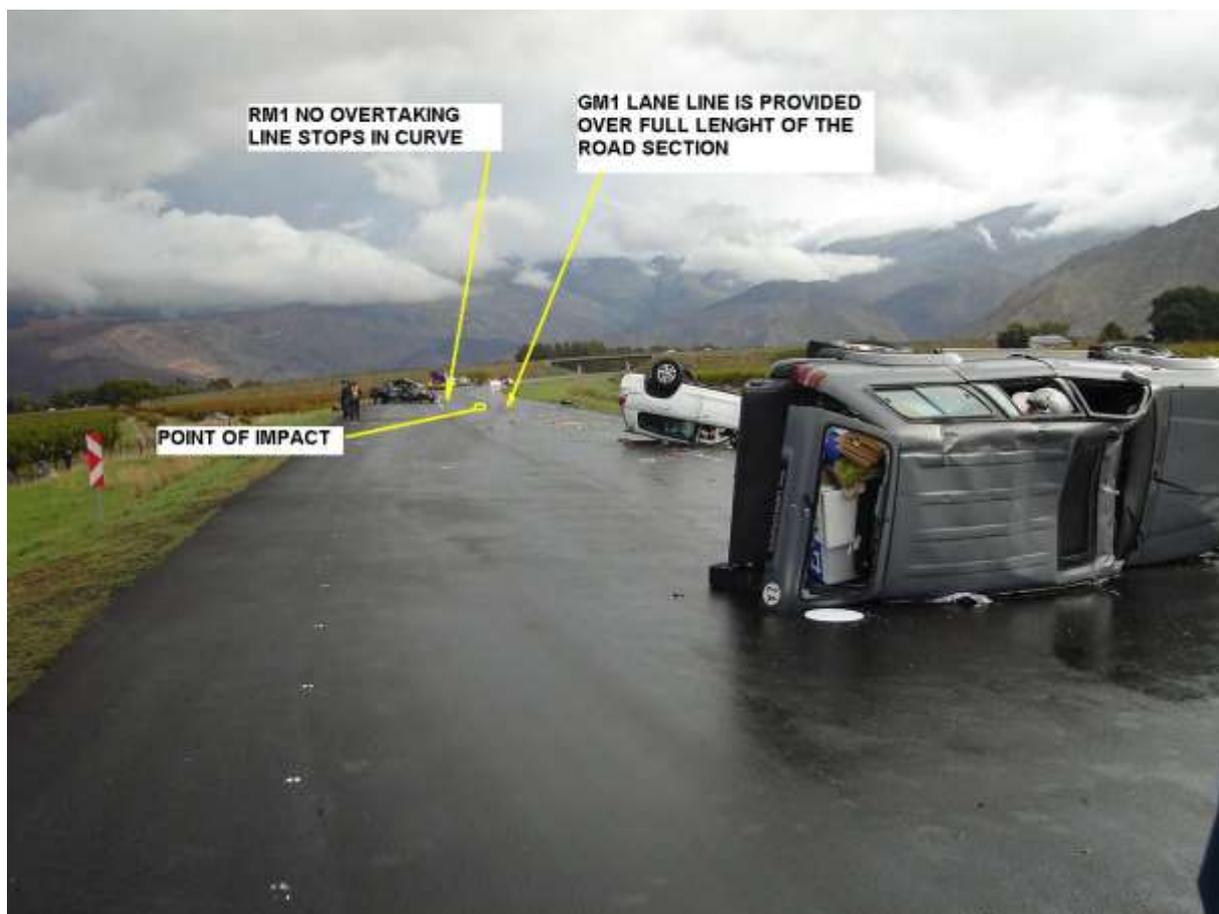
Figure 7- 58: Andrew: Gap in lane markings view to the west

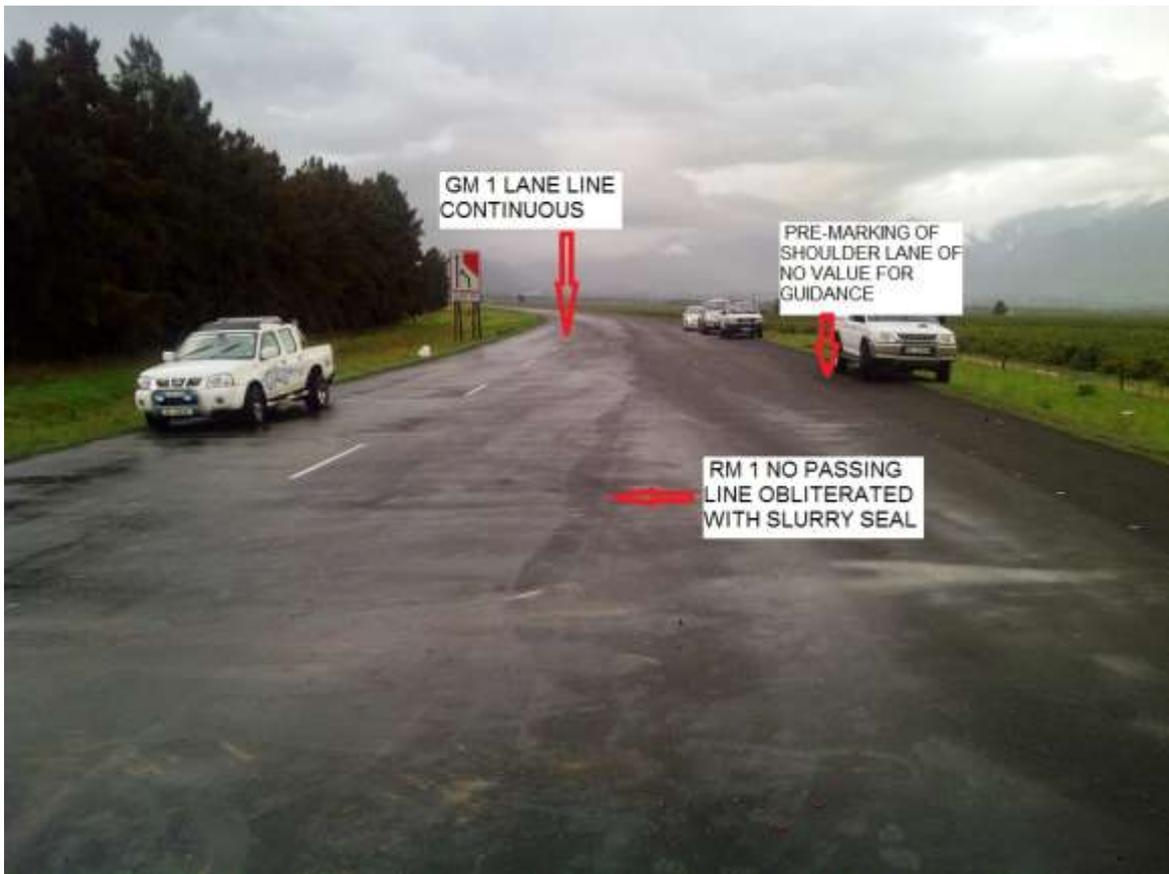
Figure 7- 59: Andrew: Gap in lane markings view to the east
