A Comparison of the Performance
of
High-Voltage Insulator Materials
in
a Severely Polluted Coastal Environment

Wallace Lockwood Vosloo

Dissertation submitted for the Degree of Doctor of Philosophy
in Engineering Science at the University of Stellenbosch

March 2002

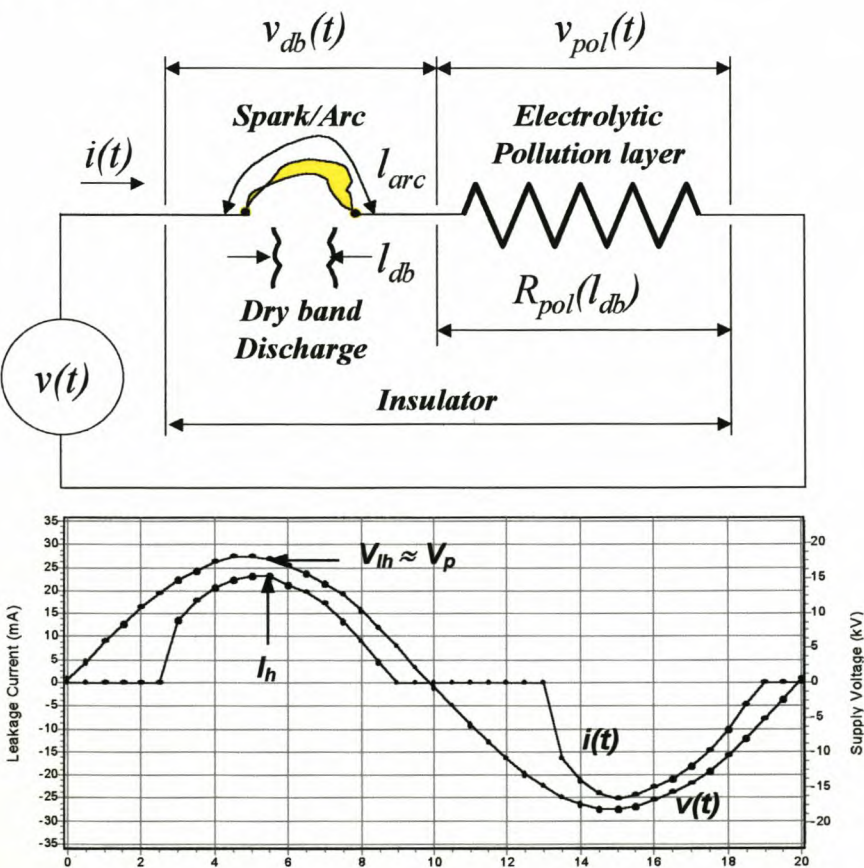
Figure1.3 Schematic electrical diagram representing the dry-band discharge (spark/arc) and electrolytic pollution layer on an insulator. An example of a typical leakage current and supply voltage waveform is included.

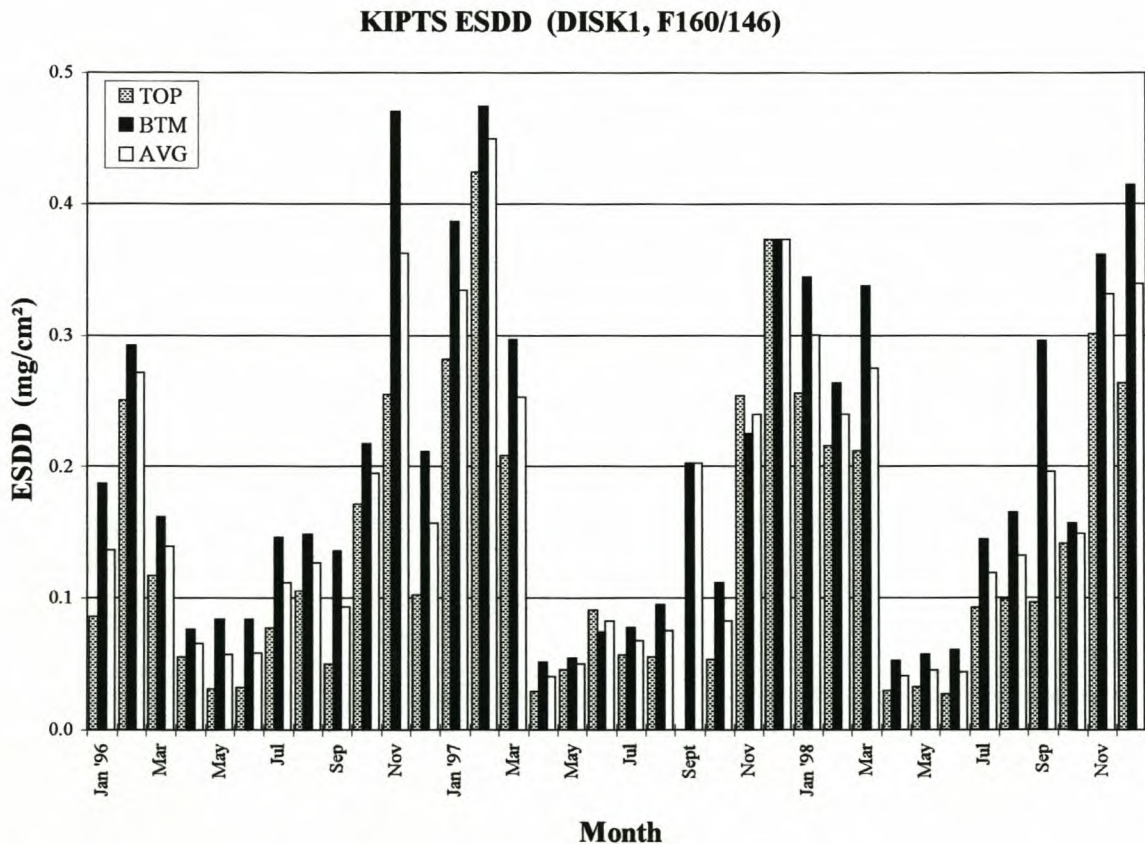
Figure 2. 2 Monthly equivalent salt-deposit density (ESDD) measurements at KIPTS on F160/146 glass disks (1996 - 1998)

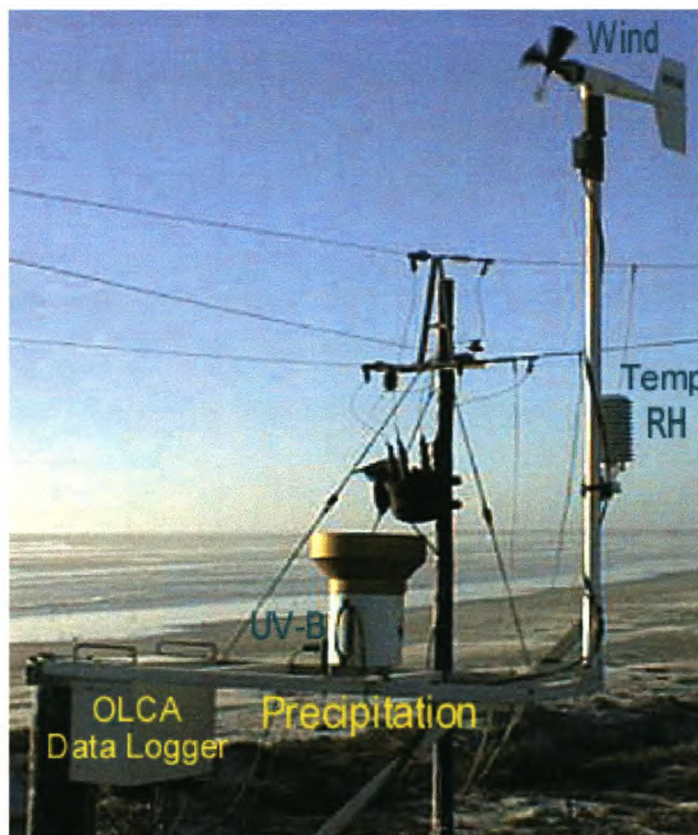
Figure 2. 8 Main components of the on-line leakage current analyser (OLCA)

Commercially available leakage current and climatic data loggers were investigated. They were found to be unsuitable for the test programme. The author therefore investigated the various leakage current parameters monitored internationally and then, jointly with the local company NETELEK, developed a leakage current data-logger system (the IH48). The logger was successfully installed at KIPTS and details of the system were published [32]. A new smaller data-logger system, which monitors both leakage current and climatic conditions, was needed in the field and for the test programme. The author, together with another local company CT-Lab, developed the On-line Leakage current Analyser (OLCA) (see Figure 2. 8) to accommodate these needs. The OLCA is now commercially available and sold internationally. Both the IH48 and the OLCA were used in the test programme to monitor and record (on computer) the leakage currents. The IH48 was used as back up to the OLCA in event of failure and, in addition, to monitor the leakage current levels above the chosen OLCA sensor range of 500 mA. The leakage current sensor used is galvanically isolated (up to 6 kV) and has a bandwidth of 10 kHz.

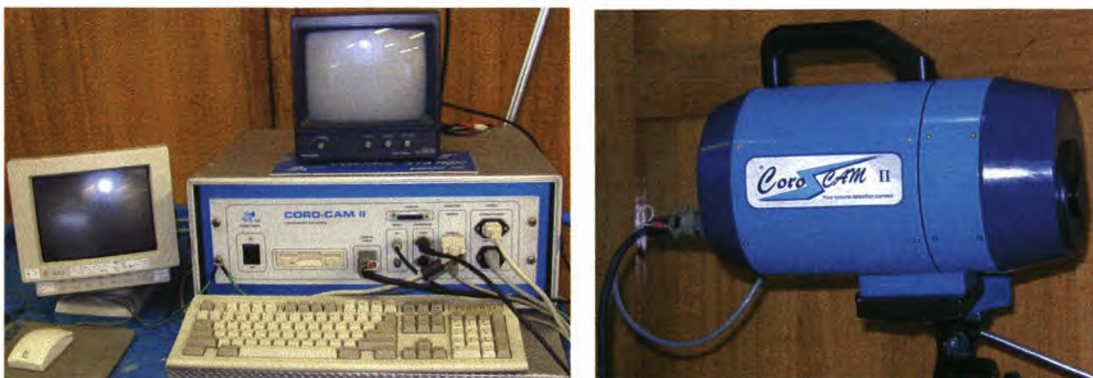
Figure 2. 10 CoroCAM Mark II, image-intensified, ultraviolet-sensitive, video camera and leakage current frame-grabber system

The CoroCAM Mark II (see Figure 2. 10) was designed to overcome these problems. The amplification of the photon multiplication tube was increased ten fold, to 100 000 x, and the image intensifier was made gate controlled. The camera is fully weatherproof and controllable from a distance of up to 40 m. The filters are enhanced, to aid outdoor observations. The leakage current, supply voltage (sampled at 10 kHz) and visual observation are recorded in synchronism and stored on a disk. The system is fully integrated and the user defines the leakage current trigger level, the exposure time and where on the 50 Hz cycle the image-intensifier gate opens.

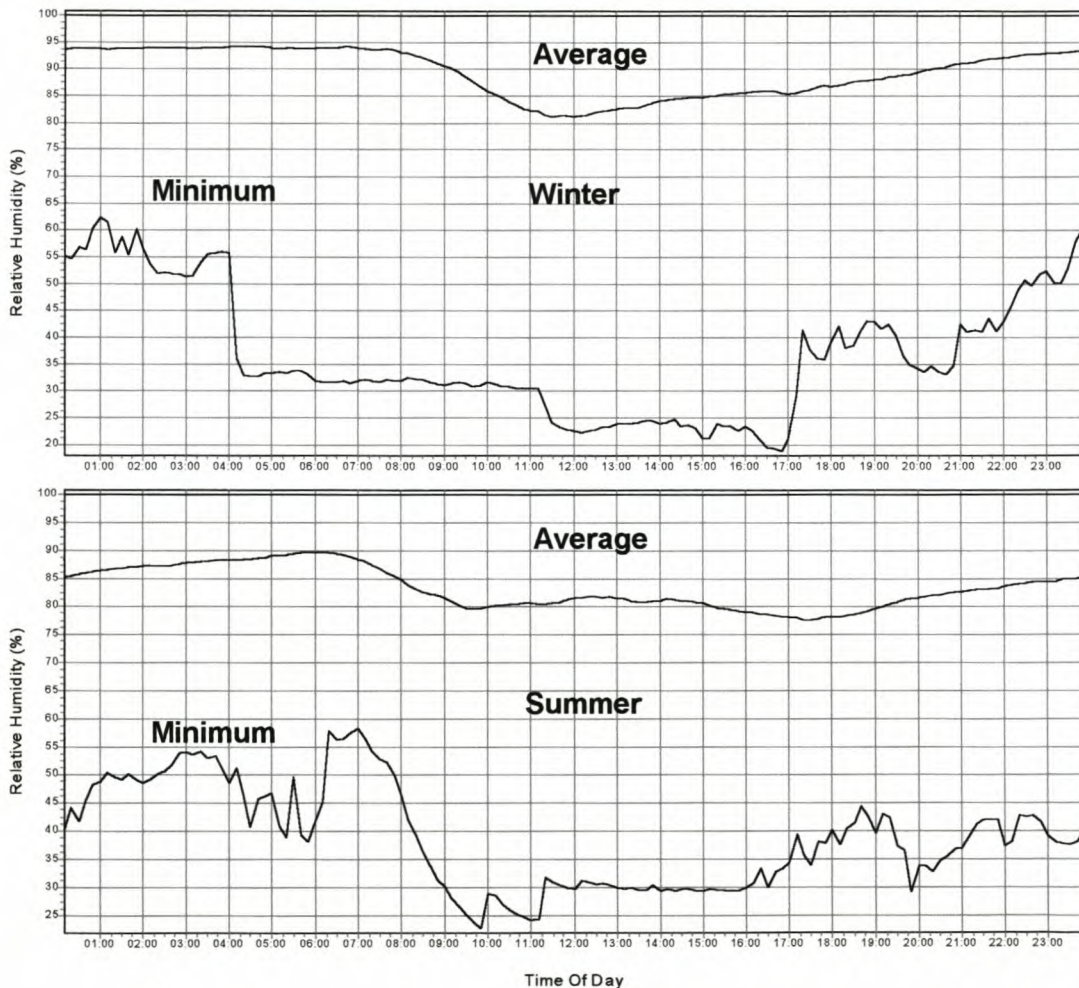
Figure 3. 10 Time-of-day trends of the minimum, average and maximum (100%) relative humidity measurements during the winter and summer periods.

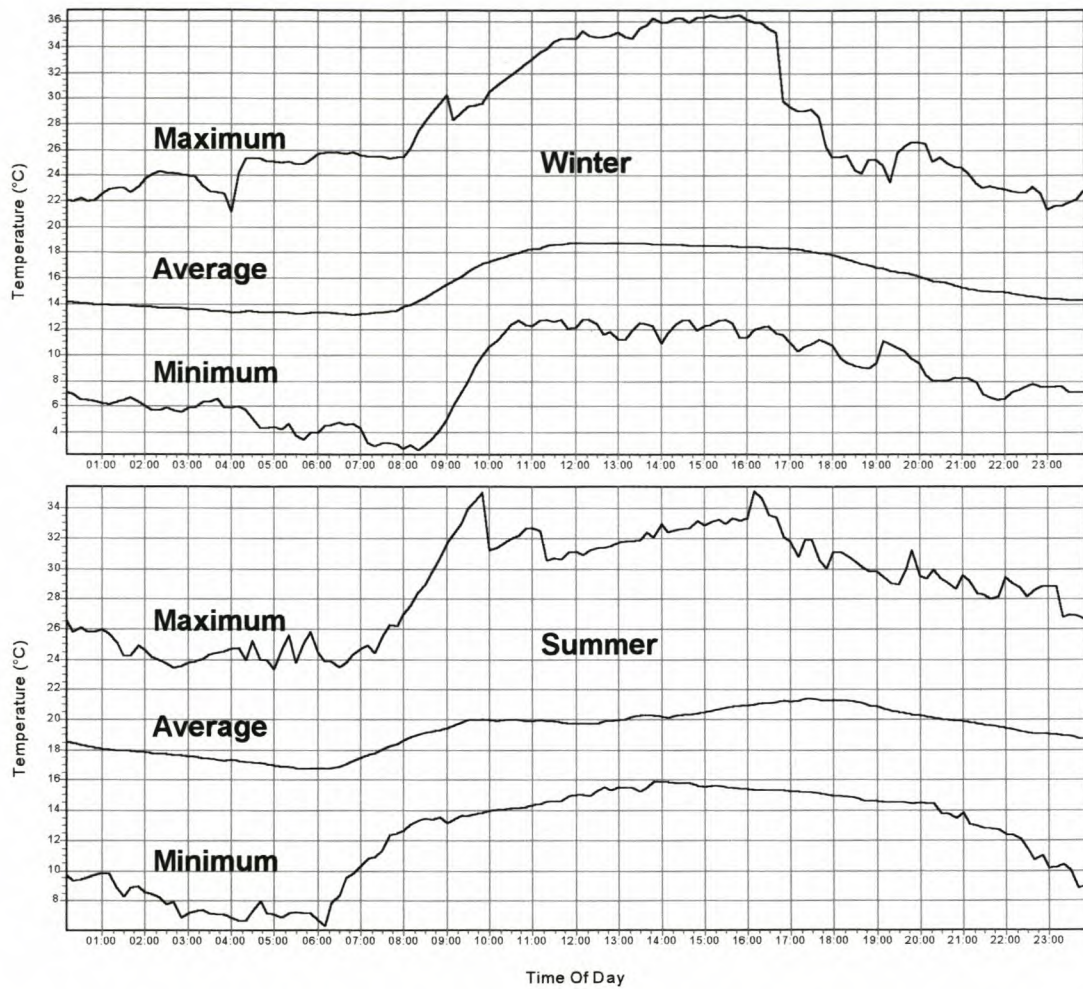
Figure 3. 13 Time-of-day trends of the minimum, average and maximum ambient temperature measurements during the winter and summer periods.

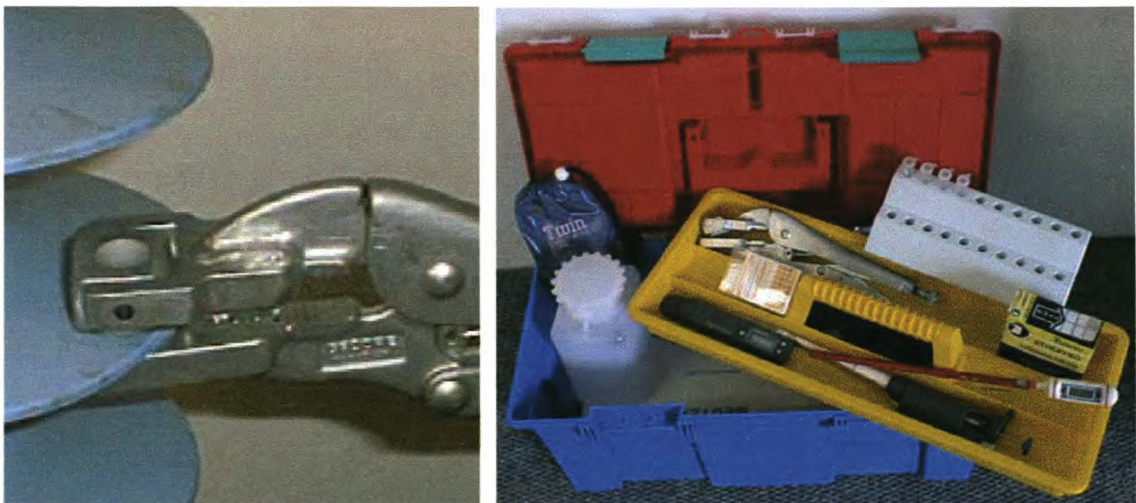
Figure 4. 5 LESDD sampling tool and associated toolbox with measuring equipment.

Localised ESDD (LESDD) measurements were made on insulators 6S and 7E energised and non-energised using the method as discussed in the paper “A novel method to measure the contamination level of insulators – spot contamination measurement” [54]. Four readings corresponding to the cardinal points (north, east, south, and west) were taken on the top of the sheds. The LESDD test commenced at the first shed on the live side and was done subsequently on the next shed up towards the earth side, and then restarting at the live side. By not sampling on the same shed for every test, the disturbance of the pollution layer was minimised. The LESDD sampling tool and associated measuring equipment is shown in Figure 4. 5 below.

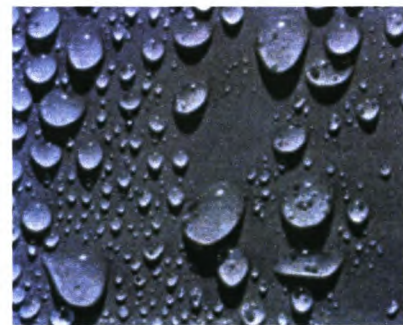
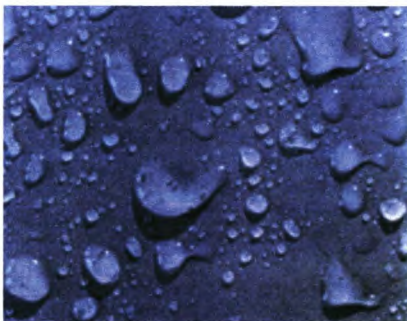
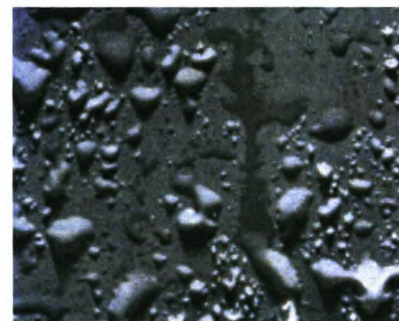
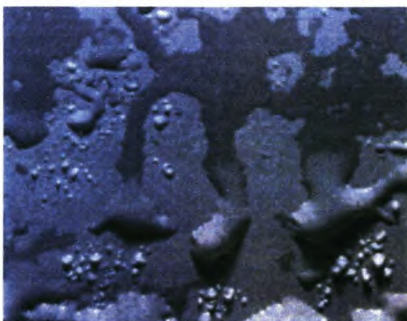
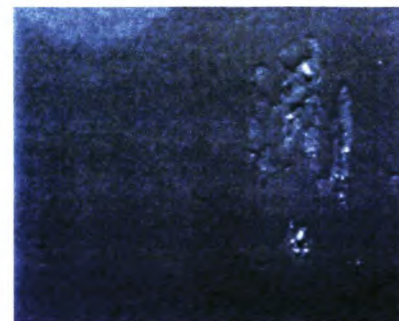
Figure 4. 13 Typical photographs of surfaces with HC from 1 to 6 (natural size), as copied directly from the STRI guide [58].

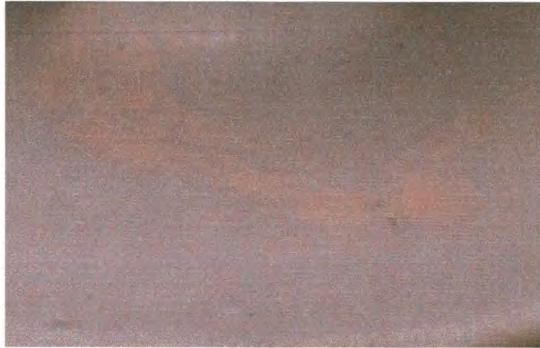
(a) Discolouration

Discolouration: Discolouration is a change in the base colour of the housing material of the composite insulator [60]. See Figure 5.1 (a).

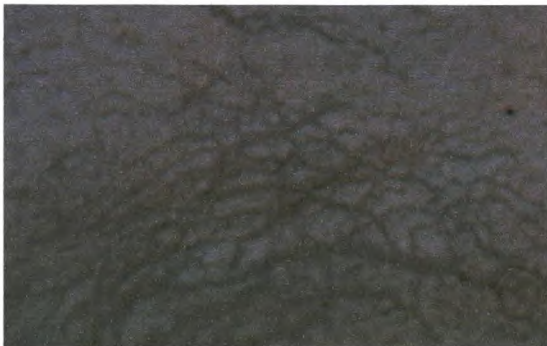
(c) Crazing

Crazing: Crazing comprises of surface micro-fractures of depths approximately 0.01 to 0.1 mm [60]. When the surface fractures are deeper than 0.1 mm, they are then referred to as “alligatoring” or crocodile skin [60]. See Figure 5.1 (c).

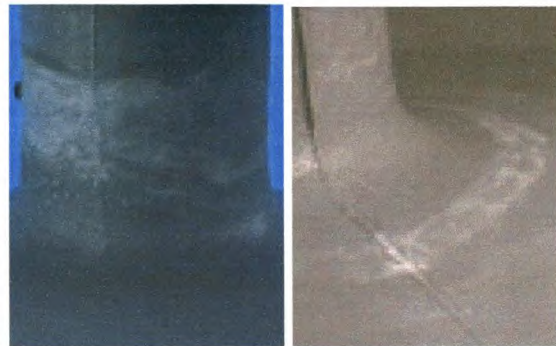
(d) Dry bands

Dry bands: Dry bands are the signs left on the insulator material surface after dry-band activity has taken place. See Figure 5.1 (d).

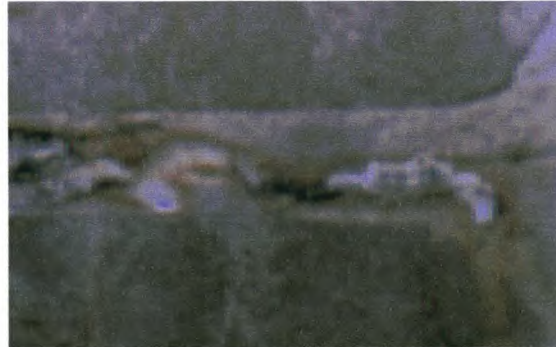
(f) Erosion

Erosion: Erosion is the irreversible and non-conducting degradation of the surface of an insulator that occurs by loss of material [60]. This can be uniform, localised or tree-shaped. See Figure 5.1 (f).

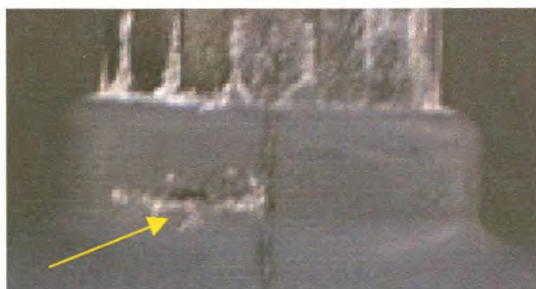
HTV SR insulator 1S: Energised – Clear signs of dry band activity were still observed, with associated light discolouration. The first signs of end-fitting corrosion affecting the polymeric material moulded over it were observed on the dead end (see Figure D.2). **Non-energised** - No signs of deterioration were found.

Figure D.2 Photo of end-fitting corrosion (dead end) affecting the polymer material on insulator 1S observed in week 4.

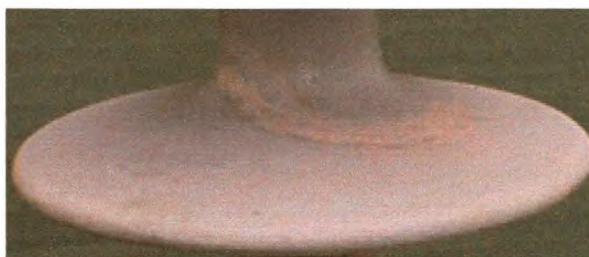
RTV SR coated porcelain insulator 4C: Energised – Clear signs of dry band activity were observed, showing light discolouration (see Figure D.3). Light patchy discolouration was still found. Light corrosion run off from the dead end-fitting was still noted on the shed top (also on the non-energised). **Non-energised** – No signs of material deterioration were found.

Figure D.3 Photo of dry band activity on insulator 4C observed in week 4.

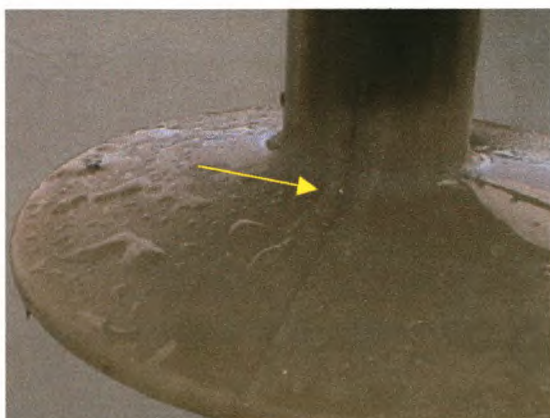
Cycloaliphatic insulator 5A: Energised – Blackening in the mould line and white discolouration adjacent to the mould line (see Figure D.4, which also shows the worsening hydrophobic properties of the insulator) was still observed. Dry band activity was still observed, showing light black discolouration. **Non-energised** – No signs of deterioration were found.

Figure D.4 Photo showing black and white discolouration at mould line on insulator 5A observed in week 6.

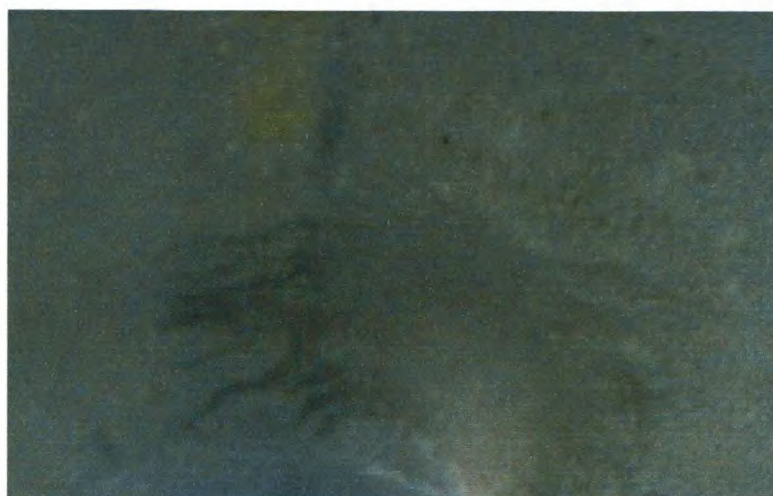
EPDM insulator 2E: Energised – Signs of dry band activity were still observed, showing light discolouration. Medium patchy discolouration was found (see Figure D.9). Light corrosion run off from the dead end-fitting was still noted (also on the non-energised). End-fitting corrosion protruding through the polymeric material moulded over it was still observed on both ends. Light signs of crazing in the pollution layer were still observed. **Non-energised** – Signs of end-fitting corrosion affecting the polymeric material moulded over it were still observed on both ends. However, no further signs of deterioration were found.

Figure D.9 Photo showing medium patchy discolouration and light crazing in the pollution layer on insulator 2E seen in week 30.

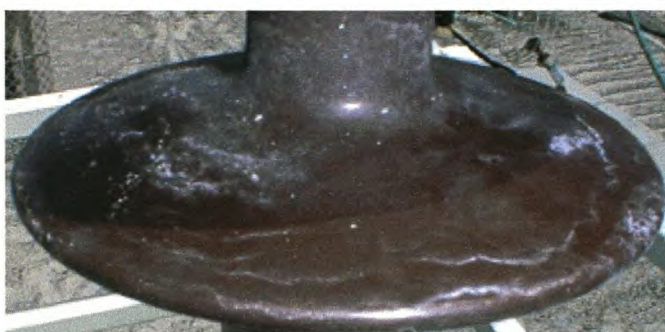
Porcelain insulator 3P: Energised – No signs of material deterioration were found. Signs of dry band activity were still noted, in the form of a white residue. However, there were signs of crazing in the pollution layer (see Figure D.10). Light corrosion run off from the dead end-fitting was still noted on the shed top (also on the non-energised). **Non-energised** – No signs of material deterioration were found.

Figure D.10 Photo showing white residue and light crazing in the pollution layer on insulator 3P seen in week 30.

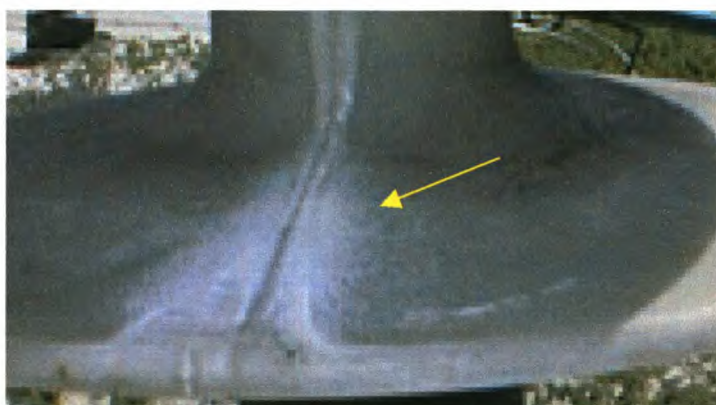
Figure D.11 Photo showing chalking on insulator 5A seen in week 30.

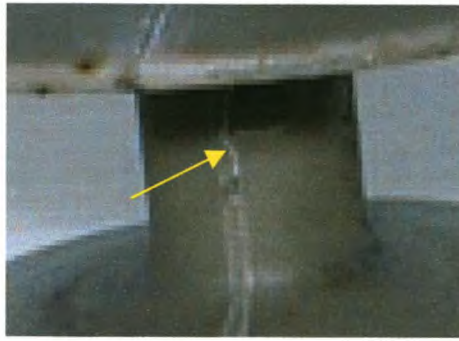
Figure D.12 Photo showing light erosion on insulator 5A seen in week 36.

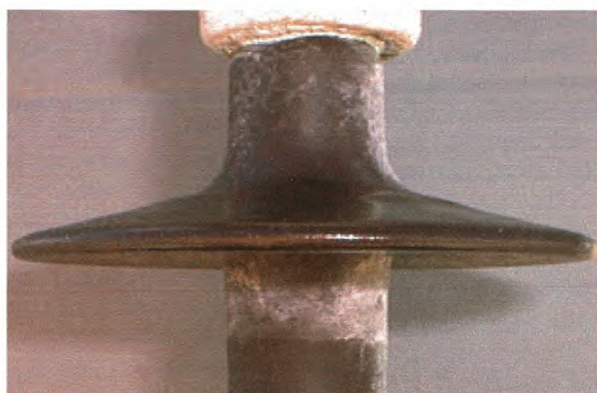
Porcelain insulator 3P: Energised – No signs of material deterioration were found. Signs of dry band activity were still noted, in the form of a white residue (see Figure D.13). Light corrosion run off from the dead end-fitting was still noted on the shed top (also on the non-energised). **Non-energised** – No signs of material deterioration were found.

Figure D.13 Photo showing signs of dry band activity and white residue on insulator 3P seen in week 42.

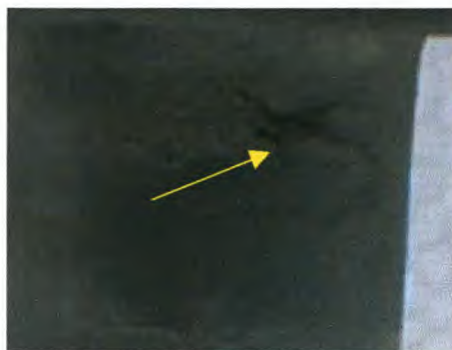
Figure D.15 Photo showing light tracking (possibly only in the pollution layer) on insulator 2E seen in week 48.

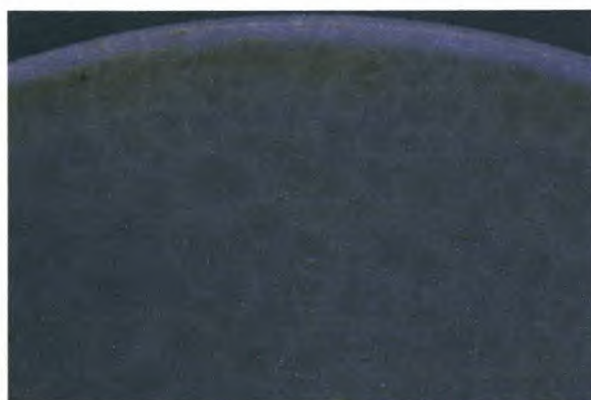
EPDM insulator 2E: Energised – Dry band activity was still observed, showing medium discolouration. Medium patchy discolouration was still found. Light corrosion run off from the dead end-fitting was still noted (also on the non-energised). End-fitting corrosion protruding through the polymeric material moulded over it was still observed on both ends. Light signs of crazing in the pollution layer were still observed. The light tracking observed in week 48 was not visible anymore, however very light erosion was now seen in its place. **Non-energised** – End-fitting corrosion affecting the polymeric material moulded over it was still observed on both ends. Signs of light discolouration were observed on the northern side on the shed tops for the first time (see Figure D.16). However, no further signs of deterioration were found.

Figure D.16 Photo showing light discolouration on non-energised insulator 2E seen in week 53.
