**A Comparative Study of Insulator Materials
Exposed to High Voltage AC and DC
Surface Discharges**

*Thesis presented in partial fulfilment of the requirements for the
degree of Master of Science in Engineering*

Stellenbosch University

Department of Electrical and Electronic Engineering

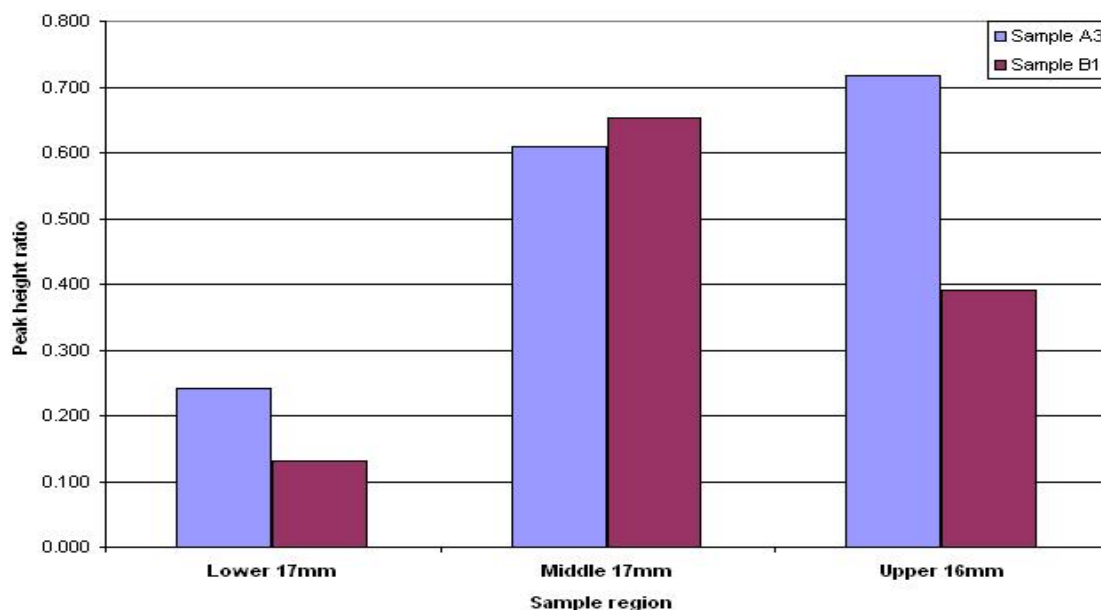
Fig. 48: Peak height ratios for loss of ATH filler for samples A3 and B1.

Fig. 48 shows the peak height ratios for the loss of ATH filler for all three regions of the two samples. A low value for the peak height ratio indicates a high loss of ATH filler.

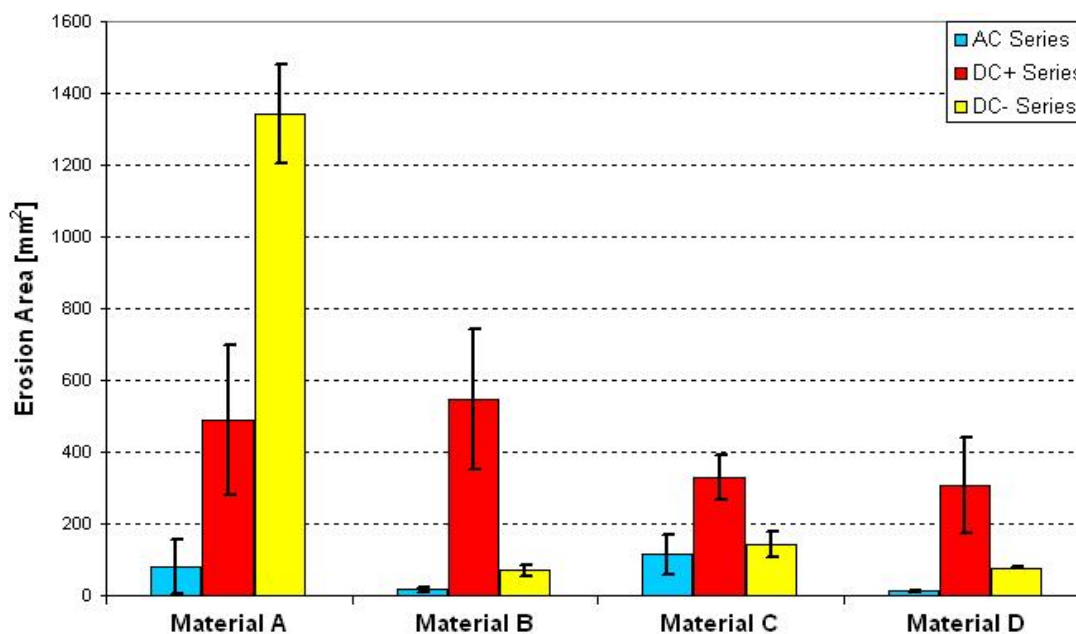
Fig. 101: Erosion area measurements for four different insulation materials and three different voltage types.
