In-Plane Structural Response of Single-Storey Unreinforced Walls Constructed Using Alternative Masonry Units

Thesis presented in fulfilment of the requirements for the degree of Master of Engineering in Structural Engineering in the Faculty of Engineering at Stellenbosch University

April 2019

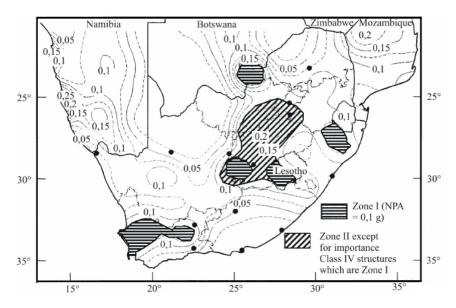
The code also maps out, as shown in Figure 2.2, the zones in the country prone to seismic activities, and for which structures are to be designed accordingly. Zone I represents areas of natural seismicity and Zone II, areas of natural and mining-induced seismicity. These zones indicate regions with a peak ground acceleration- a_g that has a 10% probability of being exceeded in a 50-year period. Measured at the surface of the earth during an earthquake event, the peak ground acceleration is often used for seismic design.

Figure 2.2: South African Seismic Hazard Zones (SANS 10160-4, 2011)

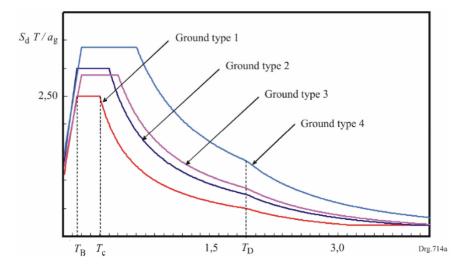
From experiments the values of the behaviour factor for unreinforced masonry (URM) have been proven to be q = 1.5 (Tomaževič, 1999). This value is also proposed in SANS 10160-4 (2011). With a set of equations provided in the code, four different response spectra can be produced for the respective ground type. The response spectra are normalised in relation to the peak ground acceleration, a_g , to produce the normalized design response spectra $S_d(T)/a_g$. Figure 2.4 shows, for a behaviour factor q = 1.0 and 5% damping, the normalised design response spectra as presented in SANS 10160-4 (2011) for the four ground types,.

Figure 2.4: Normalized Design Response Spectra - $S_d(T)/a_q$ (SANS 10160-4, 2011)

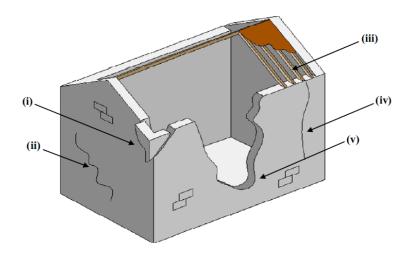
Catastrophic failures occur in Adobe structures due to their low ductility, which makes them very brittle structures. As shown in Figure 2.5, their failure mechanisms include the separation of walls at corners (i) or roofing (iii), diagonal (ii) and vertical (iv) cracking in the wall, and out-of-plane failure (v).

Figure 2.5: Failure Mechanisms of a Typical Adobe Structure (Bhattacharya et al., 2014)

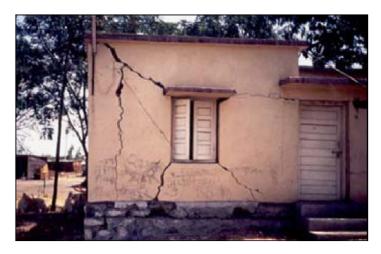
The failure mechanisms observed in brick masonry structures include shear cracks in walls and junction failure of the corner resulting in out-of-plane collapse, which in turn leads to the disintegration of floors and roofing and, ultimately, the collapse of the whole building. Figure 2.6 shows various cracks in a brick masonry building after an earthquake event.

Figure 2.6: Cracks in an Unreinforced Brick Masonry Building(Bhattacharya et al., 2014)

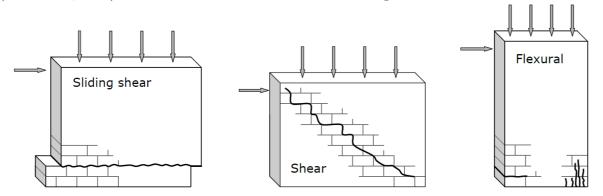
Various characteristics – such as the geometry, the quality of materials, the load application and boundary conditions – influence the type of failure mode of masonry walls under in-plane seismic loads. From analysis of earthquake damages as well as experimental results, three types of failure modes have been identified, namely sliding shear, diagonal shear, and flexural failure (Tomaževič, 1999). These failure modes are illustrated in Figure 2.8.

Figure 2.8: Failure Modes of Masonry Walls (Tomaževič, 1999)

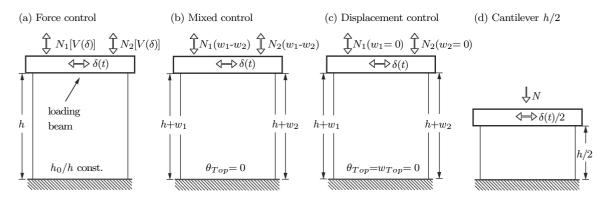
In Figure 2.10, the control of the vertical movement is represented by the symbol N which can either be in terms of the vertical force V, or vertical displacement w. The top rotation of the loading beam is represented by θ_{Top} . The subscripts 1 and 2 are used to differentiate between the two apparatus controlling the vertical movement of the loading beam.

Figure 2.10: Different Configurations for Fixed-fixed Boundary Conditions (Wilding et al., 2018)

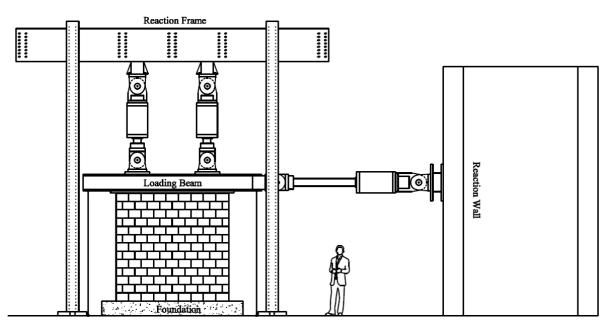
The results of the tests performed suggest that changing the boundary conditions from fixed-ends to cantilever, on two identical wall specimens, will result in the failure modes changing from shear to flexural failure. Similarly, increasing the pre-compression level resulted in a change from flexural and sliding failure modes to shear failure mode, and contributed to an increase of the compressive and shear stiffness of the masonry specimen.

Figure 2.11: ETH Zurich Test Set-up (Salmanpour, 2017)

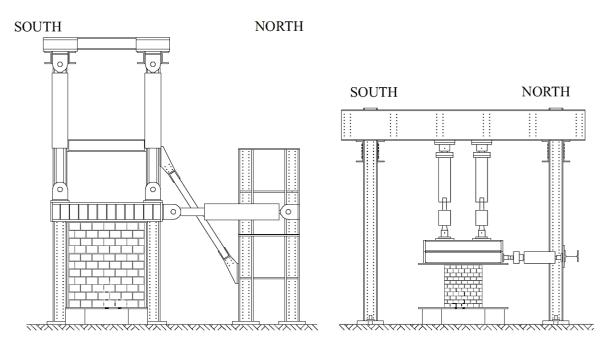
as the axial and shear forces on the wall. With this configuration, different boundary conditions were applied on the wall. The two vertical actuators were coupled with the horizontal actuator allowing for a control of the shear span. The set-up on the right of Figure 2.12 was used to test half-scale masonry walls. Three actuators (two vertical and one horizontal) were used and controlled in a similar manner as those used for full-scale tests. In this configuration two beams bolted together were used as one deep loading beam.

Figure 2.12: EPFL Test Set-ups for Full-scale and Half-scale Walls (Petry, 2015)

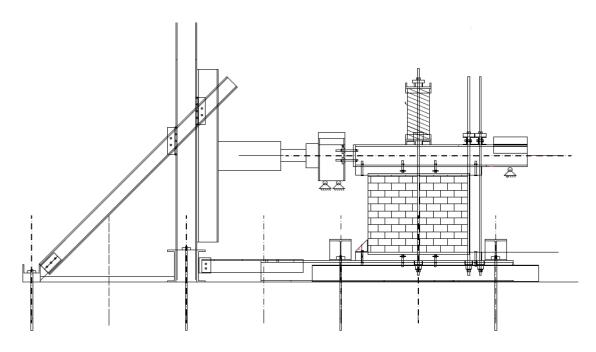
A 500 kN Instron testing machine was utilized for the application of the horizontal force on the spreader beam in a pulling action. Gravity load applied on the specimen was achieved by means of post-tensioning rods together with coil springs to reduce an increase in the forces generated in the rods due to opening cracks and the dilatancy behaviour of masonry. Two additional sets of vertical rods were used at one end of the beam, reducing the uplift of the wall specimen and the rotation of the loading beam due to the applied shear force, and ensuring that the specimen failed with a diagonal shear crack (De Beer, 2016).

Figure 2.13: Stellenbosch University Test Set-up for Small Walls (De Beer, 2016)

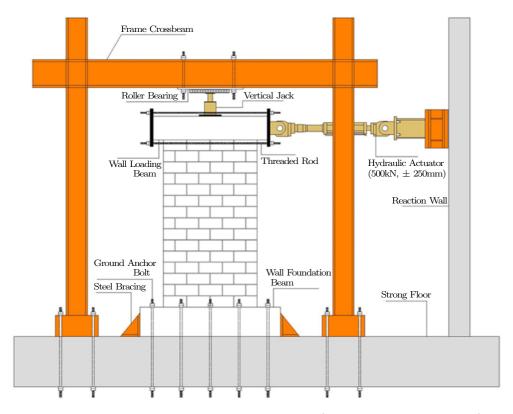
The test set-up from Key Laboratory of RC&PC Structures of the Ministry of Education – Southeast University – China, shown in Figure 2.16, was used to test self-insulating concrete masonry shear walls under in-plane cyclic loading. Each wall specimen was reinforced with steel bars and built on a foundation beam anchored to the laboratory floor. The axial load was applied by the vertical jack, connected to the crossbeam of a steel frame, and kept constant throughout the test. The horizontal cyclic loads were applied by the horizontal hydraulic actuator which was mounted to a reaction wall (Mohamad and Chen, 2017).

Figure 2.16: Southeast University Test Set-up (Mohamad and Chen, 2017)

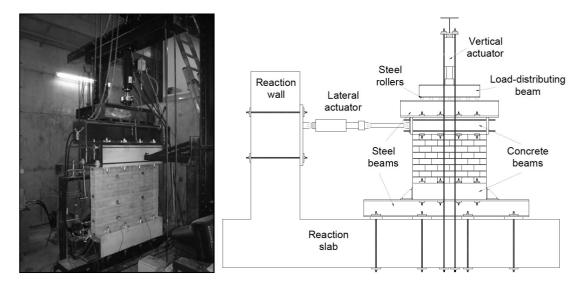
To avoid uplift of the wall base, the bottom concrete beam was fixed to steel beams through steel bolts. Two adjustable clamping angles were used on each side of the concrete beam to prevent slippage of the specimen. The steel beams were connected to the strong floor through steel rods. The vertical load was applied by means of an actuator with vertical steel cables anchored at the strong floor. The load was then distributed at the wall top through a stiff steel beam and a set of steel rollers allowing displacement of the wall with respect to the vertical actuator. The horizontal load was applied with another actuator and transmited to the wall by means of two steel plates attached to the top concrete beam.

Figure 2.17: Set-up used for Reinforced Concrete Block Masonry Walls (Haach et al., 2009)

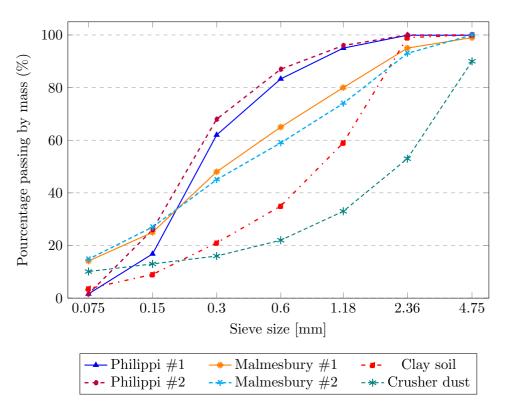
The gradings of the different materials, shown in Figure 3.1, indicate that both Philippi sands are very fine, with Philippi sand #2 being slightly finer. Malmesbury sand #2 is slightly coarser and shows a much better grading than the other three finer sands. As the mix proportions for the different units used in this study were adopted from the mix designs proposed by Fourie (2017), his suggestion of blending the sand for appropriate grading was also adopted.

Figure 3.1: Grading of Materials

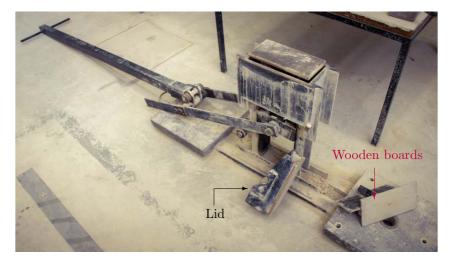
The dimensions of each block were determined based on the manual earth block press available in the laboratory. Manufactured by *Hydraform*, this block press, shown in Figure 3.2 can produce a masonry unit, which is 290mm long, 140mm wide and 116mm high.

Figure 3.2: Hydraform Block Press

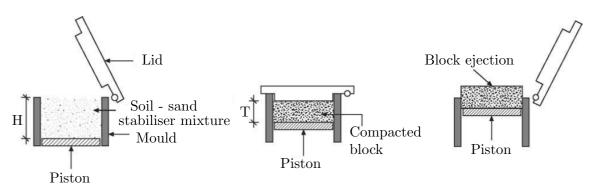
Figure 3.3: Static Compaction Process (Venkatarama Reddy, 2012)

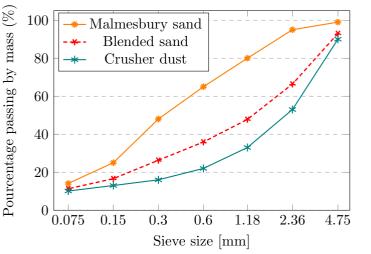
Figure 3.4: Grading of CMU aggregates

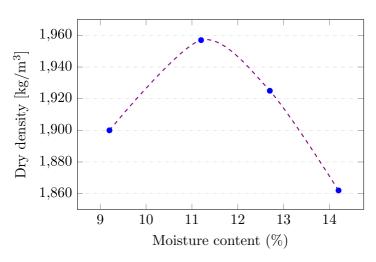
From the obtained results, the optimum moisture content of the mix was found to be 11.3%. The compaction effort from the compacting machine can be characterized as dynamic compaction. In contrast, as previously described, the compaction effort exerted with the manual block press was static. It was decided that the OMC would be increased to 12% in order to ensure that the resulting mixture will be suitable to be used in the block press and would hold its shape once compacted.

Figure 3.6: Dry Density - Moisture Content Results

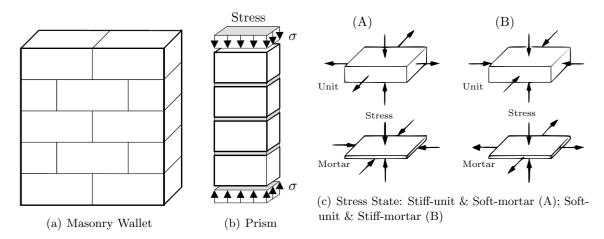
compression in the masonry unit (Kaushik *et al.*, 2007). However, it has also been reported that the opposite stress states, i.e. triaxial compression in masonry unit and lateral tension with axial compression in mortar joints, would develop in a masonry specimen constructed with soft units and stiff mortar. Furthermore, tests conducted on prism specimens constructed with soft bricks and a combination of different mortar grades have shown an increase of the masonry compressive strength due to an increase in the mortar strength which increased the bond strength (Kaushik *et al.*, 2007).

Figure 4.4: (a) Masonry Wallet, (b) Stacked Bond Prism, and (c) Unit-Mortar Stress State (Zucchini and Lourenço, 2007; Wu *et al.*, 2013)

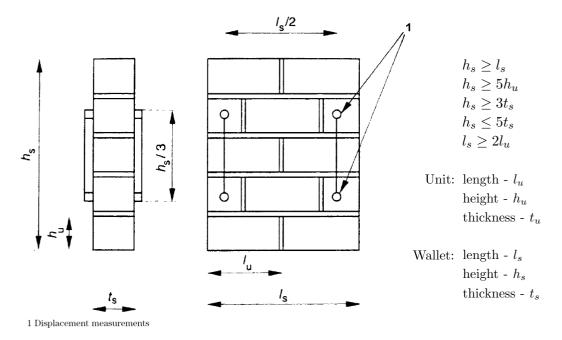
At the time of test, the specimen is placed centrally and in full contact with the testing apparatus. The applied load is gradually increased such that failure of the specimen occurs after 15 to 30 minutes from the commencement of loading. To determine the modulus of elasticity, displacement measuring devices are fitted onto the specimens to measure the change in height.

Figure 4.5: Masonry Wallet Specimen

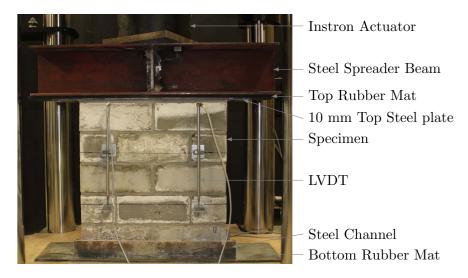
The load was then applied at the top of the specimen with its magnitude increasing at a constant rate until failure. As the units were of different types with different strengths, the loading rates for the CMU, CSEB, Adobe and AACB were respectively 0.4 mm/min, 0.25 mm/min, 0.2 mm/min and 0.3 mm/min. These rates were selected to ensure each specimen failed between 15 to 30 minutes from the moment the loading was applied. Shown in Figure 5.6 is the test set-up with an AACB wallet specimen placed in the testing machine.

Figure 5.6: Masonry Wallet Test Set-up

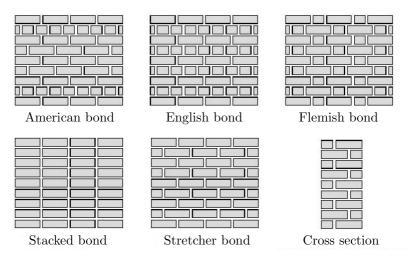
In practice, different arrangements between masonry units and mortar joints can be adopted, as illustrated in Figure 5.7. Masonry structures in South Africa, including Category 1 buildings are typically built in the stretcher bond pattern. This pattern is therefore adopted for the walls built in this experimental study.

Figure 5.7: Masonry Bonds Adopted in Practice (Pelà, 2009)

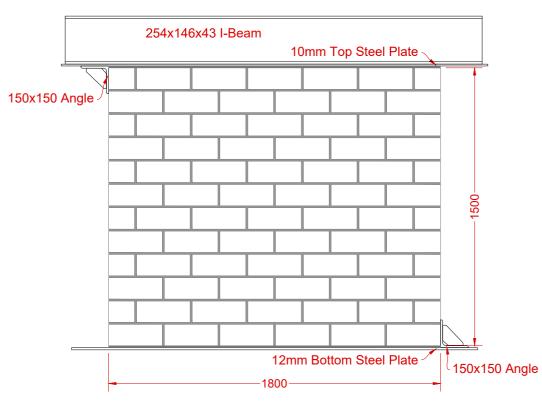
Due to the limited time available for the block manufacturing and the number of experimental tests required for this study, the length (l_w) of the walls was to be 1.8m. With an aspect ratio of 1.2 (l_w/h) , the height (h) was therefore 1.5m. With these dimensions, it was sought to construct a wall that would be sufficiently squat to result in diagonal shear failure mode during the shear-compression wall test. Both bed and head mortar joints in the walls were about 10mm thick, the wall had 6 units in length and 12 units in height, the wall dimensions were then, $1800\pm5 \times 1500\pm5 \times 140$ mm, as shown in Figure 5.8.

Figure 5.8: Dimensions of Wall Specimen

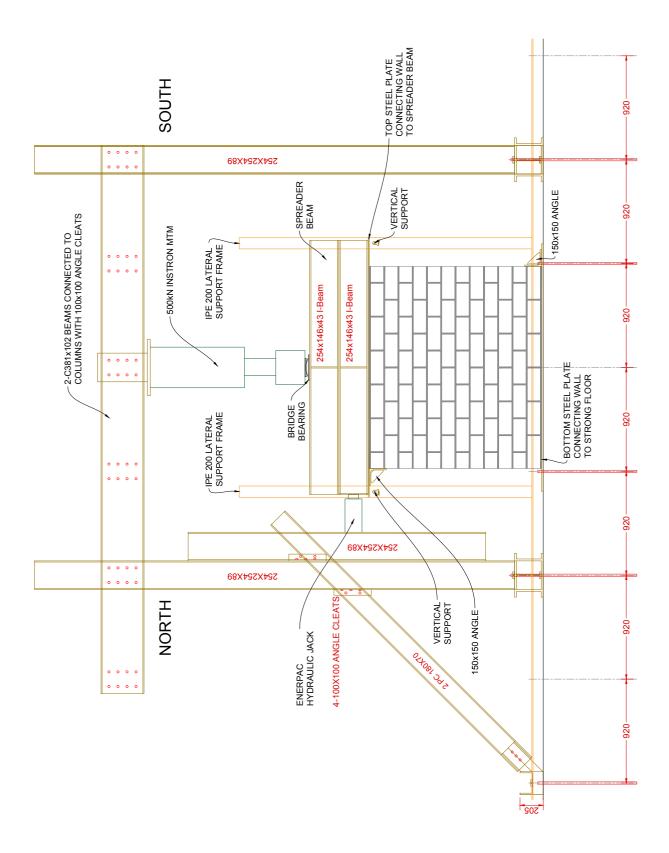
Figure 5.12 shows the drawing of the designed test set-up where the wall specimen, the loading system, and the lateral steel support frames can be seen.

Figure 5.12: Drawing of Test Set-up A (all dimensions in mm)

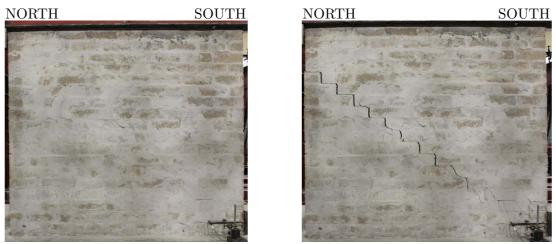
The test resulted in a diagonal shear failure of the wall specimen, as shown in Figure 5.15. As this was the failure mode sought to be achieved with the designed test set-up, it was decided that the other four wall specimens would be tested with the new configuration of the test set-up which is referred to as "Test set-up B".

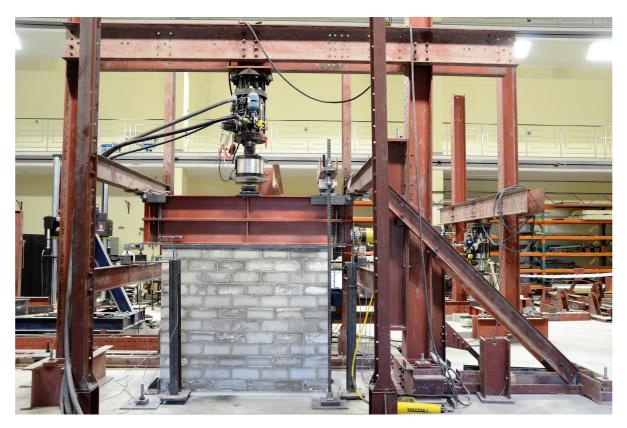
From the obtained results of both mock wall tests, it can be concluded that Test set-up A configuration resulted in a fixed-free or cantilever boundary condition as the in-plane vertical displacement of the spreader beam was not controlled. However, with Test set-up B configuration, the vertical displacement could be controlled resulting in little rotation induced at the top of the wall. Figure 5.16 shows the test set-up with a wall specimen and Figure 5.17, the drawing of Test set-up B.

Figure 5.16: Test Set-up with Wall Specimen

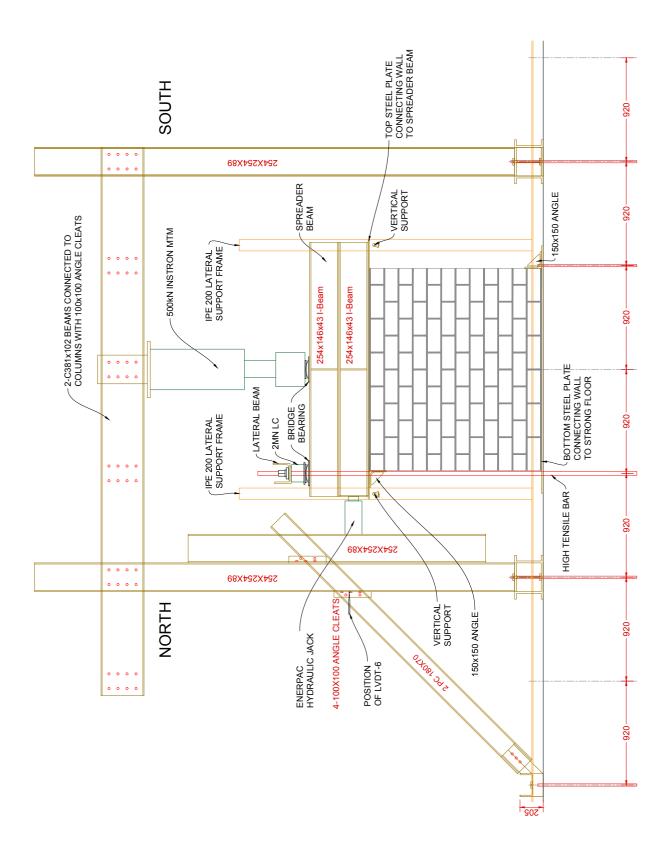
Figure 5.17: Drawing of Test Set-up B (all dimensions in mm)

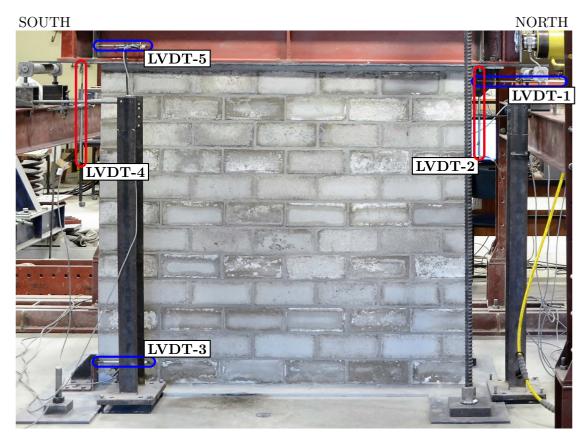
Figure 5.18: Close up View of Wall Indicating Locations of LVDTs

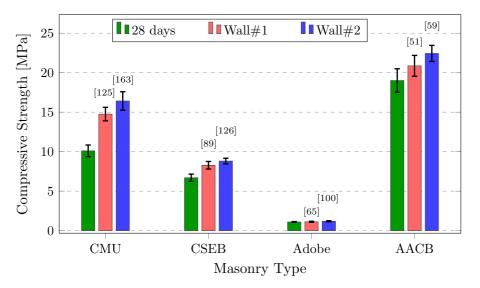
Figure 6.1: Unit Compressive Strength Results

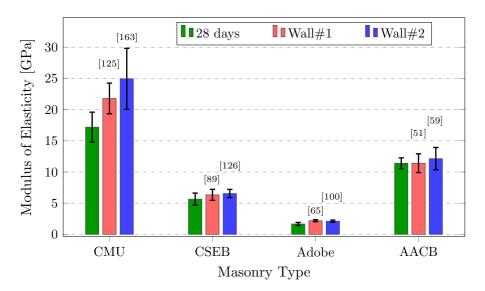
Figure 6.2: Unit Modulus of Elasticity Results

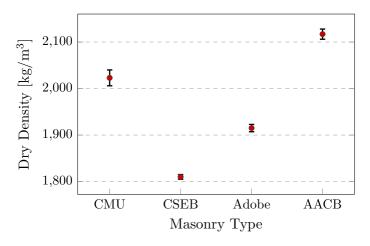
Figure 6.3: Dry Density Results

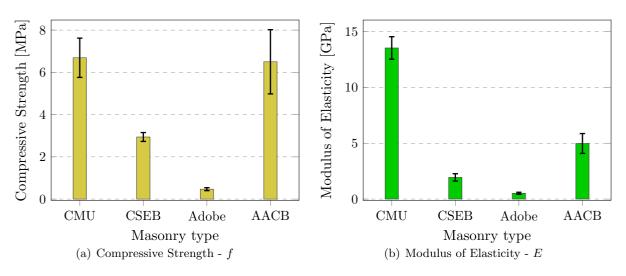
Figure 6.4: Masonry Wallet Results

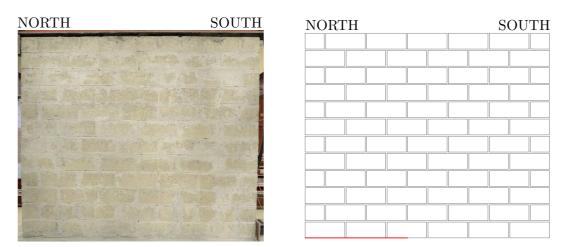
Figure 6.6: CMU-W-A: Crack Patterns

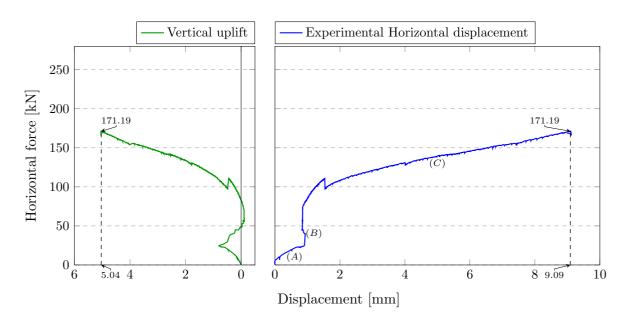
Figure 6.7: CMU-W-A: Test Results

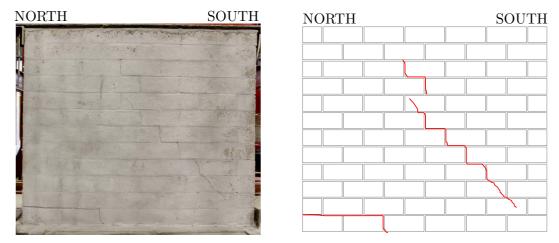
Figure 6.8: CMU-W-B: Crack Patterns

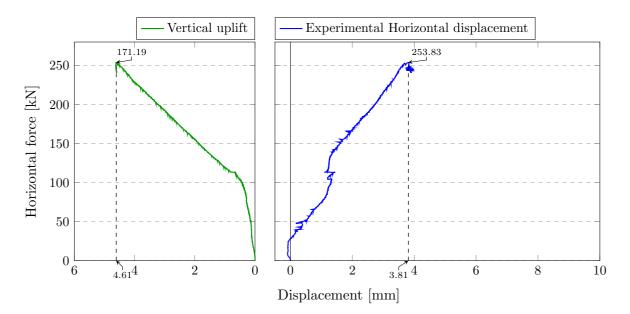
Figure 6.9: CMU-W-B: Test Results

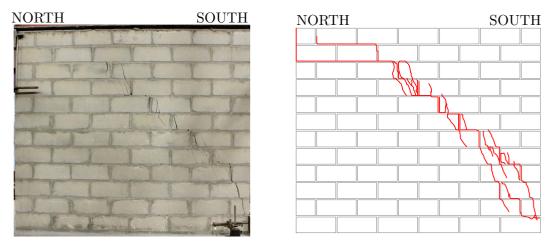
Figure 6.10: CSEB-W-A: Crack Patterns

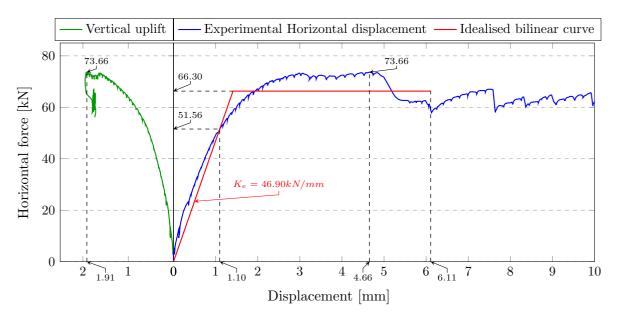
Figure 6.11: CSEB-W-A: Test Results

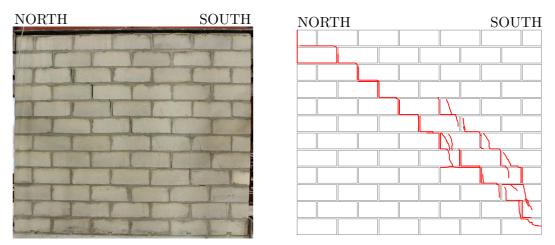
Figure 6.12: CSEB-W-B: Crack Patterns

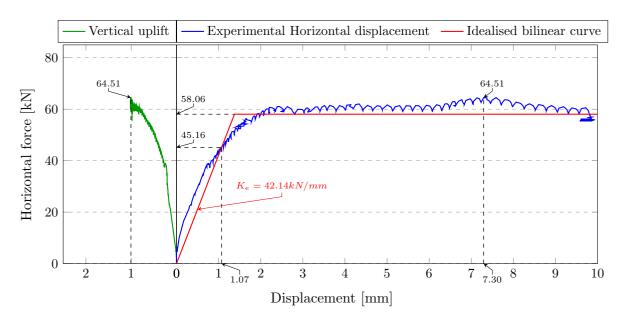
Figure 6.13: CSEB-W-B: Test Results

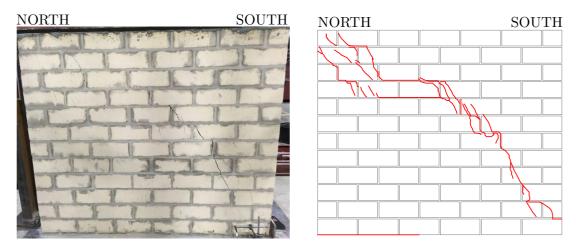
Figure 6.14: Adobe-W-A: Crack Patterns

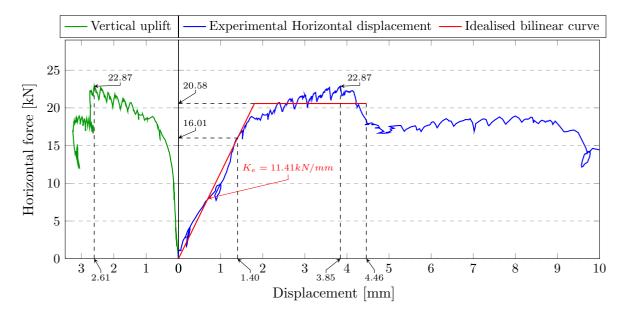
Figure 6.15: Adobe-W-A: Test Results

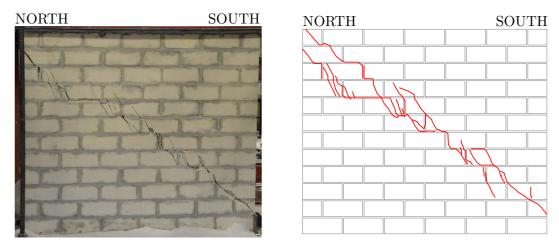
Figure 6.16: Adobe-W-B: Crack Patterns

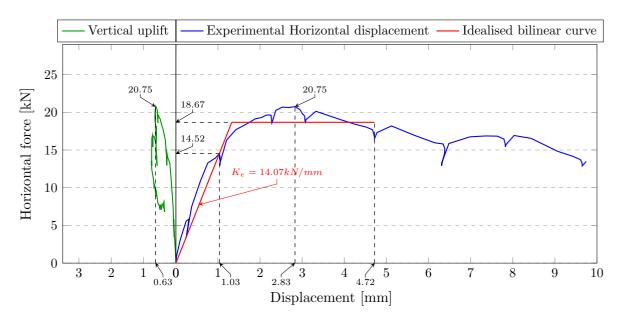
Figure 6.17: Adobe-W-B: Test Results

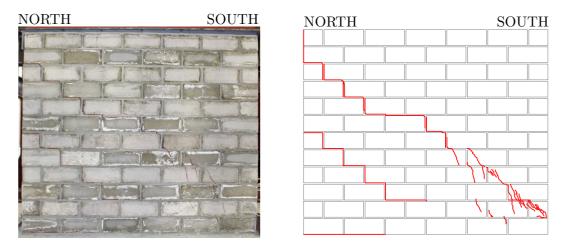
Figure 6.18: AACB-W-A: Crack Patterns

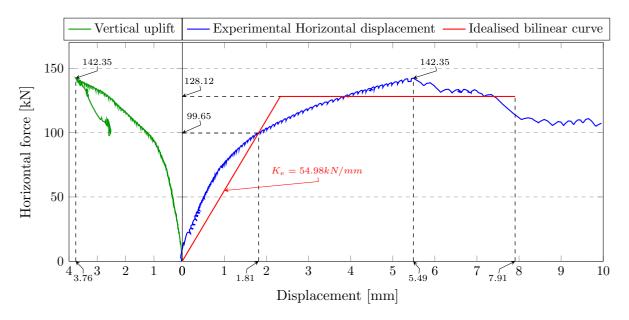
Figure 6.19: AACB-W-A: Test Results

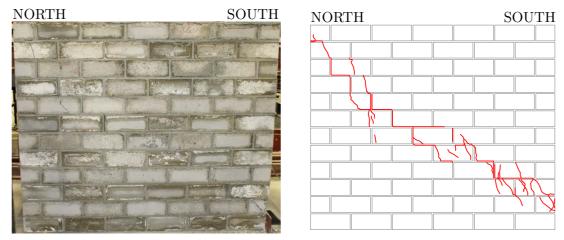
Figure 6.20: AACB-W-B: Crack Patterns

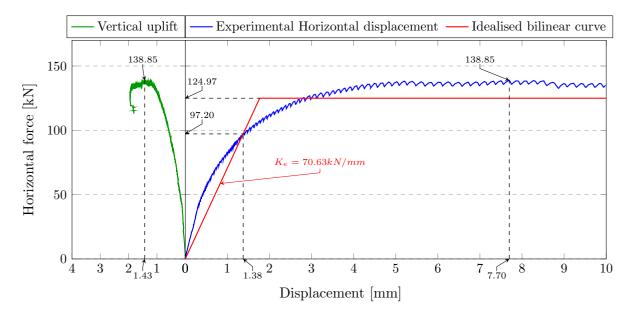
Figure 6.21: AACB-W-B: Test Results

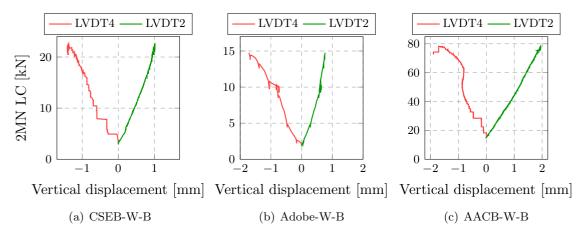
Figure 6.23: 2MN LC force vs Vertical Displacement

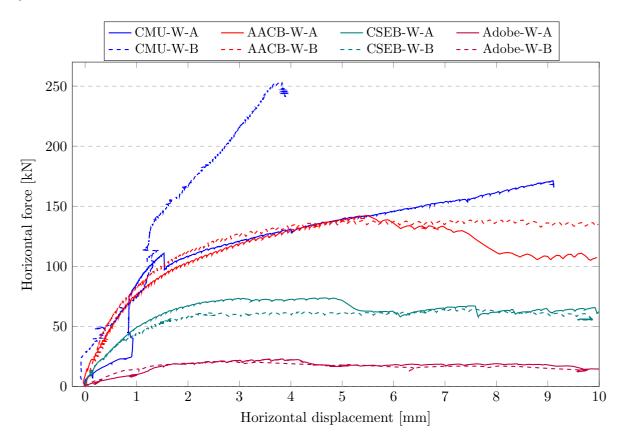
Figure 6.24: Masonry Wall Test Results

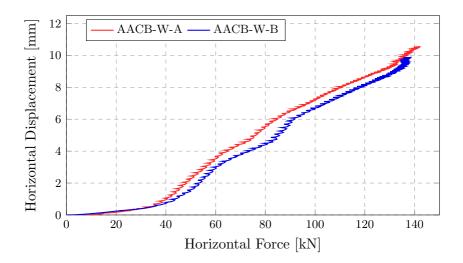
Figure 6.25: LVDT-6 Readings (AACB-W-A & AACB-W-B)

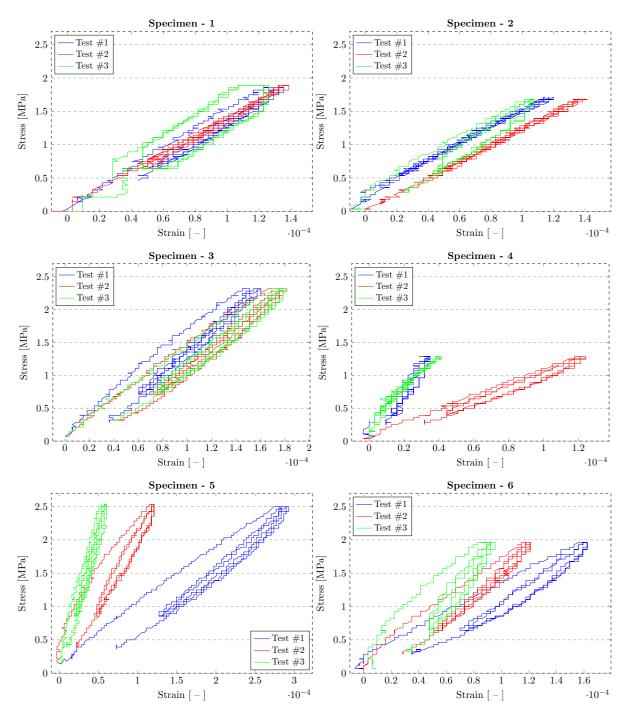
Figure A.1: CMU: Stress - Strain Responses at 28 days

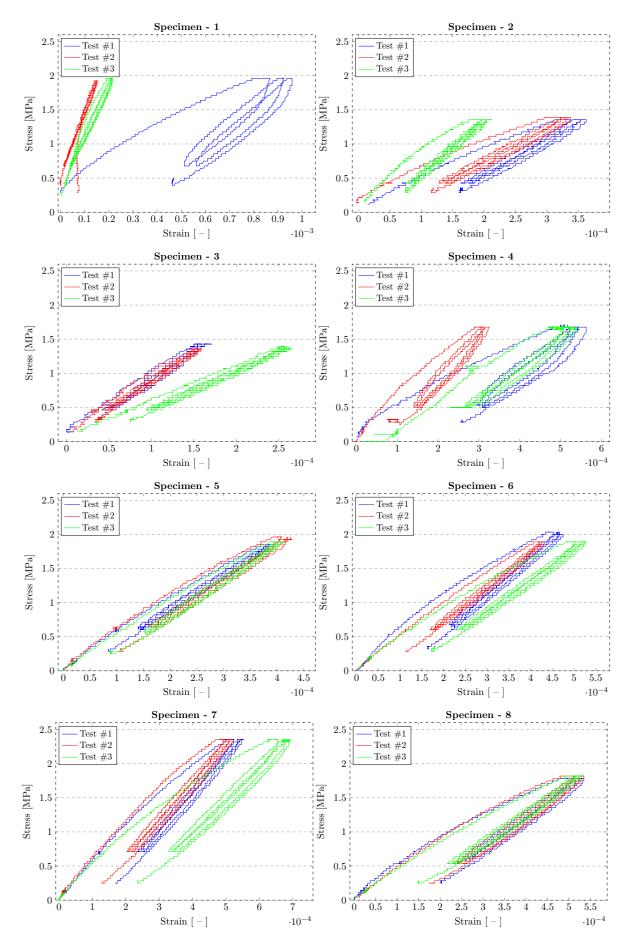
Figure A.2: CSEB: Stress - Strain Responses at 28 days

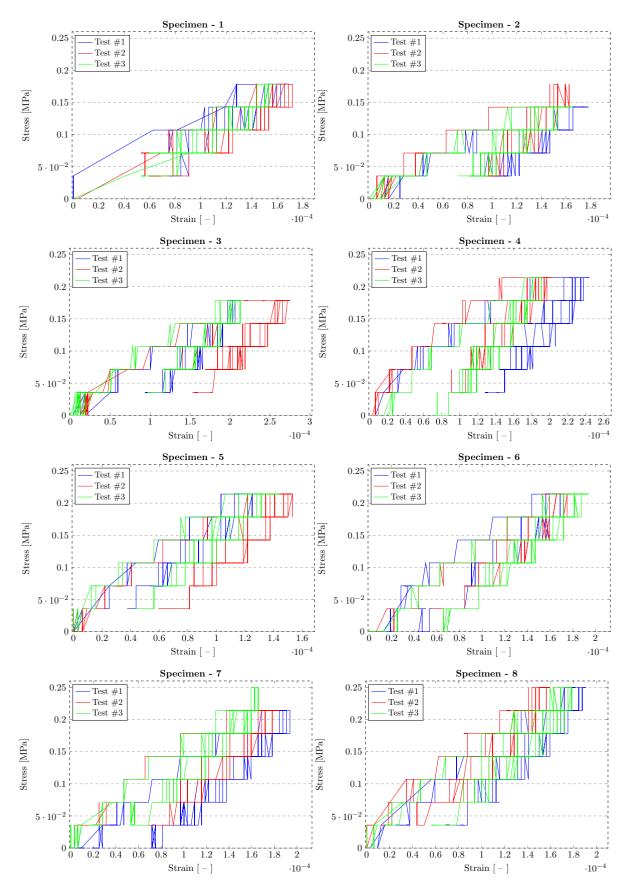
Figure A.3: Adobe: Stress - Strain Responses at 28 days

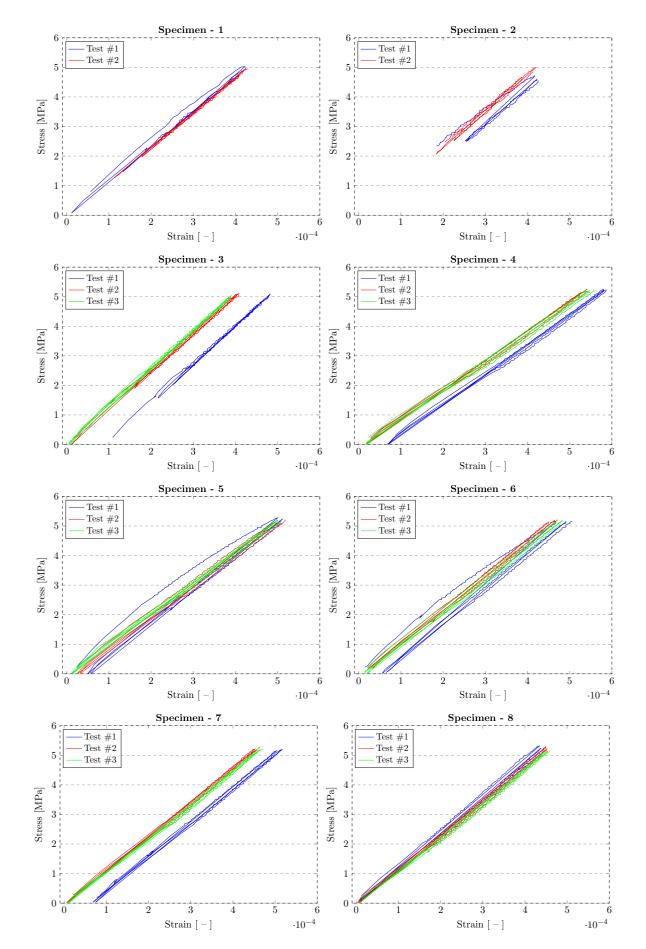
Figure A.4: AACB: Stress - Strain Responses at 28 days

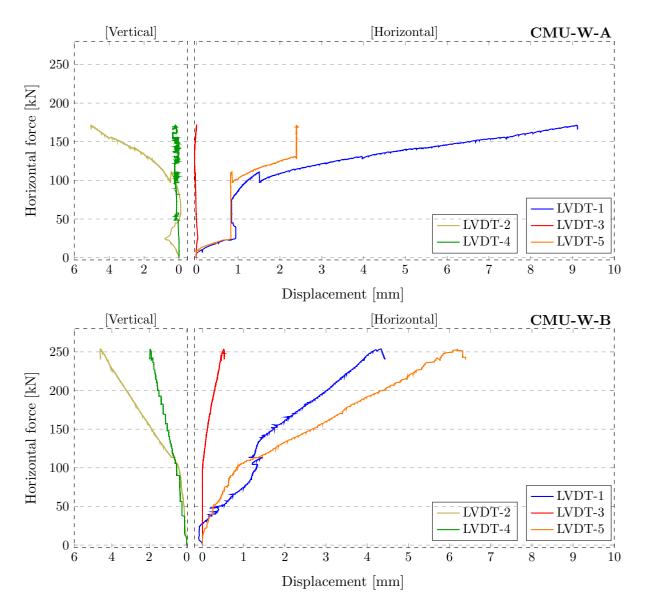
Figure C.1: CMU Walls: LVDT Readings

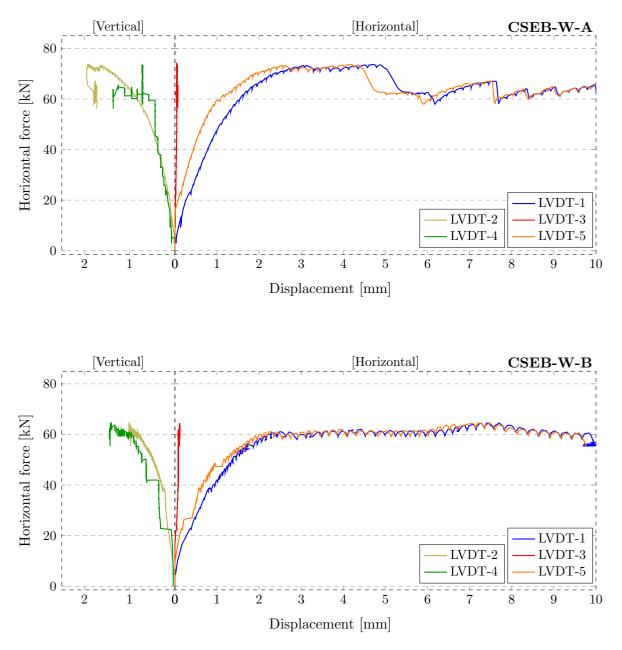
Figure C.2: CSEB Walls: LVDT Readings

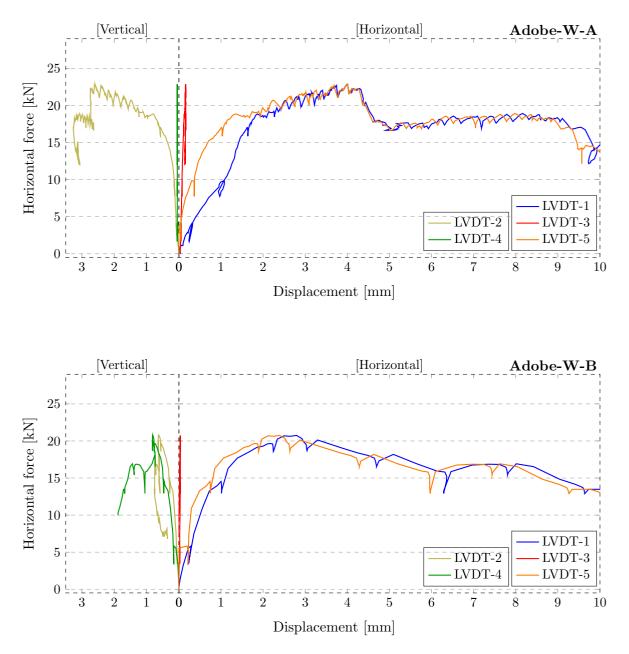
Figure C.3: Adobe Walls: LVDT Readings

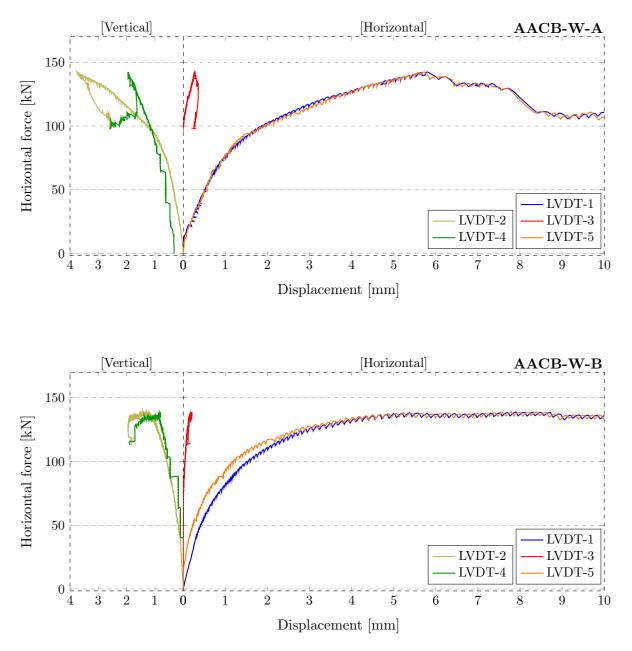
Figure C.4: AACB Walls: LVDT Readings

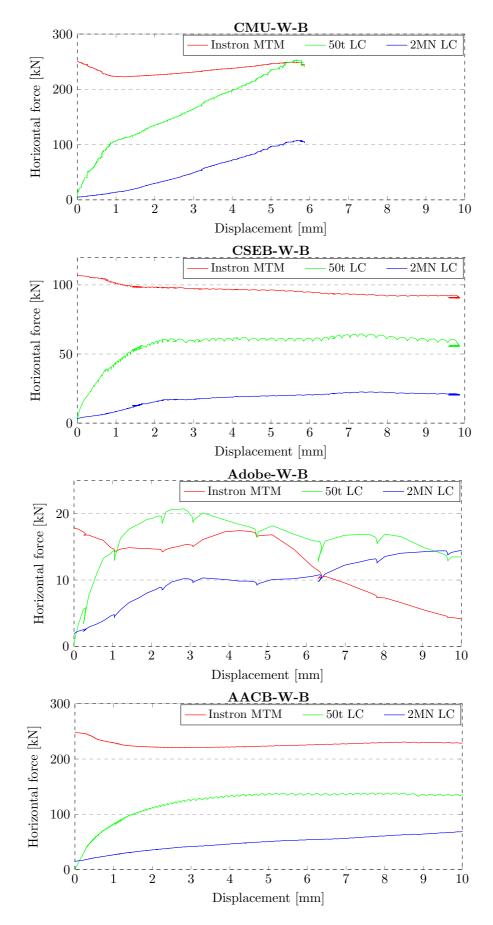
Figure C.5: Masonry Walls: Intron MTM, 50t & 2MN LC Readings

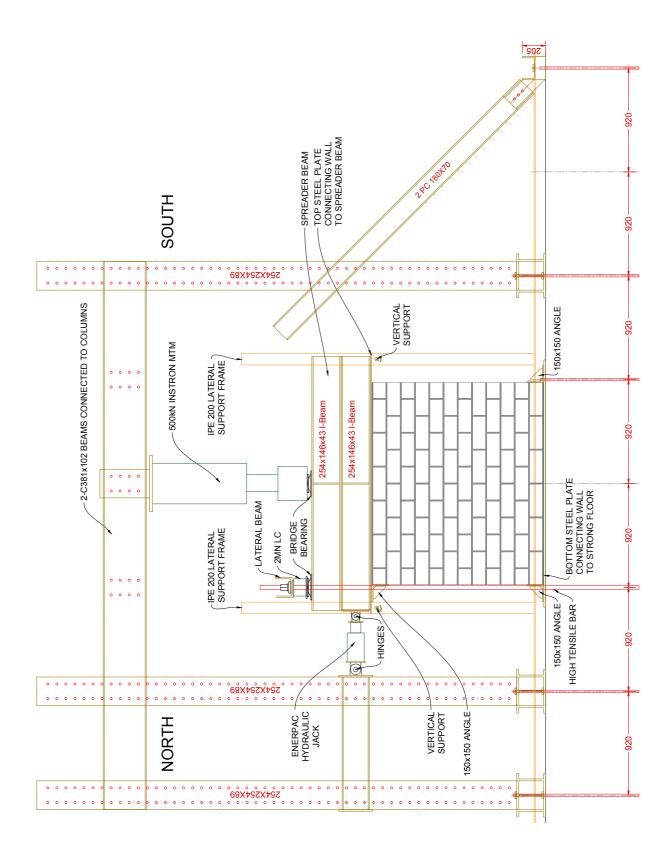
Figure C.6: New Test Set-up Proposal (all dimensions in mm)
