Creep Damage Assessment of Ex-Service 12% Cr Power Plant Steel Using Digital Image Correlation and Quantitative Microstructural Evaluation

Abstract: The lifetime of steam pipelines in long-term operation in coal-fired power plants are limited due to material damage that resulted from creep exposure. In the present study, the authors comparatively assess the damage of ex-service 12% Cr piping steel with varying degrees of exposure while using accelerated creep tests that employ digital image correlation (DIC) as well as microstructural investigation that is based on electron microscopy. The DIC technique, which allows multiple creep curves to be measured at temperatures ranging from 550–600 °C from a single specimen, revealed higher Zener–Hollomon parameters for a high damage material with a high void density when compared to a material with lower damage and lower void density. Both of the material states showed similar hardness values, subgrain sizes, and boundary character, despite the difference in void densities. Slightly higher inter-particle spacing of MX precipitates results in a lower threshold stress of 79 MPa for the high damage steel when compared to 97 MPa for the low d

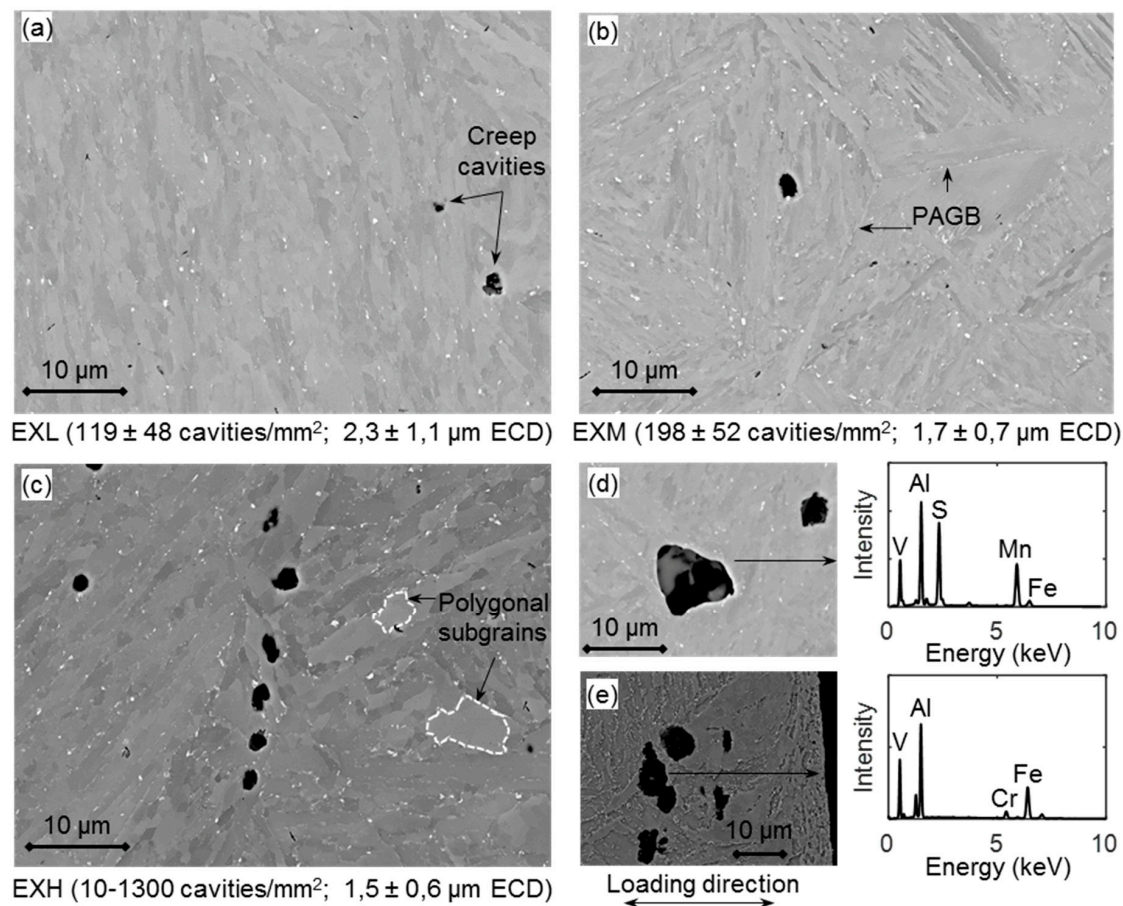
Figure 7. Backscatter Electron Scanning Electron Microscopy (BS-SEM) images showing micro-grains and voids in (**a**) EXL, (**b**) EXM and (**c**) EXH material. Large inclusions in (**d**) EXL material are shown by Energy Dispersive X-ray Spectroscopy (EDS) to contain Al and Mn and they are also located (**e**) near the ruptured end of the EXH material. ECD = Equivalent Circle Diameter.

Although not shown here, the cavity sizes are lognormally distributed. Interestingly, for the sampled material larger cavity sizes were measured for EXL than EXM and EXH—suggesting delayed cavity growth in the latter material possibly due to the production from a different melt having differences in virgin material void sizes and the presence of inclusions as nucleation sites [8]. Some large voids (>10 µm) in the EXL material are associated with inclusions, as suggested by EDS analysis

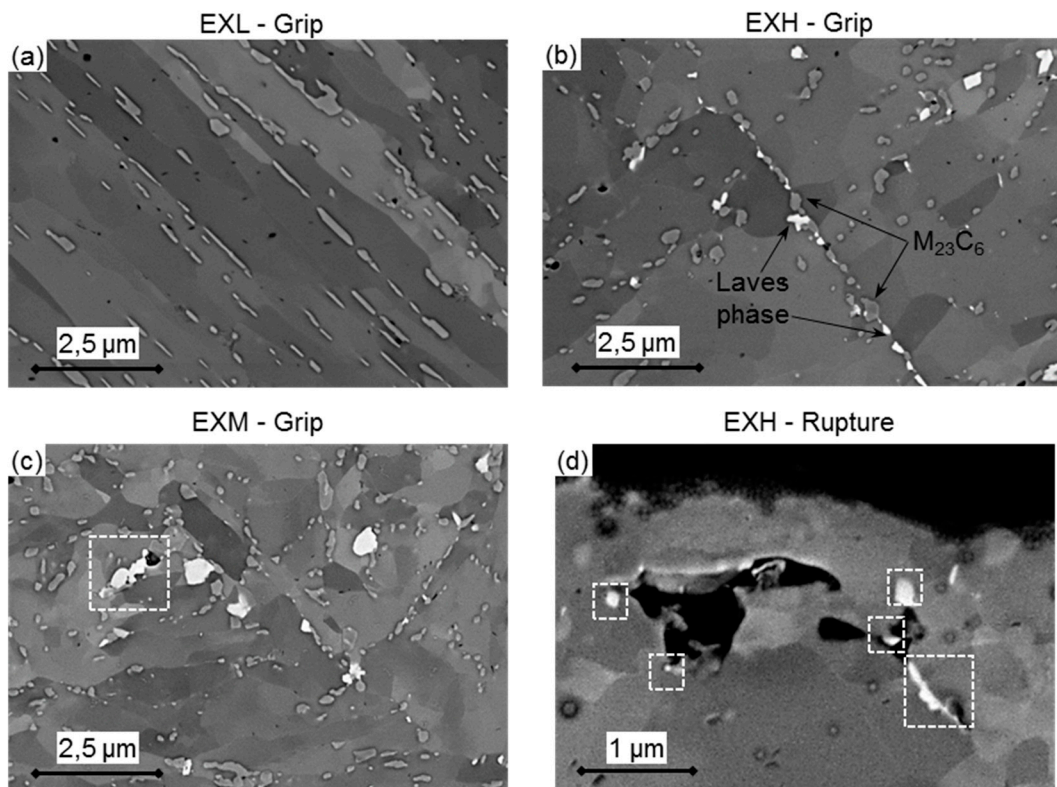
Figure 13. Concentric Backscatter-SEM (CBS-SEM) images of (**a**) EXL, (**b**) EXH and (**c**) EXM grip regions. $M_{23}C_6$ and Laves phase particles can be preliminarily identified in the images based on the local brightness of features. Laves phase particles are found adjacent to large voids near the (**d**) rupture surface of EXH as outlined in white squares.

The EXL material demonstrates stringers of $M_{23}C_6$ particles (notably Figure 13a) along micro-grain boundaries that appear to be more broken up in the EXM and EXH material (Figure 13b,c). Evidence of cavity growth near larger Laves phase particles was found in EXM (as seen in Figure 13c, outlined by a white square) and EXH. Specifically, large voids surrounded by Laves phase clusters were noticed near the rupture surface of an EXH specimen in Figure 13d. Figure 14 also indicates that Laves phase predominantly nucleates adjacent to Cr-rich carbides and along micro-grain boundaries. The mean particle diameter, volume number density, and inter-particle spacing [32] of $M_{23}C_6$ and Laves phase particles are compared in the error bar plots in Figure 15a,b, respectively.

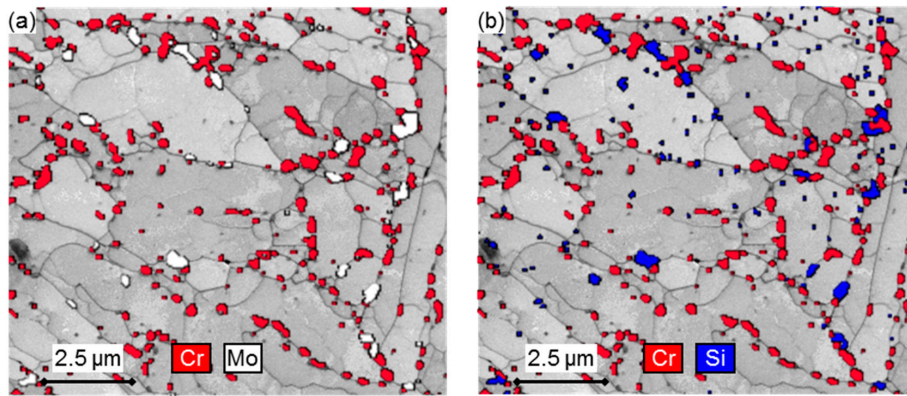
Figure 14. EDS maps of (**a**) Cr and Mo and (**b**) Cr and Si overlaid over Transmission Kikuchi Diffraction (TKD) band contrast maps in EXH material, indicating the location of carbides (Cr) and Laves phase particles (Mo and Si) along micro-grain boundaries.

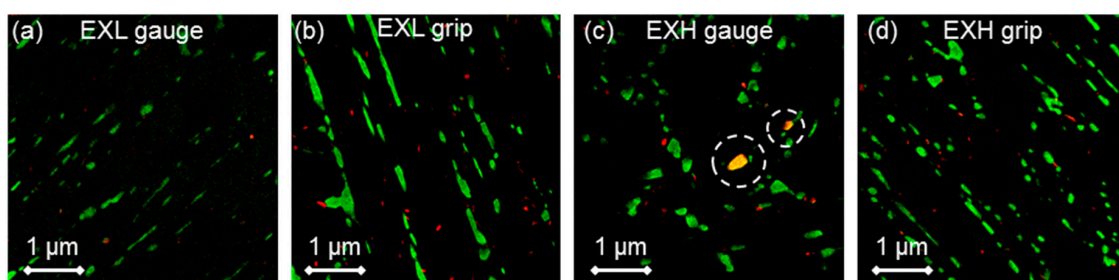
Figure 16. Composite Cr (green) and V (red) elemental maps obtained from Energy-Filtered Transmission SEM (EFTEM) of (**a**,**b**) EXL and (**c**,**d**) EXH gauge and grip regions, respectively. Z phase particles are indicated by the circle outlines in (**c**).

Composite Cr (green) and V (red) EFTEM maps are shown in Figure 16 for the EXL (a,b) and EXH (c,d) gauge and grip regions, respectively. The VX particles appear to be dispersed in the matrix with no preferential alignment, as evident for the larger Cr-rich particles. The extraction of VX particle parameters from thin foil samples while using this technique is challenging due to the degradation of the signal-to-noise ratio from the iron matrix (most notably in Figure 16a) as well as the low sample density. However, small differences between the EXL and EXH materials are still evident in the calculated parameters that are shown in Figure 15c. Most notably, the coarsening of VX particles with a concomitant increase in inter-particle spacing and decrease in number density is found in the EXH material as compared to the EXL counterpart. However, differences in the gauge region are not as obvious. It has been suggested that, since no significant changes in VX precipitate morphology is found during long-term creep testing of X20, these particles play a smaller role than $M_{23}C_6$ precipitates in micro-grain stability [18,50].

Z phase particles are highlighted in the EXH gauge region (Figure 16c) identified as overlapping regions of the Cr and V maps. Observation of this phase suggests that EXH shows increased dissolution of the creep strengthening VX particles due to the growth of large Z phase particles, resulting in decreased creep strength and increased creep damage [11].

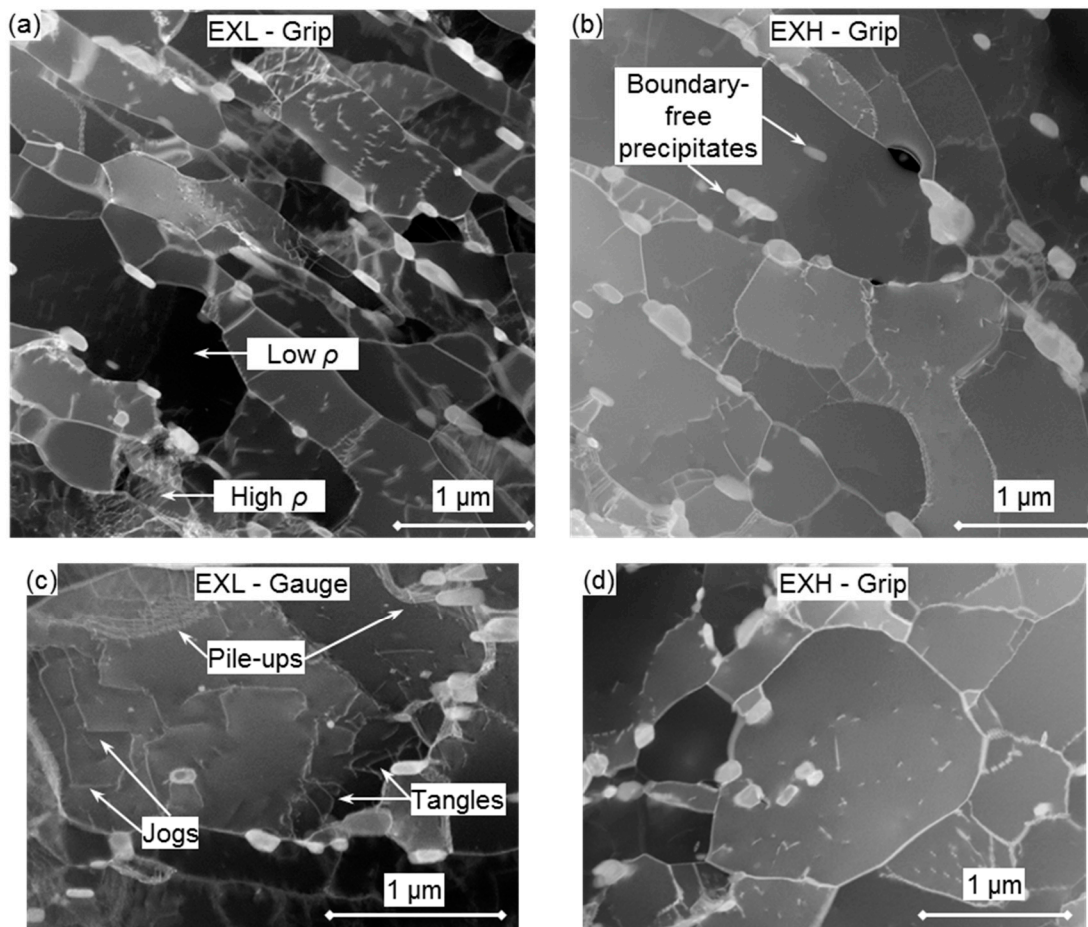
Figure 17. Annular Dark Field Scanning TEM (ADF-STEM) micrographs of (**a**) EXL, (**b**) EXH grip regions, (**c**) various dislocation interactions at the gauge center of EXL material, and (**d**) an equiaxed micro-grain in the EXH grip region. Regions of high and low concentrations of dislocations ρ are indicated in (**a**).

Qualitative differences in dislocation densities and substructure are shown in ADF-STEM micrographs in Figure 17a,b for EXL and EXH grip regions, respectively. A heterogeneity in micro-grain-interior dislocation densities is noted in the EXL material with some micro-grains displaying a higher concentration of dislocations than others. Lower densities are noted in the larger micro-grains in the EXH material. The presence of larger and more polygonised grains that are shown in Figure 17d in the EXH state reinforces previous observations (Table 5).

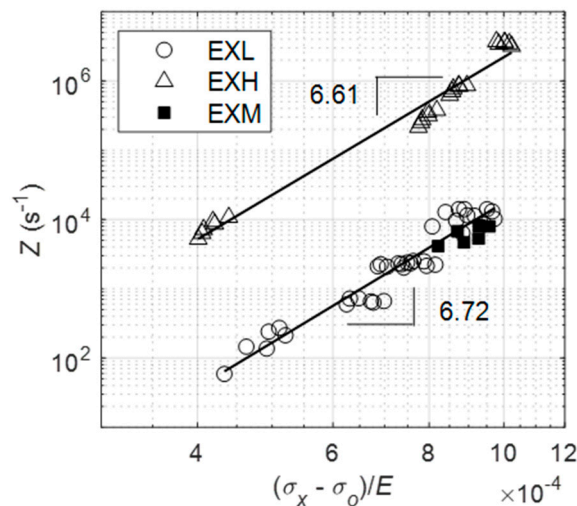
Figure 21. Plot of Zener–Hollomon parameters of EXL and EXH materials. A single stress state for EXM is included for comparison with EXL.

Data from both EXL and EXH each fall onto a straight line on the double logarithmic plot, the gradient of which closely corresponds with the stress exponents that were previously calculated in Figure 20a and they are represented by equations of $2.56\text{E}24\left(\frac{\sigma_x - \sigma_o}{E}\right)^{6.72}$ and $1.5326\left(\frac{\sigma_x - \sigma_o}{E}\right)^{6.61}$ for EXL and EXH, respectively. These results are similar to findings by El Rayes and El-Danaf [10] for as-produced and ex-service 12% Cr steel while using hot tensile tests.

Z values from a single stress state for the EXM material lies close to the EXL data, stemming from similar creep rates between the two material states. This implies that the Z parameter that was obtained while using the proposed accelerated creep technique can be used to establish the relative damage between service-exposed X20 as an alternative to other techniques, such as hardness testing, which would otherwise not reveal a difference in damage.

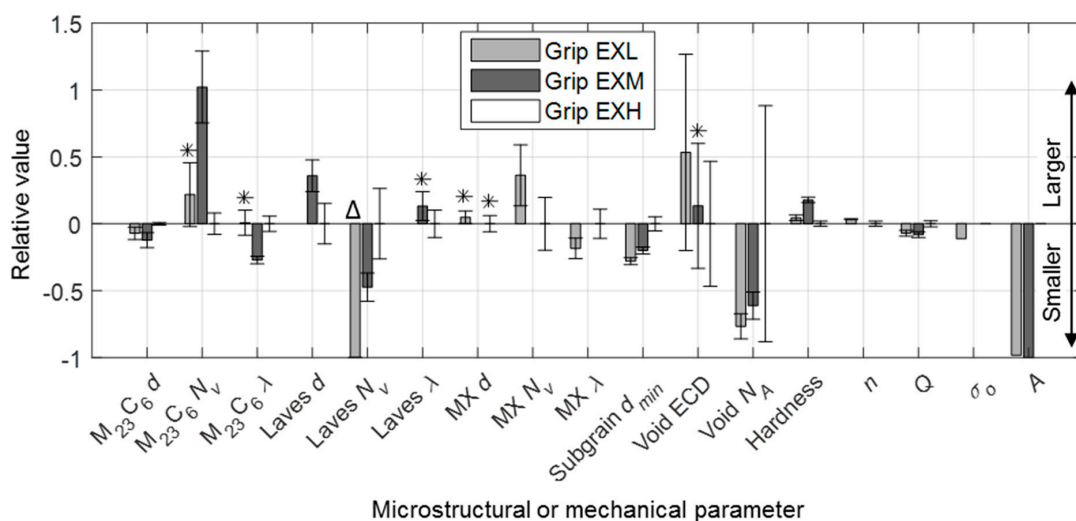
Based on these grounds, key mean microstructural parameters are compared via unpaired *t*-testing with a 0.05 significance value to indicate statistically significant differences between EXL, EXM, and EXH grip regions in Figure 22 while using values of the latter region as a baseline. Mechanical-based parameters, such as BMD equation parameters, threshold stresses and Zener-Hollomon pre-exponentials *A*, are also included along with the traditional means of damage assessment using cavity densities.

Figure 22. Relative differences in microstructural parameters indicating damage using the EXH grip region as a baseline. Note: d = diameter, d_{min} = minor diameter, N_v = volume density, λ = inter-particle spacing, N_A = area density, n = stress exponent, Q = activation energy, σ_o = threshold stress, A = Zener–Hollomon pre-exponential. Asterisks (*) indicate features that are not statistically different from the baseline. Δ indicates that no Laves phase was recorded in the EXL grip region

The most prominent differences in microstructural damage indicators is noted in micro-grain width (measured from BS-SEM), as well as the precipitate distribution, specifically Laves phase

(between EXL and EXM/EXH) and $M_{23}C_6$ (between EXM and EXL/EXH). The micro-grain width shows increasingly coarser, polygonised grains with damage level, correlating somewhat with cavity density measurements. With no significant amounts of Laves phasesbeing observed in the EXL grip, one contributing factor to increased damage in EXH is the solid solution depletion of Mo and Cr due to the formation of Laves phase ($(Fe,Cr)_2Mo$) and the growth of $M_{23}C_6$ carbides. This effect appears to outweigh any potential benefit gained from particle strengthening [18]. The relative ability of different precipitates to pin micro-grain boundaries is established by considering their respective normalised Zener pinning pressure, given as $P_z/\gamma = 3f/d$ [58], where P_z is the Zener pinning pressure, γ is the boundary surface energy per area, f is the particle volume fraction and d is the particle diameter. In the EXH gauge region, $M_{23}C_6$ and Laves phase precipitates result in an average normalised pressure of 0.74 and 0.13 μm^{-1}, respectively. The corresponding values in the EXL gauge region are 0.97 and 0.045 μm^{-1}, respectively. Therefore, Laves phase is shown to be ineffective in pinning micro-grains, providing a 5–20 smaller pinning pressure as compared to $M_{23}C_6$ particles. Additionally, as Laves precipitation is known [49] to often occur adjacent to $M_{23}C_6$ particles (also found in this work in Figures 13b and 14), the Zener pinning pressure that is responsible for micro-grain boundary pinning is reduced as the effective precipitate size increases. Such clustering has also been found in previous research to cause a reduction in yield strength of the material, especially when the particle sizes exceed 0.2 μm (similar to sizes obtained in this study) [59]. Although it has been shown that solid solution depletion of Mo takes a minor role in overall creep damage in some 9%–12% Cr steels [18], it is considered here together with larger micro-grain sizes to be the principle difference between EXL and EXH besides cavity density. Traces of Z phase that are found in the EXH material could also suggest higher damage levels than in EXL, although no conclusions can be drawn from the small amount observed.

The deformation resistance of EXM revealed from the deformation tests, however, cannot be explained in the same manner as it has similar Laves phase inter-particle spacing to that of EXH. Instead, a dense $M_{23}C_6$ particle distribution is the only feature investigated that explains the enhanced strength of EXM, with P_z/γ values of 1.29 μm^{-1} in the grip region. Previous investigations [18,50] emphasised the hardening effect of these carbides from stabilising the substructure and pinning boundaries. These microstructural results, together with the deformation measurements, therefore suggest that EXM has a similar amount of remnant creep strength as EXL, despite the higher category of damage based on cavity density. This highlights the benefit of exploring alternative damage indicators, such as the Zener–Hollomon parameter and precipitate densities, in the assessment of service-exposed X20. Creep strain and rate data that were used in this work as well as microstructural statistics are provided in an online repository [60].
