# **An Evaluation of HTV-SR Insulators with Different Creepage Lengths under AC and Bipolar DC in Marine Polluted Service Conditions**

*Thesis presented in partial fulfilment of the requirements for the degree Master of Science in Engineering at the University of Stellenbosch*

This study was conducted at the Koeberg Insulator Pollution Test Station (KIPTS) on the west coast of Cape Town in the Western Cape province of South Africa. KIPTS is an internationally recognized insulator pollution test facility, which is widely used by both insulator manufacturers and academic researchers from many parts of the world. STRI and ABB, both Swedish-based companies, are good examples of international subscribers to the KIPTS research facility. The first objective of this research was to design a suitable DC excitation voltage system for both DC+ and DC- to be used at KIPTS. This apparatus was designed and built at the University of Stellenbosch. The second objective was to conduct a comparative evaluation of the performance of high temperature vulcanized silicone rubber (HTV-SR) power line insulators under AC, DC+

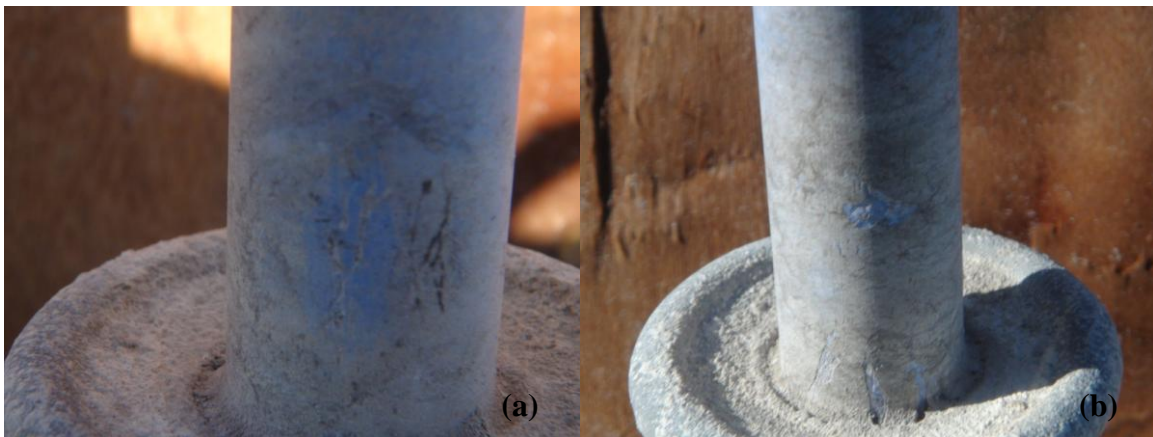
The first instance of material erosion was observed on the sheath interfacing with the live end-fitting in the southward direction. It must be mentioned that there was a directionally dominant deposit of pollution that emanated from the southward direction. By the end of the test period in week 22, more signs of material erosion were observed on the sheath interfacing with the live end-fitting in the northward direction. Figure 5-35 depicts the two instances of material erosion that were observed on the sheath interfacing with the live end-fitting in week 22. Additional instances of material erosion were observed on the sheath interfacing with the ground end-fitting in week 22. A count of total instances of material erosion recorded on the sheaths and sheds is summarized in Table 5-18.

**Figure 5-35: Two instances of material erosion on the sheath interfacing with the live end-fitting in the (a) southward direction and (b) northward direction, week 22**

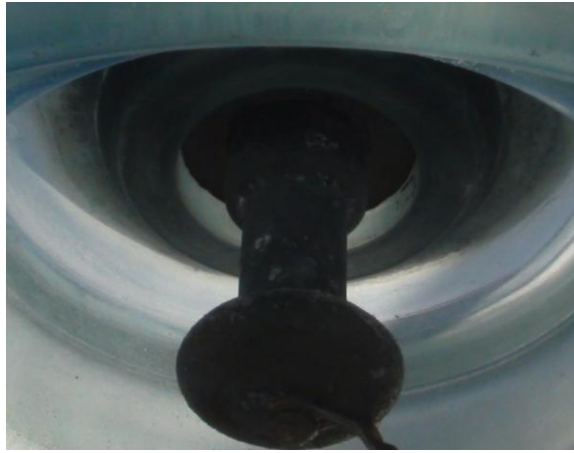
*Observations:* No surface deteriorations were observed on the AC glass disc insulator until week 22. However, traces of dryband activities were observed on the bottom of the glass disc around the pin and also on the top of the glass disc around the cap. The traces of dryband activities were first observed on the bottom of the glass disc in week 9, whereas those on the top side of the glass disc were only observed from week 13. No sign of material erosion was observed and this shows that the glass insulator performed very well on AC when compared to both DC+ (Figure 5-37) and DC- (Figure 5-38). The bottom view of the glass disc insulator is depicted in Figure 5-36.

**Figure 5-36: The bottom view of Glass disc 42 AC, week 22**

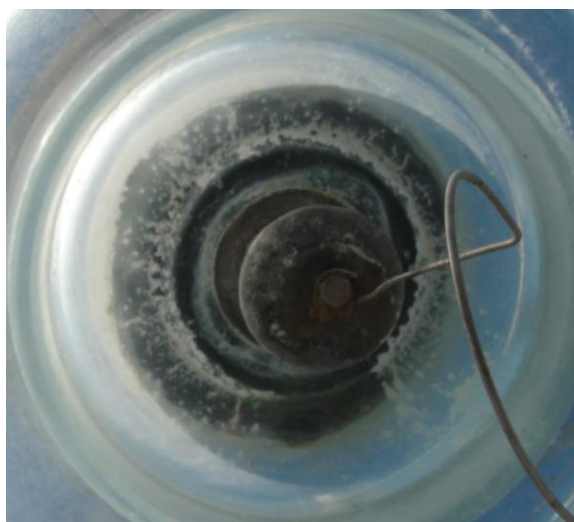
*Observations:* The first evidence of electrical activities on the insulator was observed in week 8. These included traces of dryband activities on the bottom of the glass disc around the pin and also on the top of the glass disc around the cap. Material erosion was also observed on the bottom of the glass disc around the pin in week 8. Figure 5-37 depicts material erosion as observed on DC+ in week 18. It must be mentioned that the extent of erosion on DC+ was not as severe as observed on DC-. This was evident comparing the erosion observed on DC+ to that observed on DC- (refer to Figure 5-38).

**Figure 5-37: Material erosion on the bottom of Glass disc 42 DC+ around the pin, week 18**

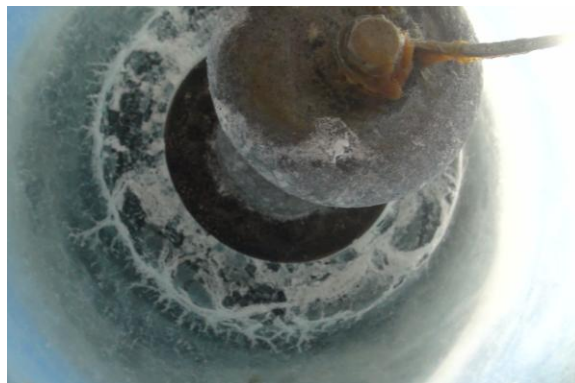
*Observations:* Traces of dryband activities were first observed on the top of the glass disc around the cap and also on the bottom of the glass disc around the pin from week 6. In addition, the first instance of material erosion was observed on the bottom of the glass disc around pin, in week 6. The extent of erosion on the glass disc insulator energized under DC- is depicted in Figure 5-38, as observed in week 16. It should be noted that the inspections on DC- were always done earlier than those for both AC and DC+. However, the first instance of erosion was observed on DC-. This suggests that the glass disc insulator performed poorly on DC- when compared to AC and DC+. In addition, the extent of erosion on DC- was found to be more severe than the one observed on DC+ (refer to Figure 5-37).

**Figure 5-38: Material erosion on the bottom of Glass disc 42 DC- around the pin, week 16**

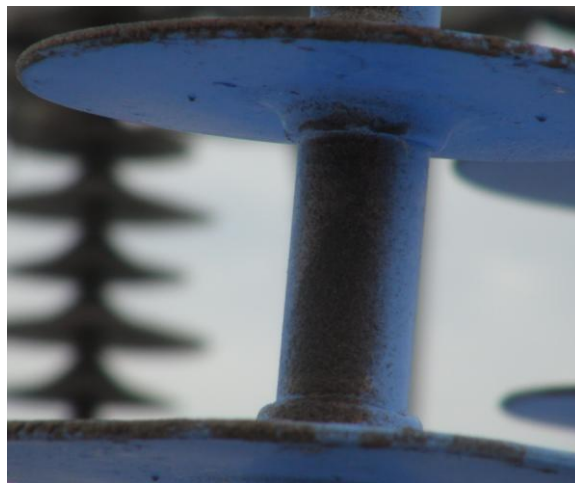
- *Deterioration:* Although not necessarily a form of deterioration, it is noteworthy that traces of dryband activities were generally observed on the shed bottoms and sheaths in all directions. No other signs of deterioration were observed.
- *Other observations:* Light pollution build-up was observed over the entire insulator, with medium to heavy pollution mainly on the shed tops and sheaths in the southward direction. Figure E-26 shows heavy pollution deposit (mainly sand) on the sheath of the test insulator in the southward direction. Salt crystals were observed in all directions, except in the southward direction.

**Figure E-26: Heavy pollution on the sheath of HTV-SR 84 AC (Week 5)**

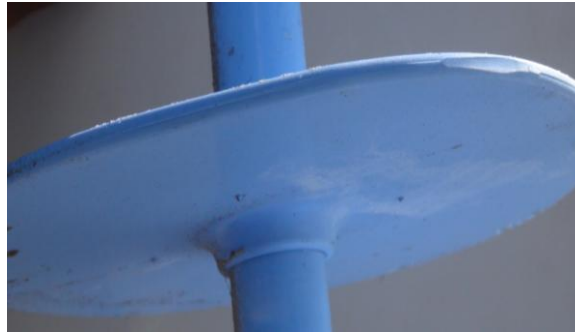
- *Deterioration:* Traces of dryband activity was prominently observed on the shed bottoms in all directions. This is evident from Figure E-27, depicting the drybands that were generally observed on the test insulator. No other signs of deterioration were observed.

**Figure E-27: Traces of dryband activity visible on the shed bottom of HTV-SR 84 DC+ (Week 3)**

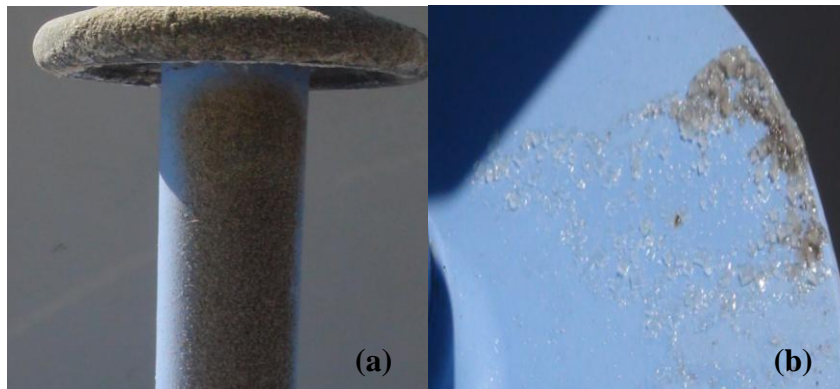
- *Other observations:* Similar to the AC test insulator, light pollution build-up was observed over the entire insulator, with medium to heavy pollution (see Figure E-28(a)) on the shed tops and sheaths in the southward direction. Salt crystals were observed dominantly on the shed tops in all directions. Figure E-28(b) shows a sample of the salt crystals that were observed on the test insulator.

**Figure E-28: (a) Heavy pollution deposits on the sheath and (b) salt crystals on the shed top of HTV-SR 84 DC+ (Week 3)**

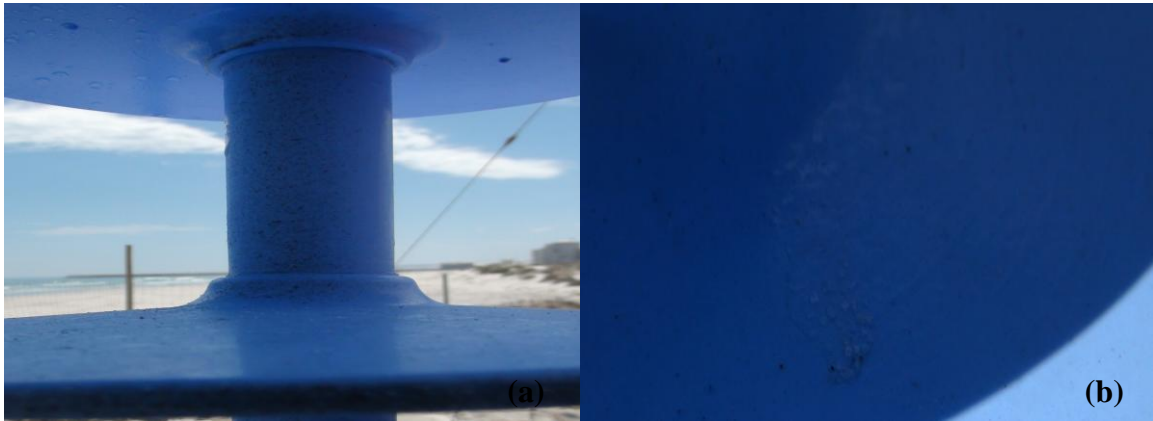
- *Deterioration:* No signs of deterioration were observed in the second week of the test program.
- *Other observations:* The test insulator was still relatively clean with only light pollution build-up observed, mainly dominant on the shed tops and sheaths in the southward direction. Salt crystals were observed on the shed tops in all directions. The general pollution conditions and a close-up view of the salt crystals observed are depicted in Figure E-29 (a) & (b), respectively.

**Figure E-29: (a) Light pollution build-up and (b) a close-up view of the salt crystals on HTV-SR 84 DC- (Week 2)**

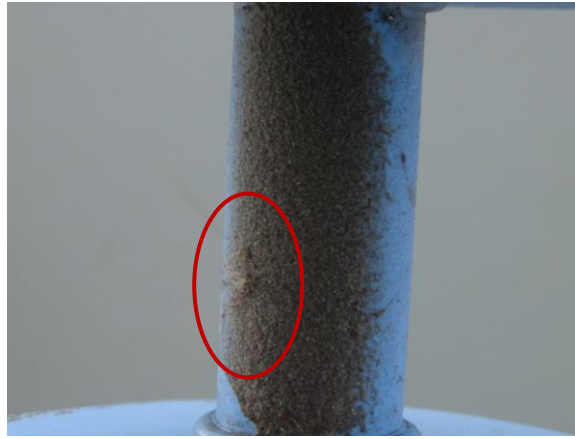
- *Other observations:* Light pollution build-up was generally observed over the entire insulator, with medium to heavy pollution in the southward direction on the shed tops and sheaths. Salt crystals were observed in all directions. Figure E-32 shows the one type of plant threads that were observed on the test insulator in all directions, except in the westward direction. A heavy pollution deposit is also clearly visible in Figure E-32.

**Figure E-32: A sample of the plant threads that were observed on HTV-SR 84 DC+(Week 8)**

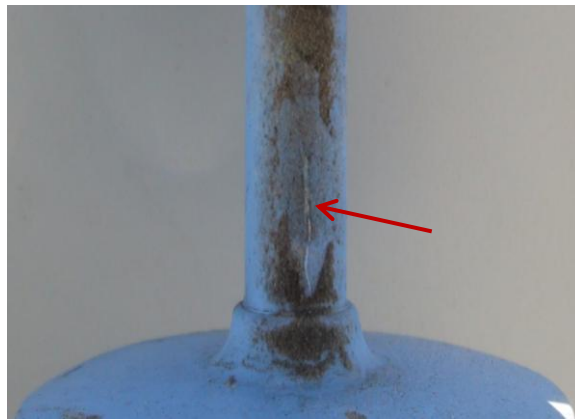
- *Deterioration:* On the second inspection cycle, traces of dryband activities could now be observed, mainly on the sheaths. Light crazing was also generally observed on the sheaths in all directions. The first sign of material erosion was observed on the middle section sheath (sheath 4) along the heavy pollution deposit in the southward direction. See Figure E-33. Evidence of dryband activities was also observed around the eroded area.

**Figure E-33: Material erosion along the heavy pollution deposit on sheath 4 of HTV-SR 84 DC- (Week 6)**

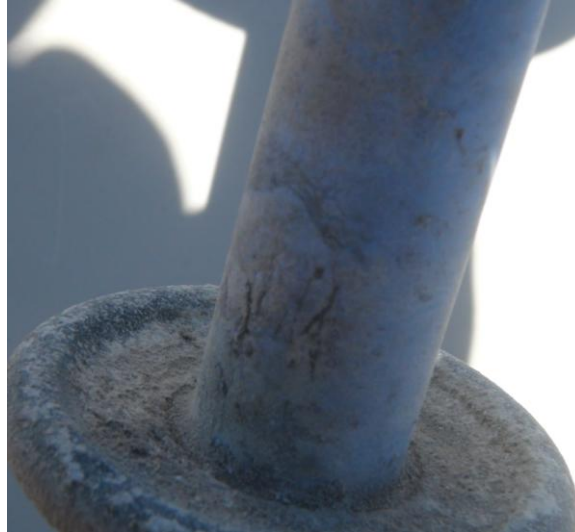
directions. The same material erosion, as was first observed in week 9 (see Figure E-30), was still observable on the sheath interfacing with the live end-fitting in the southward direction. This is depicted in Figure E-34. No new instance of material erosion was observed.

**Figure E-34: Material erosion on the sheath interfacing with the live end-fitting of HTV-SR 84 AC (Week 13)**

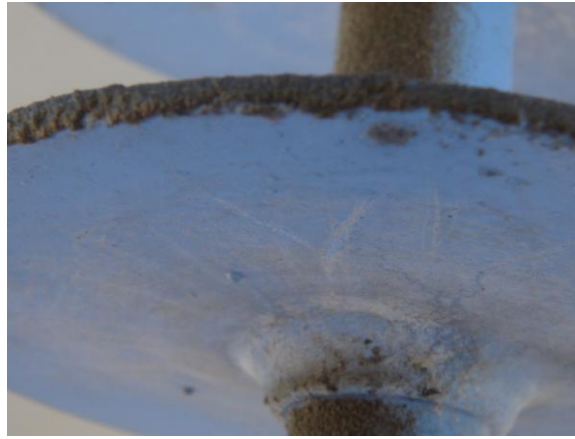
- *Deterioration:* Dryband traces, with a radial pattern on the shed bottoms, were observed in all directions. Light crazing was observed in all directions. More instances of material erosion were observed on sheath 5 closest to the ground end-fitting in the southward direction and also on the bottom of shed 3 in the westward direction. These were in addition to the first signs of material erosion previously reported on the sheath interfacing with the ground end-fitting and also on the bottom of the shed 3 in the southward direction in section E.2.2.2. Figure E-35 shows the light erosion and the signs of light crazing and drybands that were observed on the bottom of shed 3. Dark burns on pollution were observed around dryband and eroded areas.

**Figure E-35: Light material erosion, light crazing and drybands on the bottom of shed 3 of HTV-SR 84 DC+ (Week 11)**

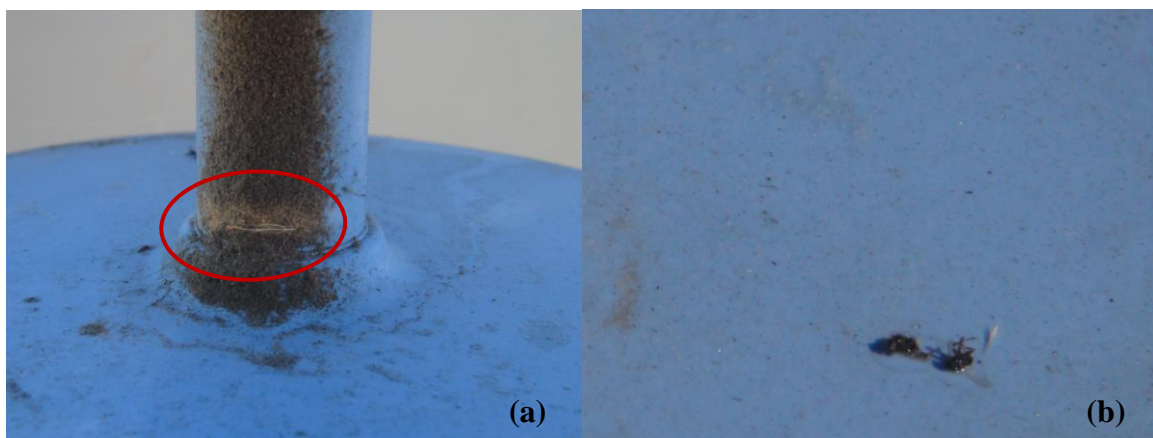
**Figure E-36: Samples of (a) the plant threads and (b) the dead insects that were observed on HTV-SR 84 DC+ (Week 11)**

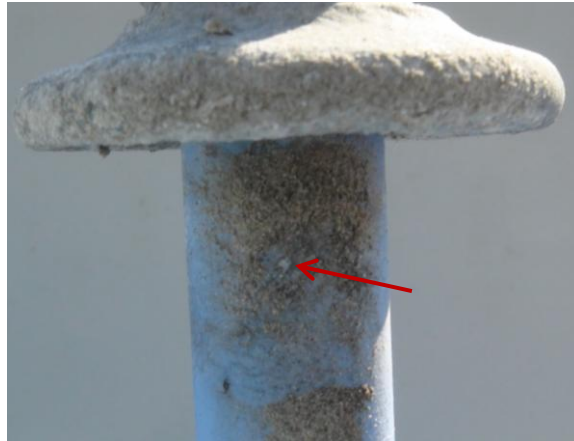
the ground and live end-fittings in the southward direction. The light erosion observed on the sheath interfacing with the ground end-fitting is shown in Figure E-37.

**Figure E-37: Material erosion on the sheath interfacing with the ground end-fitting along the heavy pollution deposit on HTV-SR 84 DC- (Week 10)**

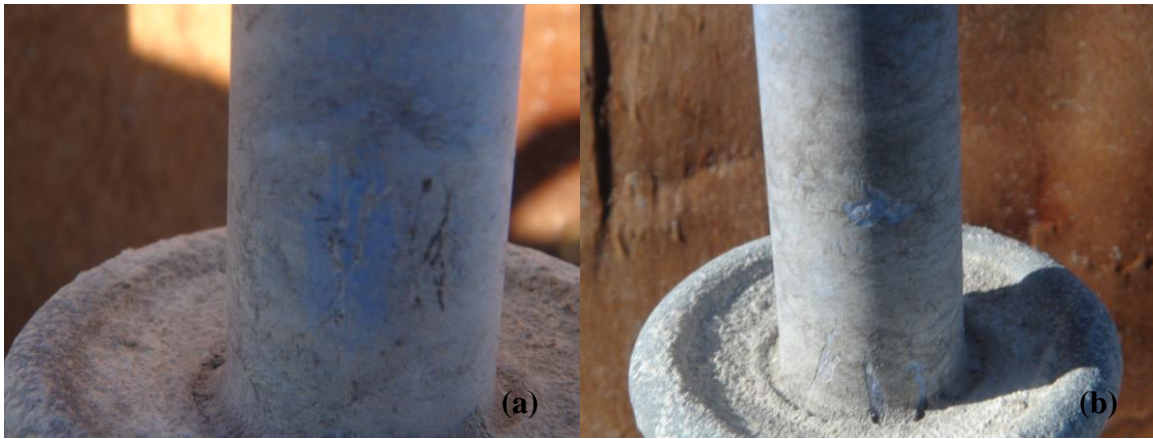
- *Deterioration:* Traces of dryband activities were generally observed in all directions. Light crazing was still observed on the shed bottoms and sheaths in all directions. More signs of material erosion were observed on the sheath interfacing with the live end-fitting in the northward direction, in addition to the erosion that was noted on the same sheath in weeks 9 and 13 in the southward direction. Additional instances of material erosion were observed on the sheath interfacing with the ground end-fitting in all directions, except in the eastward direction. Dark burns were observed around dryband and eroded areas. Figure E-38 and Figure E-39 depict material erosion on the sheath interfacing with the live and ground end-fittings, respectively.

**Figure E-38: Material erosion on the sheath interfacing with the live end-fitting in the (a) southward direction and (b) northward direction (Week 22)**

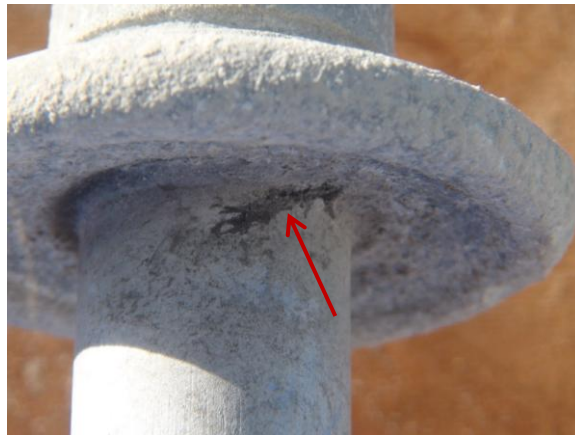
**Figure E-39: Material erosion on the sheath interfacing with the ground end-fitting (Week 22)**

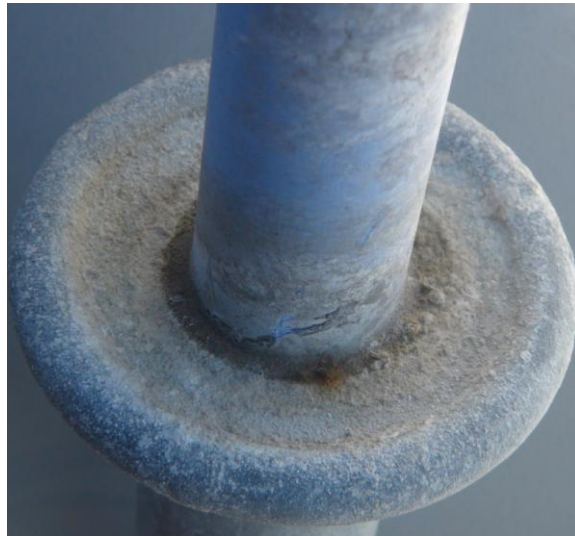
- *Deterioration:* Dryband traces were observed in all directions. Light crazing was observed on the shed bottoms and sheaths in all directions. All instances of material erosion, as previously reported for week 11, were observed in week 18. Additional erosion was now observed on the sheath interfacing with the live end-fitting in all directions, except in the eastward direction. The erosion in the southward direction is shown in Figure E-40. Blue patches (some forms of discoloration) were observed on

**Figure E-40: Material erosion on the sheath interfacing with the live end-fitting in the southward direction (Week 18)**

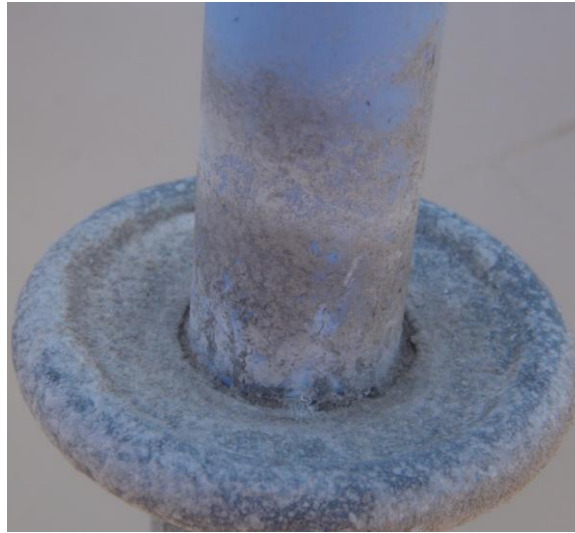
- *Deterioration:* Traces of dryband activities were observed on most parts of the insulator. Light crazing was observed on the sheaths, especially dominant around dryband areas. The instances of material erosion on the sheaths interfacing with both the ground and live end-fittings and also on sheath 4 in the southward direction were observed, as previously reported for week 10. Additional erosion was however observed on the sheath interfacing with the live end-fitting in the westward direction, as shown in Figure E-41. Blue patches (some forms of discoloration) were observed on the shed tops in all directions, except in the westward direction. It should be mentioned here that no evidence of electrical discharge activities was observed in the vicinities of the discoloured areas. See Figure E-42 below.

**Figure E-41: Material erosion on the sheath interfacing the the live end-fitting in the westward direction (Week 16)**

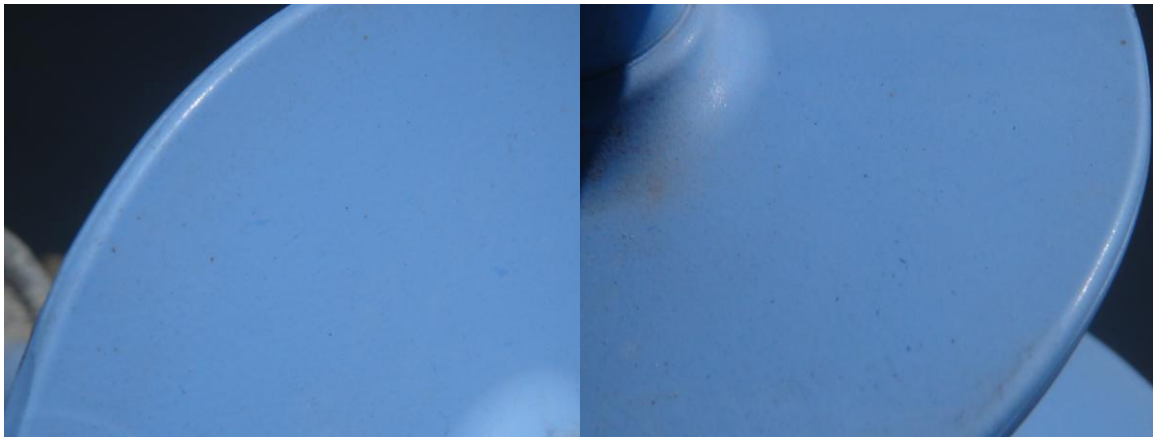
**Figure E-42: Blue patches on the shed tops (a form of discoloration) of HTV-SR 84 DC- (Week 16) (*please zoom in*)**

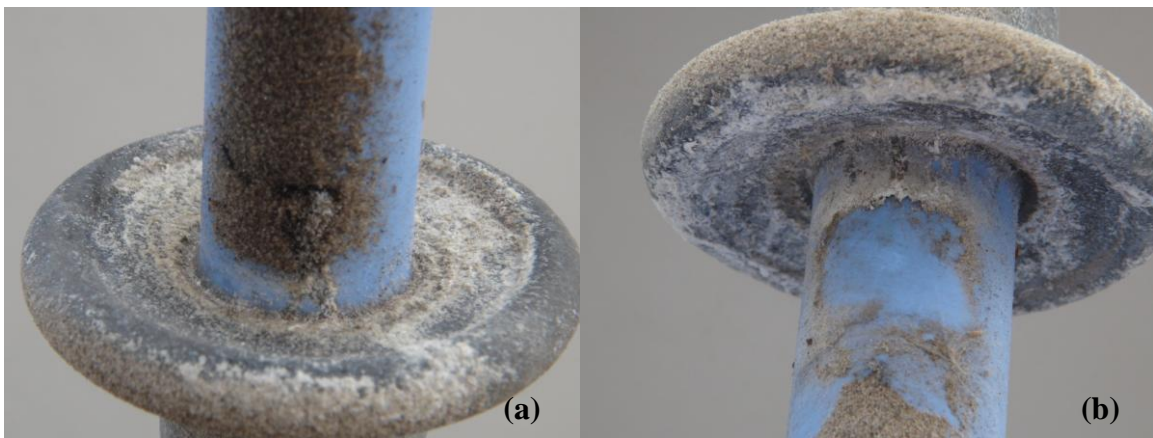
- *Deterioration:* Traces of dryband activity was observed in all directions. Dark burns were evident on the pollution layer on the sheaths interfacing with both the ground and live end-fittings in the southward direction, as shown in Figure E-43. No other signs of deterioration were observed.

**Figure E-43: Evidence of dryband activity on the sheaths interfacing with the (a) live and (b) ground end-fittings in the southward direction (Week 5)**

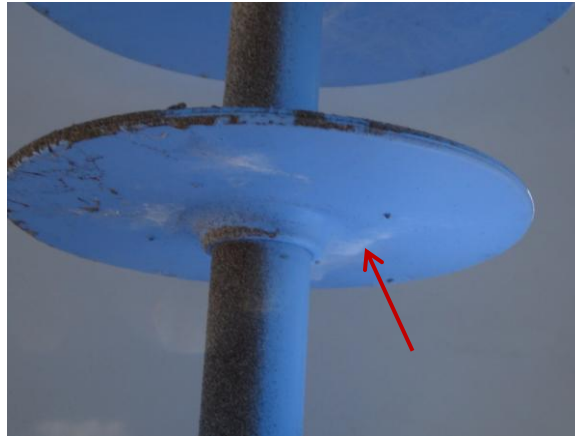
- *Deterioration:* Traces of dryband activities were prominently observed on the shed bottoms in all directions. Figure E-44 shows the traces of dryband activities on the shed bottom. No other signs of deterioration were observed.
- *Other observations:* Light pollution build-up was observed over the entire insulator, with medium to heavy pollution (see Figure E-44) on the shed tops and sheaths in the southward direction. Salt crystals were observed in all directions.

**Figure E-44: Traces of dryband activities on the shed bottom and heavy pollution on the sheaths of HTV-SR 72 DC+ (Week 3)**

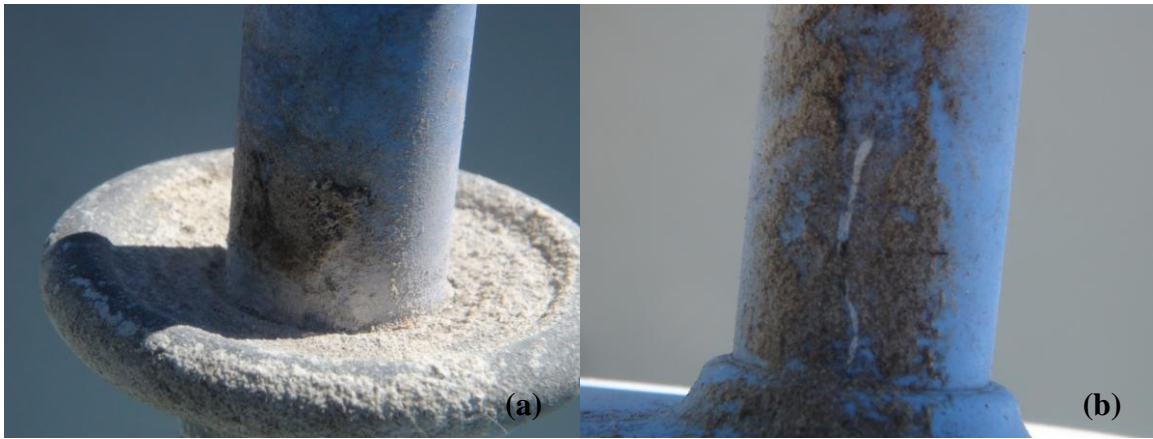
- *Deterioration:* Traces of dryband activities were observed in all directions. The first instance of light crazing was observed on the sheaths in all directions. Dark burns were observed on the pollution layer on the sheath interfacing with the live end-fitting in the southward direction. It is evident from Figure E-45 (a) that intense dryband arcing occurred on the sheath – likely to have caused erosion although it could not be confirmed. The first sign of material erosion was spotted on sheath 5 (toward the ground end-fitting) in the southward direction. Figure E-45 (b) depicts the erosion that was spotted on sheath 5, along the heavy pollution deposit in the southward direction.

**Figure E-45: (a) Dark burns on the sheath interfacing with the live end end-fitting and (b) material erosion on sheath 5 in the southward direction (Week 9)**

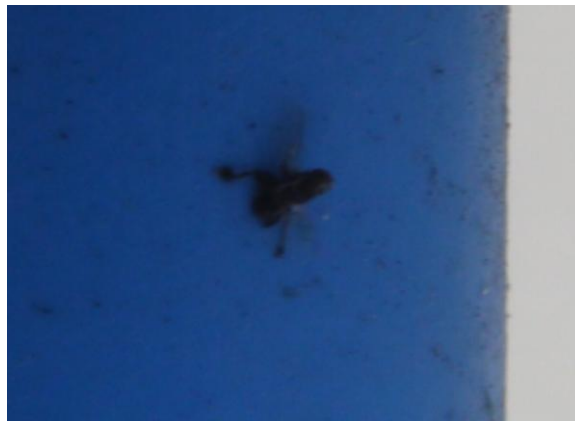
**Figure E-46: Dead insect (fly) spotted on sheath 3 of HTV-SR 72 AC in the eastward direction (Week 9)**

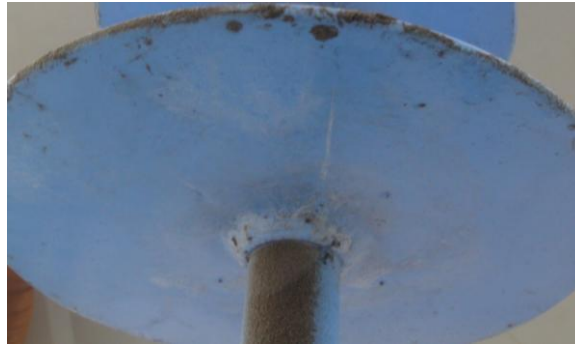
- *Deterioration:* Traces of dryband activities were observed in all directions, with a radial pattern on the shed bottoms. See Figure E-47. Light crazing was observed on the shed bottoms and sheaths in all directions. The first sign of material erosion was observed on the sheath interfacing with the ground end-fitting in the southward direction and also on sheath 2 (toward the live end-fitting) in the southward direction.

**Figure E-47: Traces of dryband activities on the shed bottom of HTV-SR 72 DC+ (Week 8)**

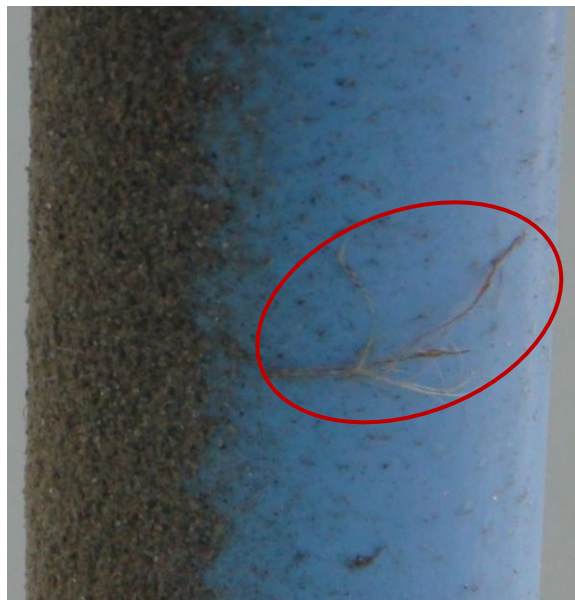
**Figure E-48: A sample of plant threads observed on HTV-SR 72 DC+ (Week 8)**

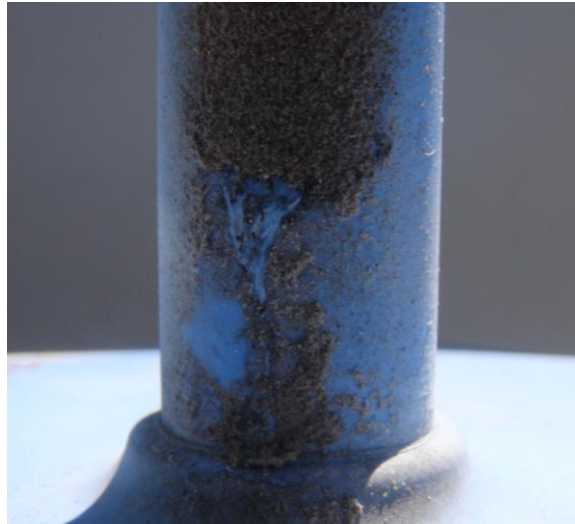
- *Deterioration:* Traces of dryband activities were dominantly observed on the sheaths in all directions. The first instance of light crazing was observed on the sheaths in all directions. The first sign of material erosion was observed on the sheath interfacing with the ground end-fitting, along the heavy pollution layer in the southward direction. This is shown below in Figure E-49.

**Figure E-49: Material erosion on the sheath interfacing with the ground end-fitting in the southward direction (Week 6)**

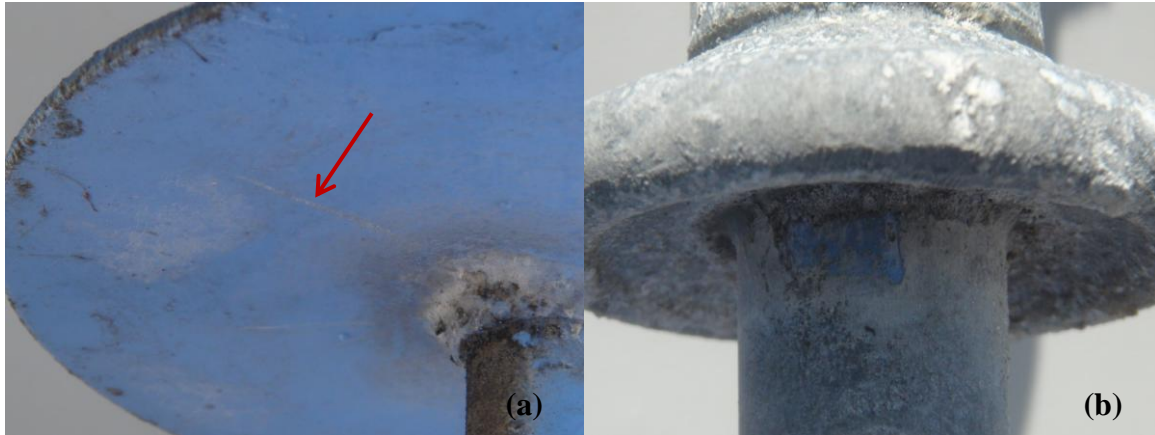
- *Deterioration:* Traces of dryband activities were observed in all directions. See Figure E-52 (a). Light crazing was generally observed on the shed bottoms and sheaths in all directions. The instances of material erosion, as previously reported for week 8, were

still observable on the sheath interfacing with the ground end-fitting in the southward direction and also on sheath 2 in the southward direction. Additional material erosion was noted on the sheath interfacing with the ground end-fitting in the northward direction; on the sheath interfacing with the live end-fitting and on the bottom of shed 3 in the southward direction. Figure E-52 shows the erosion that was observed on the bottom of shed 3 and on the sheath interfacing with the ground end-fitting.

**Figure E-52: Material erosion (a) on the bottom of shed 3 in the southward direction and (b) on the sheath interfacing with the ground end-fitting in the northward direction (week 11)**

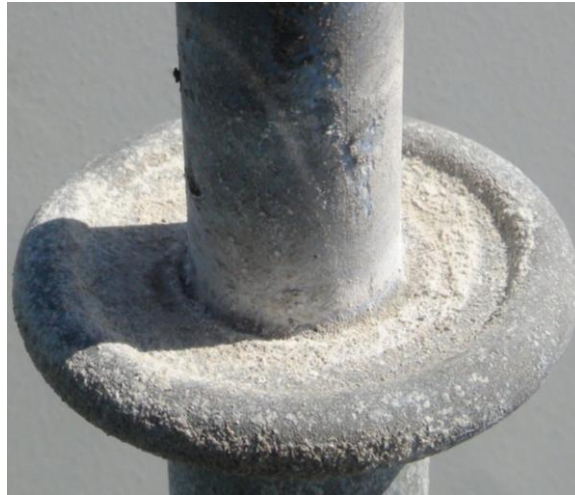
- *Deterioration:* Traces of dryband activity were dominantly observed on the shed bottoms and sheaths. Light crazing was commonly observed on the sheaths in all directions. Material erosion was now observed on the sheath interfacing with the live end-fitting in the southward direction, additional to the first sign of erosion in the southward direction noted on the sheath interfacing with the ground end-fitting in week 6. The new instance of material erosion is shown in Figure E-53.

**Figure E-53: Material erosion on the sheath interfacing with the live end-fitting (Week 10)**

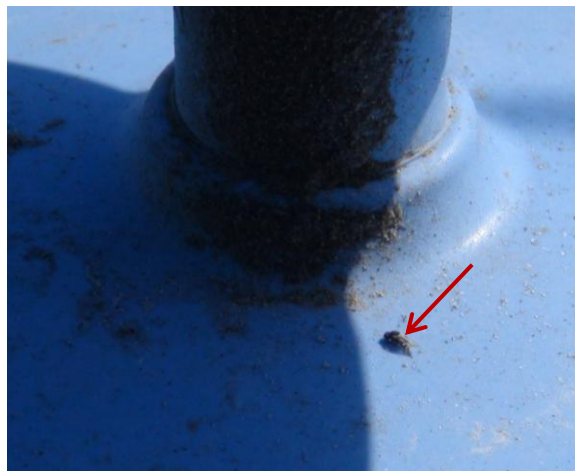
- *Other observations:* Light pollution was observed over the entire insulator, with medium to heavy pollution on the shed tops and sheaths in the southward direction. Salt crystals and plant threads were also observed. Dead insects were observed on the shed tops in the westward and southward directions. The dead insect that was observed in the southward direction is shown in Figure E-54.

**Figure E-54: Dead insect on the shed top in the southward direction (Week 10)**

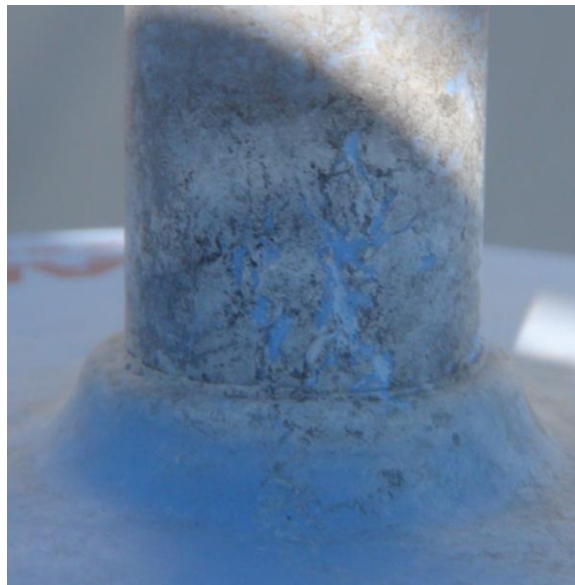
- *Deterioration:* Traces of dryband activities were observed in all directions. Light crazing was observed on the shed bottoms and sheaths in all directions. More instances of material erosion were observed on the sheaths interfacing with both the live and ground end-fittings – now observed in the northward and southward directions. Figure E-57 shows the erosion noted on the sheath interfacing with the ground end-fitting in the southward direction. The erosions on sheath 2 and bottom of shed 3 were still observed in the southward direction. Blue patches (some form of discoloration) were observed on the top of shed 4 in the northward direction.

**Figure E-57: Material erosion on the sheath interfacing with the ground end-fitting (Week 18)**

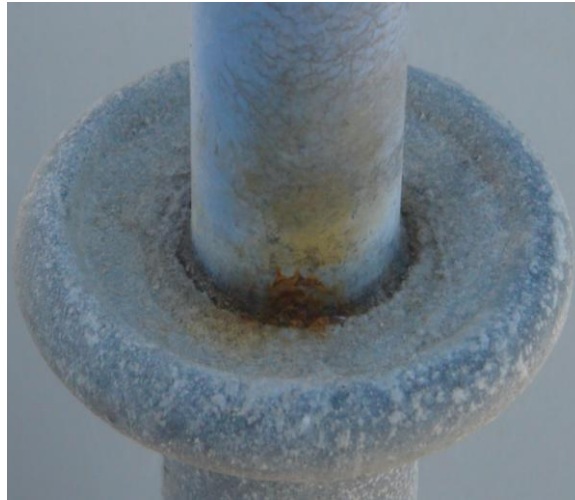
- *Other observations:* Light pollution build-up was observed over the entire insulator in all directions. No salt crystals were observed. Plant threads were observed in all directions, except in the westward direction. Rust patches were observed on the sheath interfacing with the live end-fitting in the northward direction, as shown in Figure E-58.

**Figure E-58: Rust patches on the sheath interfacing with the live end-fitting (Week 18)**

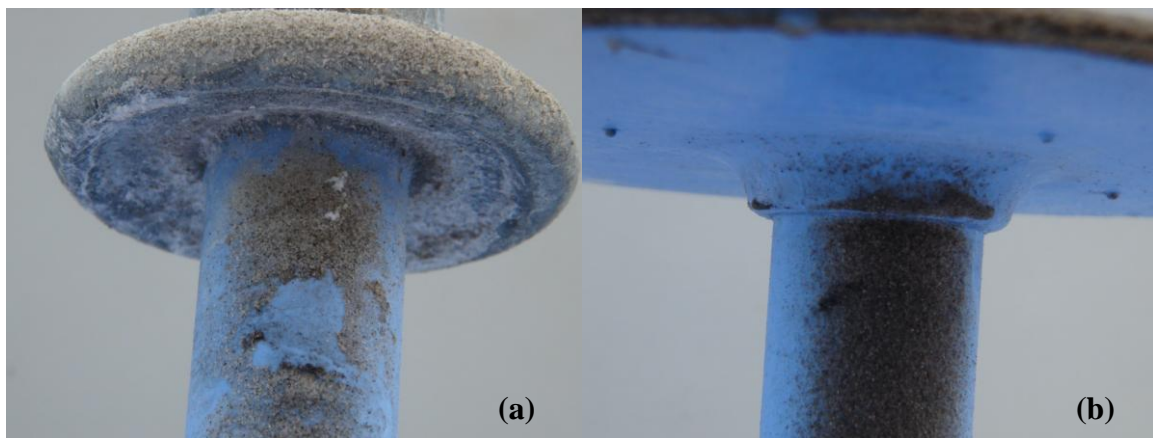
- *Deterioration:* Traces of dryband activities were observed in all directions. Dark burns were observed on pollution layer on the sheaths interfacing with the ground end-fitting and also on sheath 3 (middle section of insulator) in the southward direction. It was suspected that an intense dryband activity had occurred. This was in relation to the dark burns observed, as shown in Figure E-60. No other signs of deterioration were observed.

**Figure E-60: Traces of dark burns on pollution layer (a) on the sheath interfacing with the ground end-fitting and (b) on sheath 3 in the southward direction (Week 5)**

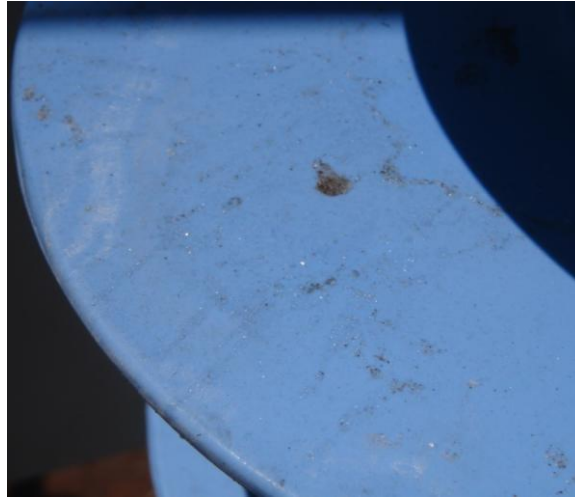
- *Deterioration:* Traces of dryband activities were generally observed on the shed bottoms, shed tops and sheaths in all directions. Figure E-61 shows traces of dryband activities observed on the shed tops. No other signs of deterioration were observed.

**Figure E-61: Traces of dryband activities on the shed top of HTV-SR 56 DC+ (Week 3)**

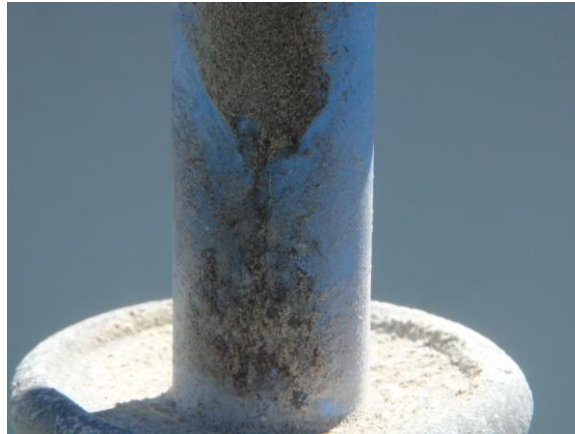
- *Deterioration:* Dryband traces were observed in all directions. Light crazing was observed on the sheaths in all directions. The first signs of material erosion were observed on the sheath interfacing with the live end-fitting and also on sheaths 3 (middle section of insulator) & 4 (toward the ground end-fitting) in the southward

direction. All instances of erosion were noticed along the heavy pollution deposits, as it can be seen in Figure E-62 and Figure E-63.

**Figure E-62: Material erosion on the sheath interfacing with the live end-fitting in the southward direction (Week 9)**

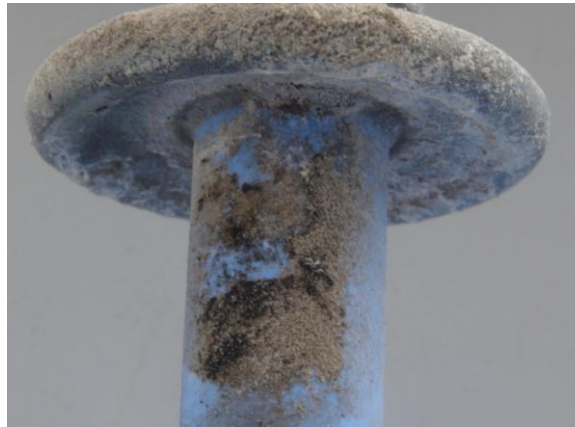
instance of material erosion was observed on the sheath interfacing with the ground end-fitting in the southward direction, as shown in Figure E-64.

**Figure E-64: Material erosion observed on the sheath interfacing with the ground end-fitting in the southward direction (Week 8)**

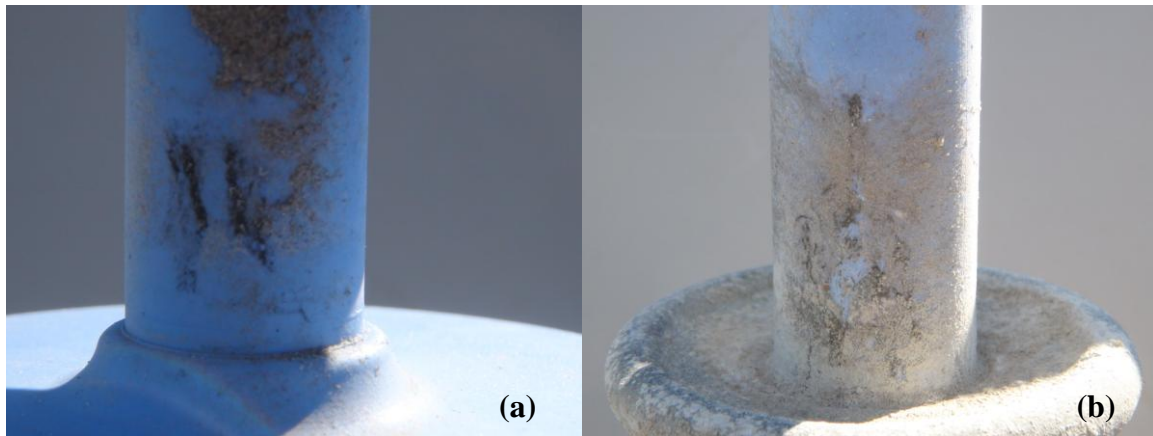
- *Deterioration:* Traces of dryband activities were observed in all directions. Light crazing was observed on the shed bottoms and sheaths in all directions. The first signs of material erosion on the sheath interfacing with the live end-fitting and also on sheaths 3 (middle section of insulator) & 4 (toward the ground end-fitting) in the southward direction were still observable, as reported in week 9. Additional instances of erosion were now observed on the sheath interfacing with the ground end-fitting

and sheath 2 in the southward direction. Dark burns were observed on pollution around the eroded area on sheath 2. Figure E-65 shows the instances of erosion as observed on sheath 3 and on the sheath interfacing with the live end-fitting.

**Figure E-65: Instances of material erosion (a) on sheath 3 and (b) on the sheath interfacing with the live end-fitting in the southward direction (Week 13)**

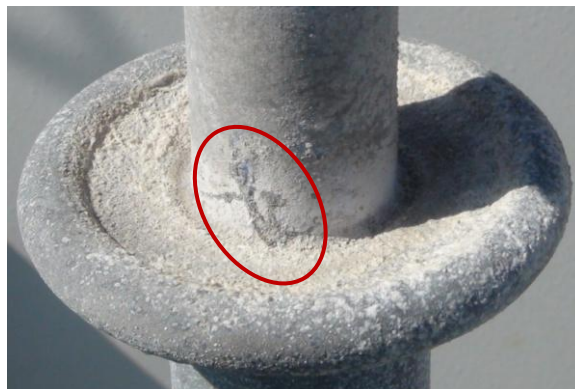
- *Deterioration:* Traces of dryband activities were observed commonly on the shed bottoms and sheaths in all directions. Light crazing was observed, mainly prominent in dryband areas. The first instances of material erosion were observed on the sheath interfacing with the live end-fitting in the northward direction and also on the sheath interfacing with the ground end-fitting in the southward direction. The erosion on the sheath interfacing with the live end-fitting is depicted in Figure E-67. It can be seen from the figure that there seems to be some form of tracking around the eroded area.

**Figure E-67: Material erosion observed on the sheath interfacing with the live end-fitting (Week 10)**

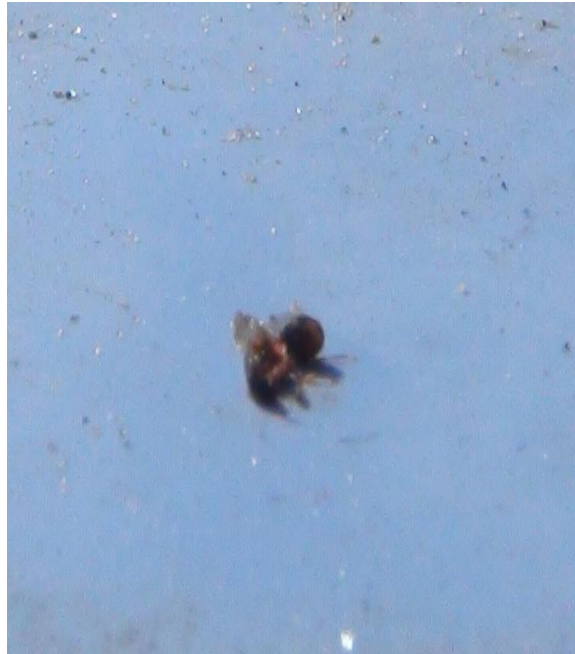
sample of the dead insects observed on the shed tops is shown in Figure E-68. Plant threads were also observed.

**Figure E-68: A dead insect observed on the shed top of HTV-SR 56 DC- (Week 10)**

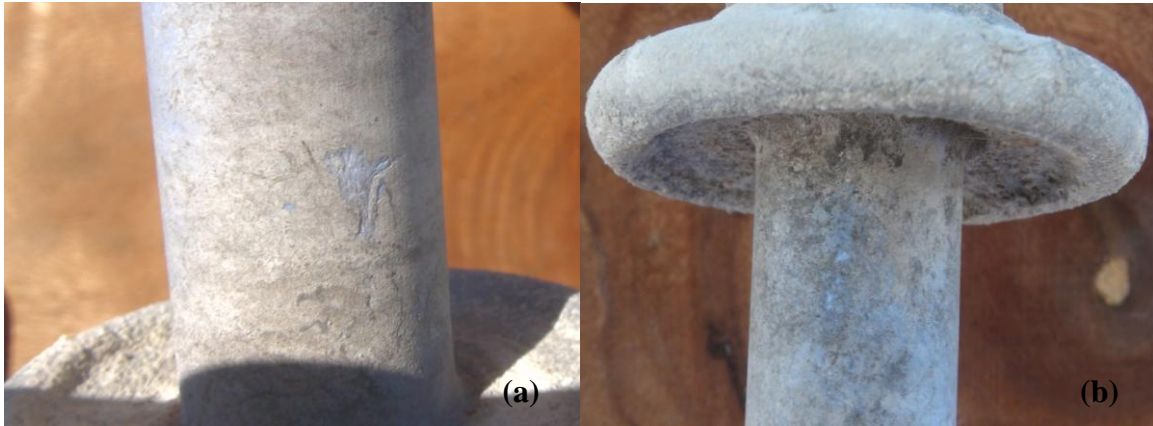
- *Deterioration:* Traces of dryband activities were observed in all directions. Light crazing was observed on the shed bottoms and sheaths in all directions. The following instances of material erosion were observed in the southward direction, as reported in week 13: on the sheaths interfacing with both the live and ground end-fittings, on sheaths 3 (middle section of insulator) & 4 (toward the ground end-fitting and sheath 2. Additional erosion was observed on the sheaths interfacing with both the live and ground end-fittings in the northward direction and also on the bottom of shed 3 in the southward direction. Figure E-69 shows a sample of erosion instances observed on the sheaths interfacing with both the live and ground end-fittings. The first instance of blue patches (some of form of discoloration) was observed on the top of sheds 2 & 3 in the eastward direction.

**Figure E-69: Instances of material erosion on the sheaths interfacing with both the (a) live and (b) ground end-fittings (Week 22)**

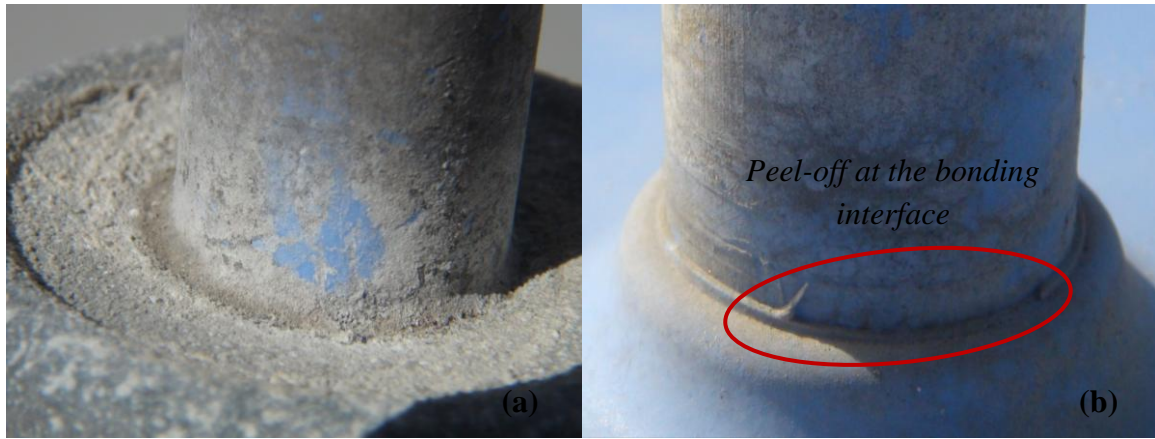
- *Deterioration:* Traces of dryband activities were observed on most parts of the insulator. Light crazing was observed on the sheaths, especially around the dryband areas. The first instances of material erosion were still observable on the sheath interfacing with the live end-fitting in the northward direction and also on the sheath interfacing with the ground end-fitting in the southward direction, as reported for week 10. However, more instances of erosion were noticed on the sheath interfacing with the ground end-fitting in all directions, except in the eastward direction and also on sheath 3 (all directions except south) & sheath 4 (westward direction). A peel-off was observed at the bonding interface of a sheath and shed, and evidence of dryband activities was also visible. Figure E-71 illustrates the erosion that was observed on the sheath interfacing with the live end-fitting and the peel-off at the sheath-to-shed bonding interface. From Figure E-71 (a), it can be seen that no tracking was present around the eroded area as suspected during week 10. The first instance of blue patches (a form of discoloration) was observed in the westward direction. See Figure E-72.

**Figure E-71: (a) Material erosion on the sheath interfacing with the live end-fitting in the northward direction and (b) material peel-off at the sheath-to-shed bonding interface (Week 16)**

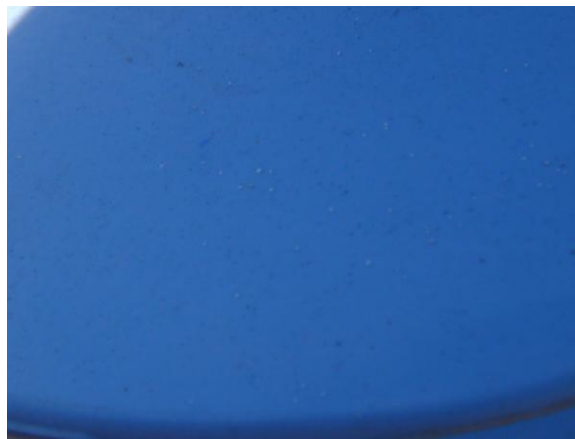
**Figure E-72: Blue patches (a form of discoloration) spotted on the shed top of HTV-SR 56 DC- (Week 16)**  
*(please zoom in)*

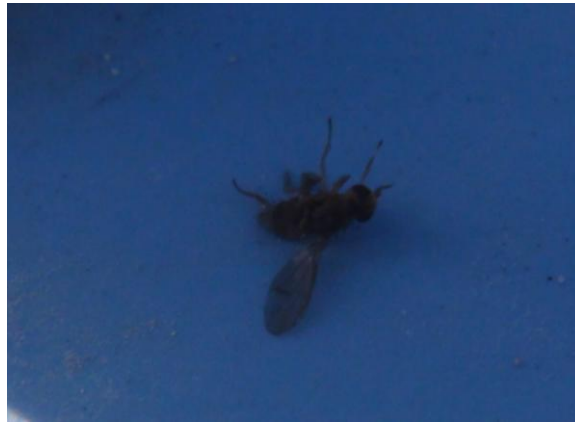
- *Other observations:* Light pollution was observed over the entire insulator. Salt crystals were observed in the northward direction. Plant threads were observed in all directions. Dead bug was observed in the southward direction. See Figure E-73. Rust spots were observed on the sheath interfacing with the ground end-fitting in the northward direction.

**Figure E-73: A dead insect on the shed top of HTV-SR 56 DC- (Week 16)**

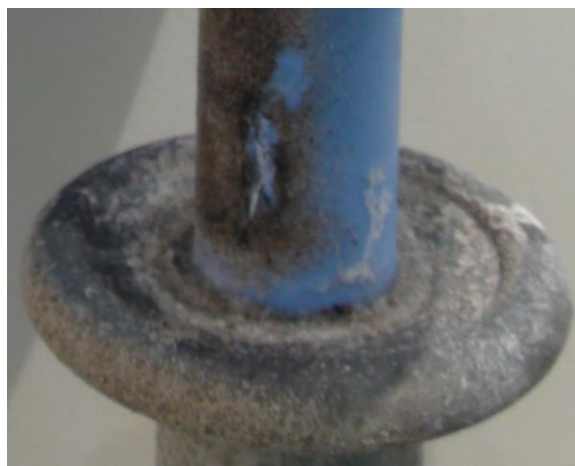
- *Deterioration:* Traces of dryband activities were observed in all directions. The first instance of material erosion was observed on the sheath interfacing with the live end-fitting in the southward direction. This erosion is shown in Figure E-74. Dark burns were observed on pollution layer on the sheath interfacing with the ground end-fitting in the southward direction.

**Figure E-74: The first sign of material erosion on the sheath interfacing with the live end-fitting in the southward direction (Week 5)**

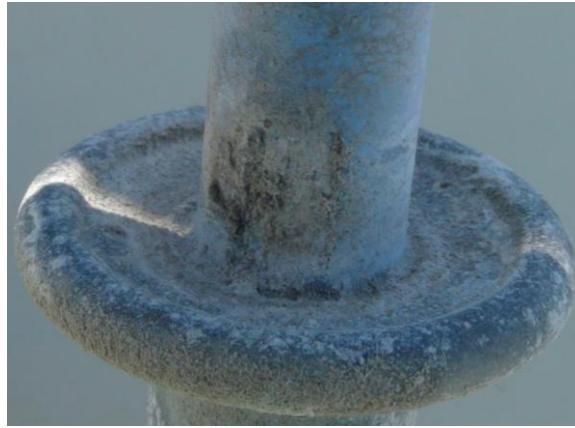
- *Deterioration:* Traces of dryband activities were observed in all directions. Light crazing was generally observed on the sheaths in all directions. The first instance of material erosion was still observed on the sheath interfacing with the live end-fitting in the southward direction, as reported in week 2. Refer to Figure E-75.

**Figure E-75: Erosion on the sheath interfacing with the live end-fitting in the southward direction (Week 9)**

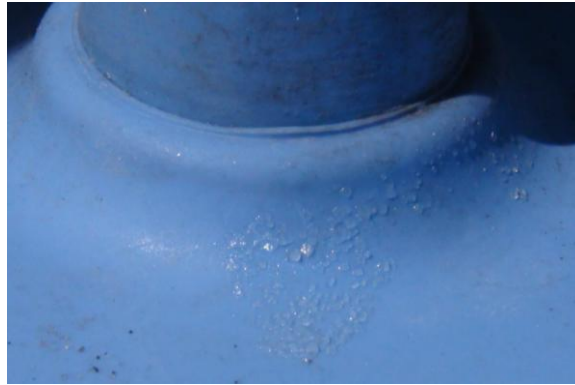
- *Deterioration:* Traces of dryband activities were observed. Light crazing was observed on the sheaths. No other signs of deterioration were observed.
- *Other observations:* The insulator was lightly polluted, with medium to heavy pollution on the shed tops and sheaths in the southward direction. Salt crystals were observed in the westward, northward and eastward directions, a sample of which is shown in Figure E-76.

**Figure E-76: Salt crystals on the shed top of HTV-SR 44 DC- (Week 6)**
