# **An Evaluation of HTV-SR Insulators with Different Creepage Lengths under AC and Bipolar DC in Marine Polluted Service Conditions**

*Thesis presented in partial fulfilment of the requirements for the degree Master of Science in Engineering at the University of Stellenbosch*

This study was conducted at the Koeberg Insulator Pollution Test Station (KIPTS) on the west coast of Cape Town in the Western Cape province of South Africa. KIPTS is an internationally recognized insulator pollution test facility, which is widely used by both insulator manufacturers and academic researchers from many parts of the world. STRI and ABB, both Swedish-based companies, are good examples of international subscribers to the KIPTS research facility. The first objective of this research was to design a suitable DC excitation voltage system for both DC+ and DC- to be used at KIPTS. This apparatus was designed and built at the University of Stellenbosch. The second objective was to conduct a comparative evaluation of the performance of high temperature vulcanized silicone rubber (HTV-SR) power line insulators under AC, DC+

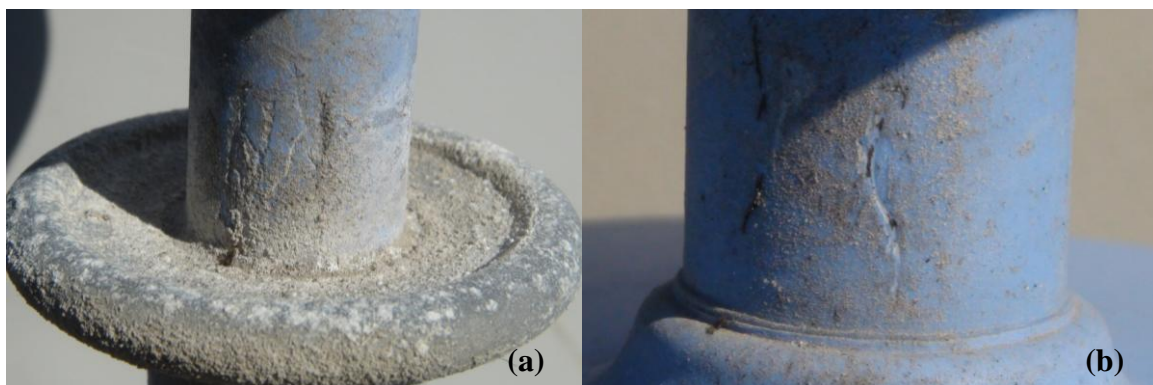
- *Deterioration:* Traces of dryband activity were observed in all directions. Light crazing was observed in all directions. In addition to the first instance of material erosion that was observed on the sheath interfacing with the live end-fitting in the southward direction, an additional instance of erosion was now observed on sheath 2 in the southward direction. Both of these instances of erosion are shown in Figure E-77. It can be seen that the erosion on the sheath interfacing with the live end-fitting is now clearly visible compared to the inspections for week 9 (refer to Figure E-75) and it appears that the eroded area has increased in comparison to the first observations made in week 5 (refer to Figure E-74).

**Figure E-77: Instances of material erosion (a) on the sheath interfacing with the live end-fitting and (b) on sheath 2 (Week 13)**

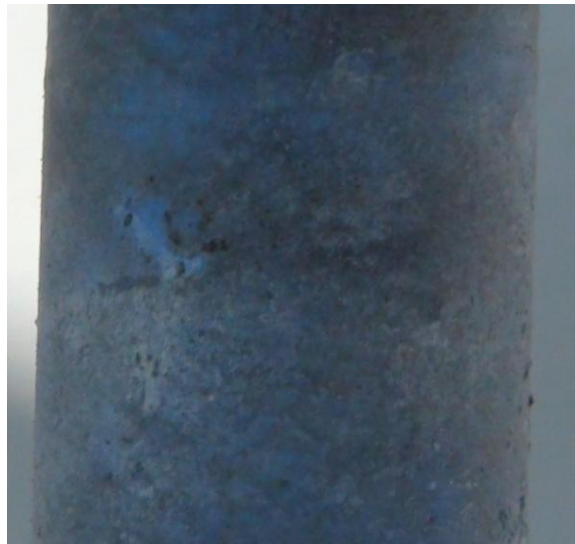
- *Deterioration:* Traces of dryband activities were observed in all directions. Light crazing was observed on the shed bottoms and sheaths in all directions. Material erosion was observed on the sheath interfacing with the ground end-fitting in the southward direction and also on the sheath interfacing with the live end-fitting in the westward and southward directions, as previously reported for week 8. More instances of material erosion were now observed on the sheath interfacing with the live end-fitting in the northward direction (see Figure E-78).

**Figure E-78: Material erosion on the sheath interfacing with the live end-fitting (Week 11)**

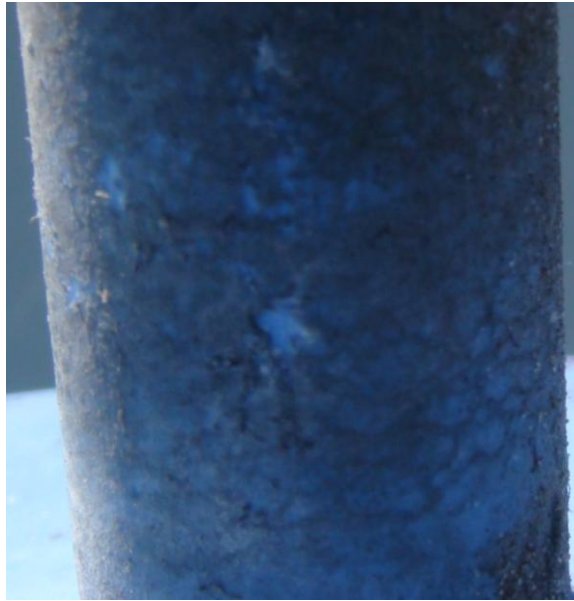
- *Deterioration:* Traces of dryband activity were observed. Light crazing was generally observed on the sheaths. The first instances of material erosion were observed on the sheath interfacing with the ground end-fitting in the westward and northward directions. See Figure E-79.

**Figure E-79: The first instance of material erosion on the sheath interfacing with the ground end-fitting (Week 10)**

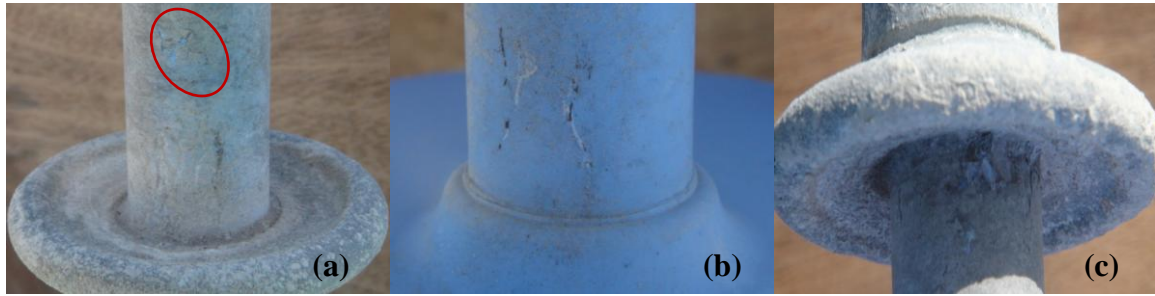
- *Deterioration:* Traces of dryband activity were observed in all directions. Light crazing was observed on the sheaths in all directions. As previously reported for week 13, material erosion was still observed on the sheath interfacing with the live end-fitting and on sheath 2 in the southward direction. More erosion was now observed on the sheath interfacing with the ground end-fitting in the northward direction. All the instances of material erosion that were observed are shown below in Figure E-80. It can be seen in Figure E-80 (a) that there is now additional erosion just above the eroded area that was first observed in week 5.

**Figure E-80: Instances of material erosion observed (a) on the sheath interfacing with the live end-fitting, (b) on sheath 2 and (c) on the sheath interfacing with the ground end-fitting**

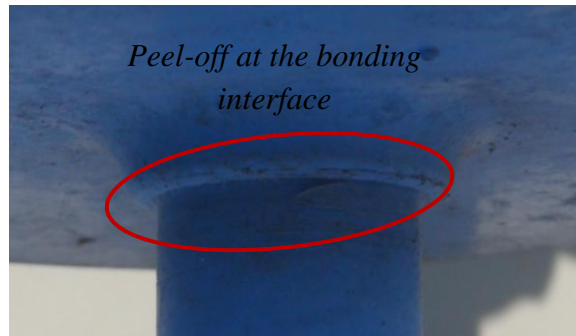
- *Deterioration:* Traces of dryband activities were observed on most parts of the insulator. Light crazing was observed on the sheaths and especially on the dryband areas. Material erosion was observed on the sheath interfacing with the ground end-fitting in the westward and northward directions, as reported in week 10. More erosion was observed on the sheath interfacing with the ground end-fitting in the southward direction and also on sheath 3 in the westward, northward and eastward directions. The first instance of blue patches (a form of discoloration) was observed in the eastward direction. A peel-off was observed at the sheath-to-shed bonding interface of a sheath and shed and evidence of dryband activities was also visible, as it can be seen in Figure E-82.

**Figure E-82: Material peel-off at the sheath-to-shed bonding interface (week 16)**

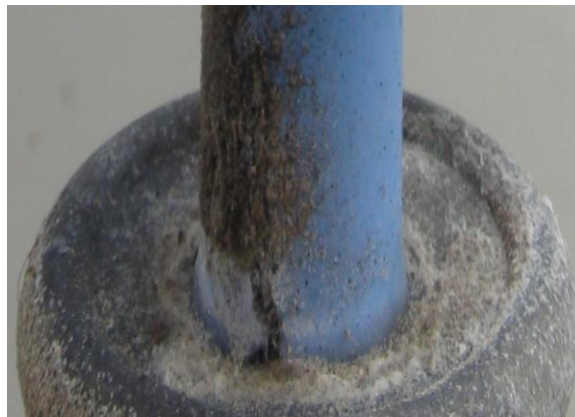
- *Deterioration:* Traces of dryband activity were observed on the shed bottoms and sheaths. It was suspected that an intense dryband activity had occurred. This was due to the dark burns that were observed, as shown in Figure E-83. It was however not possible to confirm whether material erosion was present. Light crazing was observed on the shed bottoms and sheaths in all directions.

**Figure E-83: Dark burns on pollution on the sheath interfacing with the live end-fitting (Week 5)**

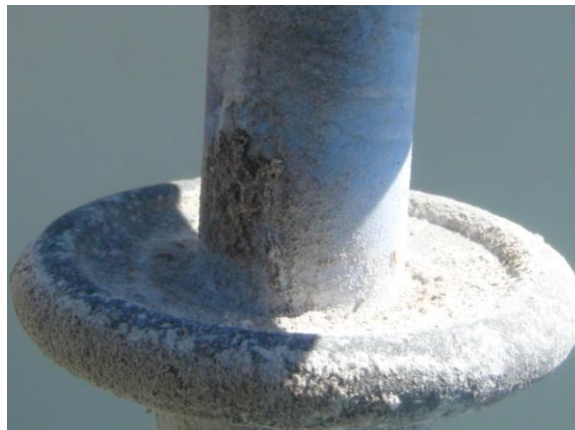
- *Deterioration:* Traces of dryband activities were observed in all directions. Light crazing was observed on the shed bottoms and sheaths in all directions. The first instance of material erosion, as shown in Figure E-84, was observed on the sheath interfacing with the live end-fitting in the southward direction and this erosion occurred at exactly the same spot where dark burns were observed in week 5 (refer to Figure E-83).

**Figure E-84: The first sign of material erosion on the sheath interfacing with the live end-fitting in the southward direction (Week 9)**

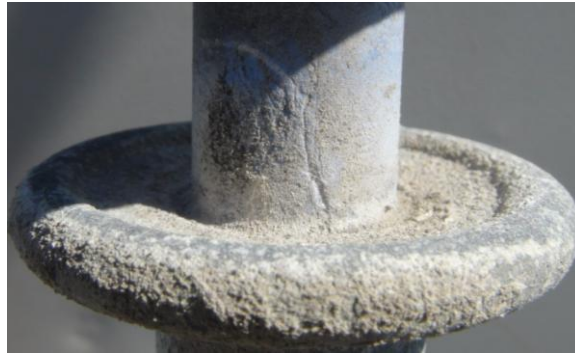
- *Deterioration:* Traces of dryband activities were observed in all directions. Light crazing was observed on the shed bottoms and sheaths in all directions. As reported for week 9, material erosion was still observed on the sheath interfacing with the live end-fitting in the southward direction. See Figure E-86 below.

**Figure E-86: Material erosion on the sheath interfacing with the live end-fitting (week 13)**

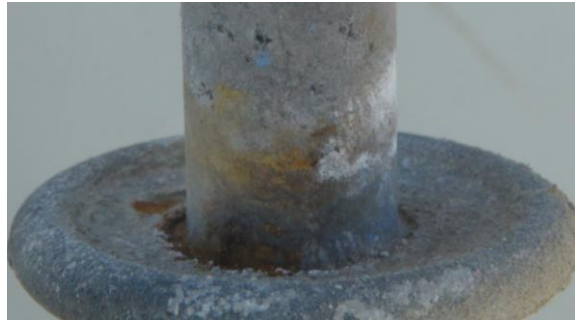
- *Other observations:* Light pollution build-up was observed over the entire insulator, with medium pollution on the shed tops and sheaths in the southward direction. Salt crystals were observed in all directions. Plant threads were observed in all directions, except in the southward direction. A dead insect was observed on the bottom of shed 2 in the westward direction. Rust deposits were observed on the sheath interfacing with the live end-fitting in the westward direction, as shown in Figure E-87.

**Figure E-87: Rust deposit on the sheath interfacing with the live end-fitting in the westward direction (Week 11)**

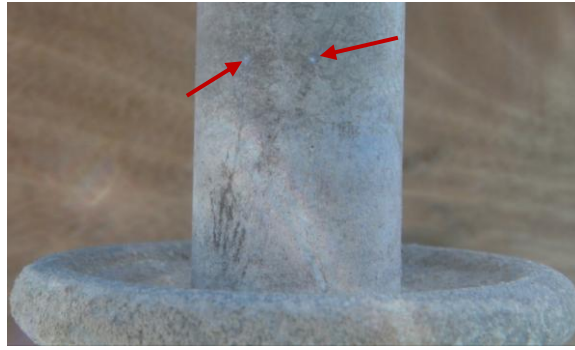
- *Deterioration:* Traces of dryband activity were observed in all directions. Light crazing was observed in all directions. As reported for week 13, material erosion was still observed on the sheath interfacing with the live end-fitting in the southward direction. Additional erosion was however observed just above the eroded area that was previously recorded in week 13, as it can be seen in Figure E-88.

**Figure E-88: Material erosion on the sheath interfacing with the live end-fitting (Week 22)**

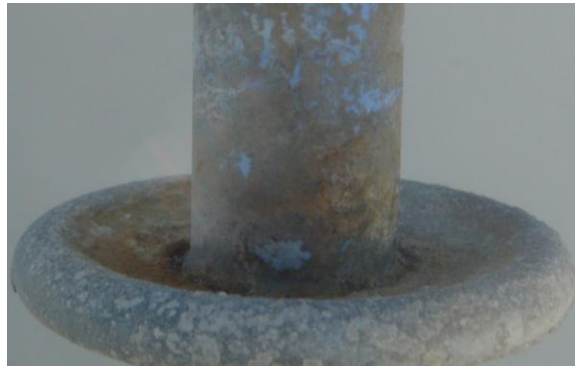
- *Deterioration:* Traces of dryband activities were observed in all directions. Light crazing was observed in all directions, but none on the top of shed 1. As reported for week 11, the following signs of material erosion were still observed: on the sheath interfacing with the ground end-fitting in all directions, except in the eastward direction; on the sheath interfacing with the live end-fitting in the northward direction; on sheath 2 (middle section of the insulator) in the southward direction. No new signs of erosion were observed.
- *Other observations:* Light pollution build-up was observed over the entire insulator. No salt crystals were observed. No plant threads were observed. Rust patches were observed on the sheath interfacing with the live end-fitting in the westward direction, as previously reported for week 11. See Figure E-89.

**Figure E-89: Rust deposit on the sheath interfacing with the live end-fitting in the westward direction (Week 18)**

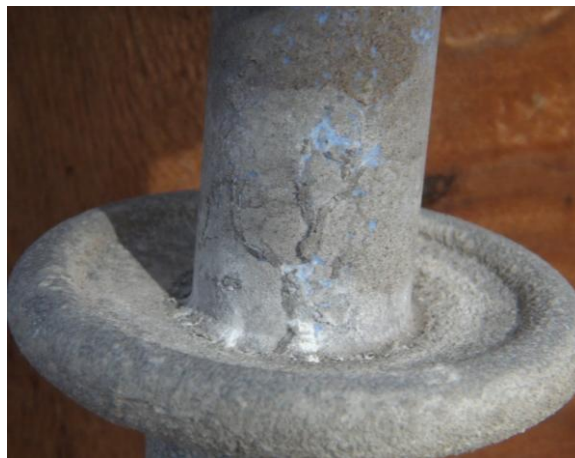
- *Deterioration:* Traces of dryband activities were observed on most parts of the insulator. Light crazing was observed on the sheaths, especially around the dryband areas. Light crazing was also observed on the bottom of shed 2 in the northward and southward directions. Signs of material erosion were still observed on the sheath interfacing with the ground end-fitting in the eastward and southward directions, as reported for week 10. This is depicted in Figure E-90.

**Figure E-90: Material erosion on the sheath interfacing with the ground end-fitting (Week 16)**

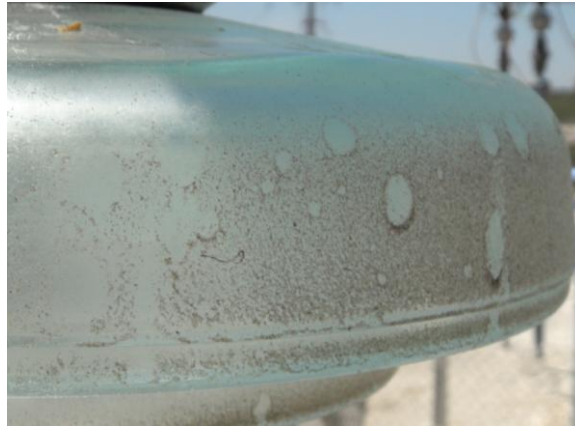
- *Deterioration:* No signs of deterioration were observed.
- *Other observations:* Light pollution was generally observed over the entire insulator, with medium pollution on the top of glass disc in the southward direction. See Figure E-92. Salt crystals were observed on the top of glass disc in all directions, except in the northward direction.

**Figure E-92: Pollution conditions on the top of glass disc (Week 3)**

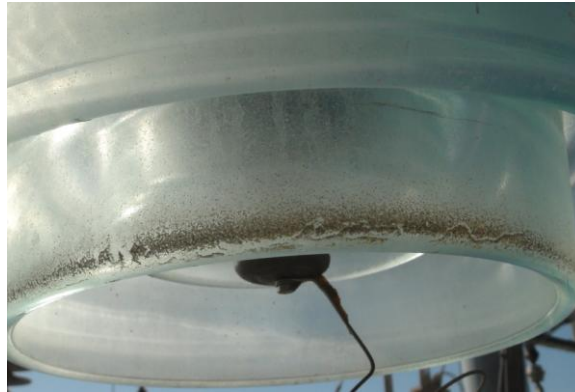
- *Deterioration:* The first traces of dryband activities were observed on the bottom of glass disc in the southward direction. Figure E-93 shows the traces of dryband activity that were spotted on the bottom of glass disc. No other signs of deterioration were observed.
- *Other observations:* Light pollution was generally observed over the entire insulator, with medium pollution on the bottom of glass disc in the southward direction. Salt crystals were observed on the bottom of glass disc in all directions, except in the westward direction. A plant thread was observed on the bottom of glass disc in the southward direction.

**Figure E-93: Traces of dryband activity on the bottom of glass disc (Week 9)**

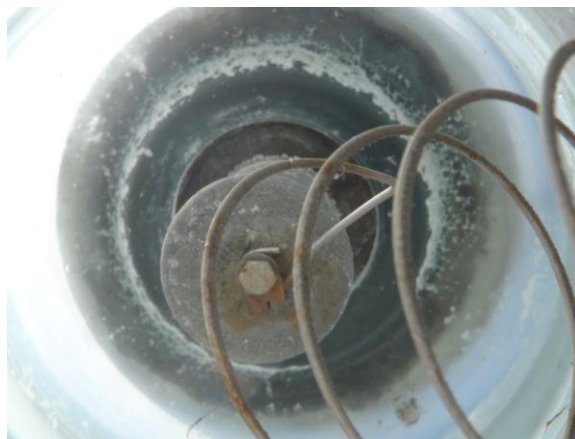
- *Deterioration:* The first traces of dryband activities were observed on both bottom and top of glass disc in all directions. The first instance of material erosion was observed on the bottom of glass disc around the pin. See Figure E-94.

**Figure E-94: Light material erosion on the bottom of glass disc around the pin (Week 8)**

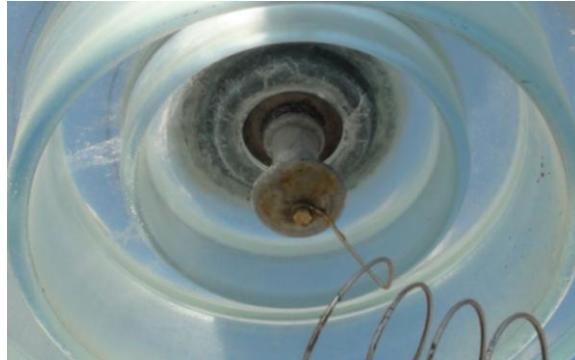
- *Deterioration:* The first traces of dryband activities were observed on the bottom of glass disc, prominent around the pin. Material erosion was first observed on the bottom of glass disc around the pin, as can be seen in Figure E-95.

**Figure E-95: The first instance of material erosion on the bottom of glass disc around the pin (Week 6)**

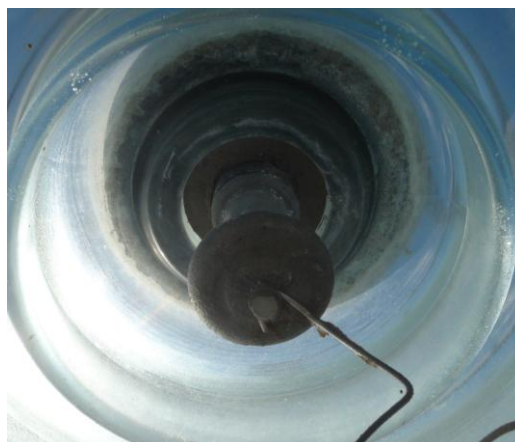
- *Deterioration:* Traces of dryband activity were seen on the bottom side of glass disc around the pin (refer to Figure E-96) and also on the top of glass disc around the cap. No other signs of deterioration were observed. No material erosion was observed, as can be seen below in Figure E-96.

**Figure E-96: Traces of dryband activity on the bottom of glass disc around the pin (Week 13)**

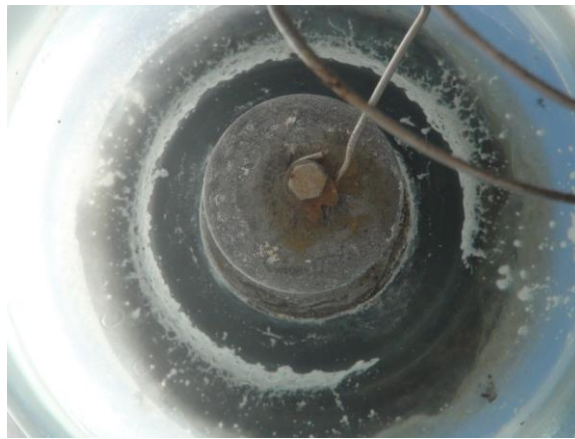
- *Deterioration:* Traces of dryband activity were observed on the bottom of glass disc around the pin. As reported for week 8, light material erosion was still observed on the bottom of glass disc around the pin. See Figure E-97.

**Figure E-97: Material erosion on the bottom of glass disc around the pin (Week 11)**

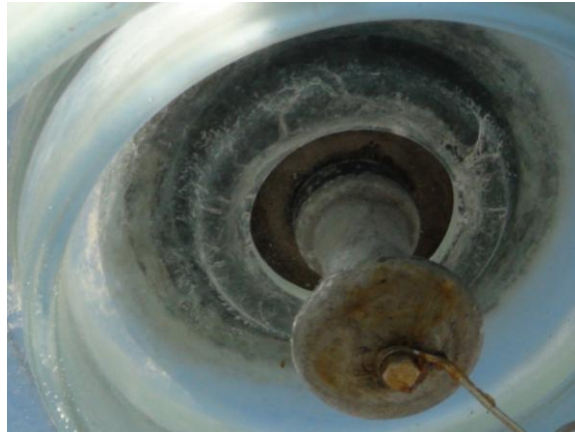
- *Deterioration:* Traces of dryband activity were observed on the bottom of glass disc around the pin. Material erosion was still observed on the bottom of glass disc around the pin, as it can be seen in Figure E-98.

**Figure E-98: Material erosion on the bottom of glass disc around the pin (Week 10)**

- *Deterioration:* Traces of dryband activity were observed on the top of glass disc around the cap in all directions and also on the bottom of glass disc around pin in all directions. Material erosion was still observed on the bottom of glass disc around pin, as reported for week 10. The traces of dryband activity and material erosion are shown in Figure E-102. It should be mentioned that the erosion has worsened compared to the observations reported for week 10 (refer to Figure E-98).

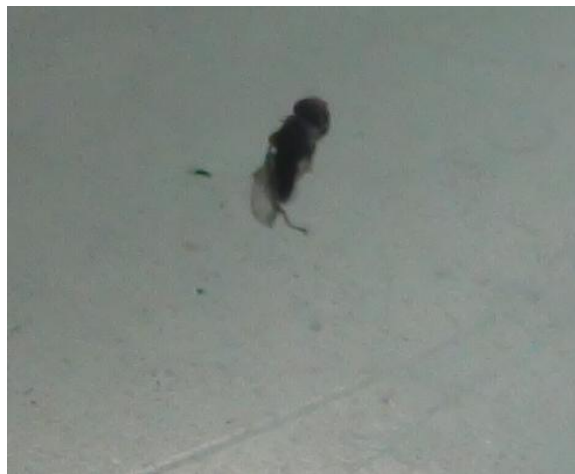
- *Other observations:* Light pollution was observed over the entire insulator, with medium pollution in the southward direction. Salt crystals were observed on the bottom of glass disc (outermost rim) in the southward direction. Plant threads were observed on the bottom of glass disc in the westward and northward directions. Depicted in Figure E-99, a dead insect was observed on the top of glass disc in the northward direction.

**Figure E-99: A dead insect on the top of glass disc (Week 10)**

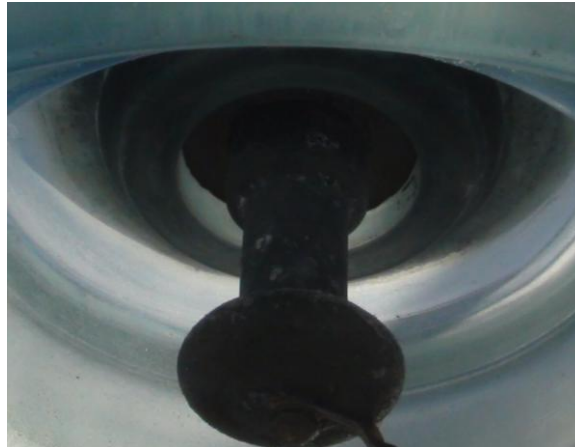
- *Deterioration:* Traces of dryband activity were seen on the bottom of glass disc around the pin and also on the top of glass disc around the cap in all directions. No other signs of deterioration were observed. It is also evident from Figure E-100 that

no sign of material erosion was observed on AC when compared to both DC+ (Figure E-101(b)) and DC- (Figure E-102 (b)).

**Figure E-100: The bottom view of glass disc (Week 22)**

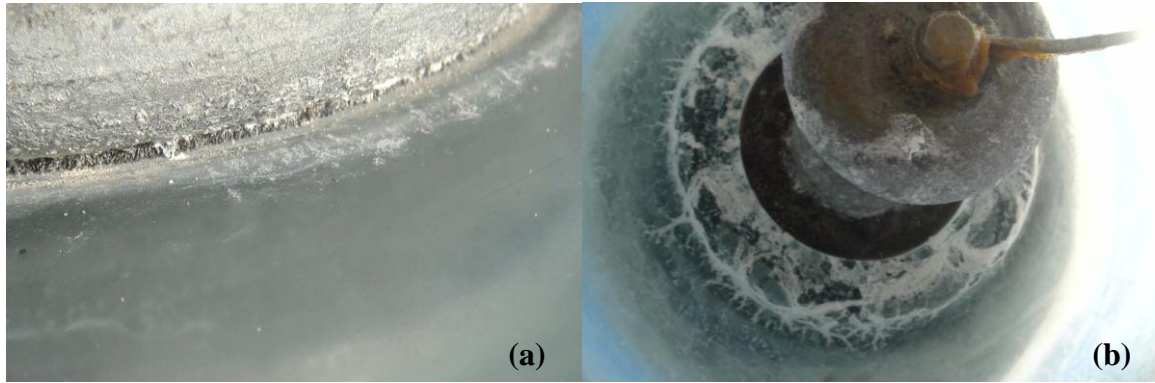
#### E.7.4.3 *Glass disc 42 DC- (Week 16)*

**Figure E-102: (a) Traces of dryband activity on the top of glass disc around the cap and (b) the signs of dryband activity and material erosion on the bottom side around the pin (Week 16)**
